**RE: Liner Inspection and Closure Report**  
**Lee 3 Fee 6H Battery**  
**API No. 30-015-41463**  
**GPS: Latitude 32.6829224 Longitude -104.3708954**  
**UL- N, Section 03, Township 19S, Range 26E**  
**Eddy County, NM**  
**NMOCD Reference No. NAPP2215430133**

Spur Energy Partners (Spur) has contracted Pima Environmental Services, LLC (Pima) to perform a liner inspection and prepare this closure report for the release of crude oil and produced water that happened at the Lee 3 Fee 6H Battery (Lee). On June 2, 2022, the initial C-141 was formally submitted. The corresponding release received the designation Incident ID NAPP2215430133 from the New Mexico Oil Conservation Division (NMOCD).

# Lee 3 Fee 6H Battery

Spur Energy  
API: 30-015-41463  
Eddy County, NM  
Location Map

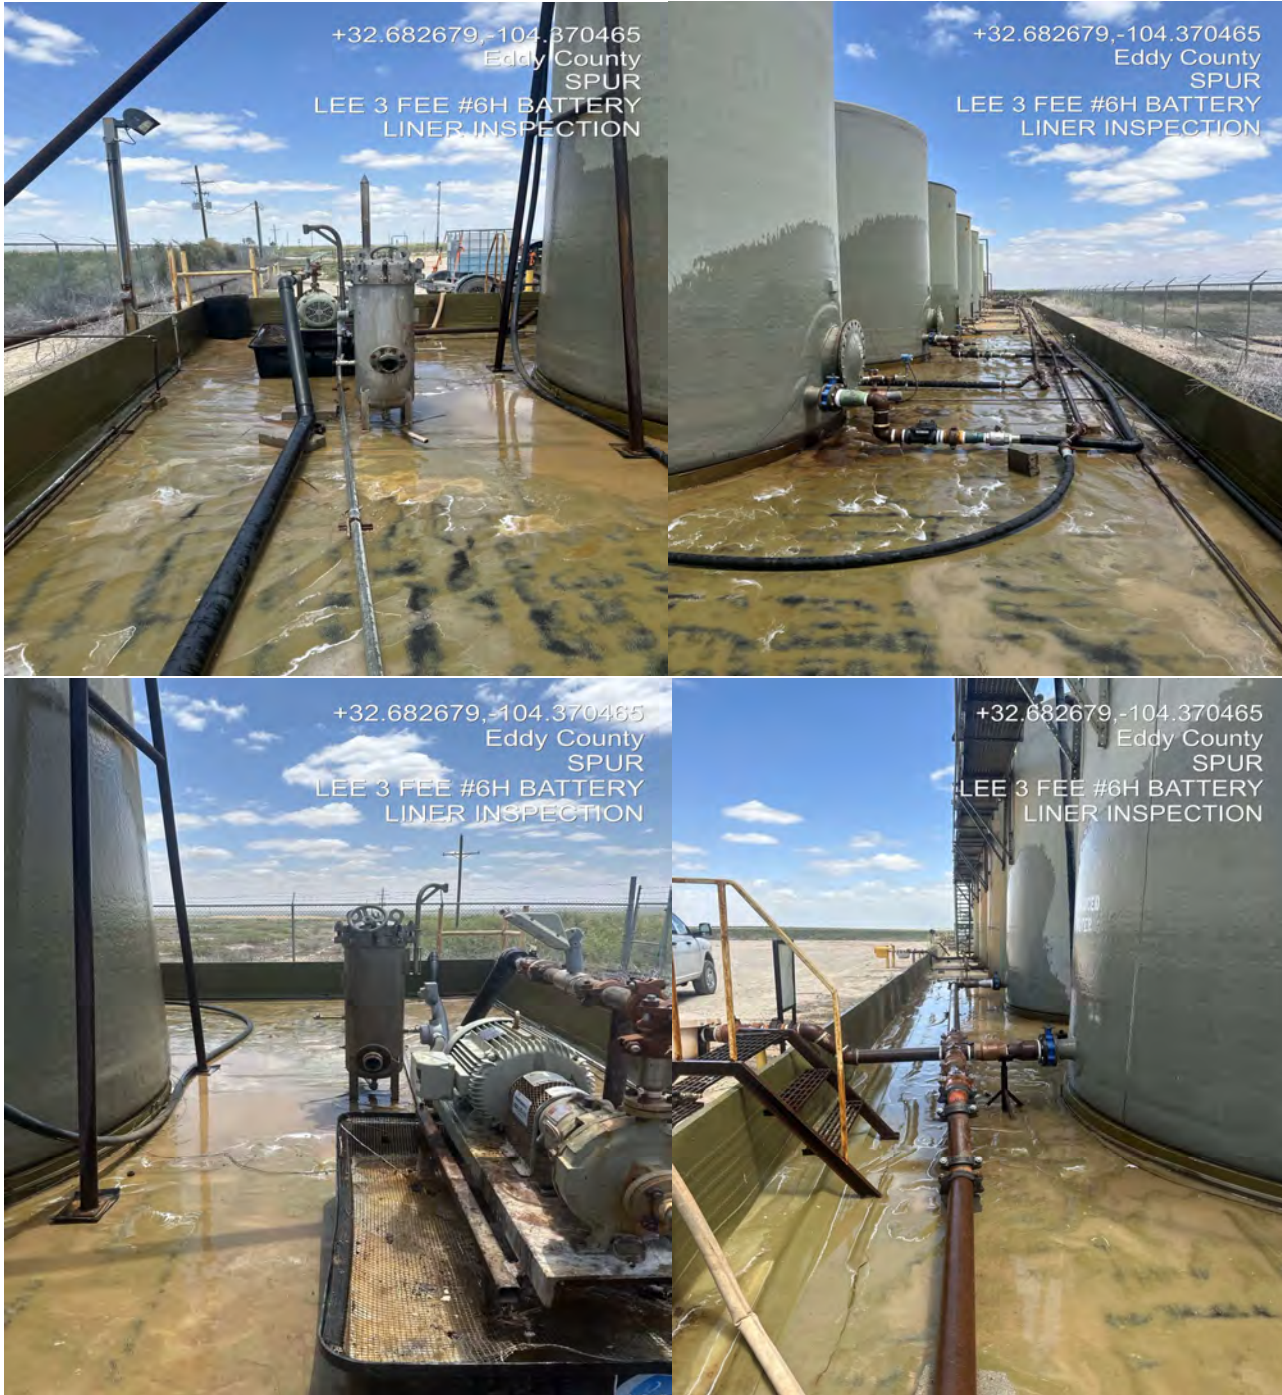
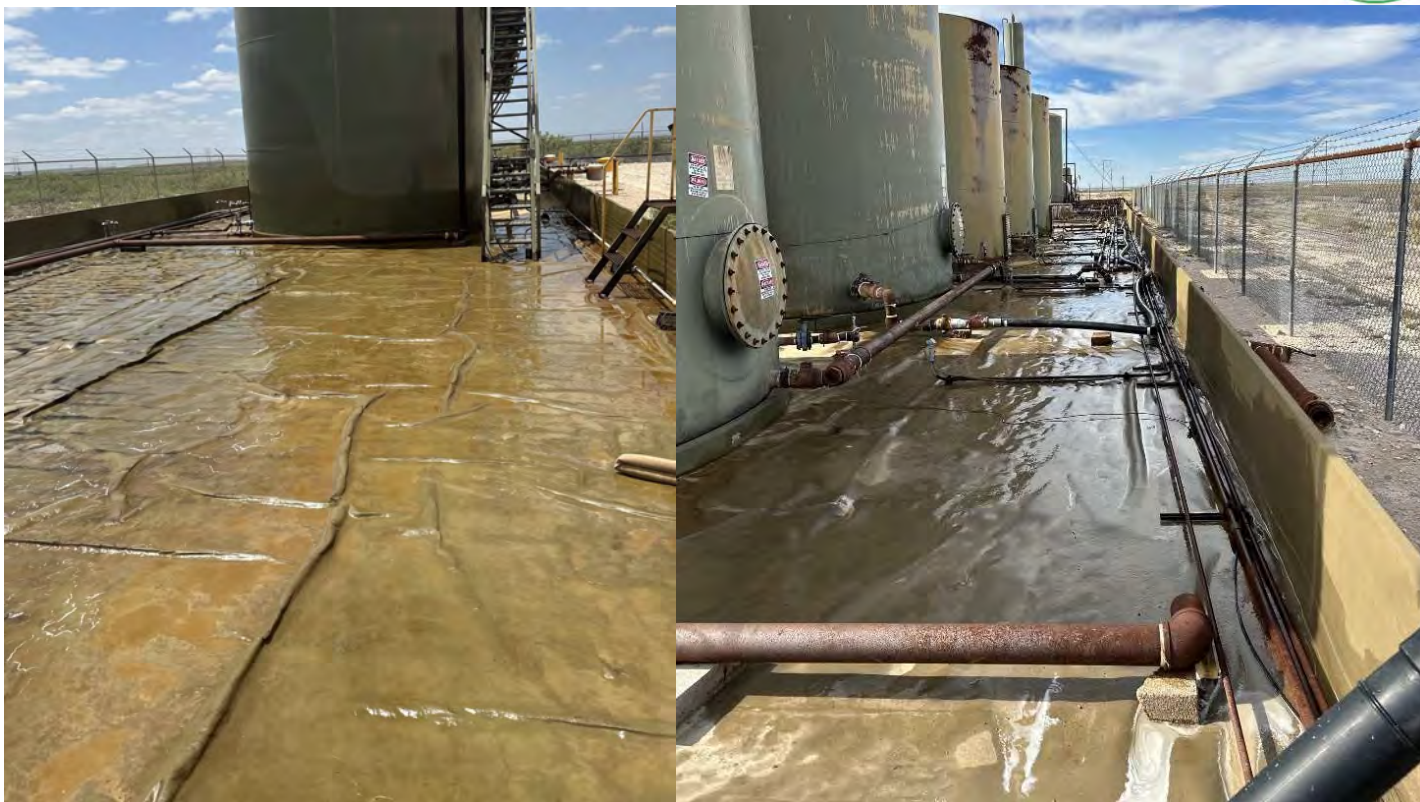
### Liner Inspection

On June 25, 2024, Pima Environmental conducted a liner inspection at the Lee, covering approximately 4,800 square feet. We concluded that the liner and containment maintained their integrity and successfully retained the fluids. The liner inspection form and photographic

Visualization	Yes	No	Comments
Is there a tear in the liner?		X	
Are there holes in the liner?		X	
Is the liner retaining any fluids?	X		The liner has a film of water due to pressure washing activities.
Does the liner have integrity to contain a leak?	X
