## CLOSURE REPORT

**State Gas Com #3 (06/27/23)**  
Unit Letter J, S32 T31N R12W  
San Juan County, New Mexico

**New Mexico EMNRD OCD Incident ID No. NAPP2317847012**

Ensolum Project No. 05A1226250

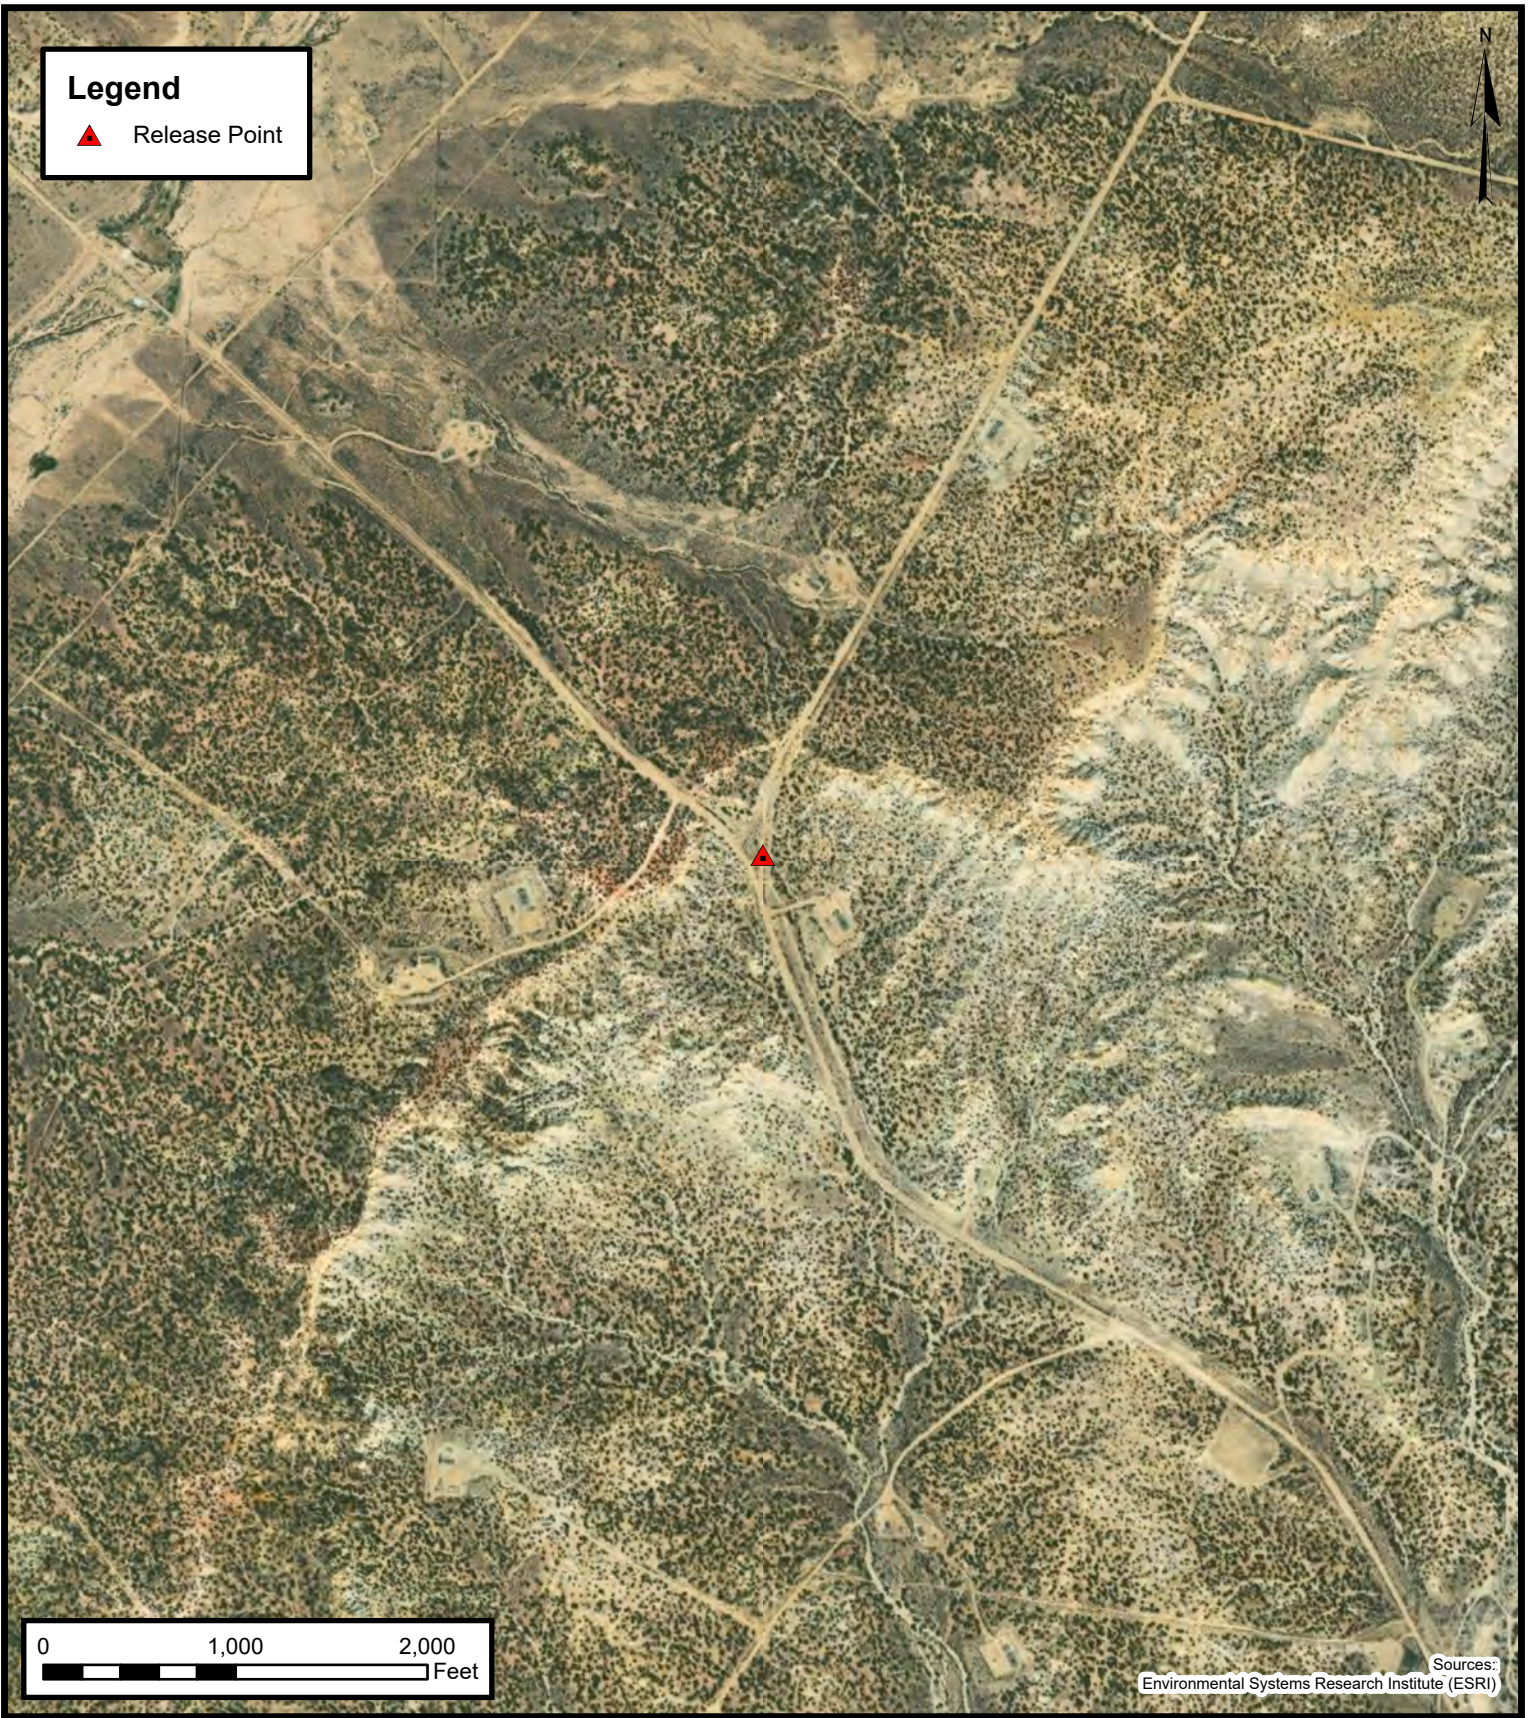
FIGURE  
2

## Site Vicinity Map

A **Topographic Map** depicting the location of the Site is included as **Figure 1**, and a **Site Vicinity Map** is included as **Figure 2** in **Appendix A**.

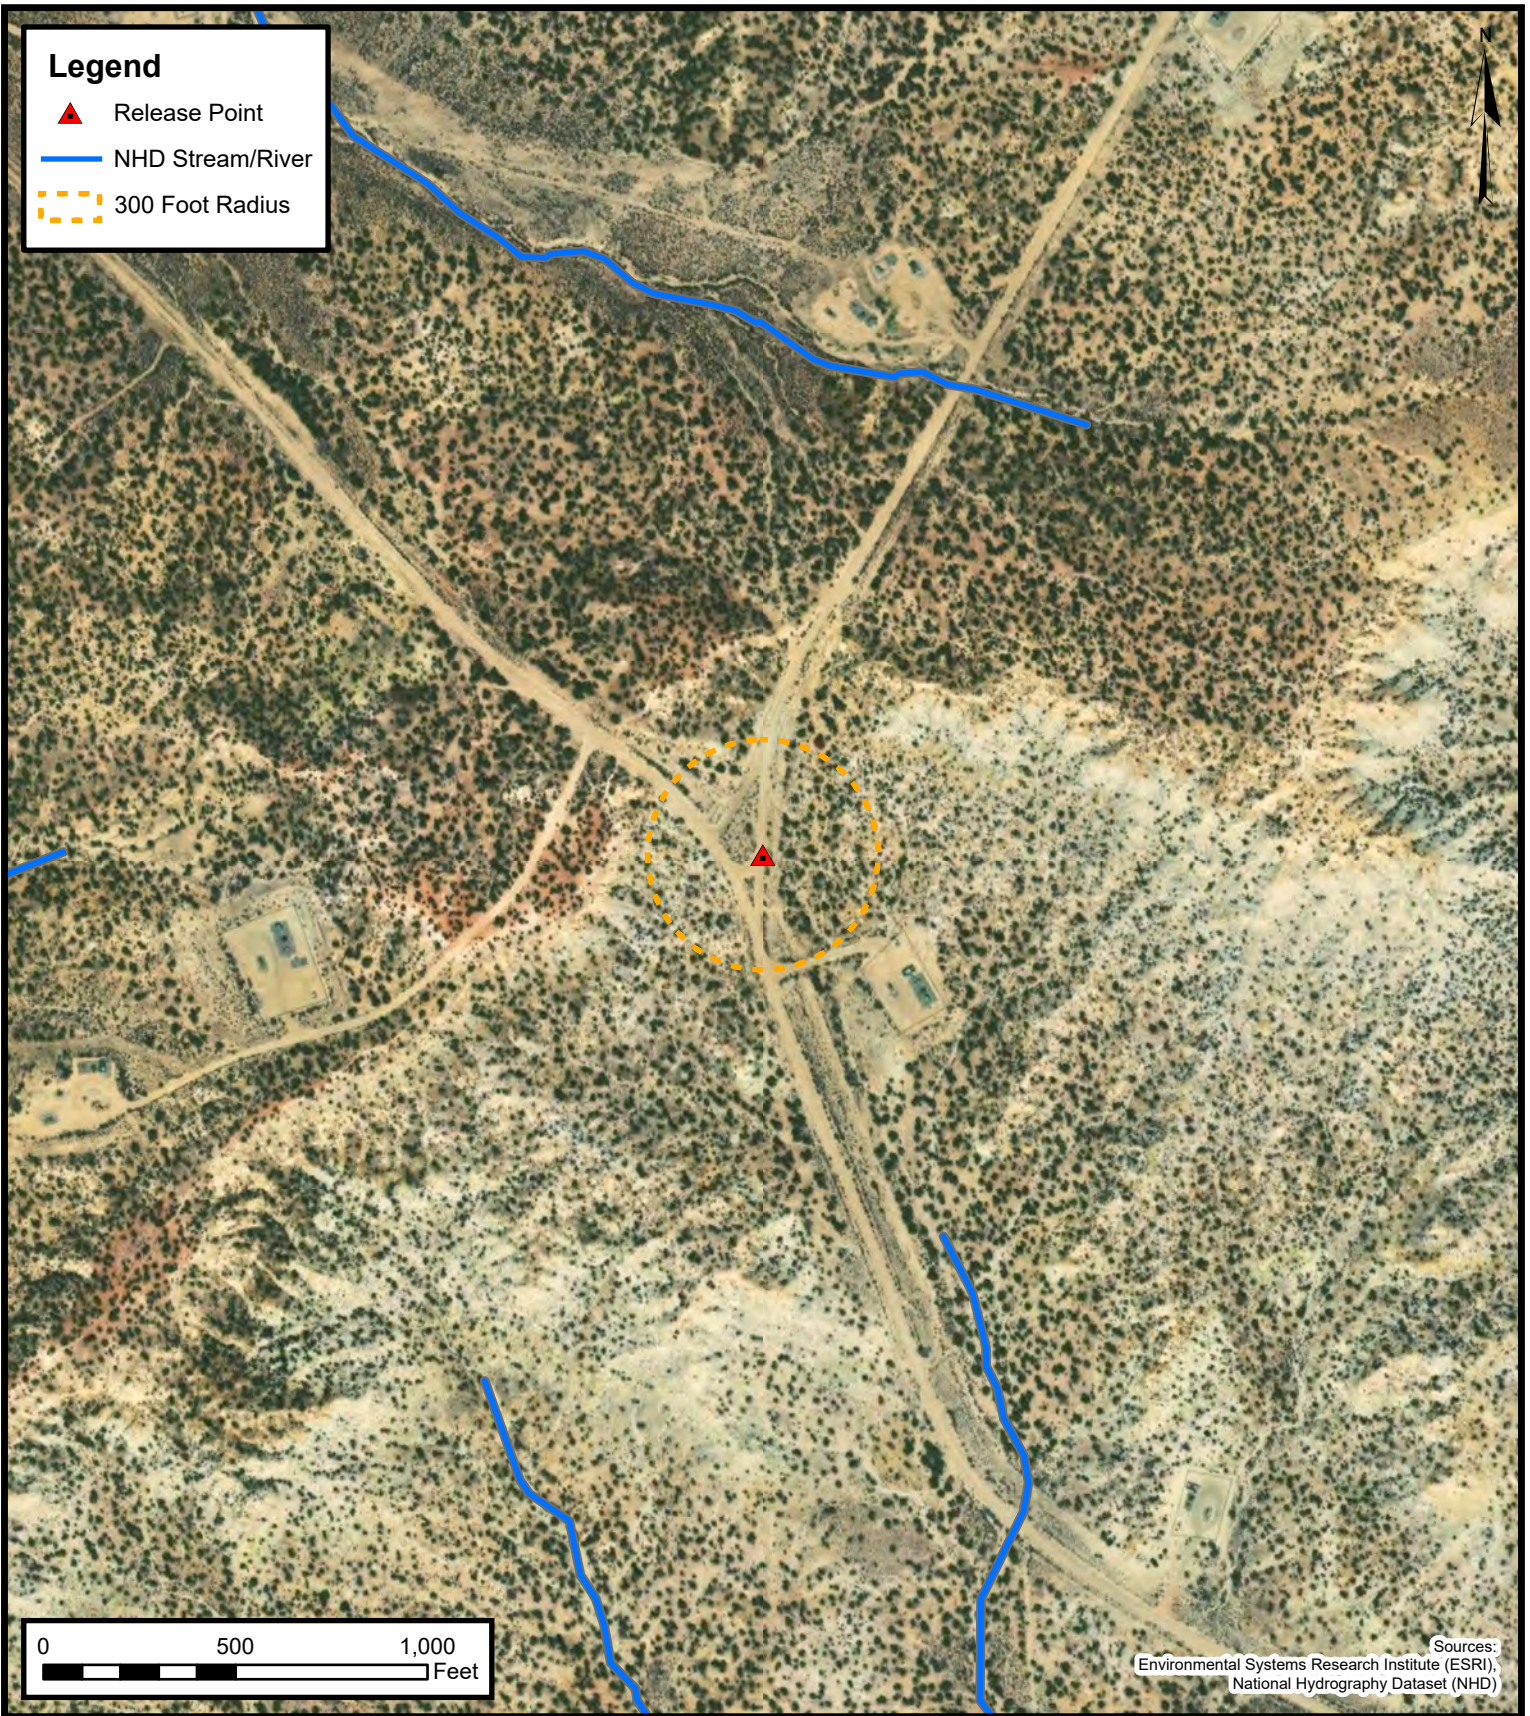
FIGURE  
C

### 300 Foot Radius Watercourse and Drainage Identification

- The Site is located within 300 feet of an NM EMNRD OCD-defined significant watercourse (**Figure C, Appendix B**).
- The Site is not located within 200 feet of a lakebed, sinkhole, or playa lake.

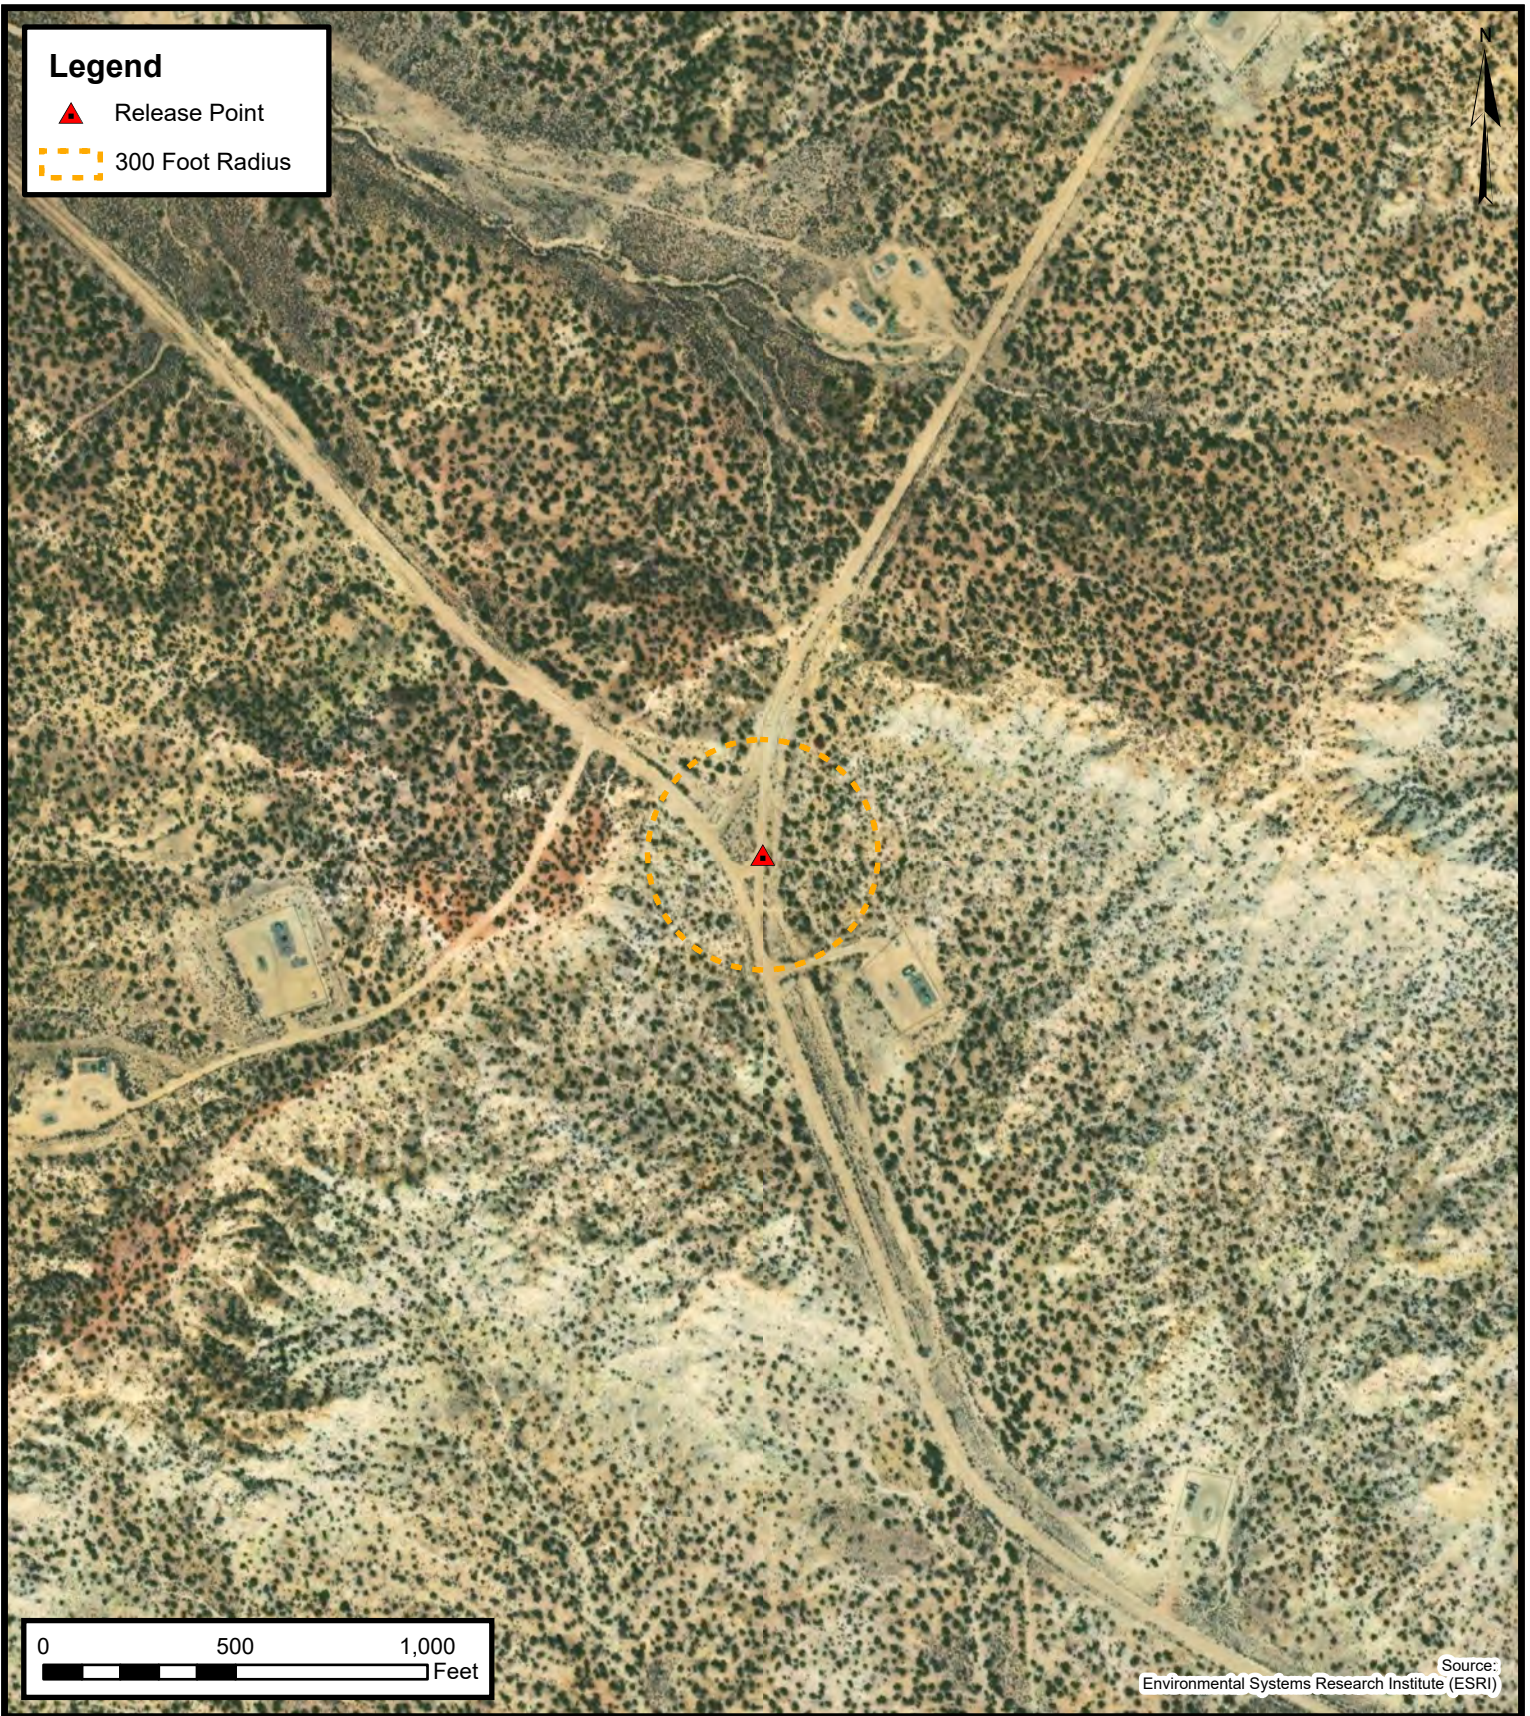
**FIGURE  
D**

### 300 Foot Radius Occupied Structure Identification

- The Site is not located within 300 feet of a permanent residence, school, hospital, institution, or church (**Figure D, Appendix B**).
- No springs, or private domestic freshwater wells used by less than five households for domestic or stock watering purposes were identified within 500 feet of the Site (**Figure E, Appendix B**).

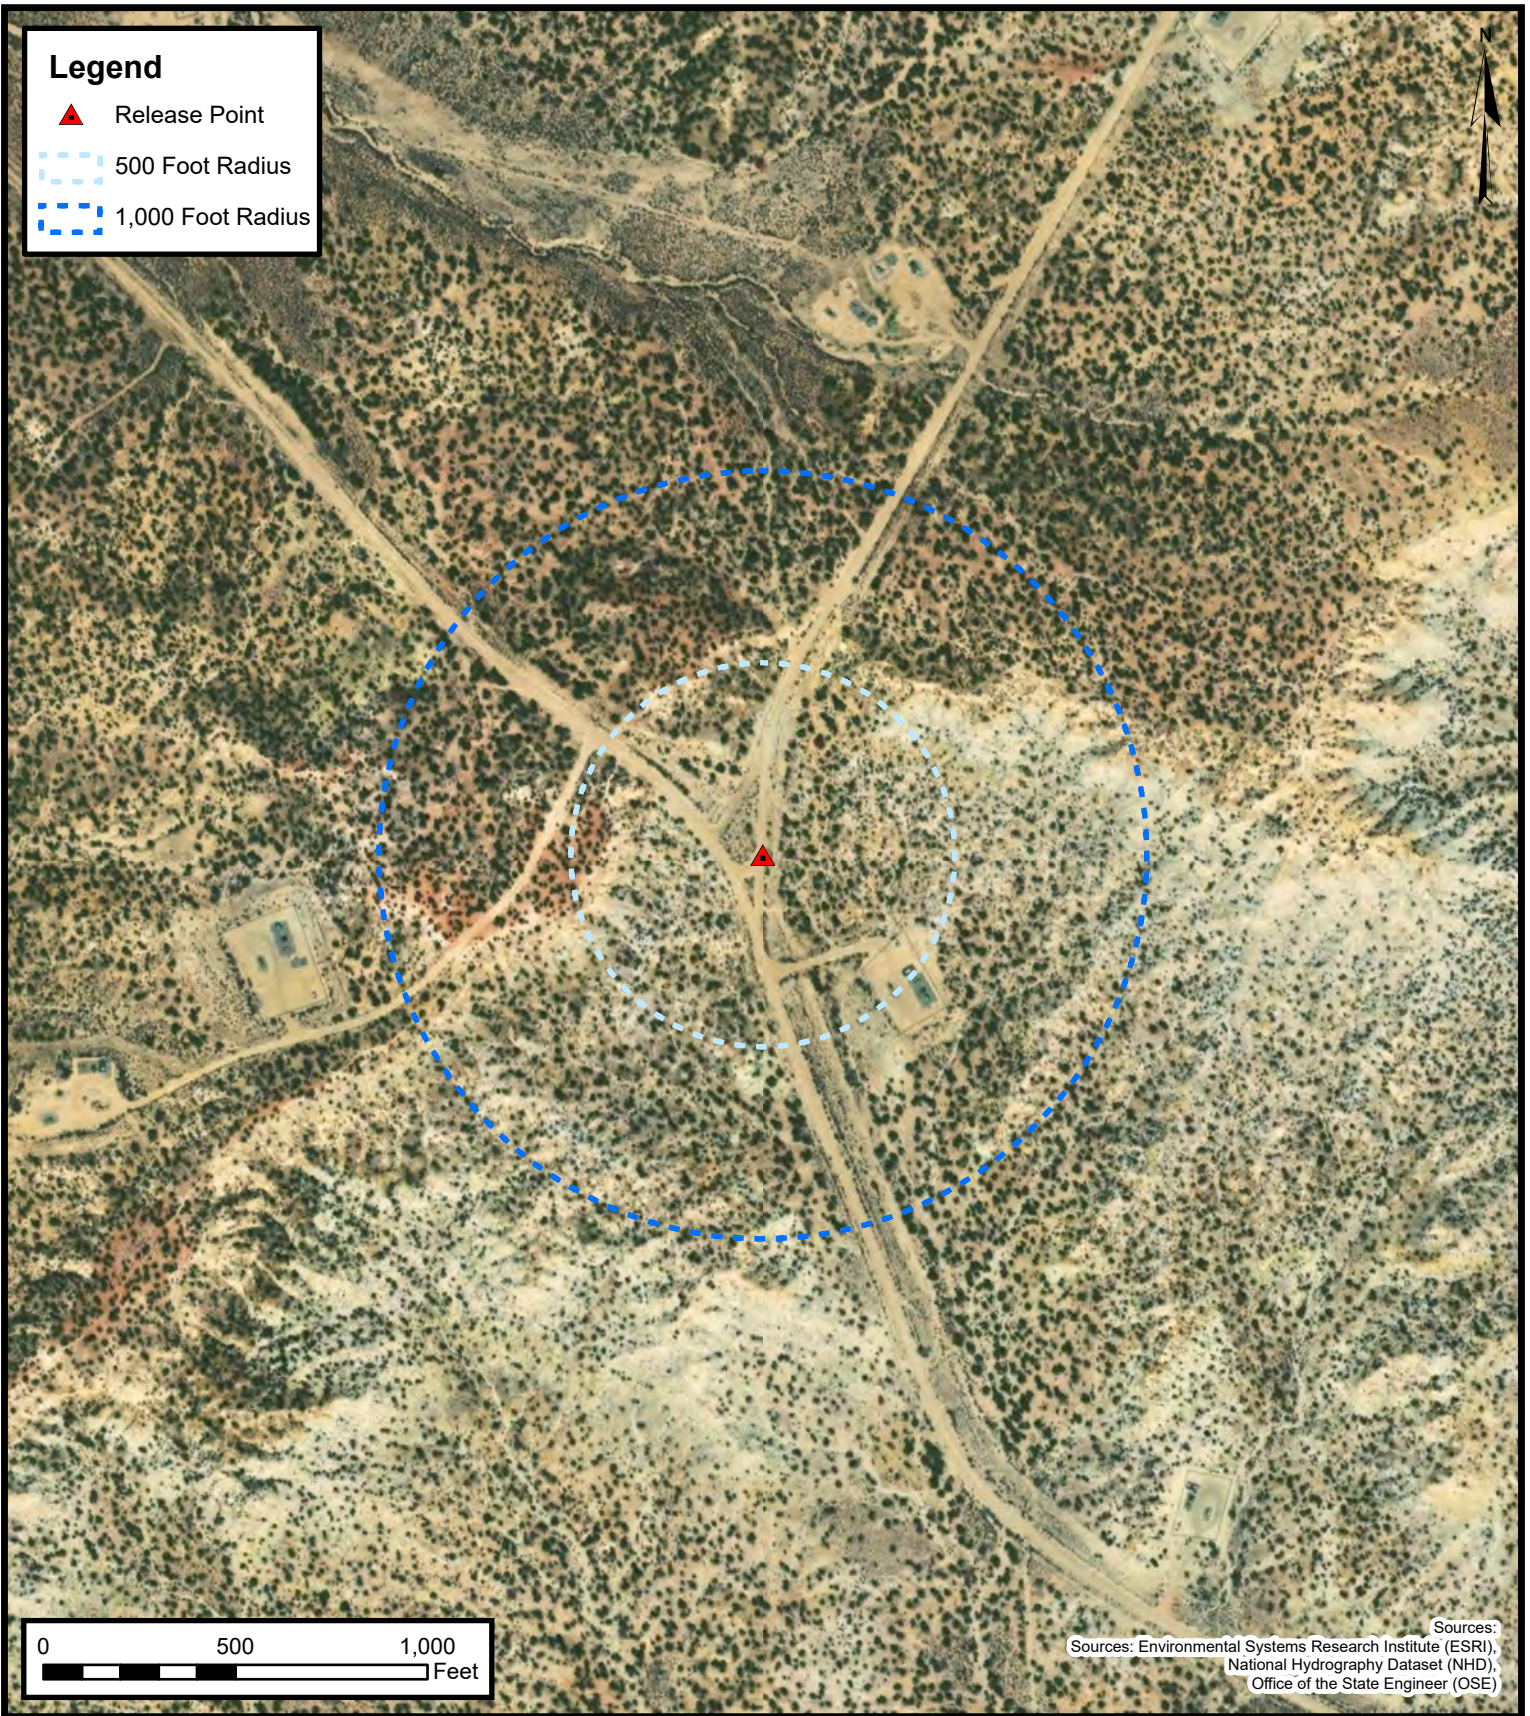
**FIGURE  
E**

**Water Well and  
Natural Spring Location**

- No freshwater wells or springs were identified within 1,000 feet of the Site (**Figure E, Appendix B**).
- The Site is not located within incorporated municipal boundaries or within a defined municipal fresh water well field covered under a municipal ordinance adopted pursuant to New Mexico Statutes Annotated (NMSA) 1978, Section 3-27-3.

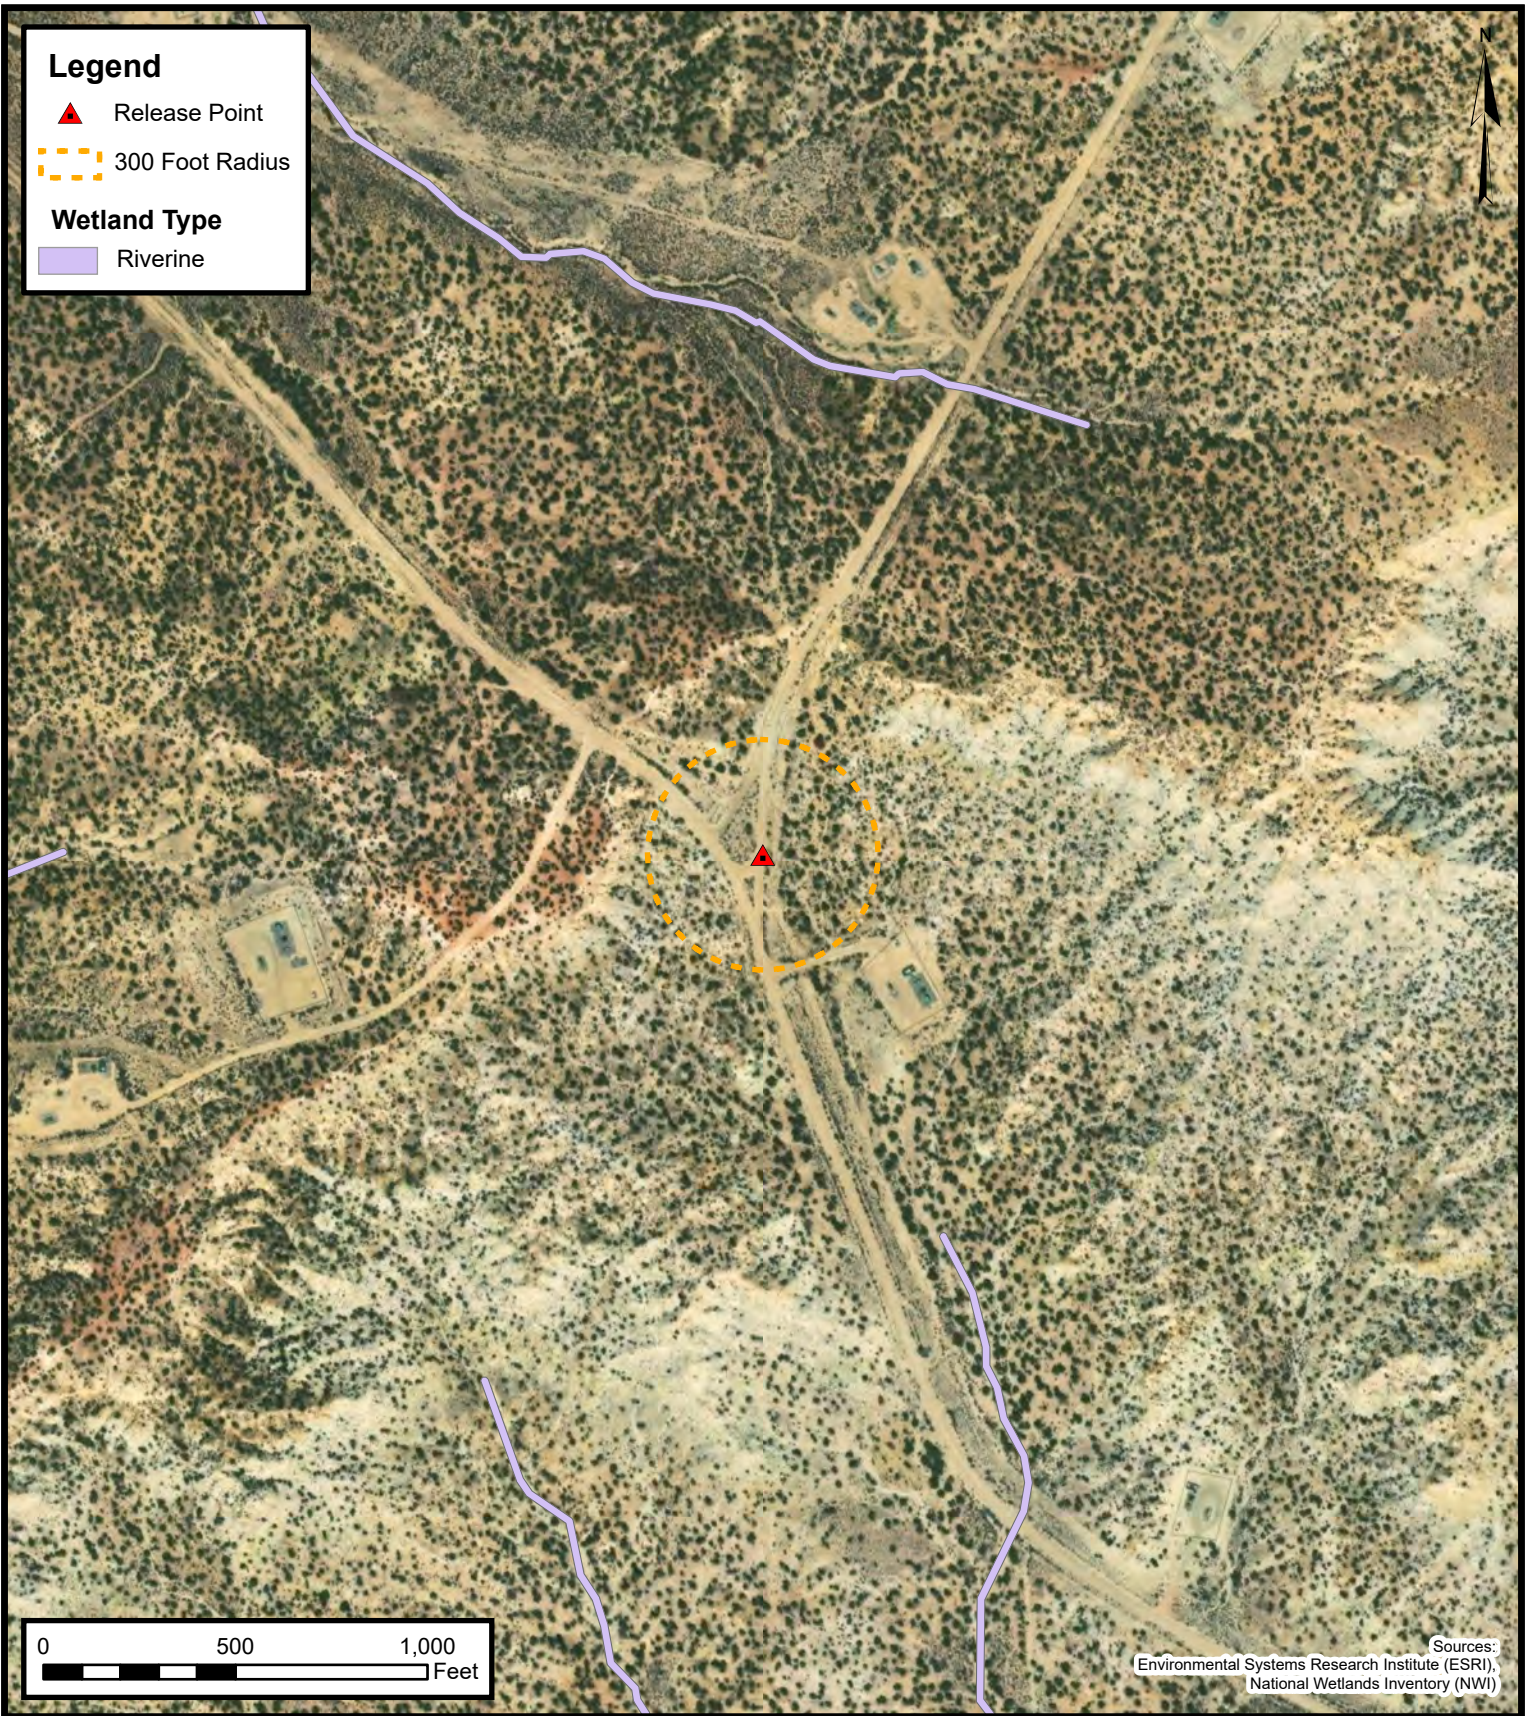
FIGURE  
F

## Wetlands

- Based on information identified in the U.S. Fish & Wildlife Service National Wetlands Inventory Wetlands Mapper, the Site is not within 300 feet of a wetland (**Figure F, Appendix B**).

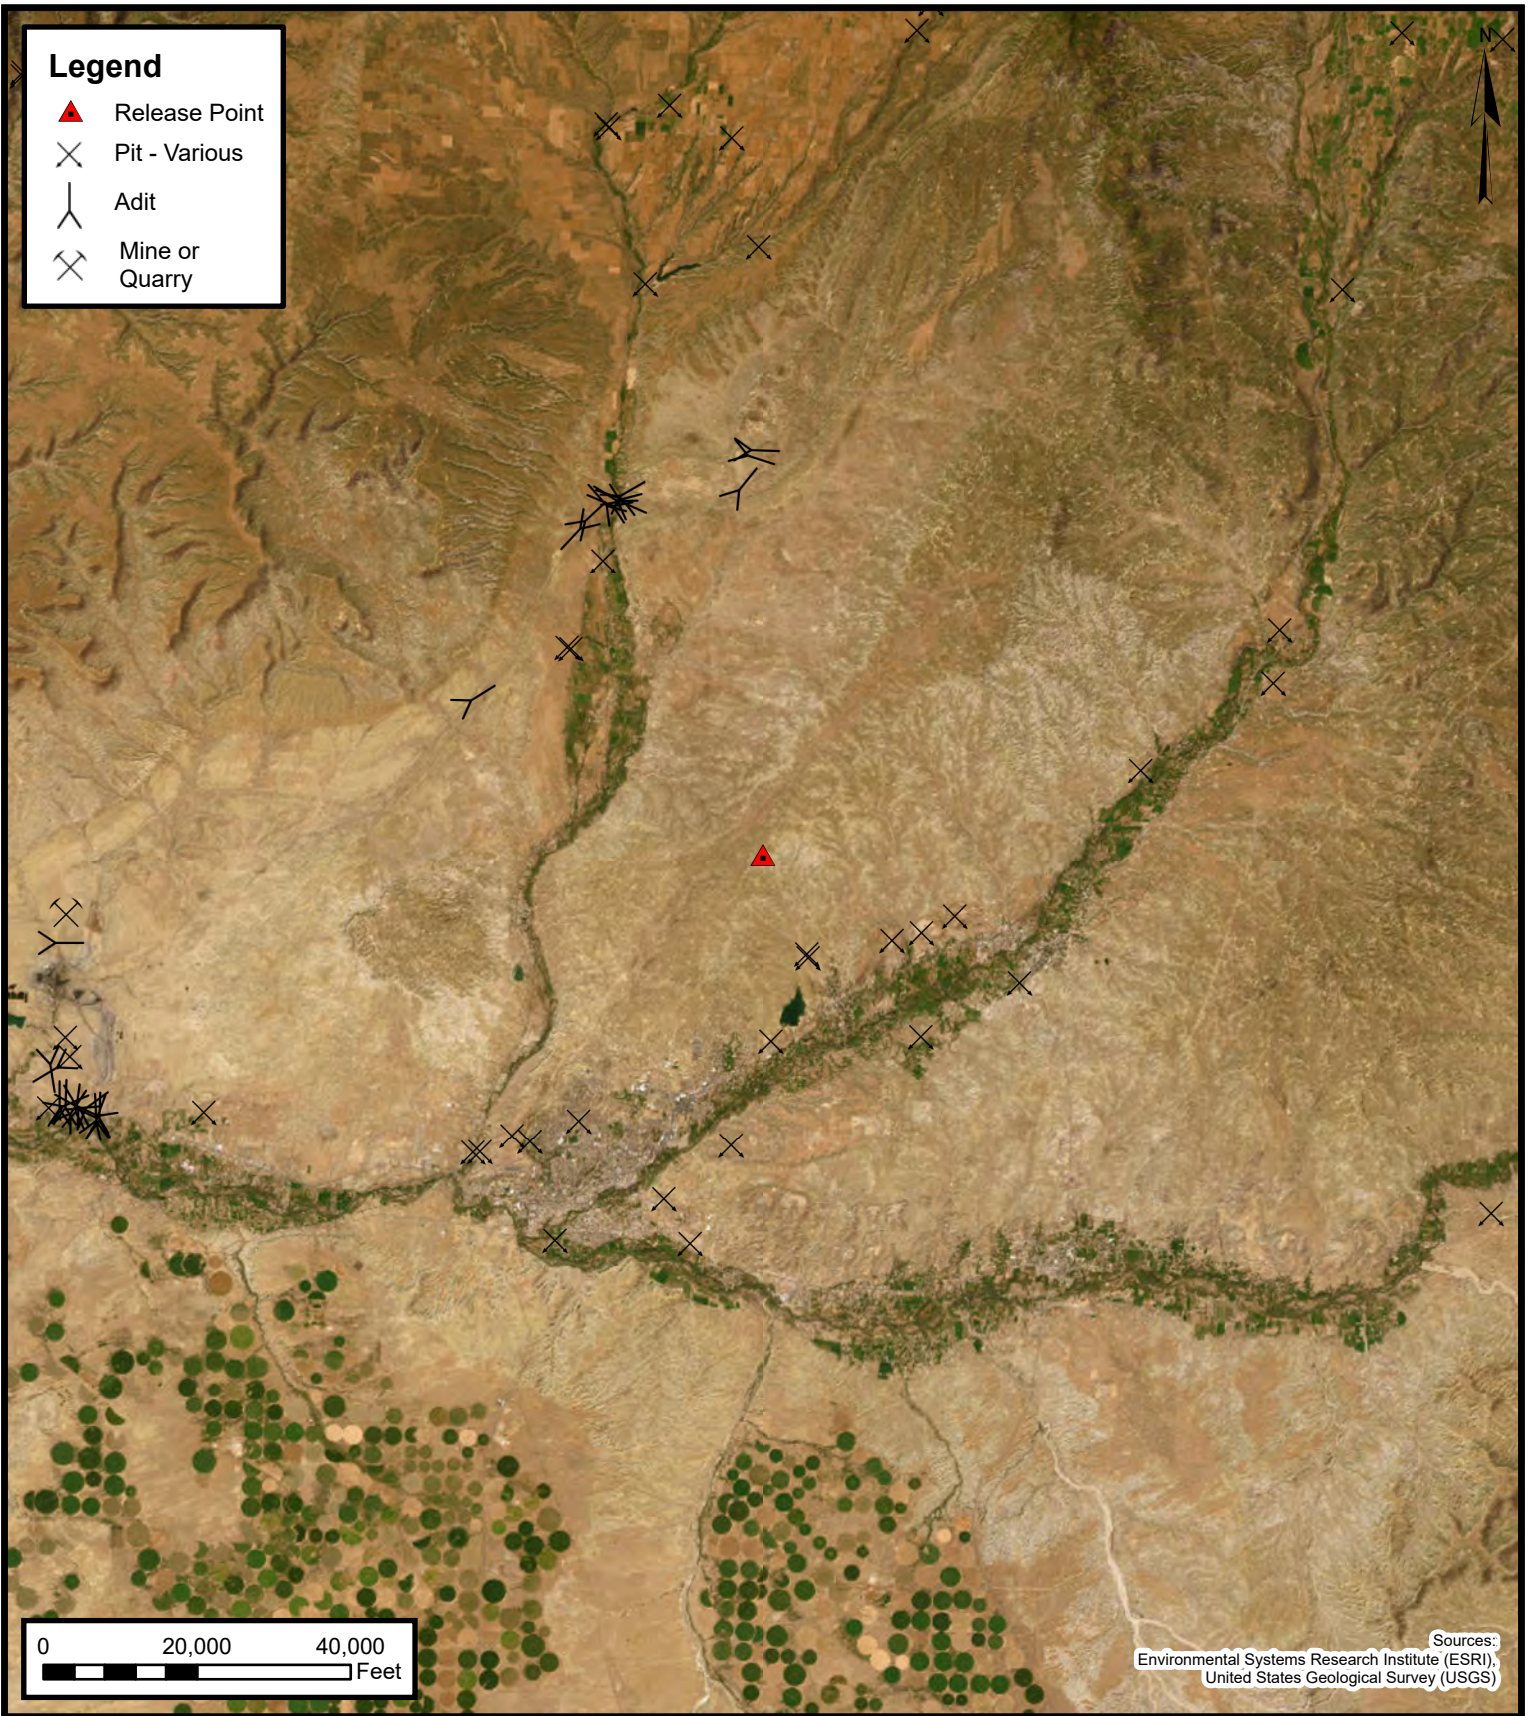
FIGURE  
**G**

## Mines, Mills, and Quarries

- Based on information identified in the NM Mining and Minerals Division's Geographic Information System (GIS) Maps and Mine Data database, the Site is not within an area overlying a subsurface mine (**Figure G, Appendix B**).

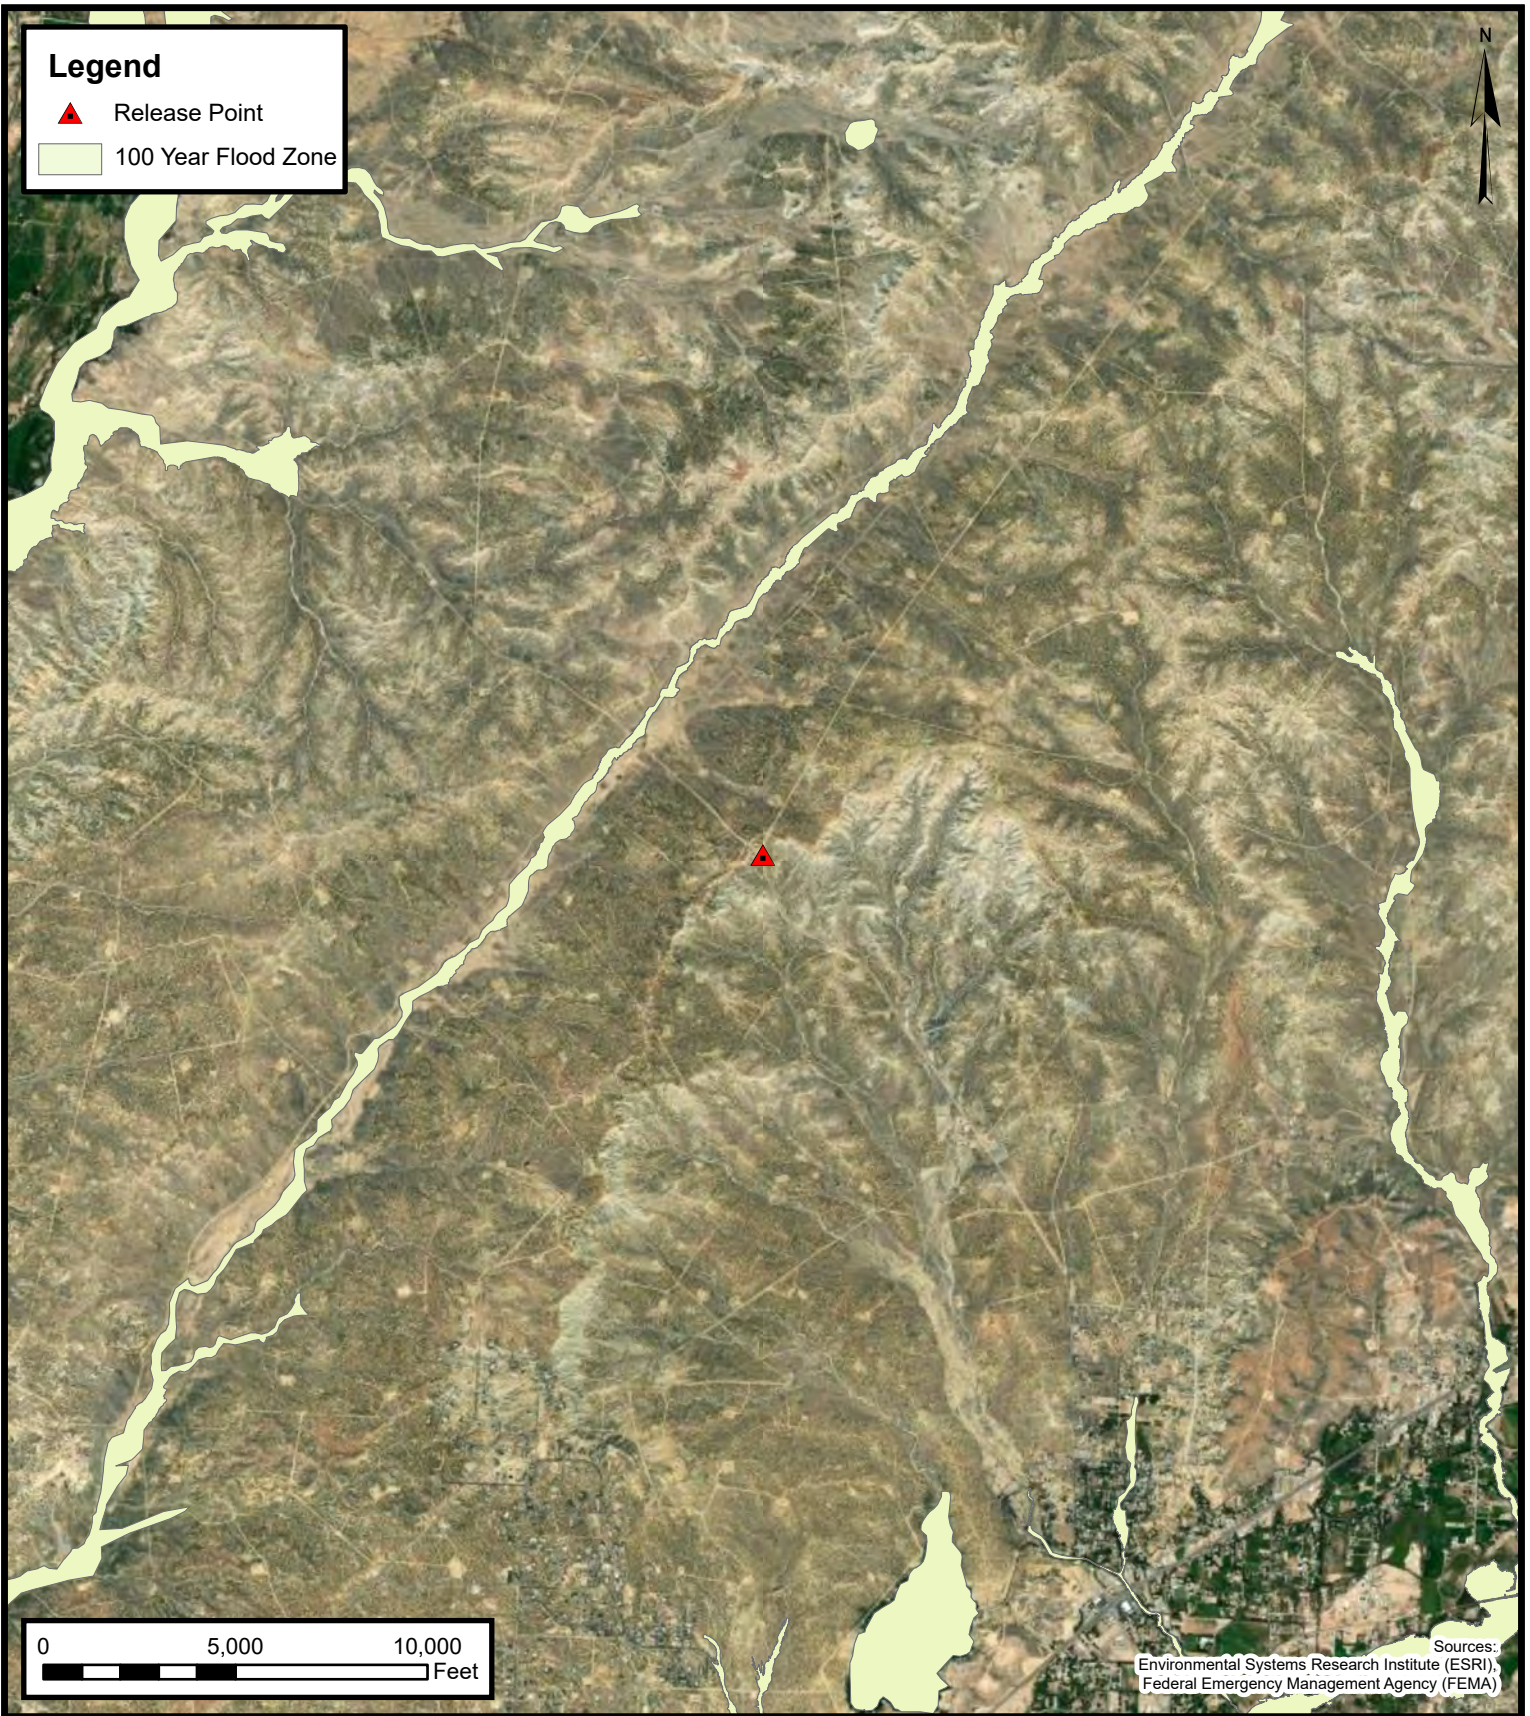
FIGURE  
H

## 100-Year Flood Plain Map

- The Site is not located within an unstable area per Paragraph (6) of Subsection U of 19.15.2.7 NMAC.
- Based on information provided by the Federal Emergency Management Agency (FEMA) National Flood Hazard Layer (NFHL) geospatial database, the Site is not within a 100-year floodplain (**Figure H, Appendix B**).

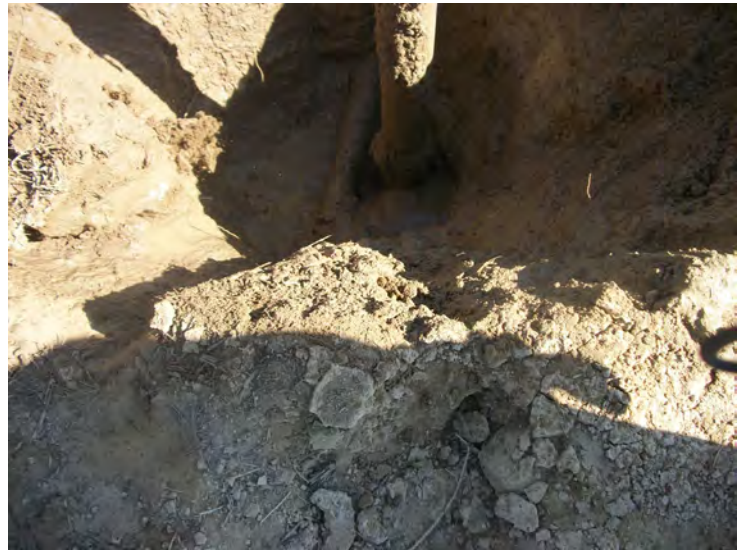
**Photograph 1**

The final excavation measured approximately 4 feet long and 3 feet wide at the maximum extents. The maximum depth of the excavation measured approximately 4 feet bgs. The flow path measured approximately 51 feet long and 8 inches wide. The lithology encountered during the completion of remediation activities consisted primarily of silty sand.

Photograph Description: View of the excavation.

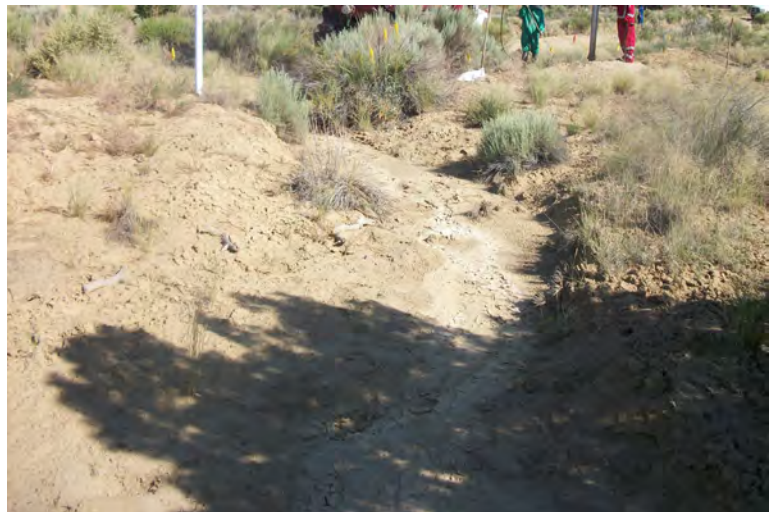
**Photograph 2**

Photograph Description: View of the sampled flow path.

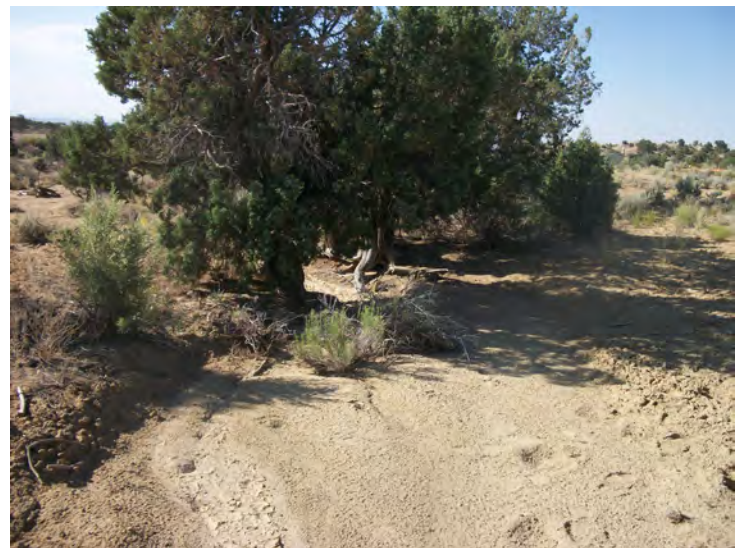
**Photograph 3**

Photograph Description: View of the sampled flow path.

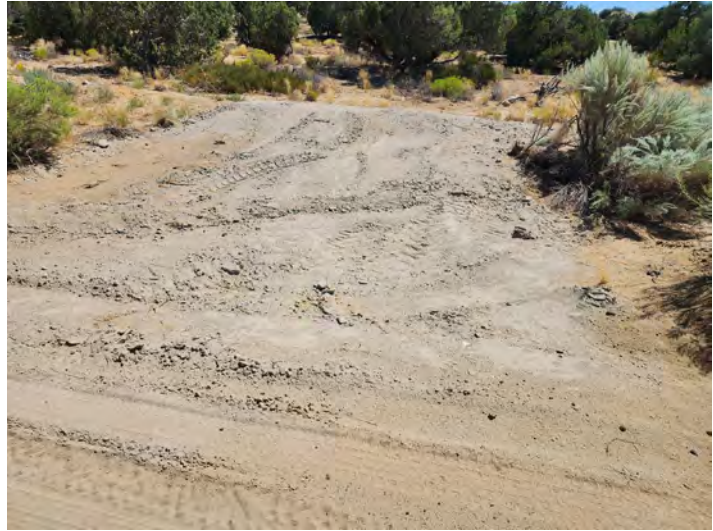
### Photograph 4

Photograph Description: View of the site after initial restoration.

The excavation was backfilled with surrounding soils and then contoured to the surrounding topography.
