## CLOSURE REPORT

**Canyon Largo #243 (08/29/23)**  
Unit Letter H, S14 T25N R7W  
Rio Arriba County, New Mexico

**New Mexico EMNRD OCD Incident ID No. NAPP2324237500**

Ensolum Project No. 05A1226278

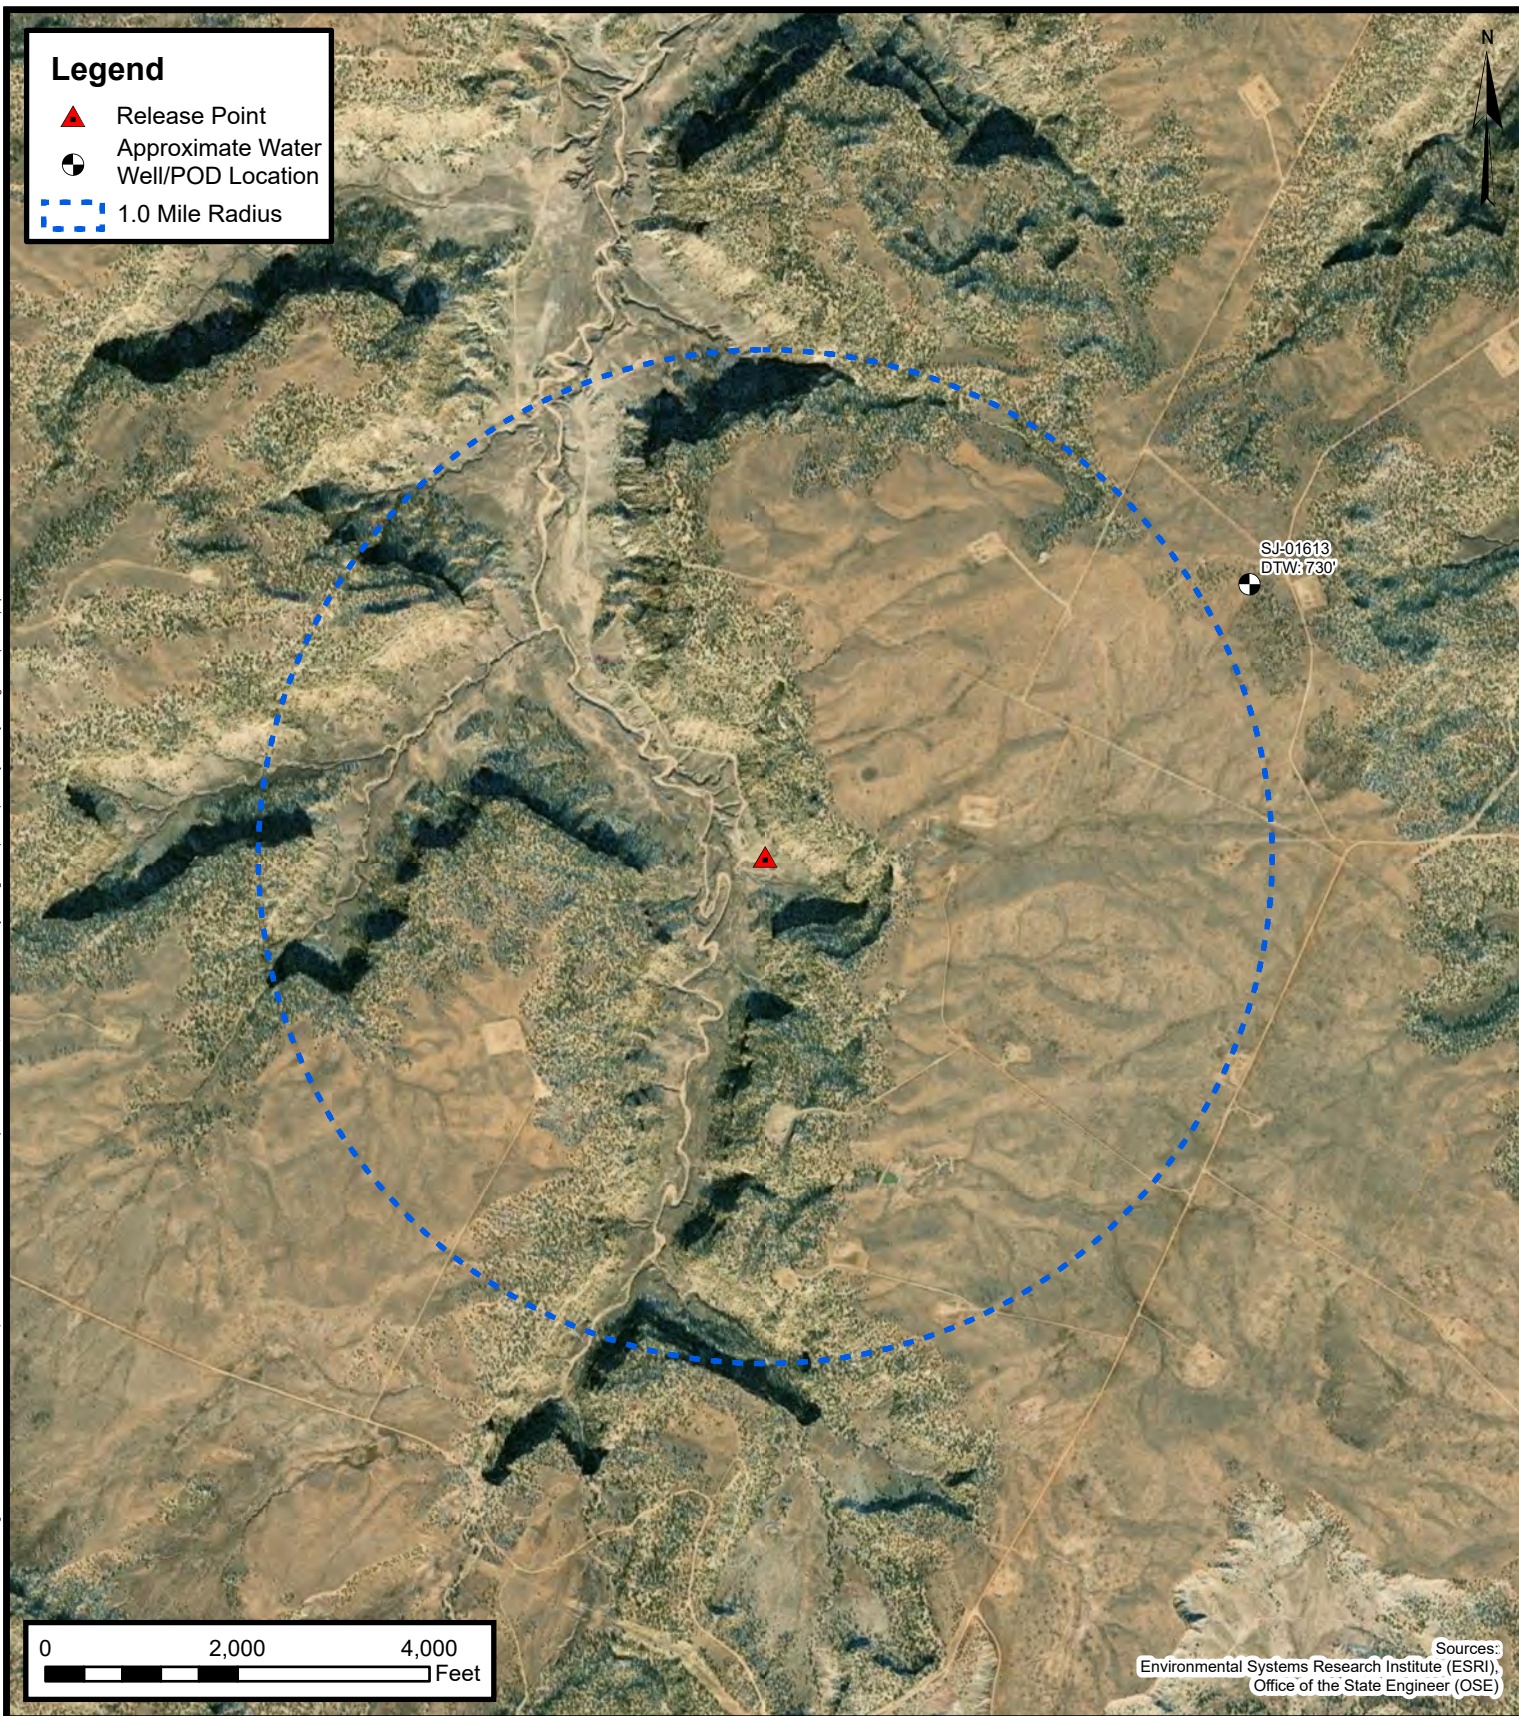
FIGURE  
**A**

- The NM Office of the State Engineer (OSE) tracks the usage and assignment of water rights and water well installations and records this information in the Water Rights Reporting System (WRRS) database. Water wells and other points of diversion (PODs) are each assigned POD numbers in the database (which is searchable and includes an interactive map). No PODs were identified in the same Public Land Survey System (PLSS) section. One POD (SJ-01613) was identified in an adjacent PLSS section (**Figure A, Appendix B**). The recorded depth to water for this POD is 730 feet below grade surface (bgs). This POD is located approximately 1.1 miles northeast of the Site and approximately 527 feet higher in elevation than the Site.

## 1.0 Mile Radius Water Well/POD Location Map

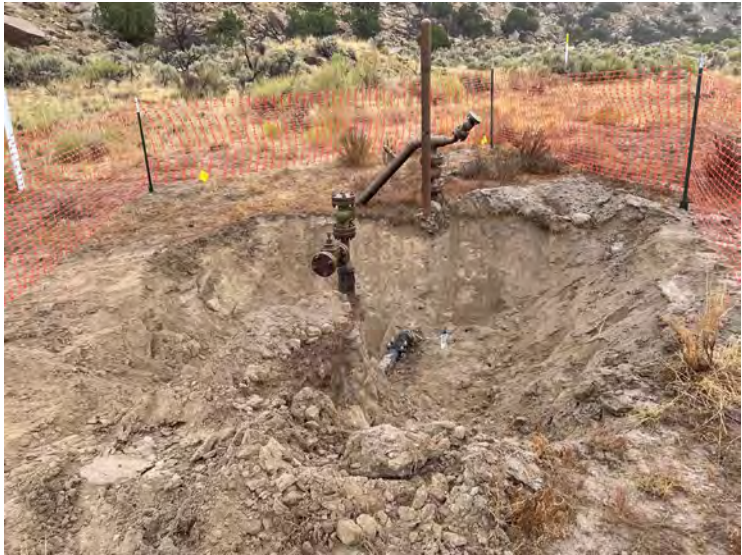
**Photograph 1**

Photograph Description: View of the in-process excavation activities.

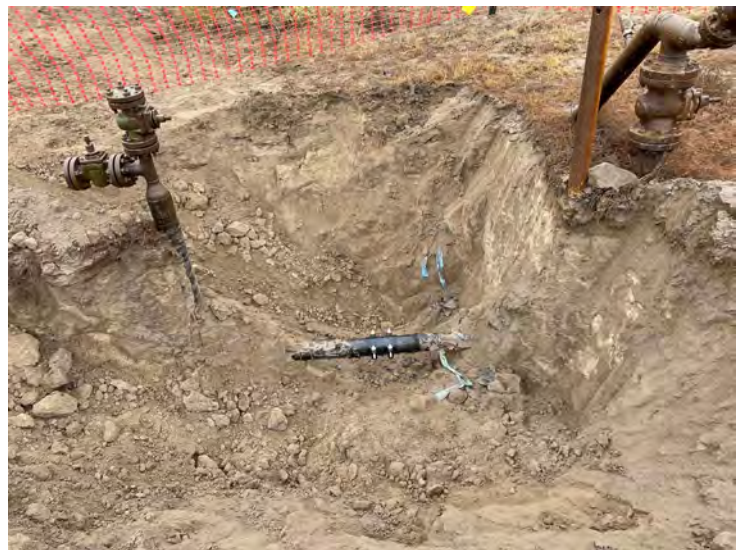
**Photograph 2**

Photograph Description: View of the in-process excavation activities.

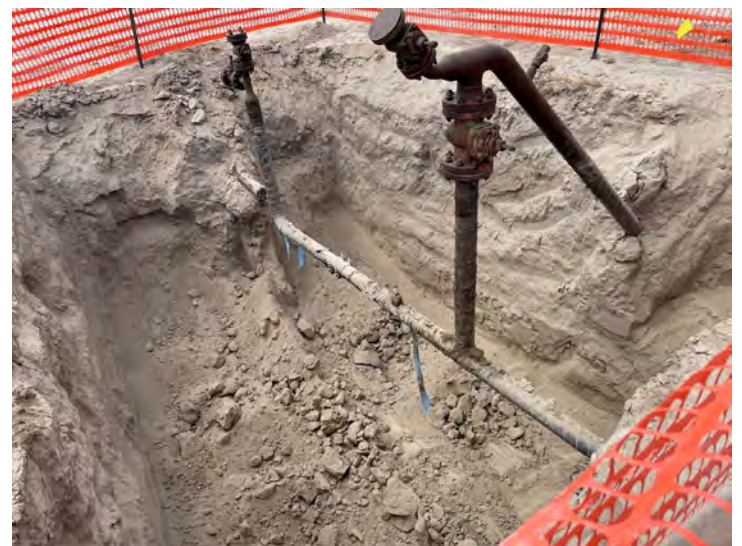
**Photograph 3**

The final excavation measured approximately 17 feet long and 13 feet wide at the maximum extents. The maximum depth of the excavation measured approximately 8.5 feet bgs. The scraped overspray area measured approximately 50 feet long and 20 wide at the maximum extents with an average depth of 6 inches. The lithology encountered during the completion of remediation activities consisted primarily of silty sand.

Photograph Description: View of the final excavation.

Enterprise has not yet determined a permanent repair strategy for the pipeline; therefore, the excavation has not yet been backfilled at the time this document was finalized. Once permanent pipeline repairs are completed, Enterprise will backfill the excavation with imported fill and then contour to the surrounding grade.

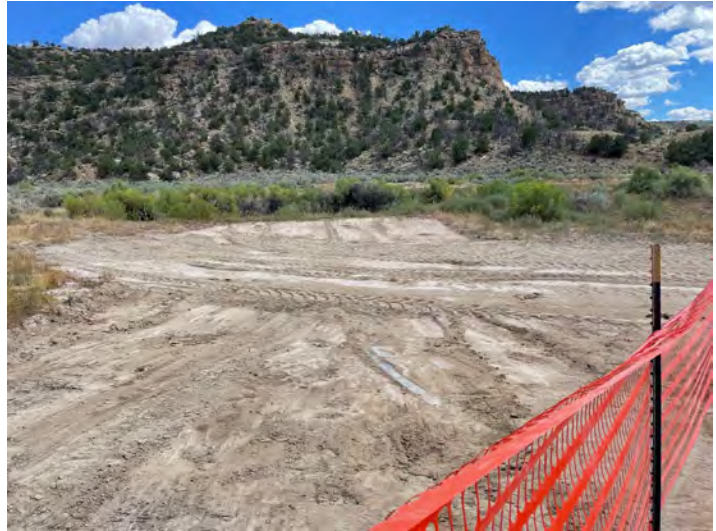
### Photograph 4

Photograph Description: View of scraped overspray area.
