**Re: Site Characterization and Remediation Work Plan  
BTA Oil Producers, LLC  
Harroun Ranch West Fire  
Unit Letter O, Section 20, Township 23 South, Range 29 East  
Eddy County, New Mexico  
NMOCD Incident ID# nAPP2411724780**

Site Characterization and Remediation Work Plan  
 BTA Oil Producers, LLC  
 Harroun Ranch West Fire  
 Incident ID# nAPP2411724780

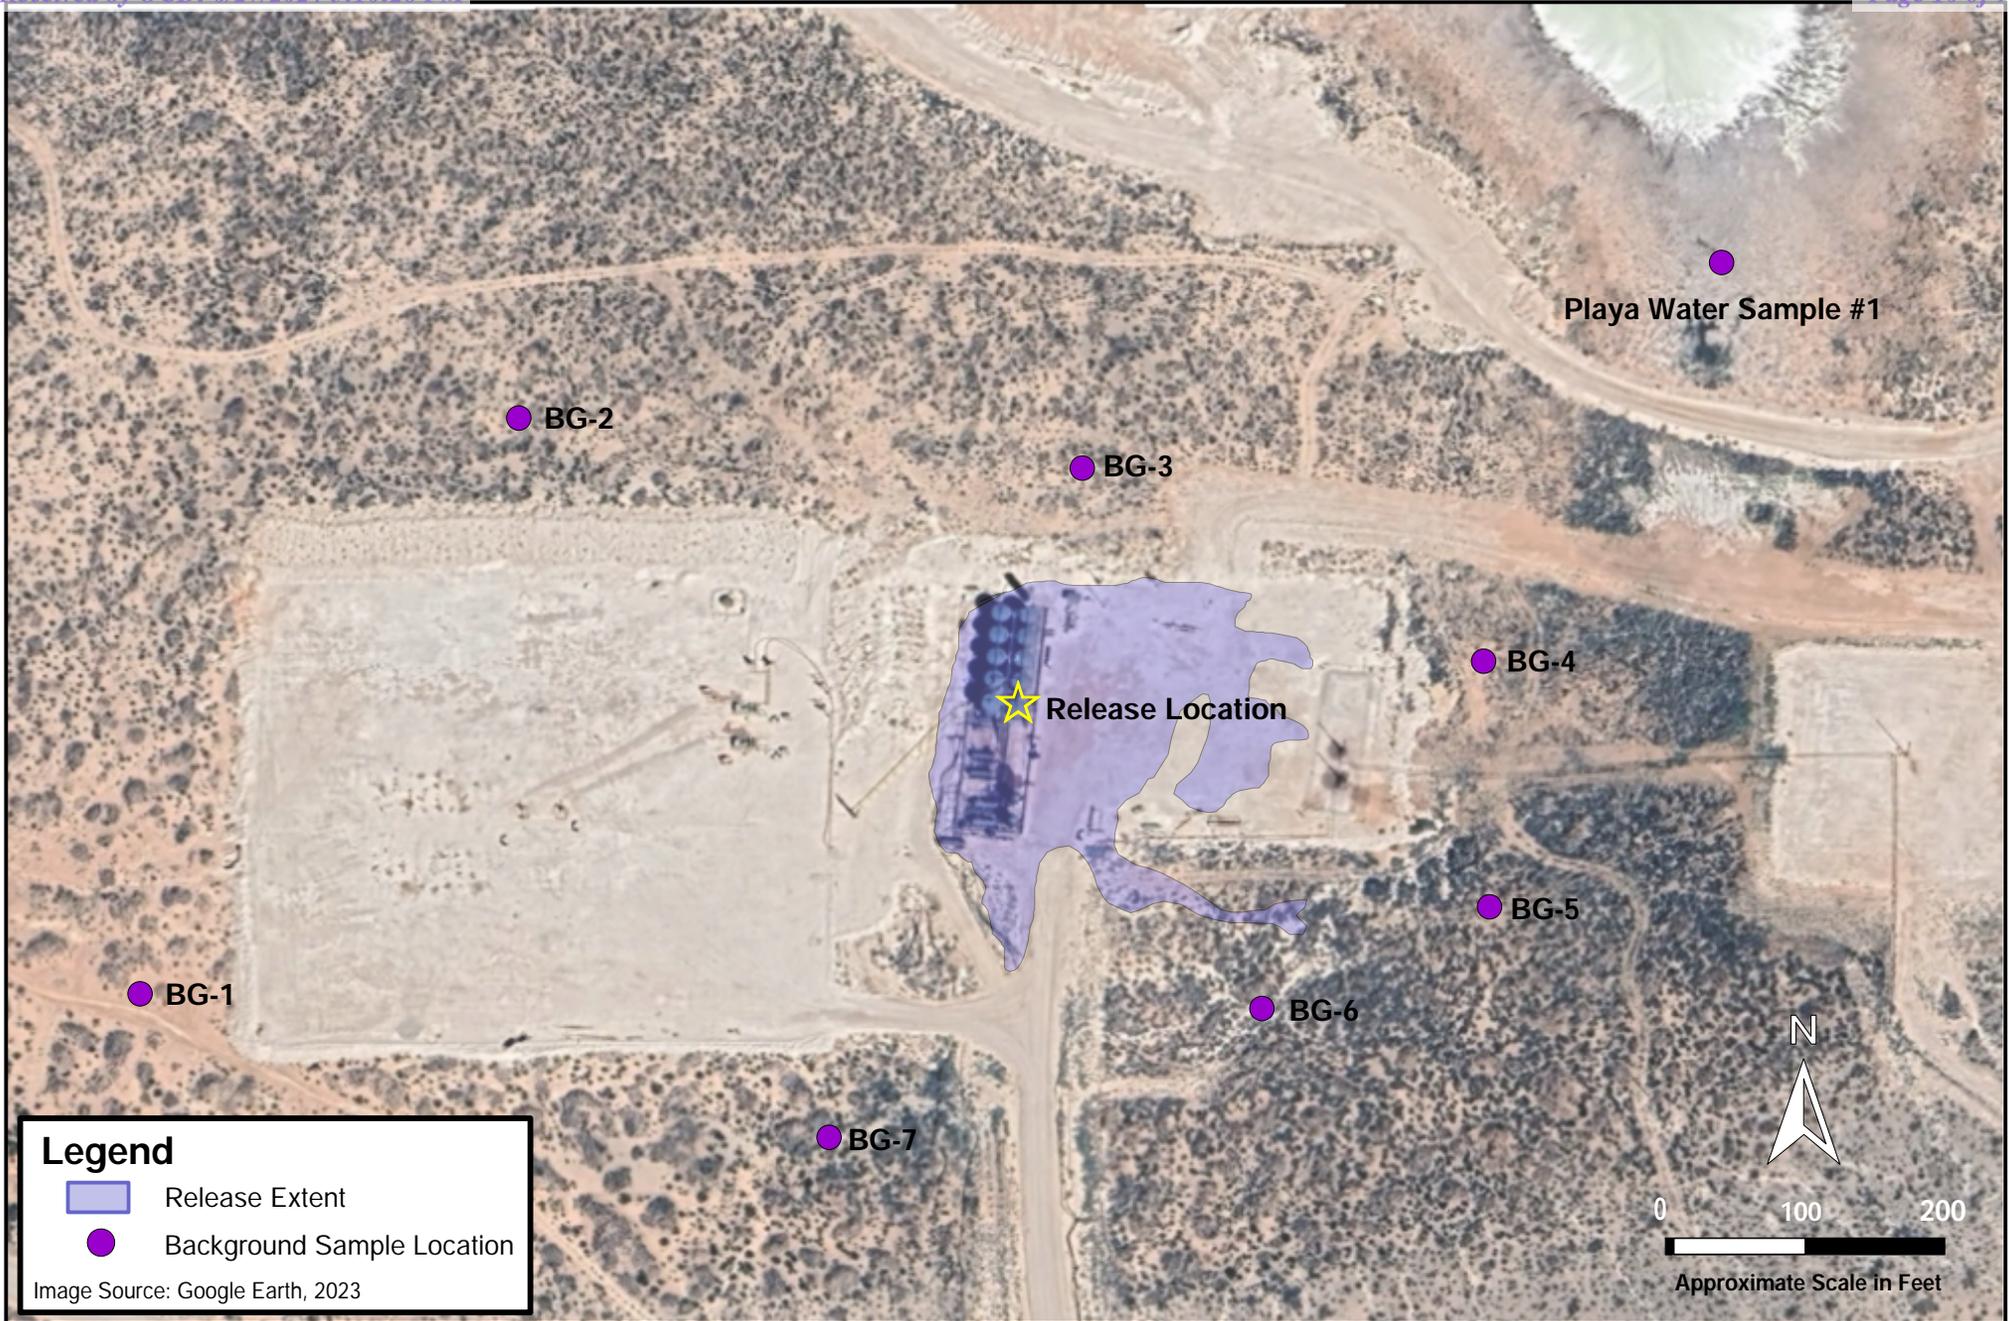
Figure No.  
**3**

On April 25, 2024, a fire consumed the Harroun Ranch West facility. Upon report of the fire, BTA immediately isolated production lines and pipelines associated with the facility, and emergency response activities were immediately initiated by the local fire department which extinguished the fire. BTA dispatched vacuum trucks immediately to begin recovering released fluids, as accessible safely. As soon as the Site was cool enough to safely approach, BTA began demolition of the remaining equipment and scraping of surficial impacted soils on the facility pad. Approximately 580 barrels (bbls) of oil and 1,200 bbls of produced water were released as a result of which approximately 100 bbls of produced water was recovered during the initial response activities. The release notification was submitted to NMOCD and the Bureau of Land Management (BLM) on April 26, 2024, and subsequently assigned the release Incident Identification (ID) nAPP2411724780. The release extent is shown in **Figure 3**.
