Re: Site Assessment, Remediation, and Closure Request
Moore State Tank Battery
API No. N/A
GPS: Latitude 32.79191 Longitude -104.15668
UL "H", Sec. 34, T17S, R28E
Eddy County, NM
NMOCD Ref. No. nAPP2333952697

Paragon Environmental, LLC (Paragon) has been contracted by Spur Energy Partners (Spur) to perform a spill assessment and conduct remediation activities for the release site known as the Moore State Tank Battery (Moore). Details of the release are summarized below:

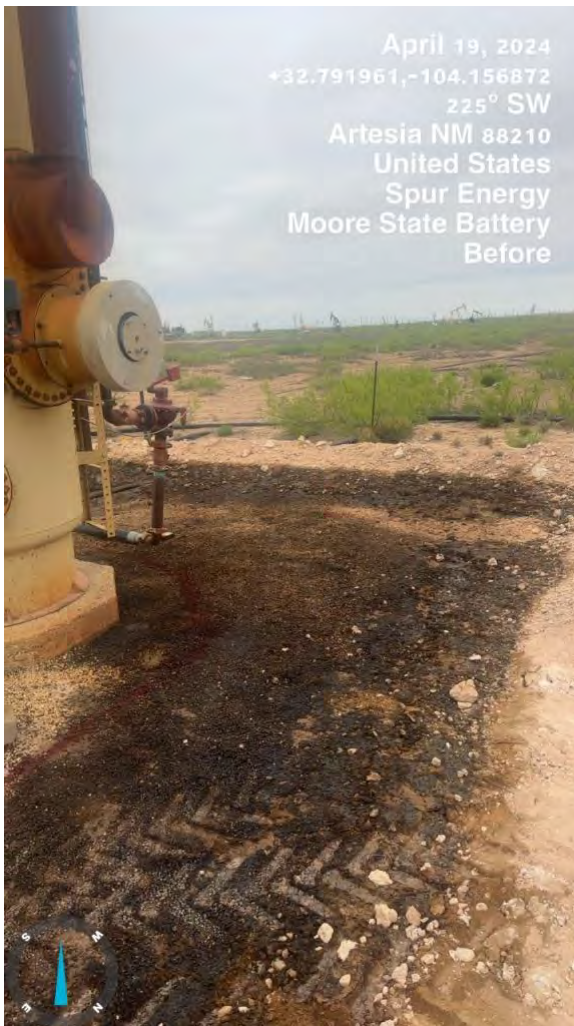
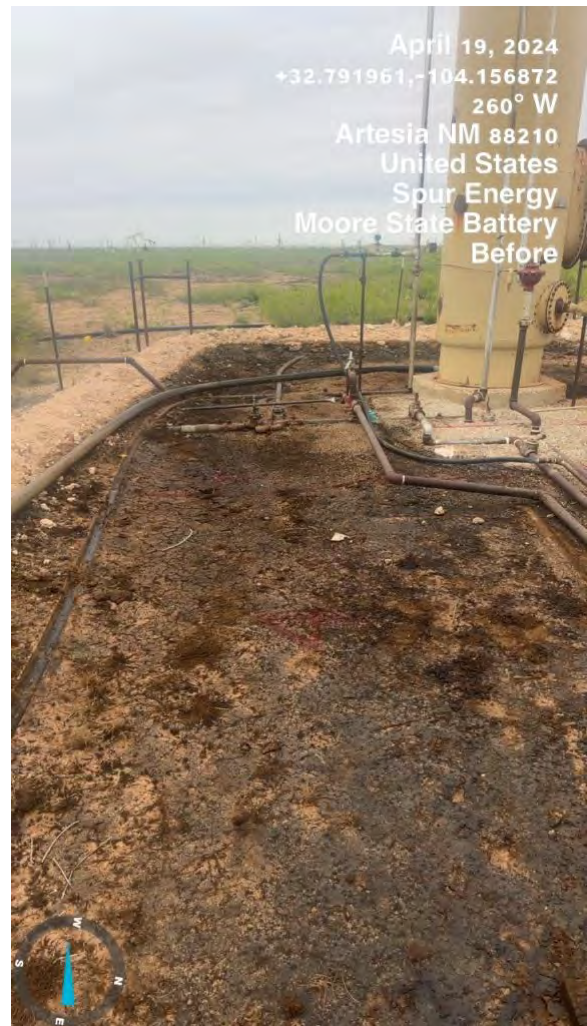
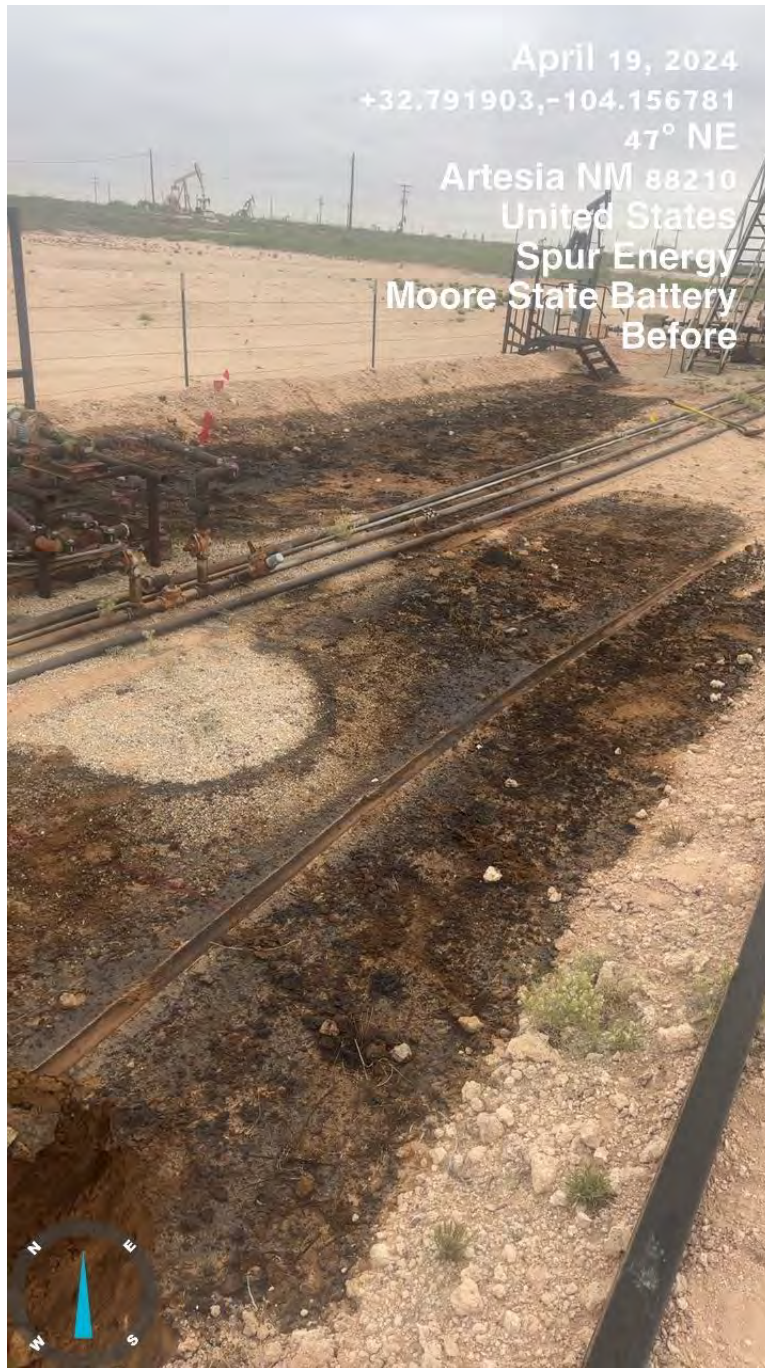
**Photographic Documentation
Before**

Release Details			
Type of Release:	Produced Water	Volume of Release:	30 bbls
		Volume Recovered:	28 bbls
Source of Release:	Circulating Line	Date of Release:	12/05/23
Was Immediate Notice Given?	Yes	If, Yes, to Whom?	NMOCD Portal
Was a Watercourse Reached?	No	If Yes, Volume Impacting Watercourse:	N/A
Surface Owner:	State	Mineral Owner:	State
The circulating line developed a pinhole due to internal corrosion, releasing produced water into the unlined containment.
