## Release Assessment and Closure

Zeus SWD Line

Vertex File Number: 24E-00851

Tap Rock Resources

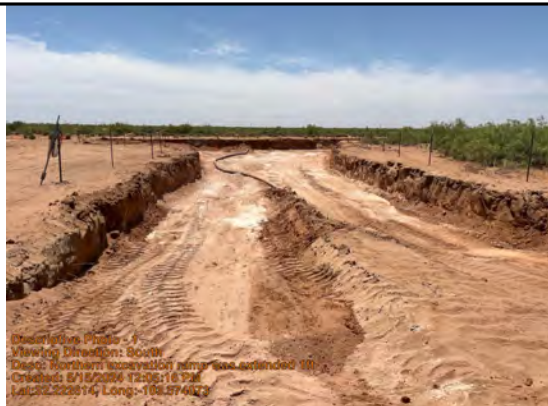
Viewing Direction: South

Northern excavation ramp was extended 1ft

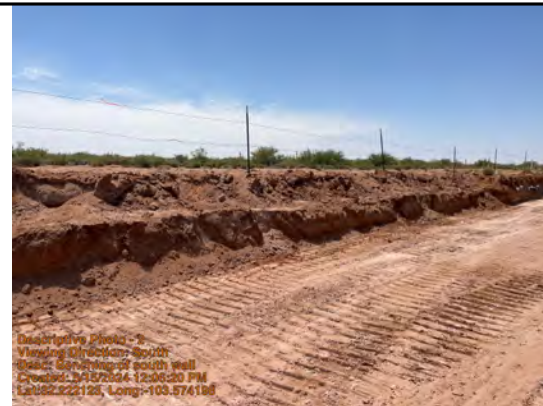
Viewing Direction: South

Benching of south wall

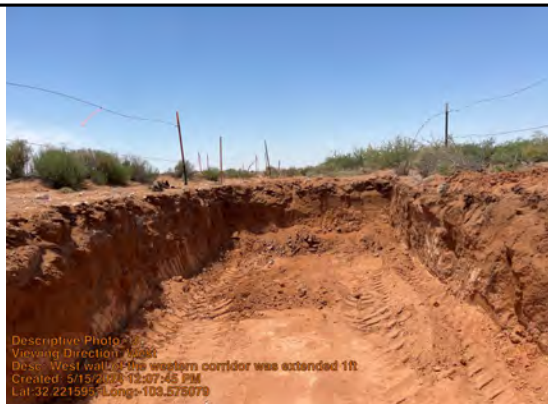
Viewing Direction: West

West wall of the western corridor was extended 1ft

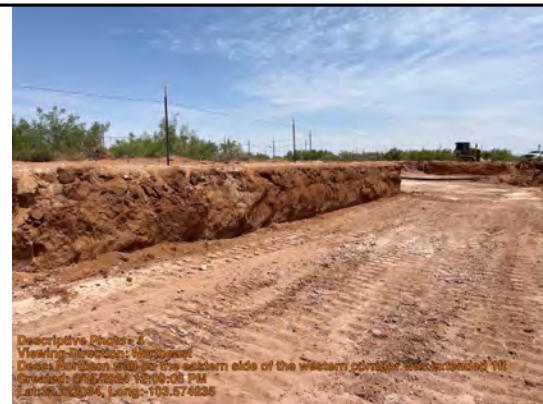
Viewing Direction: Northeast

Northern wall on the eastern side of the western corridor was extended 1ft

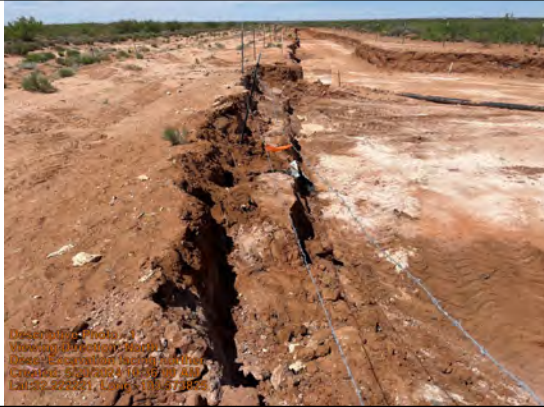
Viewing Direction: West

Excavation facing north

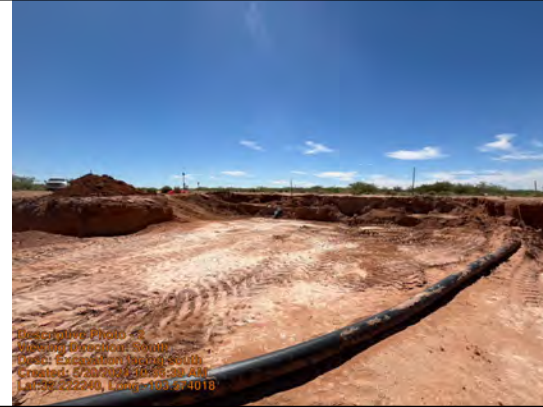
Viewing Direction: South

Excavation facing south

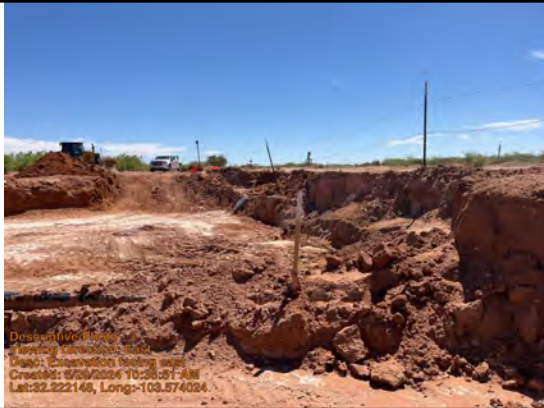
Viewing Direction: East

Excavation facing east
