FLOWLINE SUPPLYING REMUDA BASIN SWD

Incident ID nAPP2213647597

PREPARED BY:
PIMA ENVIRONMENTAL SERVICES, LLC

Remediation Closure Report

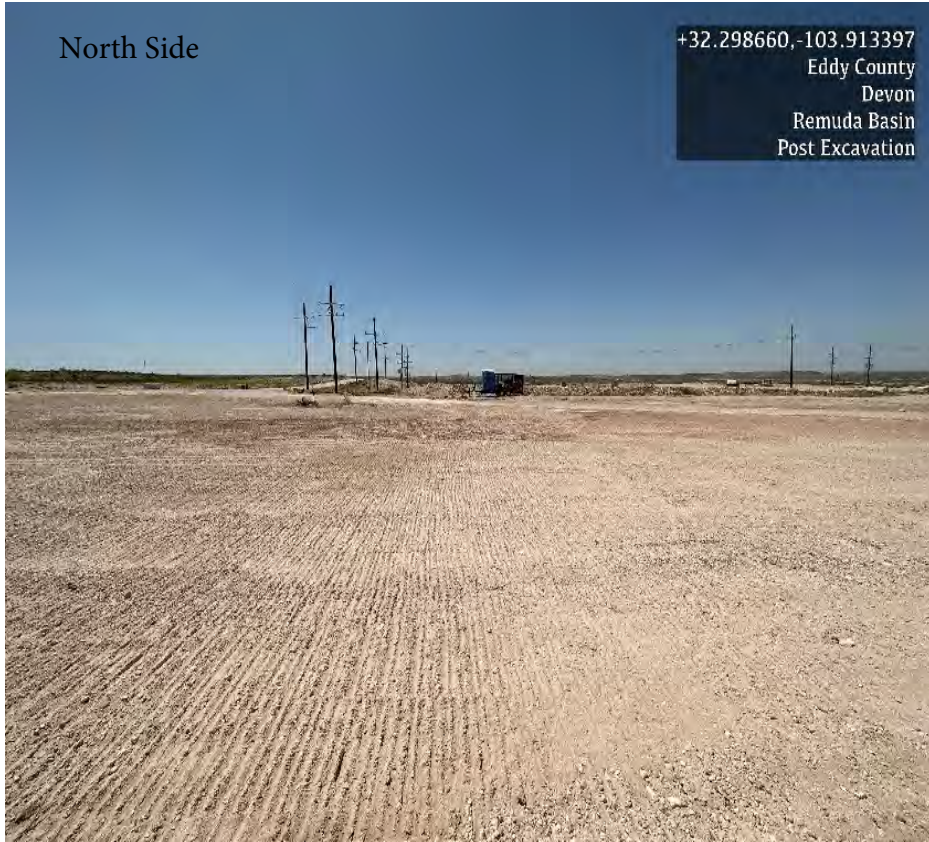
North Side

+32.298660,-103.913397
Eddy County
Devon
Remuda Basin
Post Excavation

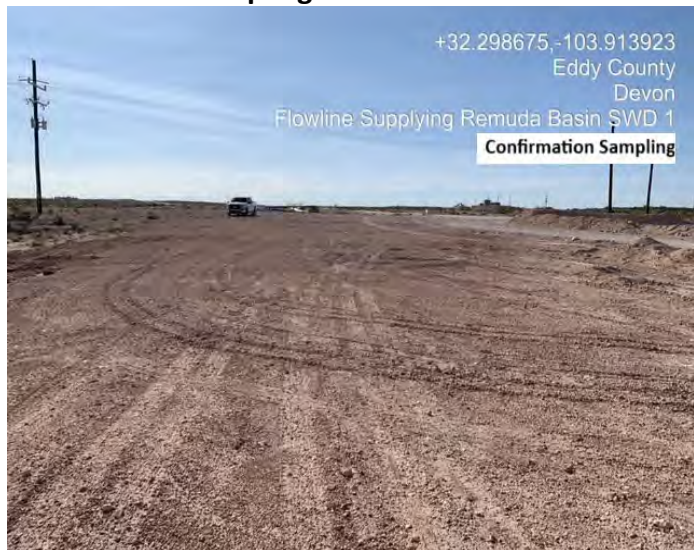
View from North to South

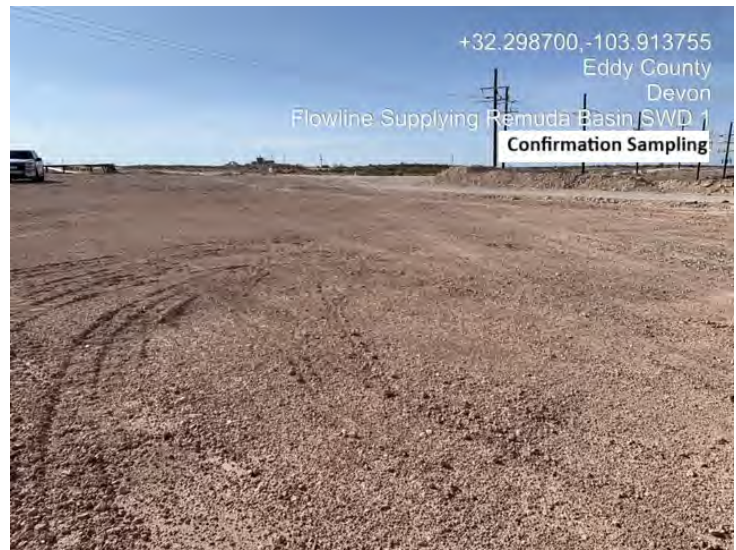
View from Northeast to Southwest

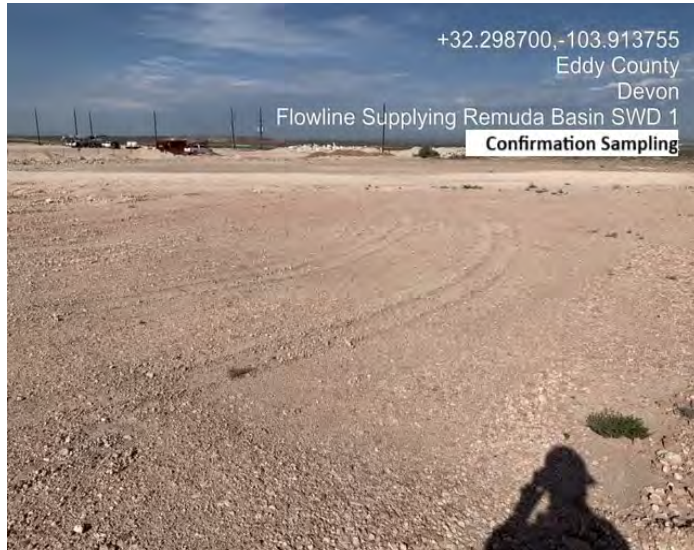
View from Southeast to Northwest

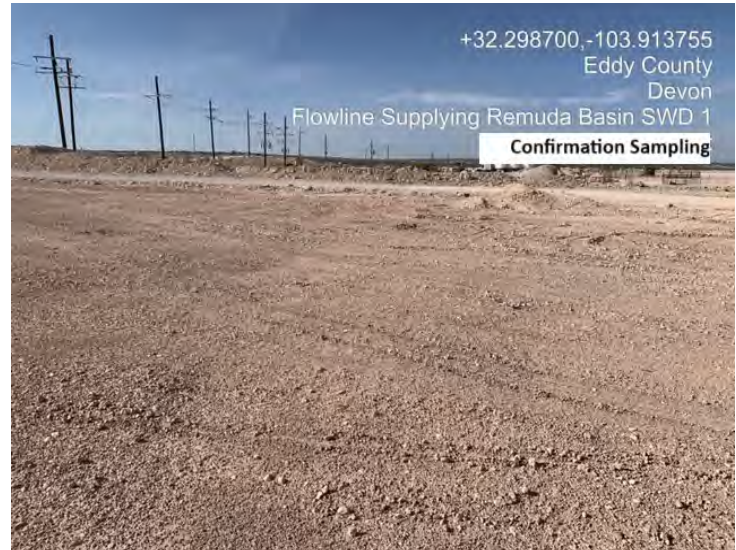
View from East to West

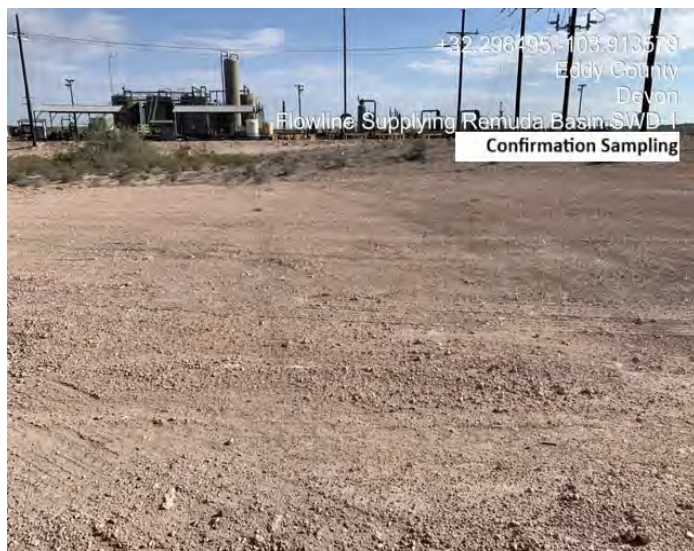
View from South to North

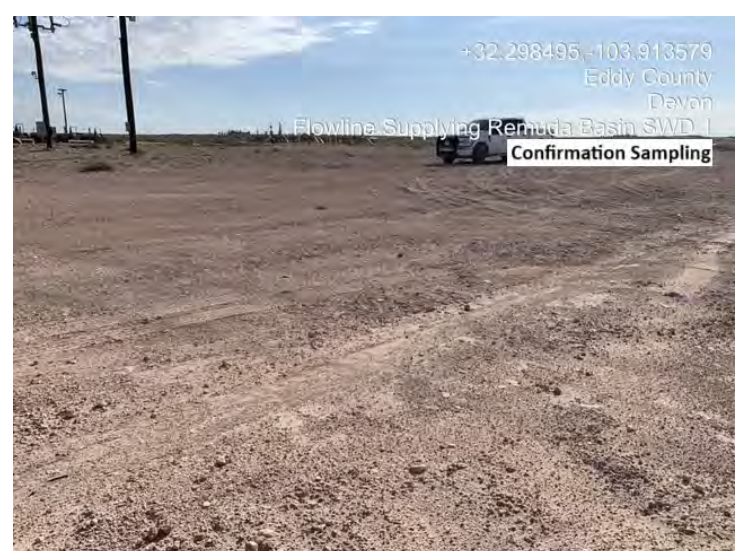
View from West to East

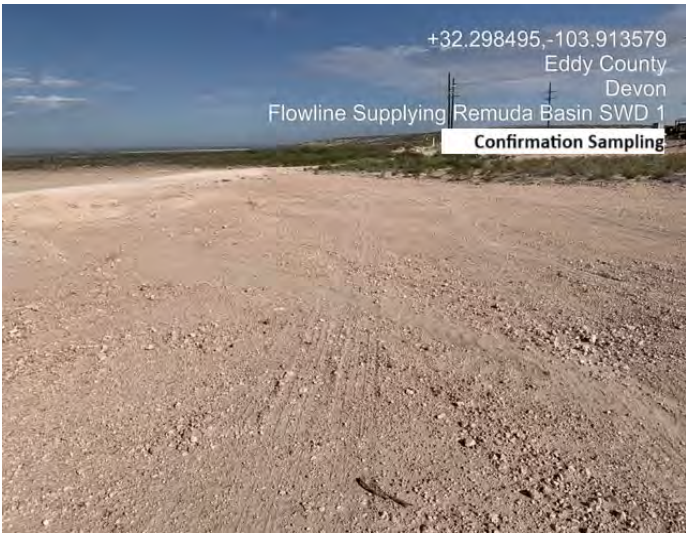
View from South to North

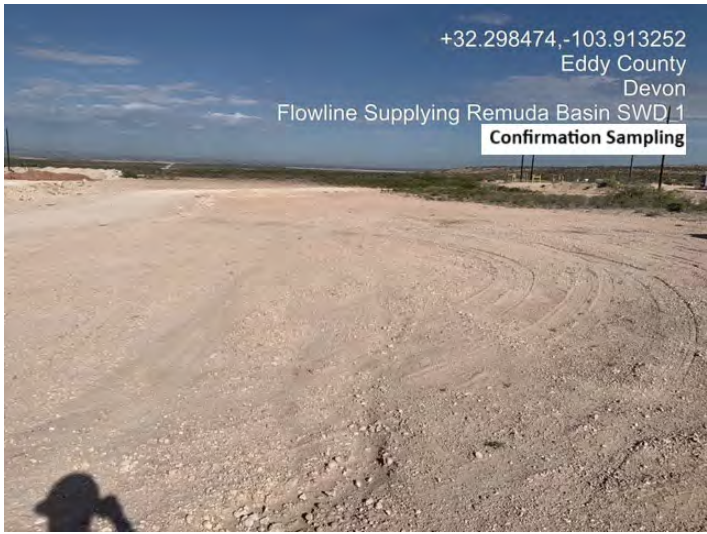
View from Southeast to Northwest
