**Re: Closure Report
ConocoPhillips Company (Heritage COG Operating, LLC)
Honey Graham 29 State #006H Tank Battery Release
Unit Letter C, Section 29, Township 26 South, Range 28 East
Eddy County, New Mexico
Incident ID NAPP2313129153**

Closure Report
August 6, 2024

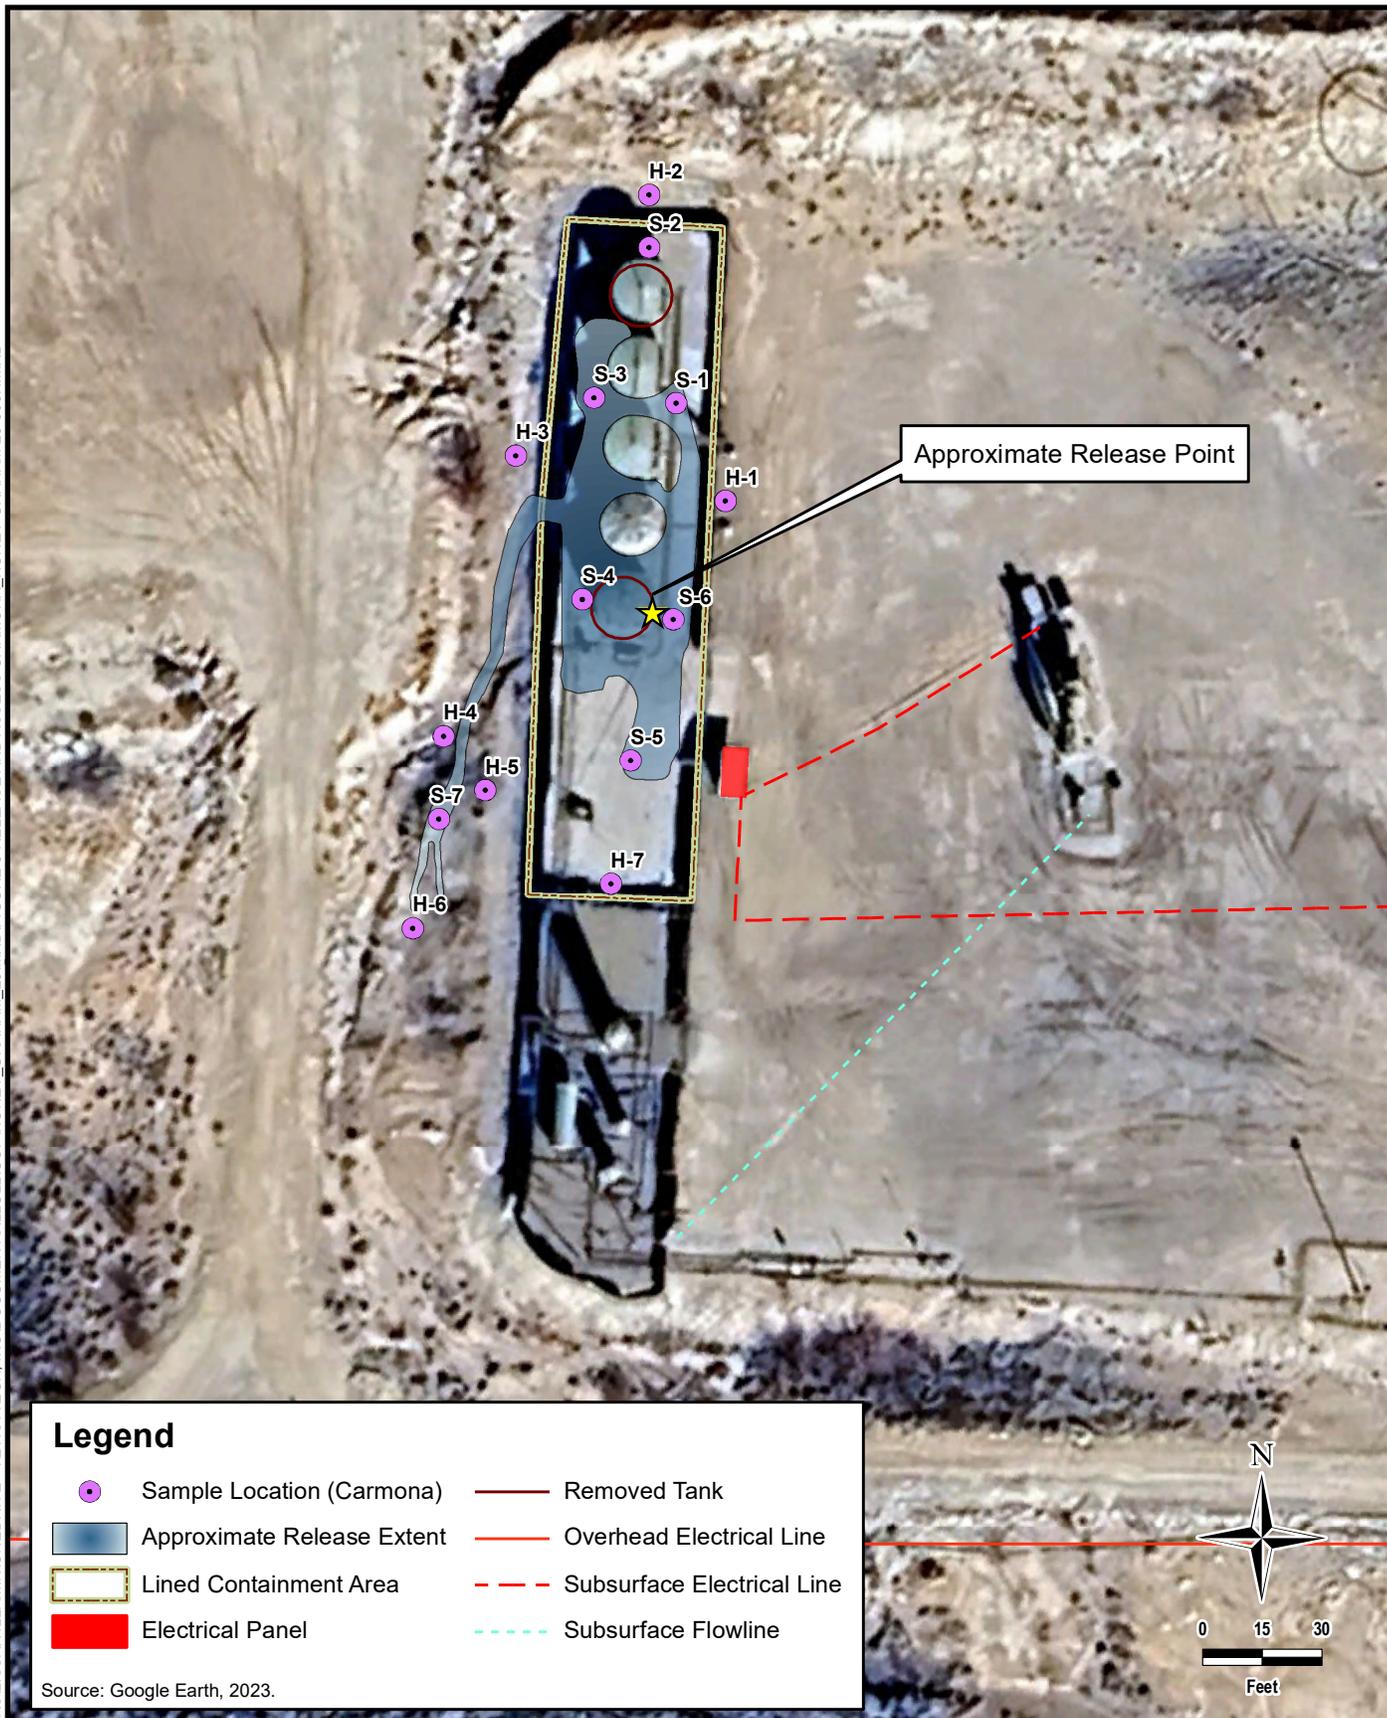
PROJECT NO.:	212C-MD-03173
DATE:	JULY 28, 2023
DESIGNED BY:	LMV
Figure No.	3

- Sample Location (Carmona)
- Approximate Release Extent
- Lined Containment Area
- Electrical Panel
- Removed Tank
- Overhead Electrical Line
- Subsurface Electrical Line
- Subsurface Flowline

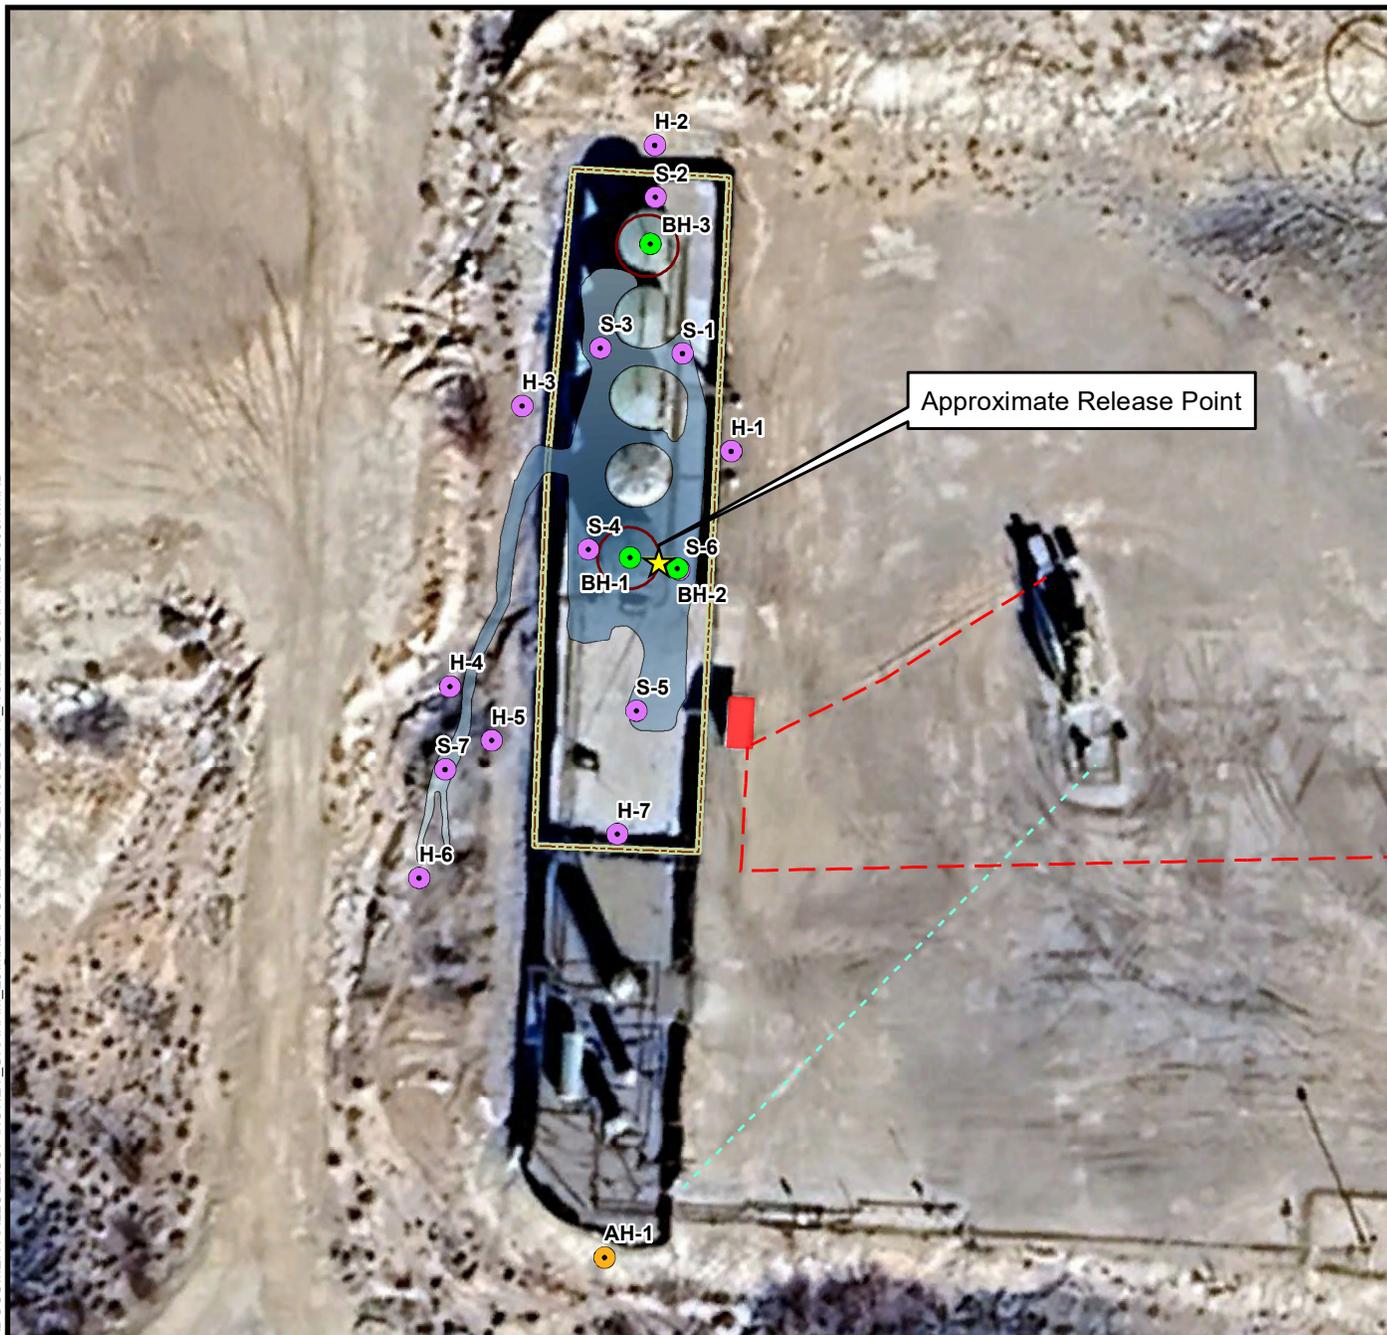
- Sample Location (Carmona)
- Boring Location (Tetra Tech)
- Hand Auger Location (Tetra Tech)
- Approximate Release Extent
- Lined Containment Area
- Electrical Panel
- Removed Tank
- Overhead Electrical Line
- Subsurface Electrical Line
- Subsurface Flowline

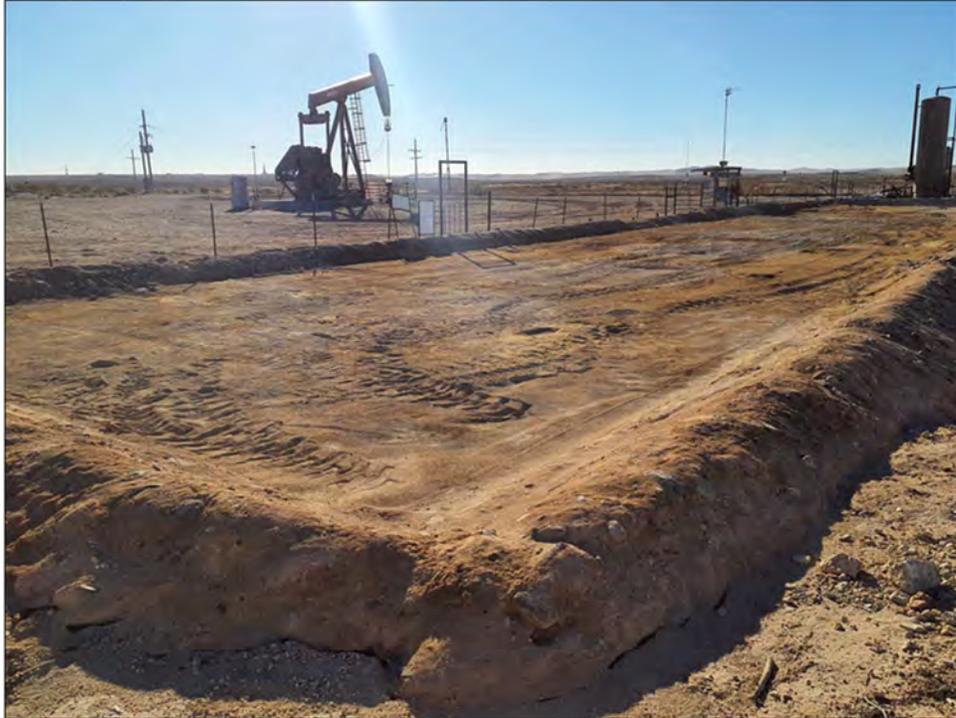
Figure 3. Overview of primary spill area, tanks are removed, facing south (Frame 8256).

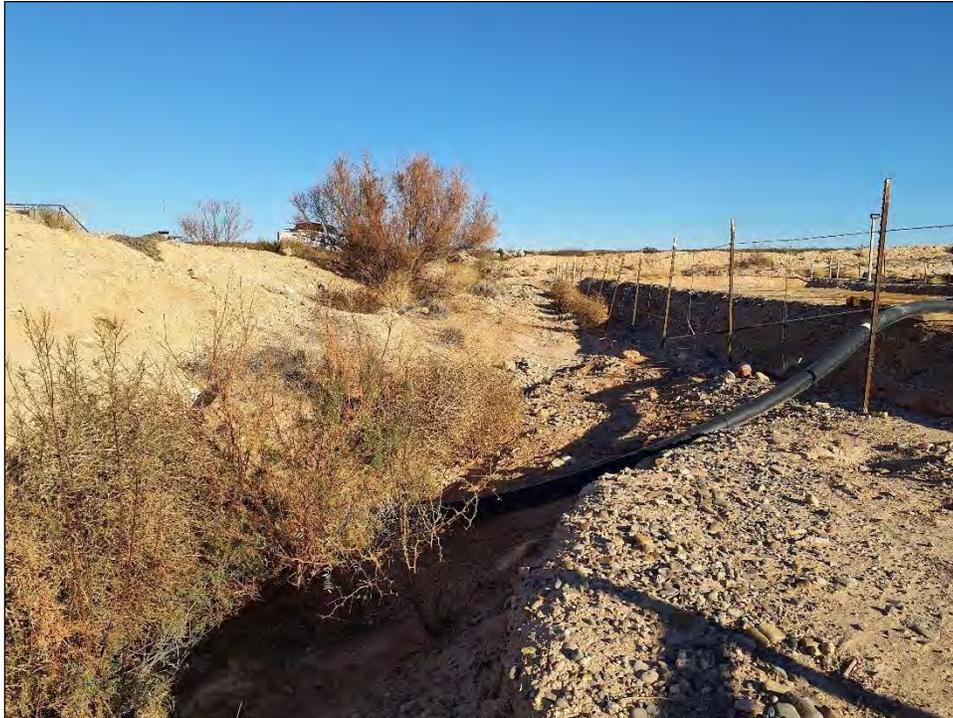
Figure 5. Overview of survey where the spill entered the drainage, facing north (Frame 3206).

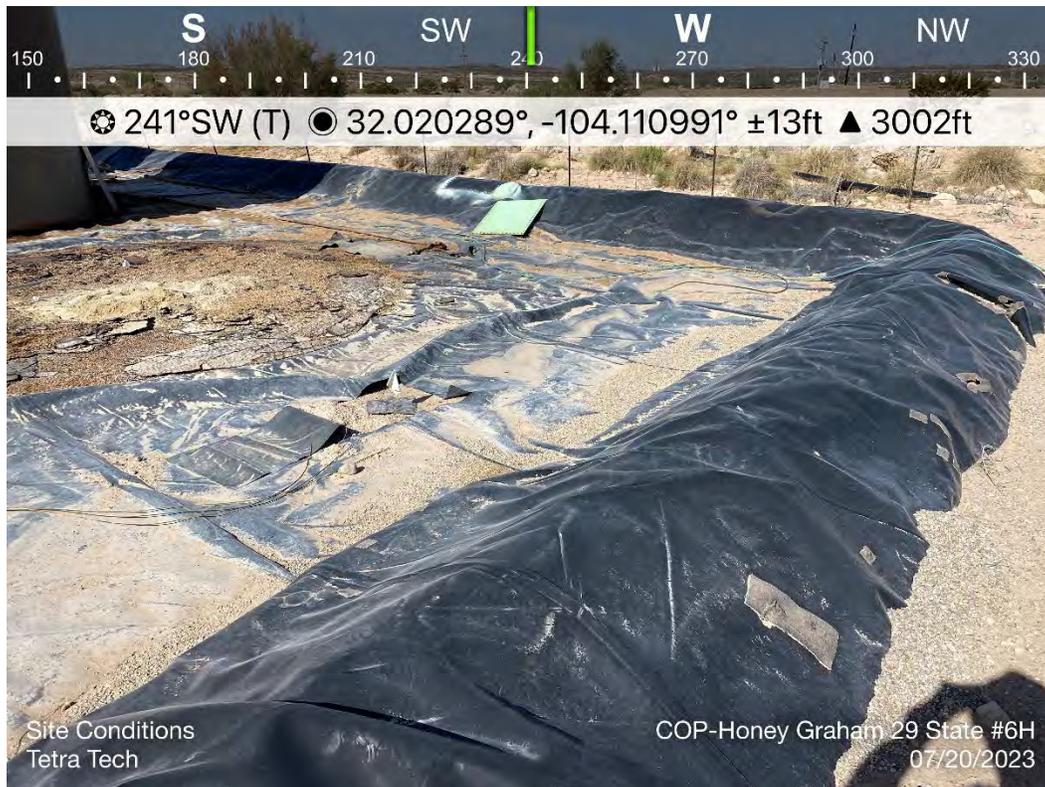
TETRA TECH, INC. PROJECT NO. 212C-MD-03173	DESCRIPTION	View southwest. Northern portion of the release area.	2
	SITE NAME	Honey Graham 29 State #006H Release	7/20/2023

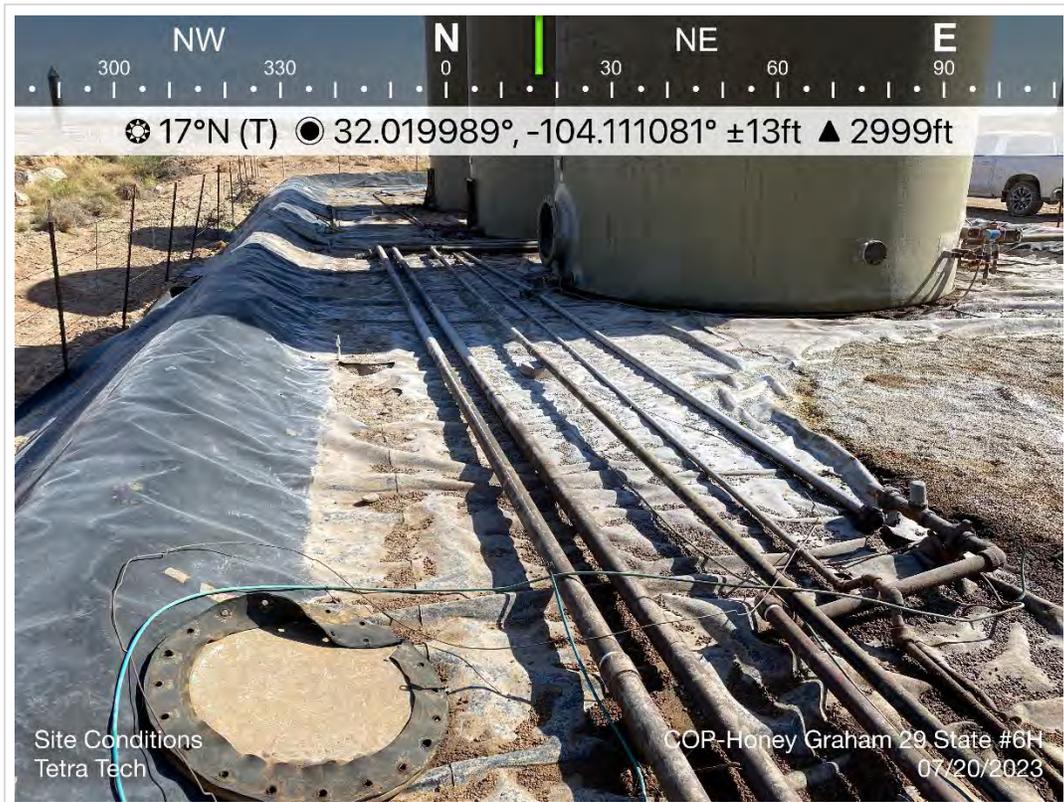
TETRA TECH, INC. PROJECT NO. 212C-MD-03173	DESCRIPTION	View north. Western side of tank battery secondary containment.	3
	SITE NAME	Honey Graham 29 State #006H Release	7/20/2023

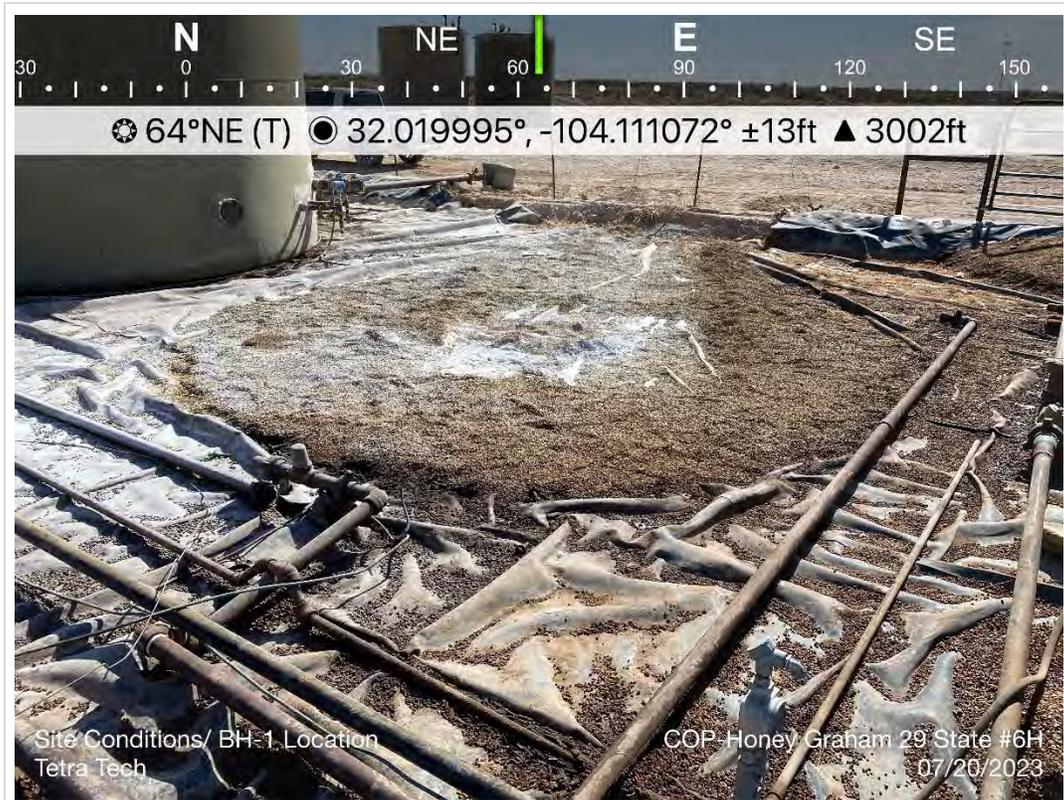
TETRA TECH, INC. PROJECT NO. 212C-MD-03173	DESCRIPTION	View northeast. Southern portion of the tank battery. Former location of removed tank.	4
	SITE NAME	Honey Graham 29 State #006H Release	7/20/2023

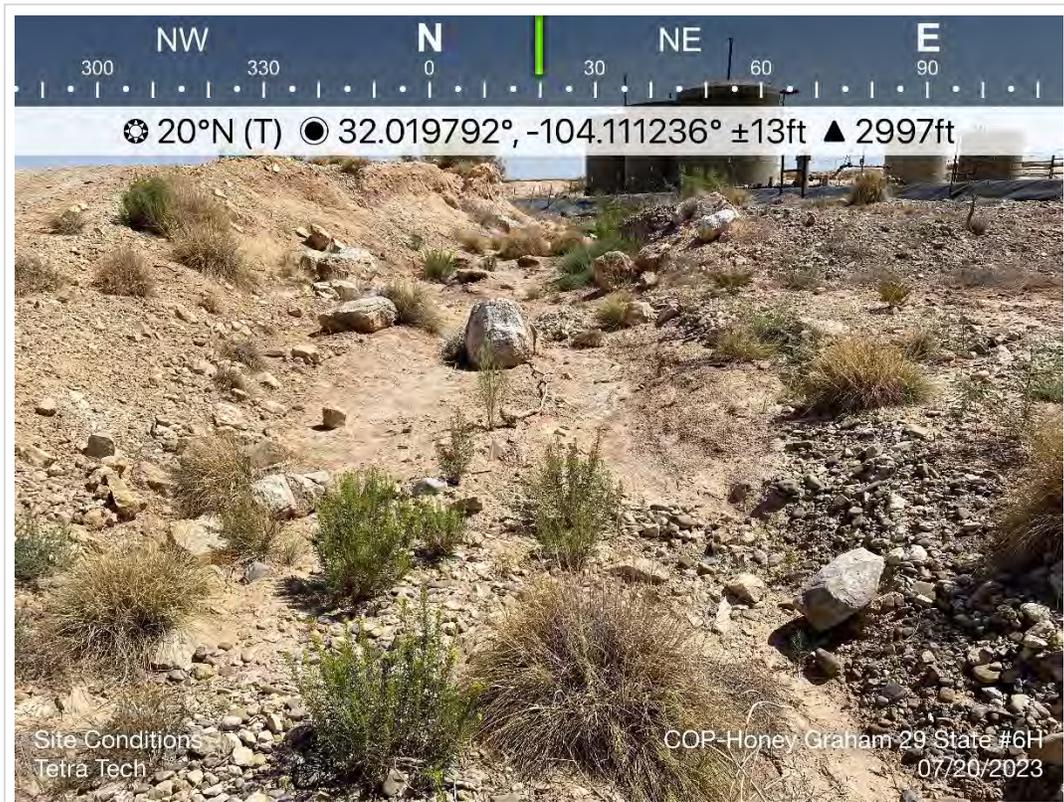
TETRA TECH, INC. PROJECT NO. 212C-MD-03173	DESCRIPTION	View north-northeast. Release area west of the tank battery.	5
	SITE NAME	Honey Graham 29 State #006H Release	7/20/2023

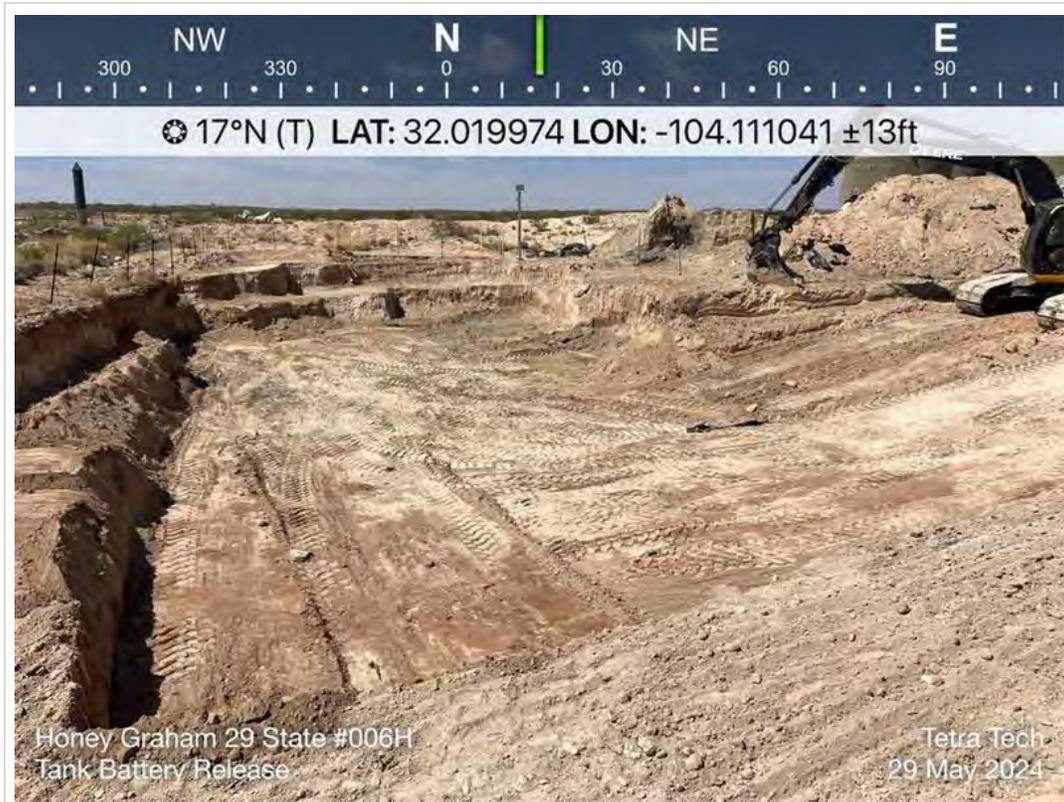
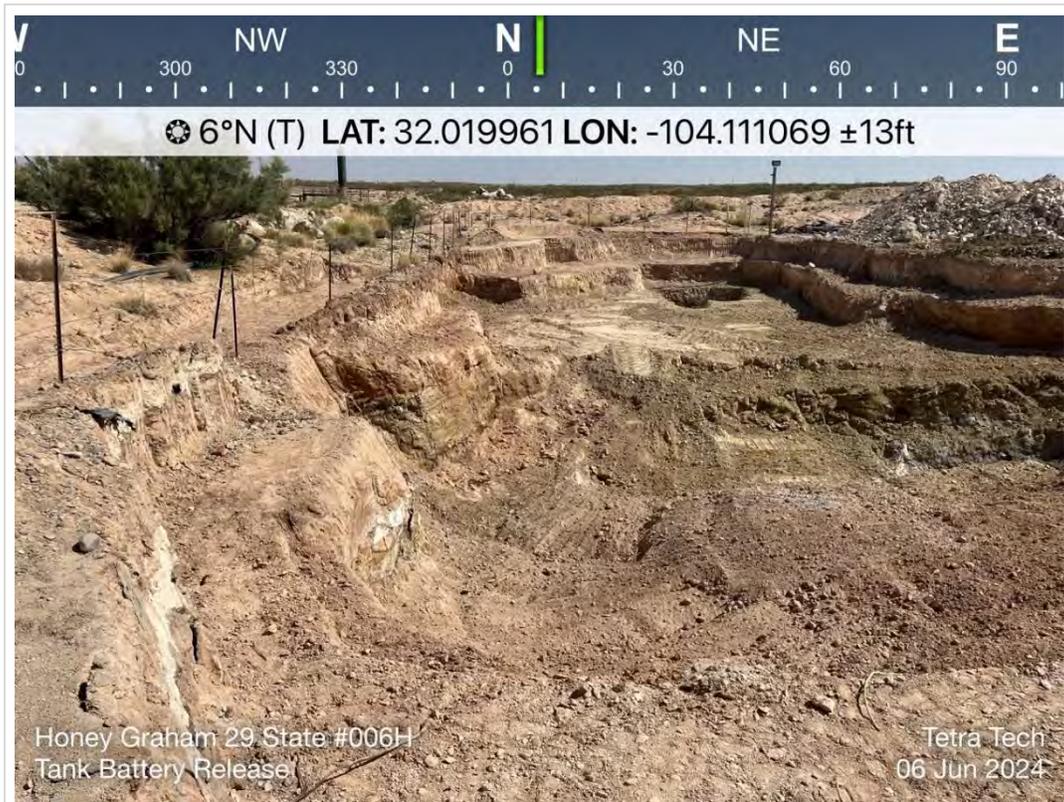
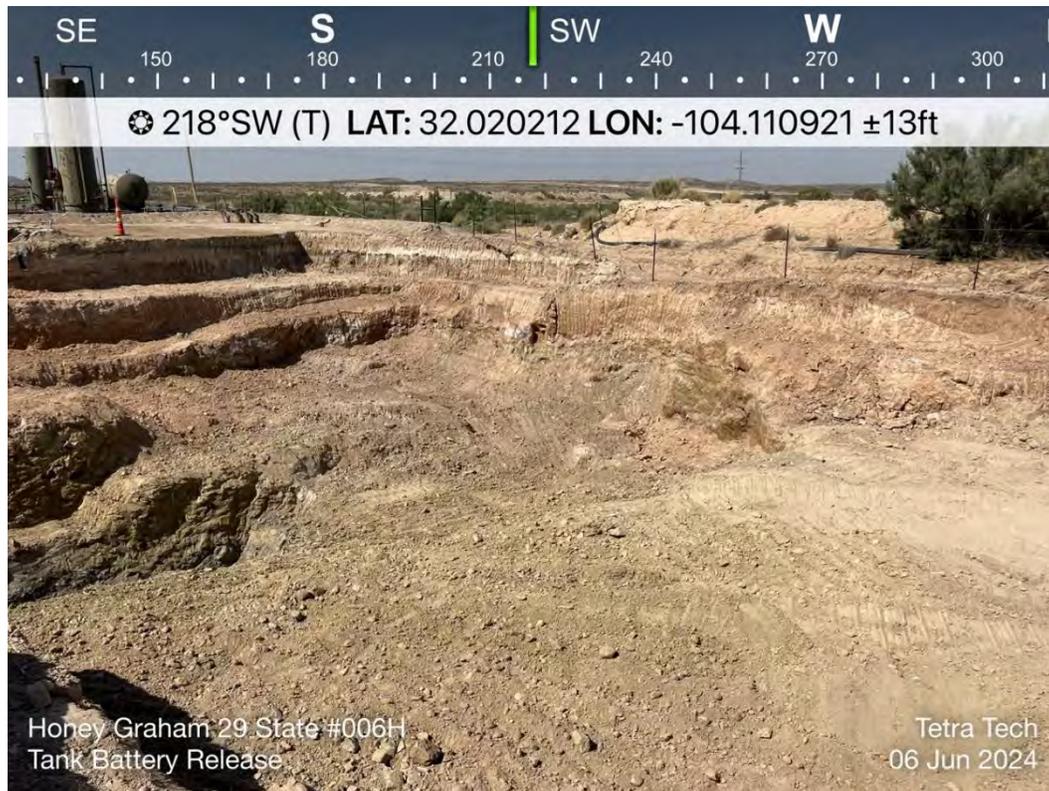
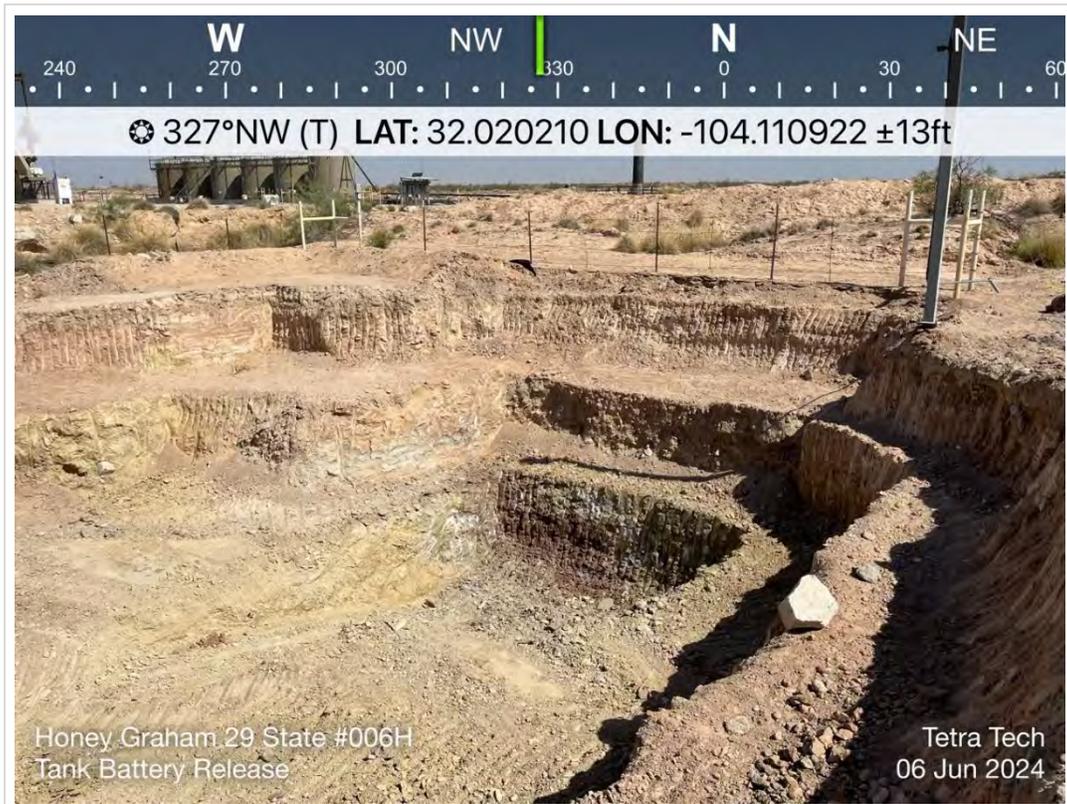
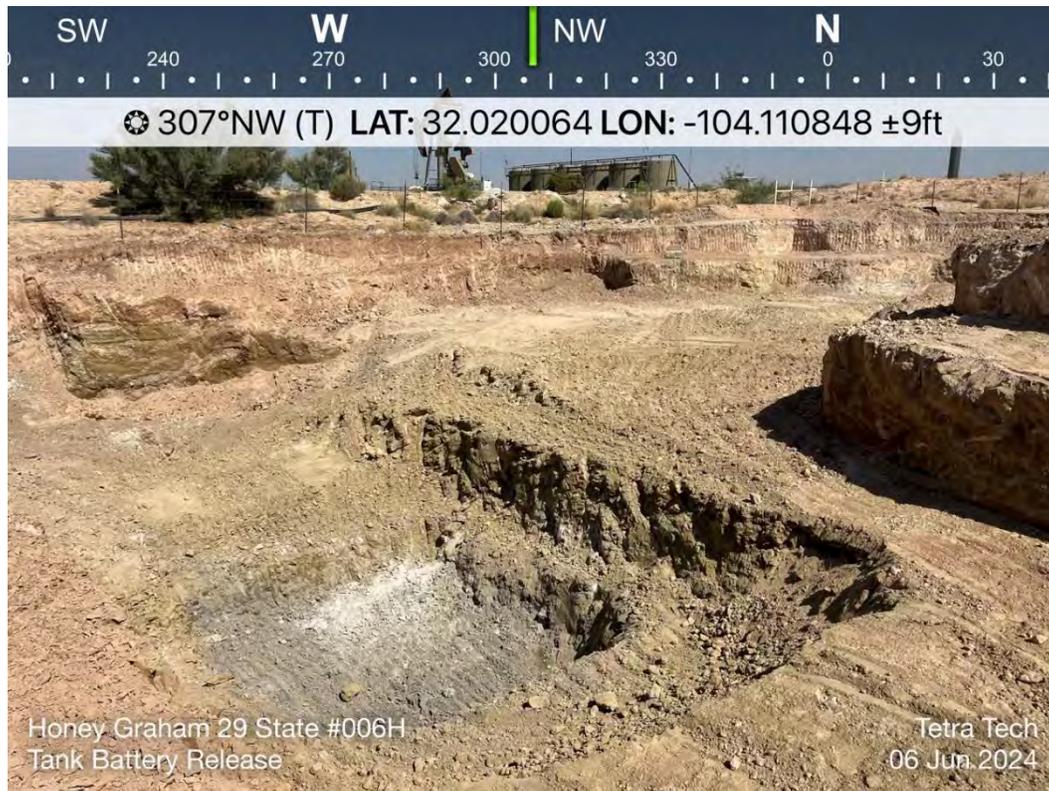
TETRA TECH, INC. PROJECT NO. 212C-MD-03173	DESCRIPTION	View north. View of remedial activities.	8
	SITE NAME	Honey Graham 29 State #006H Release	5/29/2024

TETRA TECH, INC. PROJECT NO. 212C-MD-03173	DESCRIPTION	View north. View of remedial activities.	9
	SITE NAME	Honey Graham 29 State #006H Release	6/6/2024

TETRA TECH, INC. PROJECT NO. 212C-MD-03173	DESCRIPTION	View southwest. View of remedial activities.	12
	SITE NAME	Honey Graham 29 State #006H Release	6/6/2024

TETRA TECH, INC. PROJECT NO. 212C-MD-03173	DESCRIPTION	View northwest. View of remedial activities.	13
	SITE NAME	Honey Graham 29 State #006H Release	6/6/2024

TETRA TECH, INC. PROJECT NO. 212C-MD-03173	DESCRIPTION	View northwest. View of remedial activities.	14
	SITE NAME	Honey Graham 29 State #006H Release	6/6/2024

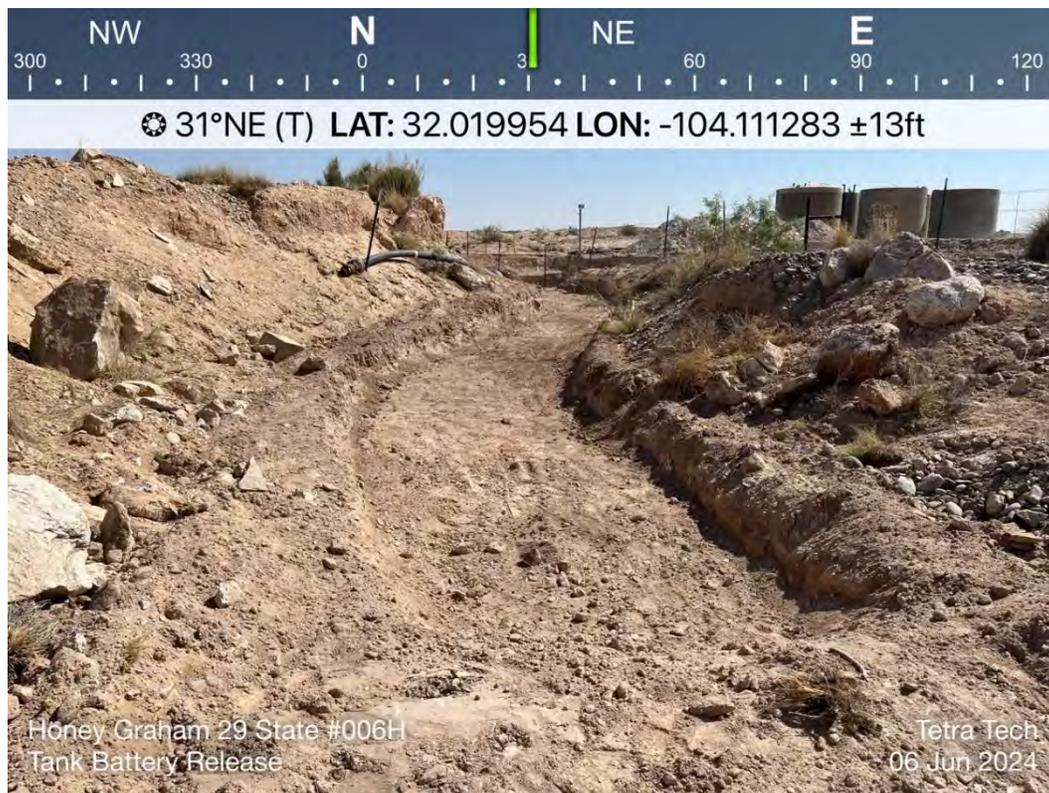
TETRA TECH, INC. PROJECT NO. 212C-MD-03173	DESCRIPTION	View north-northeast. View of remedial activities. View of approximately 1 foot excavation.	10
	SITE NAME	Honey Graham 29 State #006H Release	6/6/2024

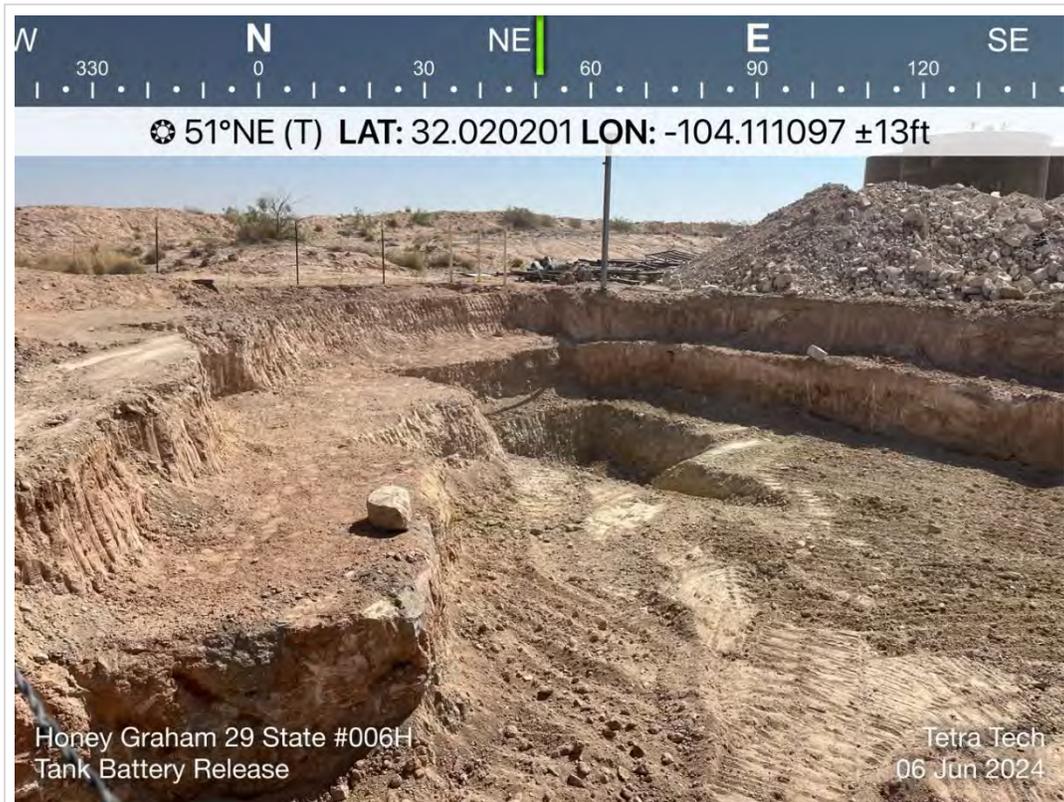
TETRA TECH, INC. PROJECT NO. 212C-MD-03173	DESCRIPTION	View northeast. View of remedial activities, view of approximately 8-foot excavation.	11
	SITE NAME	Honey Graham 29 State #006H Release	6/6/2024

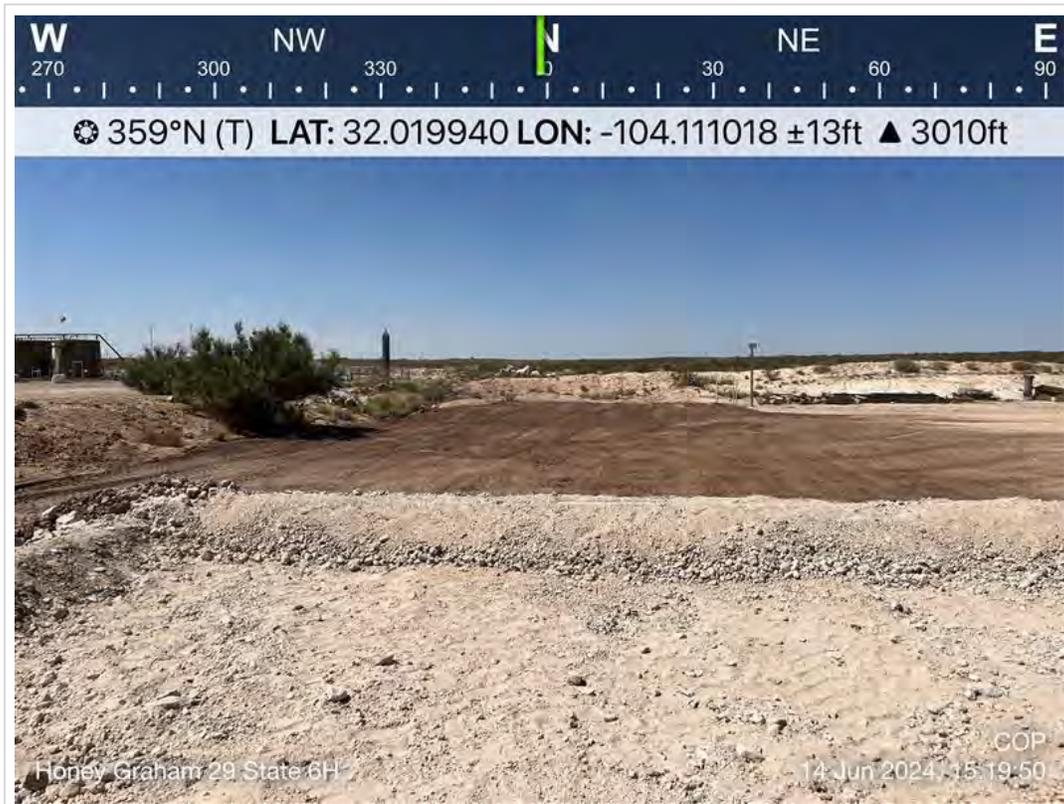
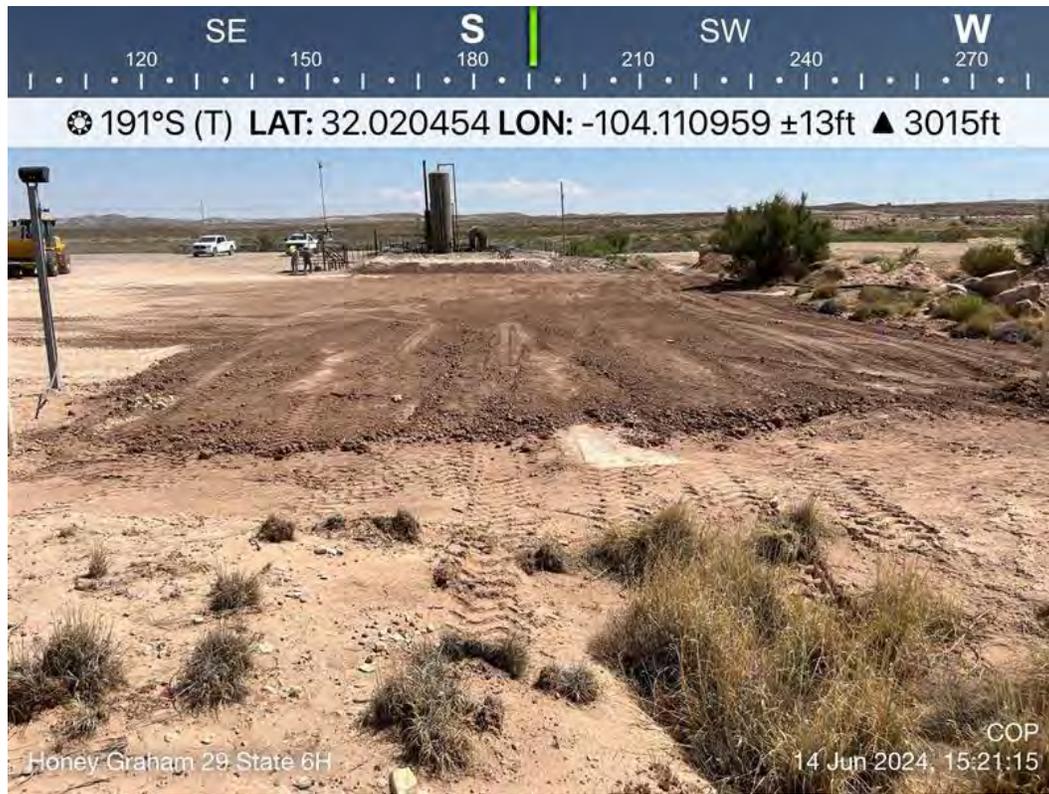
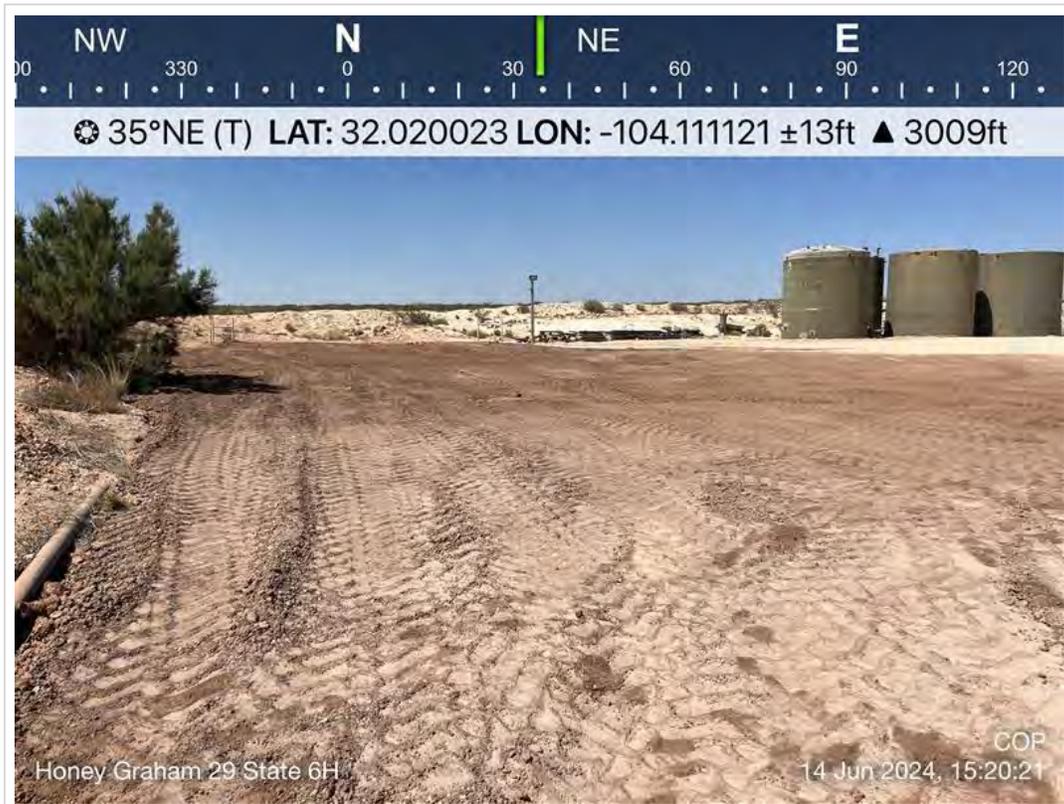
TETRA TECH, INC. PROJECT NO. 212C-MD-03173	DESCRIPTION	View north. Backfilled former tank battery area.	15
	SITE NAME	Honey Graham 29 State #006H Release	6/14/2024

TETRA TECH, INC. PROJECT NO. 212C-MD-03173	DESCRIPTION	View south. Backfilled former tank battery area.	16
	SITE NAME	Honey Graham 29 State #006H Release	6/14/2024

TETRA TECH, INC. PROJECT NO. 212C-MD-03173	DESCRIPTION	View northeast. Backfilled former tank battery area.	17
	SITE NAME	Honey Graham 29 State #006H Release	6/14/2024

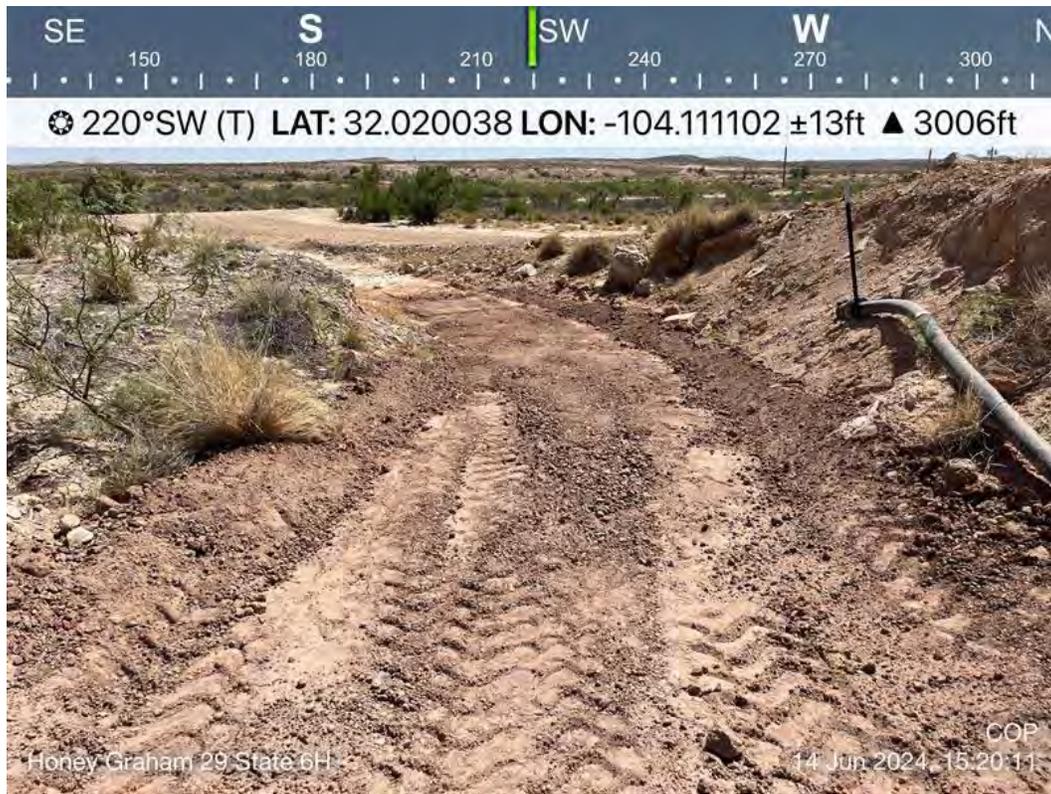
TETRA TECH, INC. PROJECT NO. 212C-MD-03173	DESCRIPTION	View southwest. Backfilled pasture area, west of former tank battery.	18
	SITE NAME	Honey Graham 29 State #006H Release	6/14/2024
