May 8, 2024 (Resubmitted August 2, 2024)

**Re: Release Characterization and Remediation Work Plan
ConocoPhillips
Wilder CTB Tank Overflow Release
Unit Letter A, Section 29, Township 26 South, and Range 32 East
Lea County, New Mexico
Incident ID NAPP2403967865**

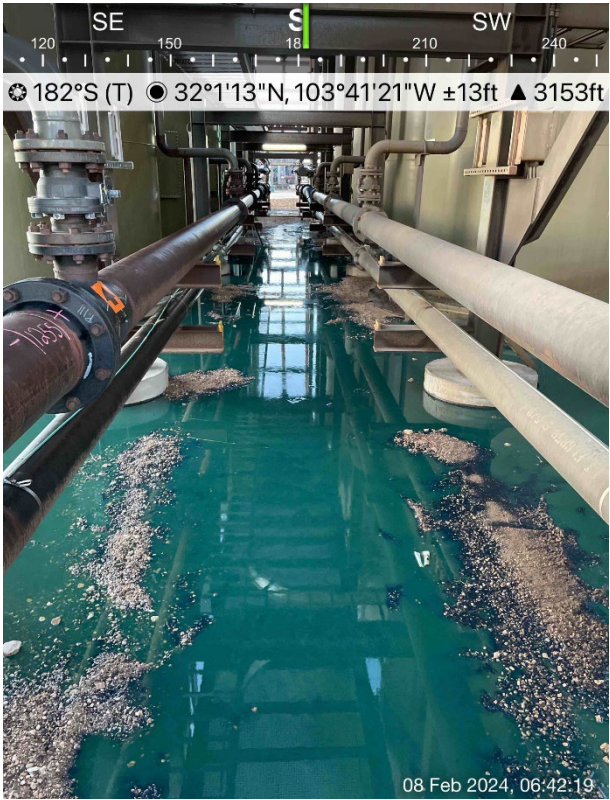
TETRA TECH, INC. PROJECT NO. 212C-MD-03442	DESCRIPTION	View south of approximate release extent inside bermed tank battery.	4
	SITE NAME	WILDER CTB TANK OVERFLOW Release	2/8/20224

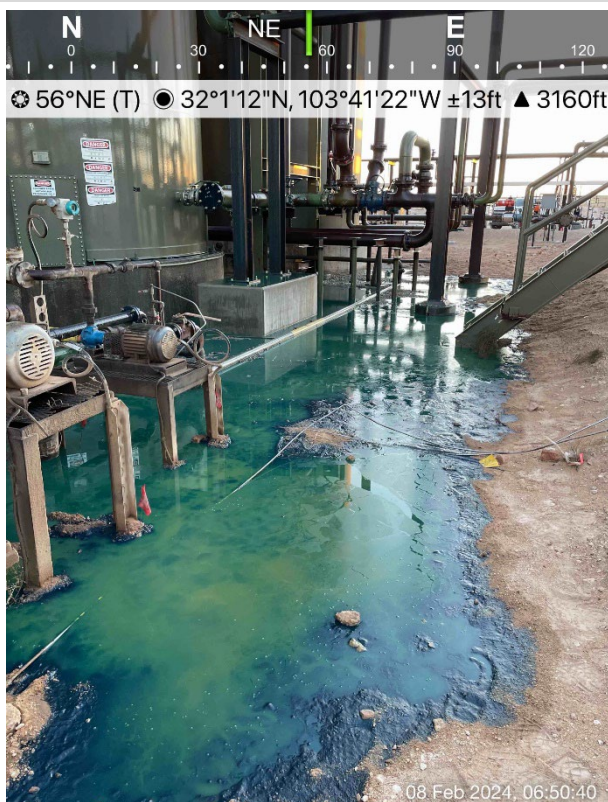
TETRA TECH, INC. PROJECT NO. 212C-MD-03442	DESCRIPTION	View east-northeast of approximate release extent inside bermed tank battery.	5
	SITE NAME	WILDER CTB TANK OVERFLOW Release	2/8/20224

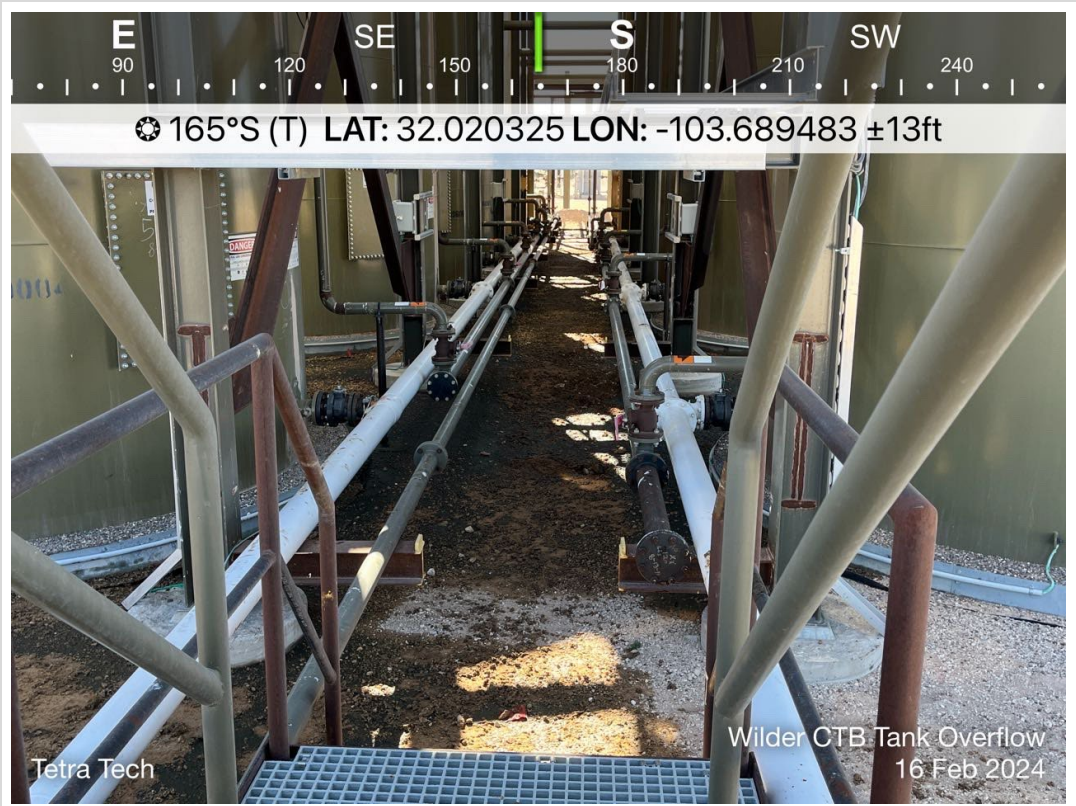
TETRA TECH, INC. PROJECT NO. 212C-MD-03442	DESCRIPTION	View south-southeast of approximate release extent inside bermed tank battery post initial response.	7
	SITE NAME	WILDER CTB TANK OVERFLOW Release	2/16/2024

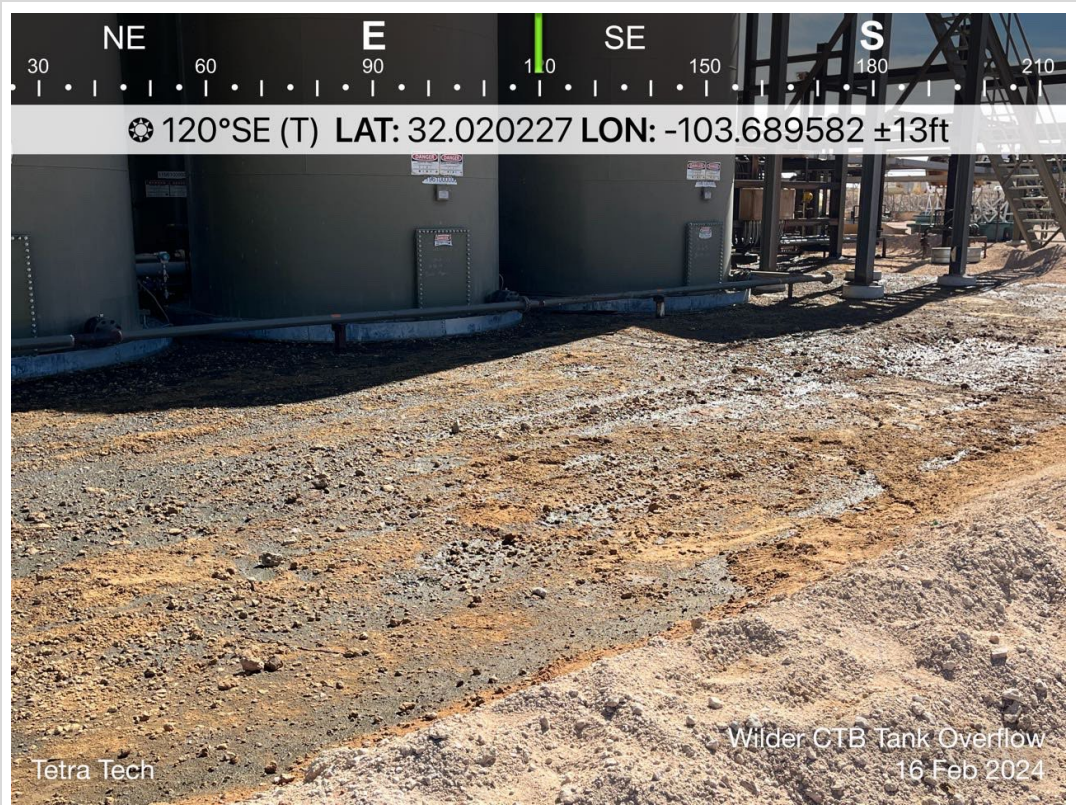
TETRA TECH, INC. PROJECT NO. 212C-MD-03442	DESCRIPTION	View east-southeast of approximate release extent inside bermed tank battery post initial response.	8
	SITE NAME	WILDER CTB TANK OVERFLOW Release	2/16/2024

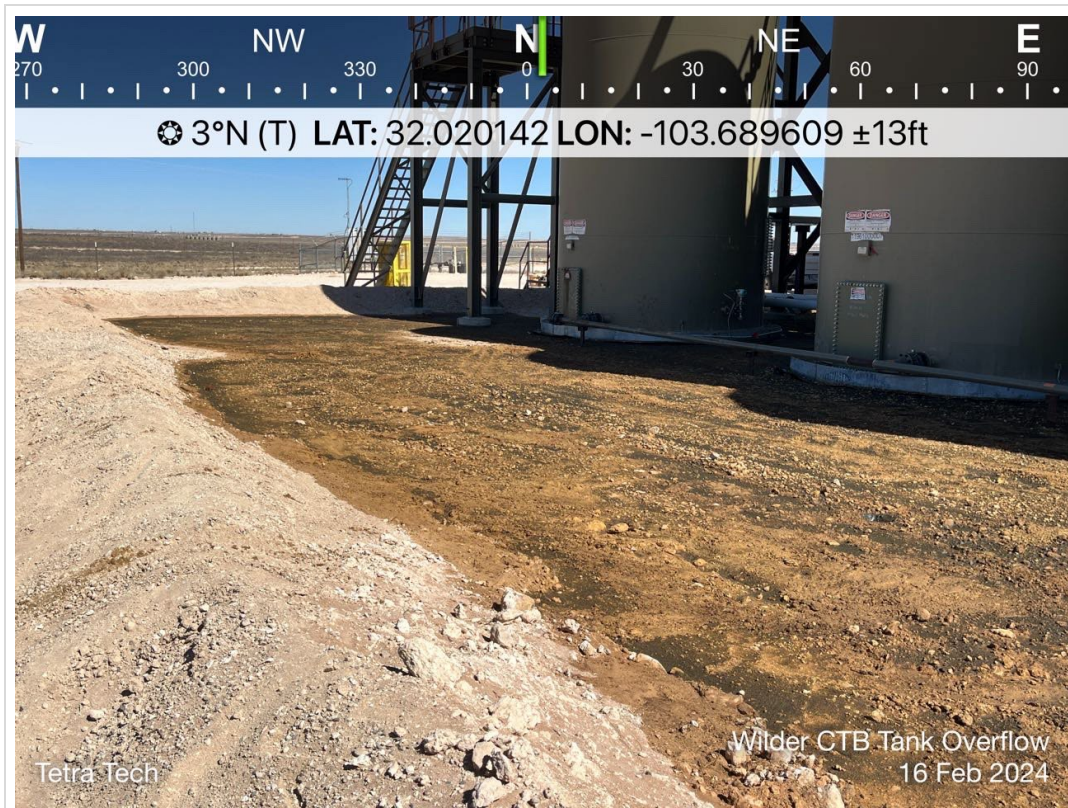
TETRA TECH, INC. PROJECT NO. 212C-MD-03442	DESCRIPTION	View north of approximate release extent inside bermed tank battery post initial response.	9
	SITE NAME	WILDER CTB TANK OVERFLOW Release	2/16/2024

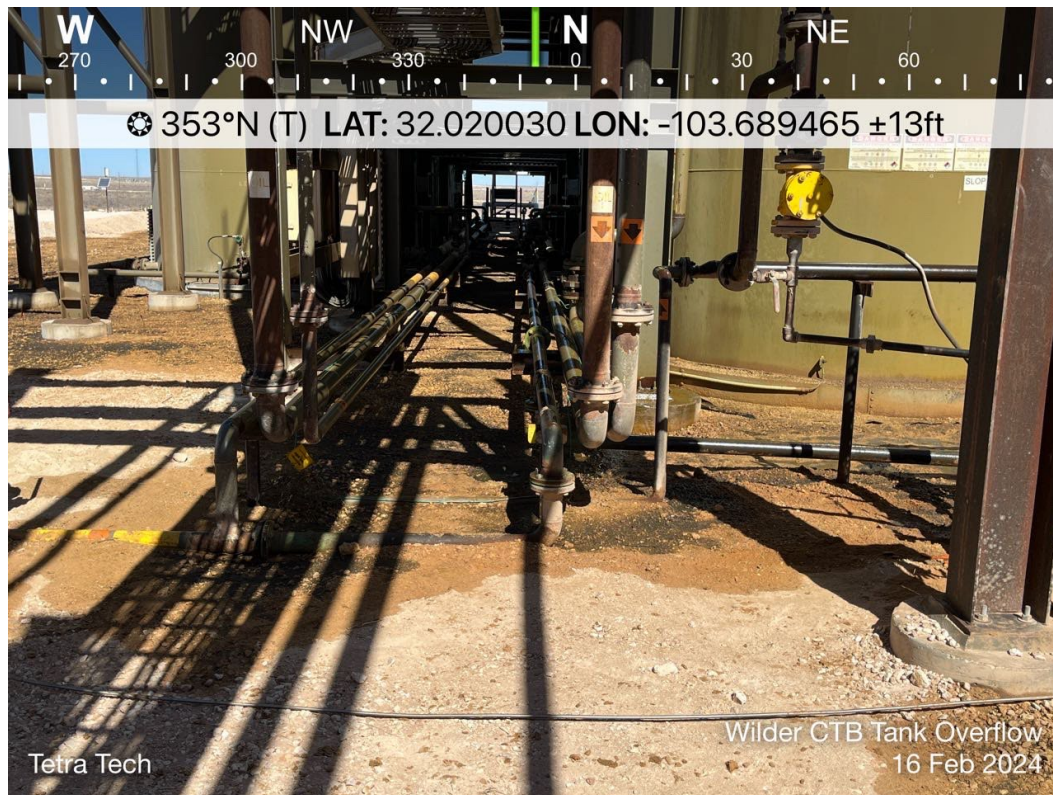
TETRA TECH, INC. PROJECT NO. 212C-MD-03442	DESCRIPTION	View north of approximate release extent inside bermed tank battery post initial response.	10
	SITE NAME	WILDER CTB TANK OVERFLOW Release	2/16/2024

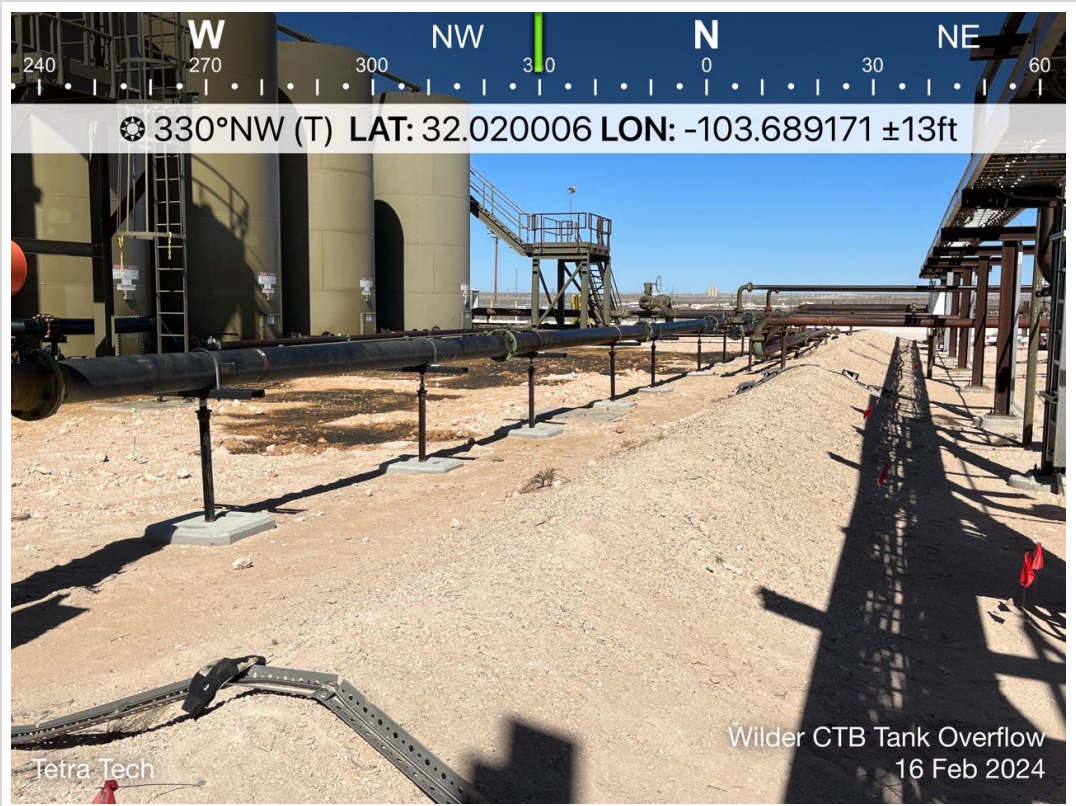
TETRA TECH, INC. PROJECT NO. 212C-MD-03442	DESCRIPTION	View north-northwest of approximate release extent inside bermed tank battery post initial response.	11
	SITE NAME	WILDER CTB TANK OVERFLOW Release	2/16/2024

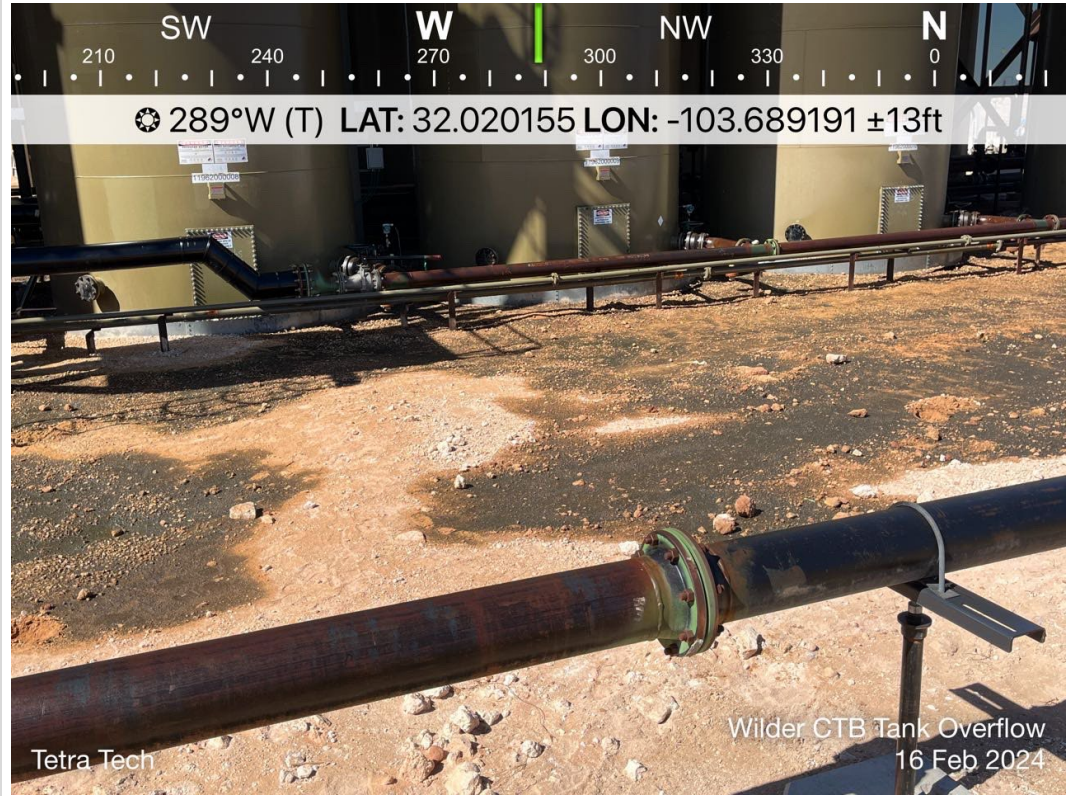
TETRA TECH, INC. PROJECT NO. 212C-MD-03442	DESCRIPTION	View west-northwest of approximate release extent inside bermed tank battery post initial response.	12
	SITE NAME	WILDER CTB TANK OVERFLOW Release	2/16/2024

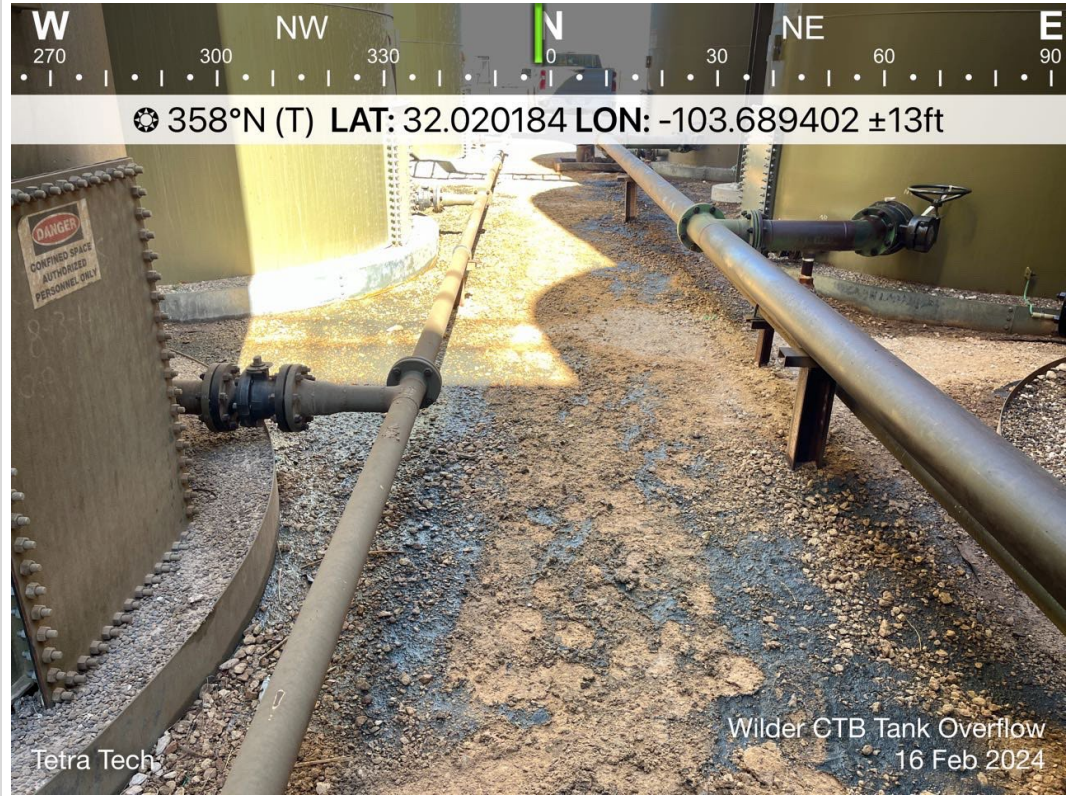
TETRA TECH, INC. PROJECT NO. 212C-MD-03442	DESCRIPTION	View north of approximate release extent inside bermed tank battery post initial response.	14
	SITE NAME	WILDER CTB TANK OVERFLOW Release	2/16/2024

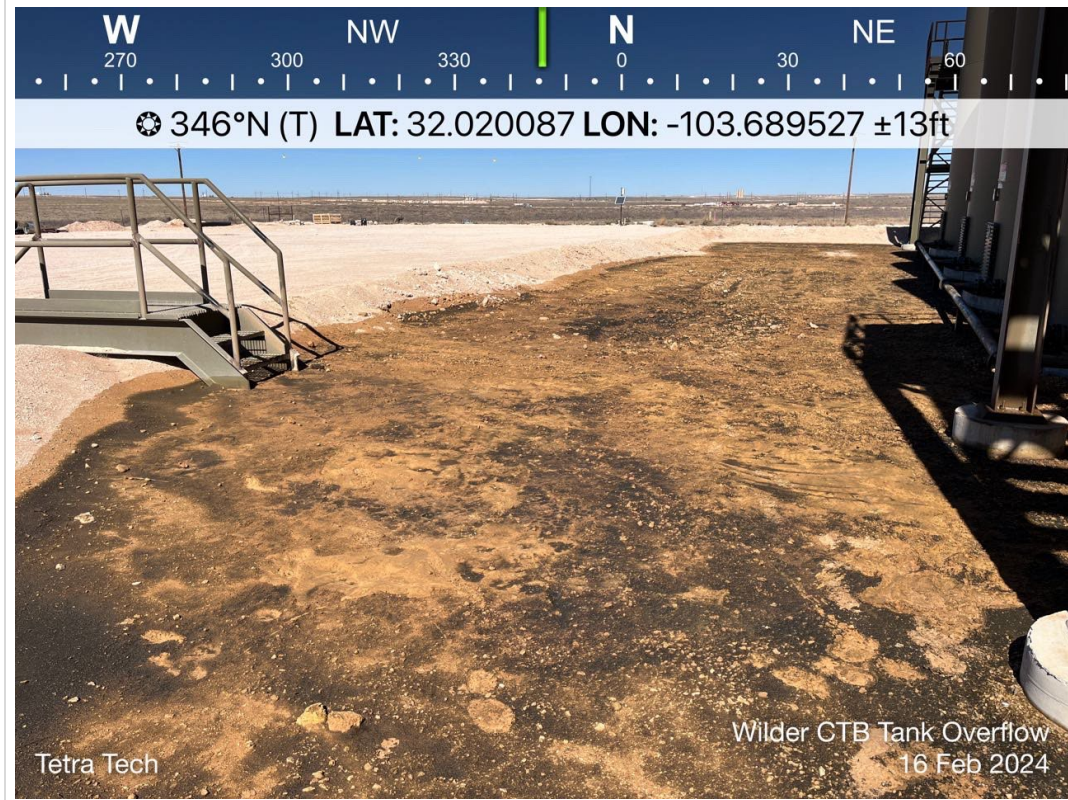
TETRA TECH, INC. PROJECT NO. 212C-MD-03442	DESCRIPTION	View north-northwest of approximate release extent inside bermed tank battery post initial response.	16
	SITE NAME	WILDER CTB TANK OVERFLOW Release	2/16/2024
