**Re: Closure Request
PLU Ross Ranch 33-25-30 USA Battery
Incident Number NAPP2414137102
Eddy County, New Mexico**

Ensolum, LLC (Ensolum) on behalf of XTO Energy, Inc. (XTO), has prepared this *Closure Request* to document liner inspection, delineation, and soil sampling activities performed at the PLU Ross Ranch 33-25-30 USA Battery (Site). The purpose of the site activities was to assess for the presence or absence of impacts to soil resulting from a release of produced water within a lined containment at the Site. Based on field observations and laboratory analytical results, XTO is submitting this *Closure Request*, describing the liner inspection and delineation activities that have occurred and requesting no further action for Incident Number NAPP2414137102.

XTO Energy, Inc
Closure Request
PLU Ross Ranch 33-25-30 USA Battery

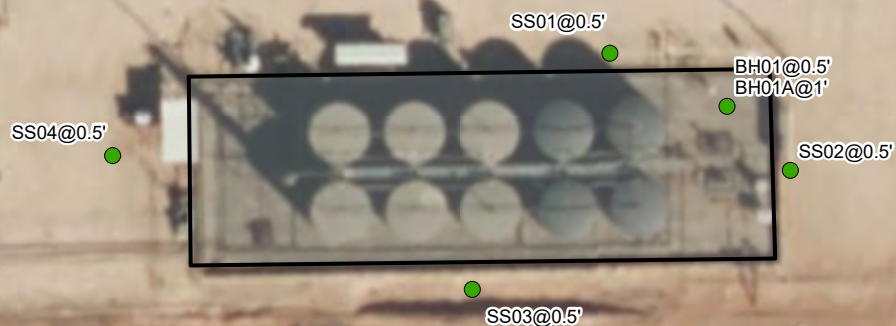
FIGURE
2

Notes:
Sample ID @ Depth Below Ground Surface.

Delineation Soil Sample Locations

Following a failed liner integrity inspection and a one call utility clearance of the work area, delineation activities were conducted on June 28, 2024, to determine the presence or absence of impacted soil underneath the lined containment area. Ensolum personnel advanced one borehole (BH01) via hand auger at the location of the tear in the liner identified during the inspection. Two discrete soil samples were collected from the borehole at depths of approximately 0.5 feet and 1 foot bgs. Borehole BH01 could only be advanced to a maximum depth of 1 foot bgs due to a competent caliche formation in the subsurface that caused hand auger refusal. Additionally, four delineation soil samples (SS01 through SS04) were collected at a depth of approximately 0.5 feet bgs on the surface of the pad, immediately surrounding the lined containment area to confirm the release stayed within the lined containment area. All delineation soil samples were field screened for volatile organic compounds (VOCs) utilizing a calibrated photoionization detector (PID) and chloride using Hach® chloride QuanTab® test strips. Field screening results and observations from the borehole were documented on a lithologic/soil sampling log, which is included as Appendix B. The borehole was backfilled with the soil removed and XTO repaired the hole in the liner. The borehole and delineation soil sample locations were mapped utilizing a handheld Global Positioning System (GPS) unit and are depicted on Figure 2. Photographic documentation was completed during the liner inspection and delineation activities and is presented in a Photographic Log included in Appendix C.

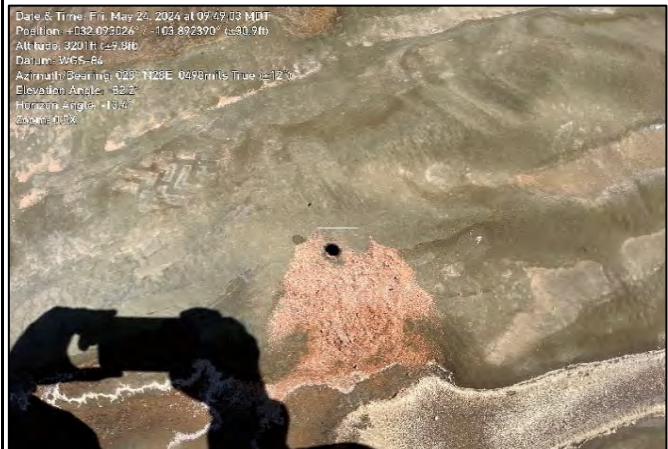
Photograph: 2 Date: 5/24/2024
Description: Liner inspection, hole in liner.
View: NA

Following the failed liner integrity inspection at the Site, Ensolum personnel advanced one borehole (BH01) at the location of the tear in the liner to assess for the presence or absence of impacted soil resulting from the May 16, 2024 produced water release within a lined containment. Two delineation soil samples were collected from the borehole, at depths of approximately 0.5 feet and 1 foot bgs and four delineation soil samples (SS01 through SS04) were collected at a depth of 0.5 feet bgs around the lined containment. Laboratory analytical results for all delineation soil samples indicated all COC concentrations were compliant with the Closure Criteria. The release was contained laterally by the lined containment walls and is delineated vertically through laboratory analytical results from BH01. All released fluids were recovered during initial response activities.

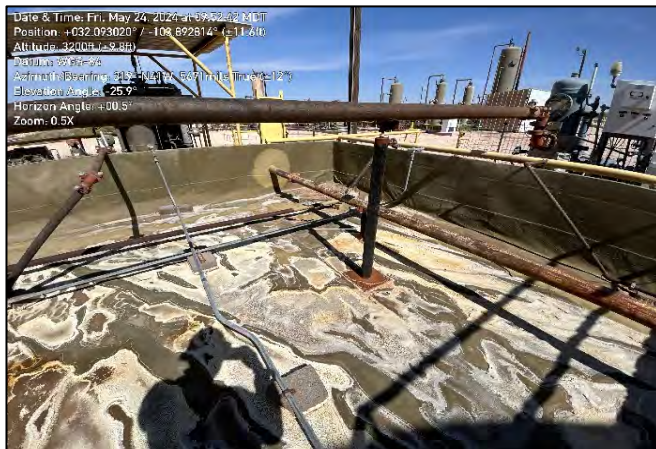
Photograph: 3 Date: 5/24/2024
Description: Salt crusting on surface of liner.
View: Northwest

During the liner inspection and delineation activities, staining and crusting on the liner was observed. XTO scheduled power washing of the liner to remove the debris and confirm the presence or absence

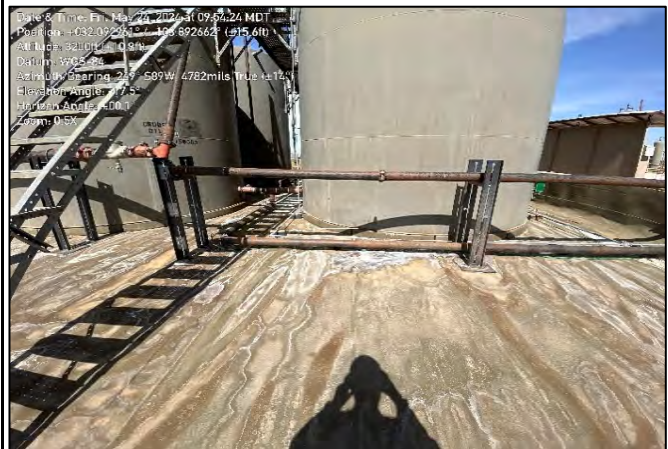
Photograph: 4 Date: 5/24/2024
Description: Salt crusting on surface of liner.
View: South

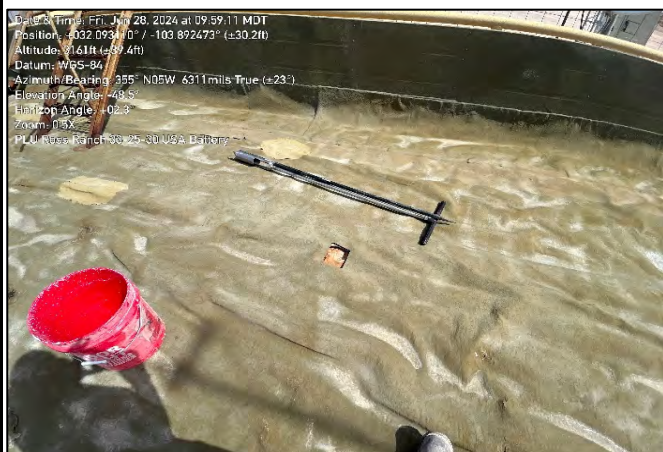
Photograph: 5 Date: 6/28/2024
Description: Liner delineation activities
View: Northwest

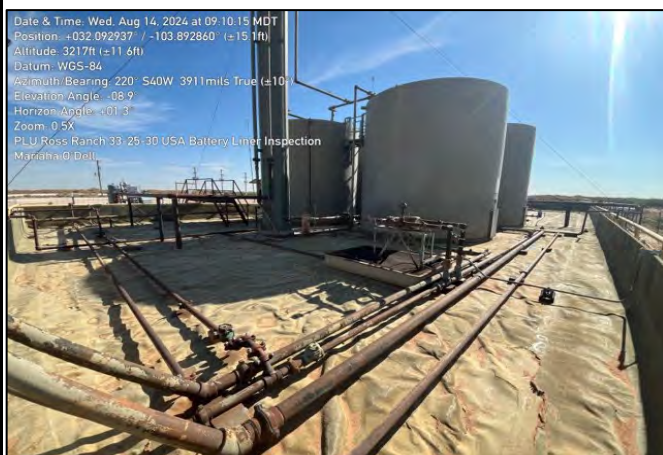
Photograph: 7 Date: 8/14/2024
Description: Liner inspection following power wash.
View: Southwest

of any additional insufficiencies in the liner. XTO submitted a 48-hour advance notice of liner inspection to be completed on August 14, 2024. Ensolum personnel conducted a liner inspection on August 14, 2024, and upon inspection, it was determined that the liner was operating as designed.

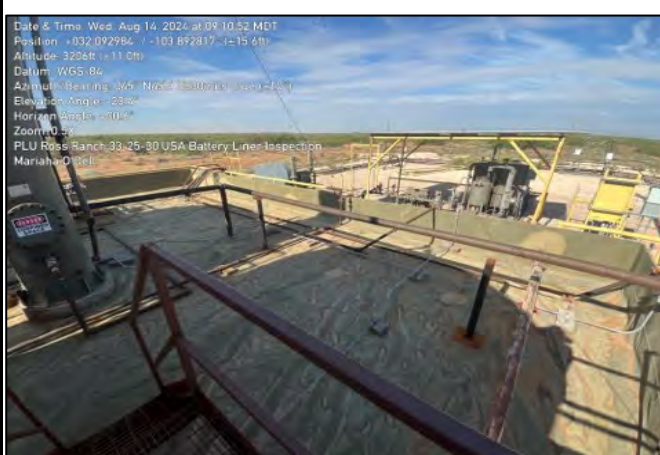
Photograph: 8 Date: 8/14/2024
Description: Liner inspection following power wash.
View: Northeast
