Re: Site Assessment, Remediation, and Closure Report
Cotton Draw Unit #509
API No. 30-025-43916
GPS: Latitude 32.1245605 Longitude -103.7077654
UL - P, 18, T25S, R32E
Lea County, NM
NMOCD Ref. No. NAB1906554479

Pima Environmental Services, LLC. (Pima) has been contracted by Devon Energy Production Company, LP (Devon) to prepare this Site Assessment, Remediation, and Closure Report for a crude oil and produced Water release that occurred at the Cotton Draw Unit #509 (Cotton). The incident was assigned incident NAB1906554479 by the New Mexico Oil Conservation Division (NMOCD).

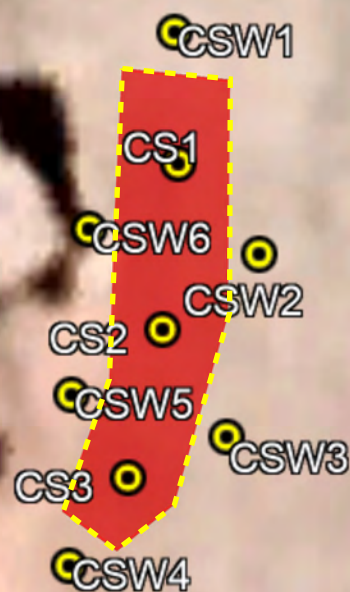
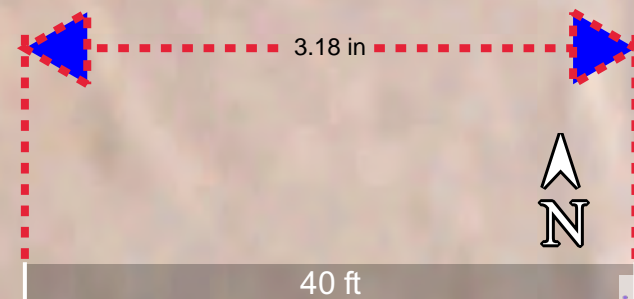
Figure 5- Confirmation Sample Map

On June 17, 2024, after sending a 48-hour notification, application ID:353630 (Appendix C), Pima returned to the site to collect 5-point confirmation samples of the excavation. The results of this sampling event can be found in the following table. A Confirmation Sample Map can be found in Figure 5.

Based on the sample results, the bottoms and sidewalls were below NMOCD Closure Criteria 19.15.29 NMAC. Based on the well water data from the New Mexico Office of the State Engineer water well (C-04618- POD1), the depth to the nearest groundwater in this vicinity measures 55 feet below grade surface (BGS), positioned 0.52 miles away from the Cotton, and was drilled on June 1, 2022. The contaminated material was sufficiently removed then transported to an NMOCD approved disposal site. The excavation was then backfilled with clean like material, machine compacted and returned to its previous state. See Appendix D for Photographic Documentation.

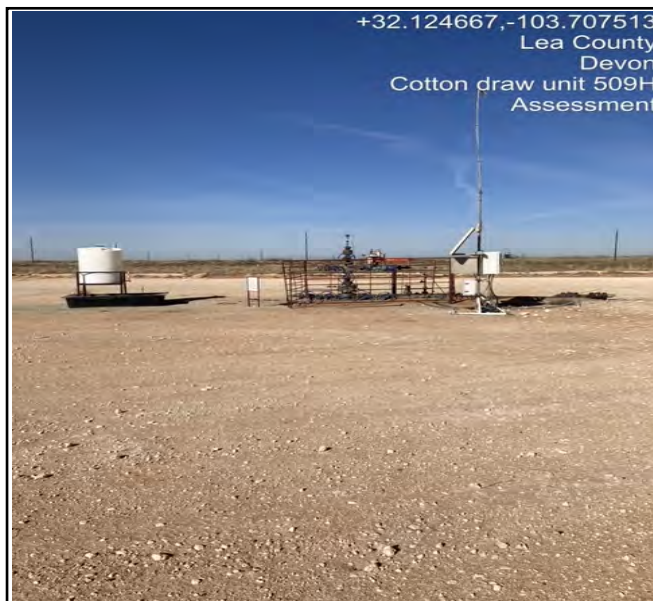
Photo of release taken during assessment on East side of location, facing West.

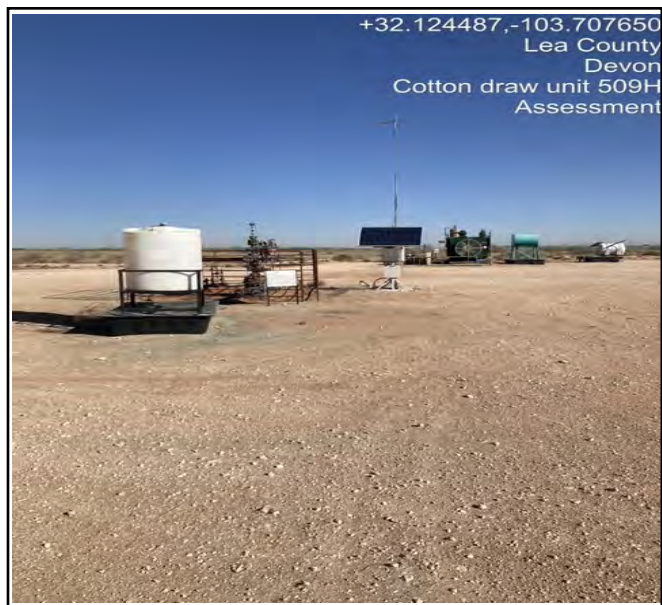
Photo of release taken during assessment on South side of location, facing North.

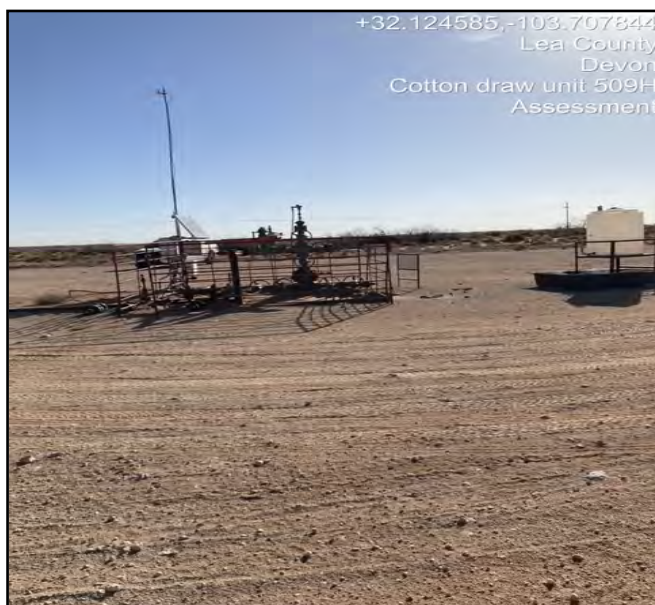
Photo of release taken during assessment on West side of location, facing East.

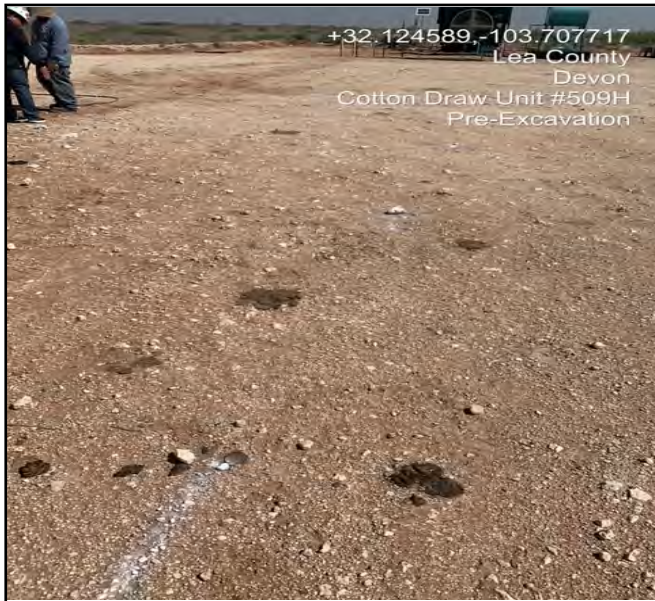
Photo of release prior to excavation, taken facing North.

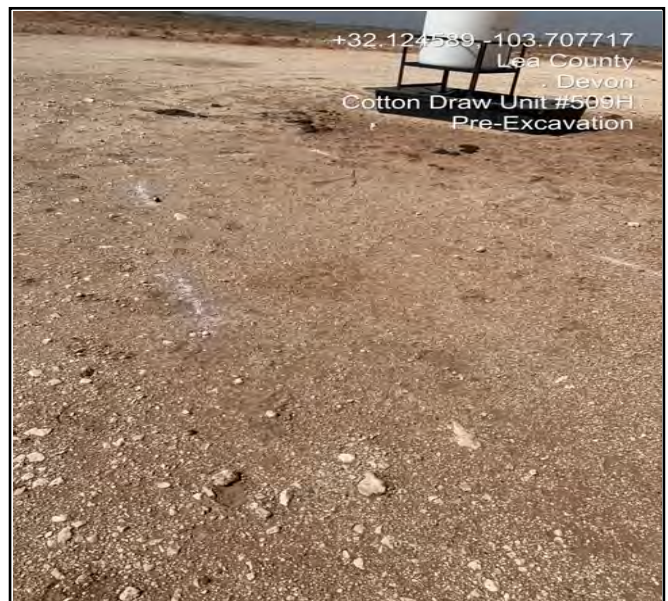
Photo of release prior to excavation, taken facing South.

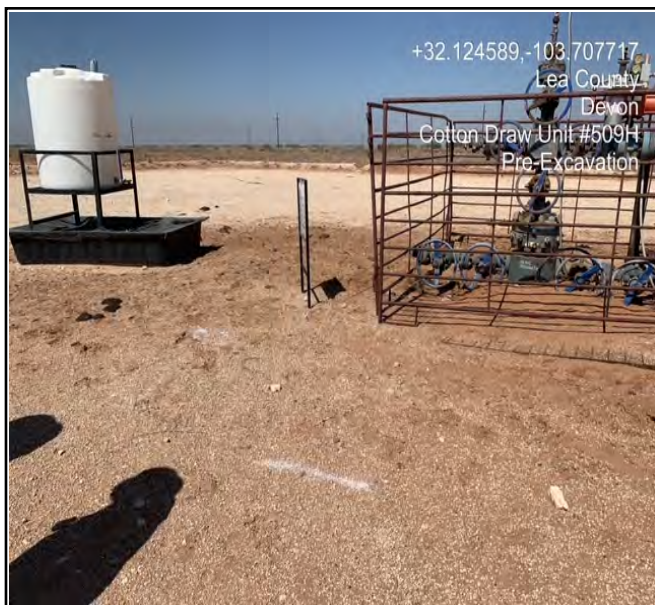
Photo of release prior to excavation, taken facing West.

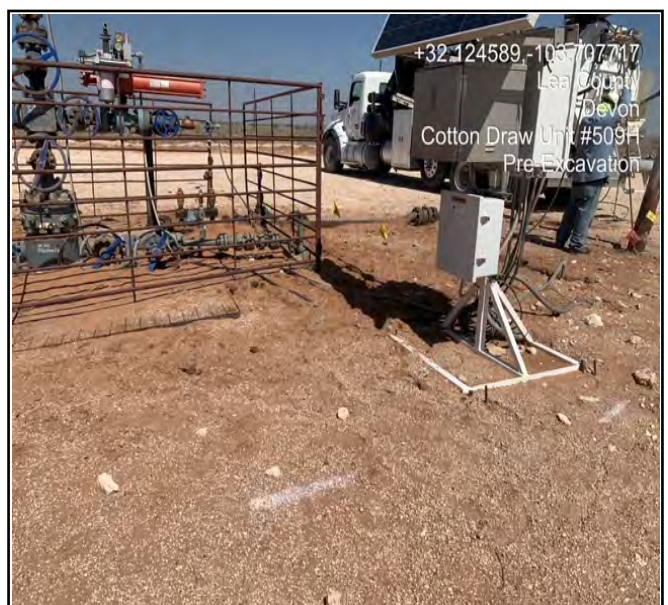
Photo of release prior to excavation, taken facing Southwest.

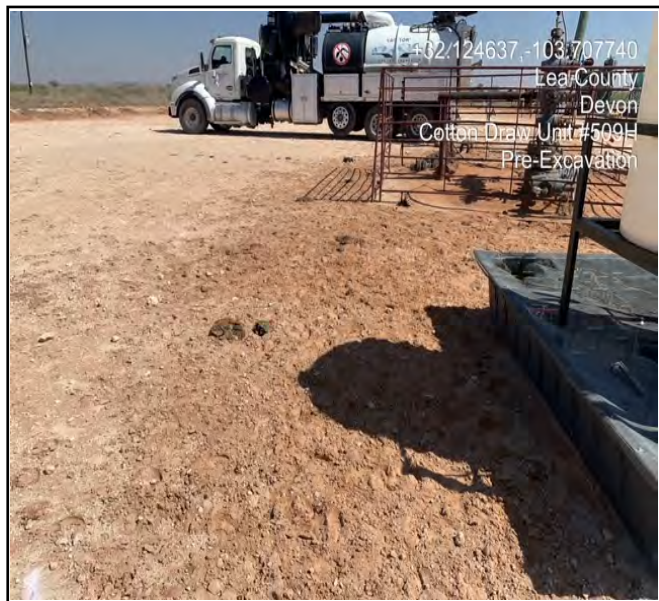
Photo of release prior to excavation, taken facing South.

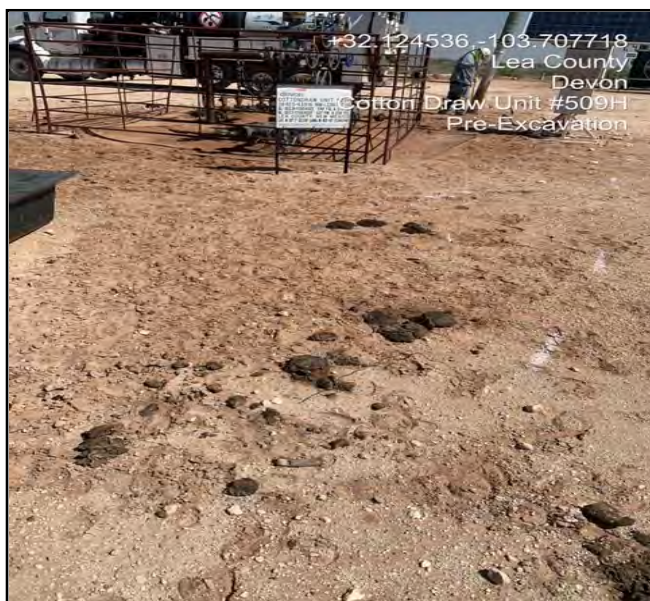
Photo of release prior to excavation, taken facing Northwest.

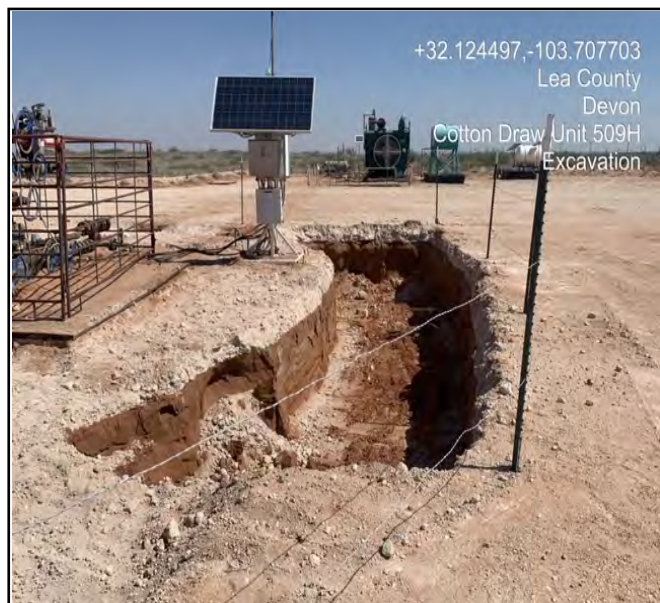
Photo taken during excavation, facing North.

On June 13, 2024, the Devon Construction Department mobilized personnel and equipment to begin immediate remediation activities. They began excavating the area to a depth of 4' BGS. The contaminated soil 85 cubic yards was hauled to an approved, lined disposal facility and clean backfill material was brought in.

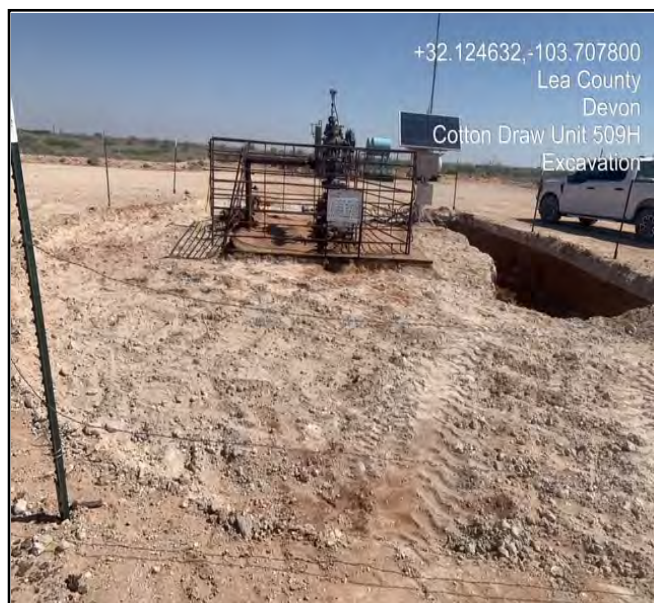
Photo taken during excavation, facing South.

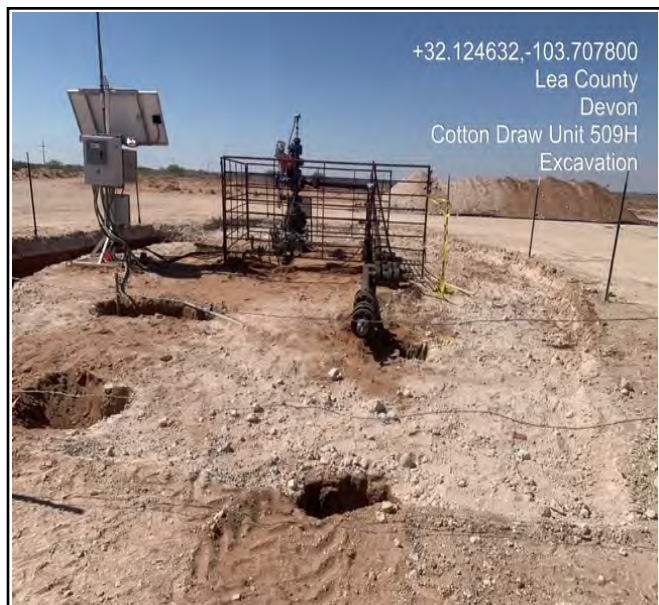
Photo taken during excavation, facing Southeast.

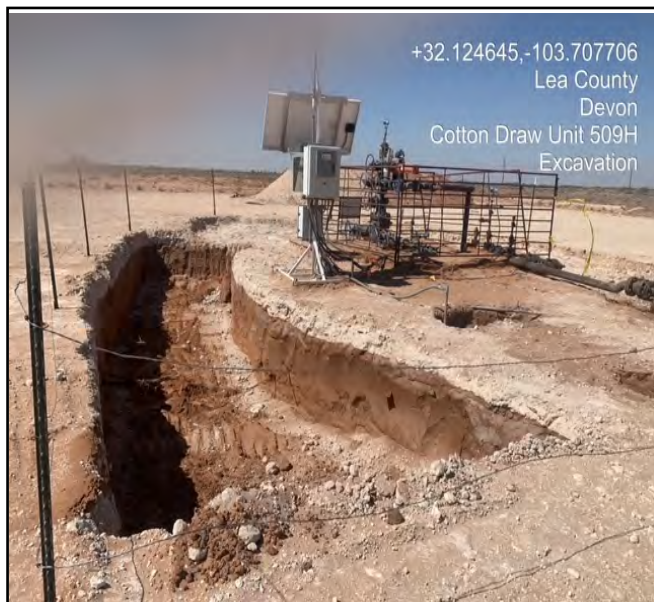
Photo taken during excavation, facing Southwest.

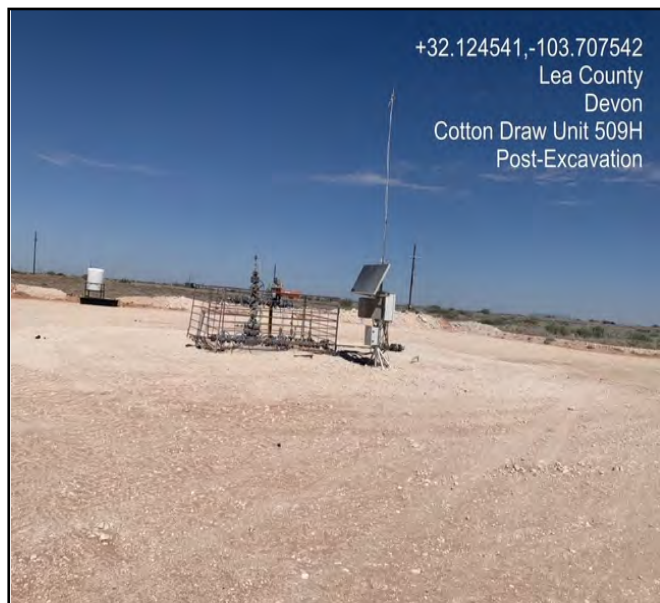
Photo taken after excavation and backfill, facing Northwest.

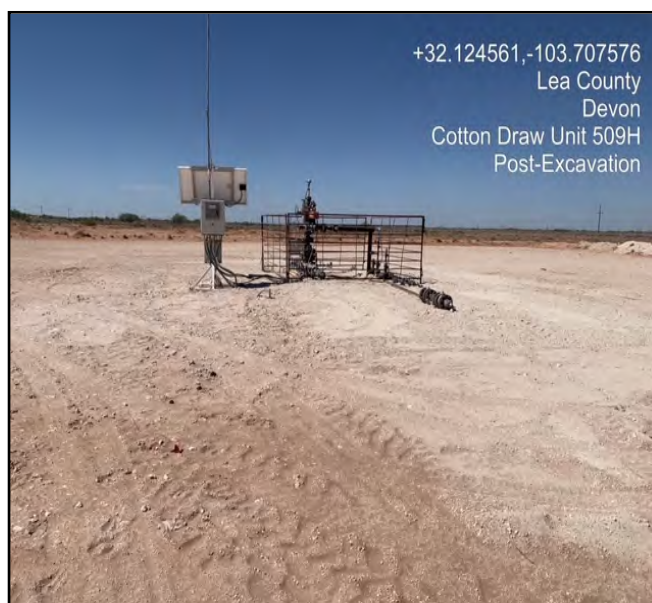
Photo taken after excavation and backfill, facing West.

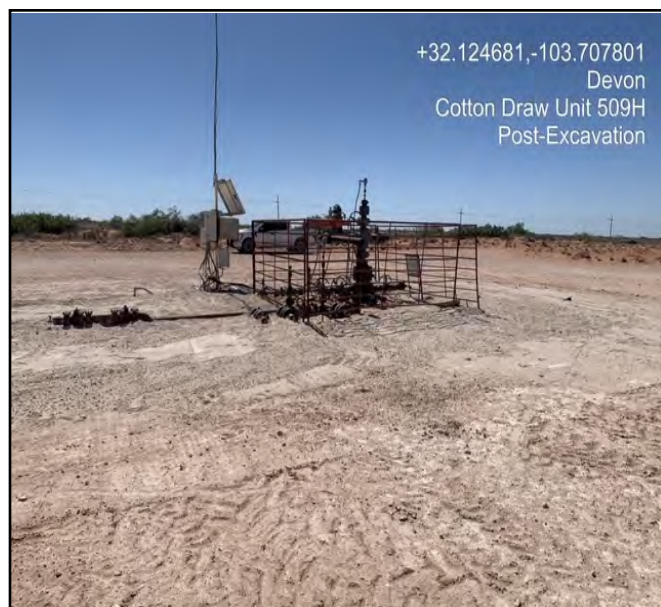
Photo taken after excavation and backfill, facing Southeast.

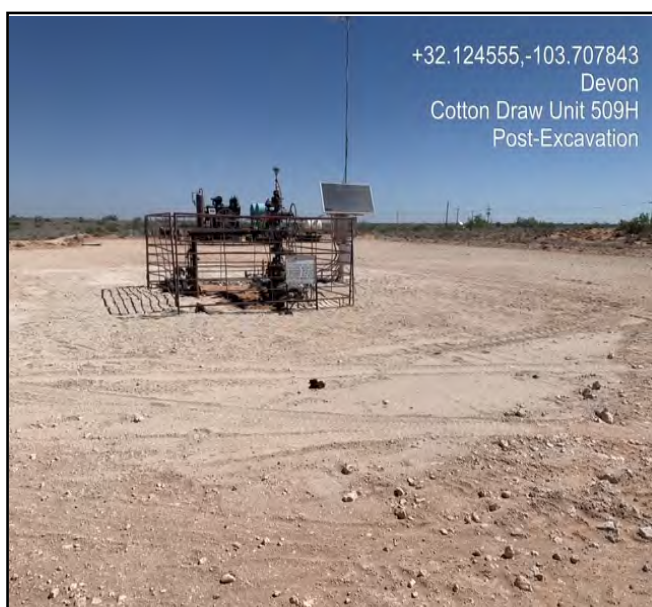
Photo taken after excavation and backfill, facing East.
