Remediation Closure

Ragin Cajun 13 Federal #002H

Vertex File Number: 23E-02967

Vertex Resource Services Inc.

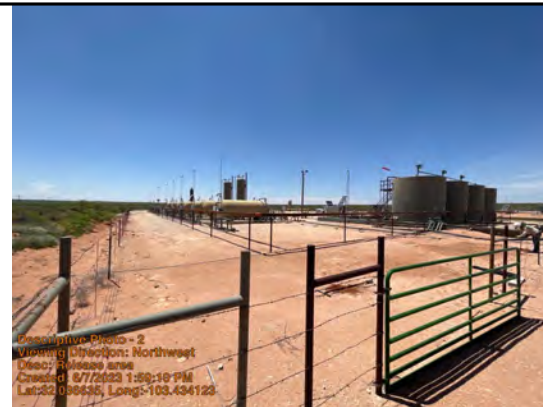
Release area

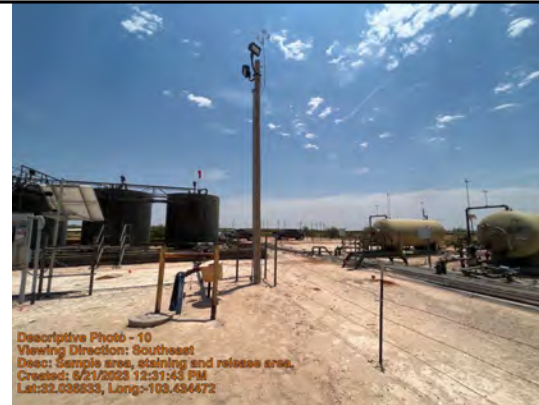
Sample area, staining and release area.

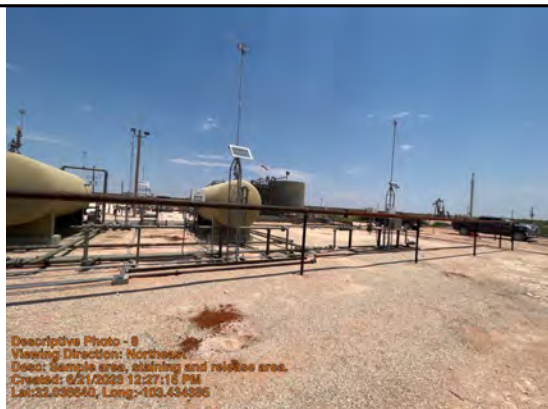
Sample area, staining and release area.

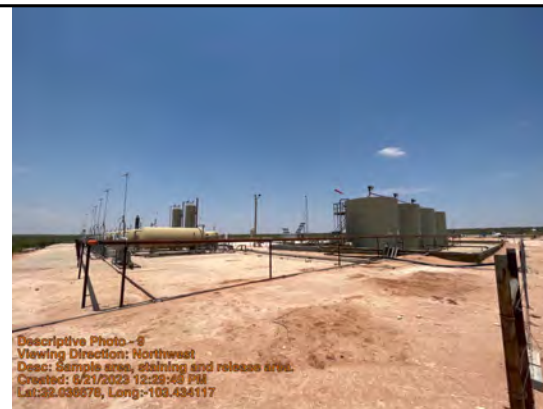
Sample area, staining and release area.

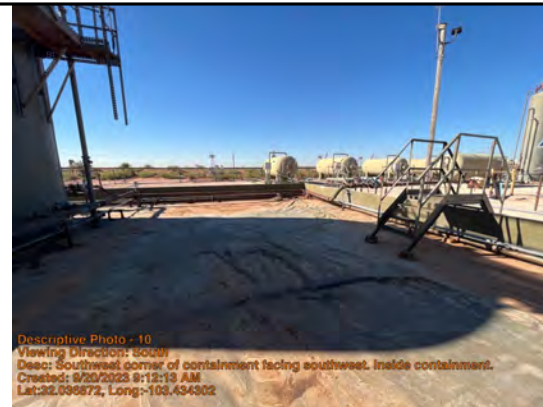
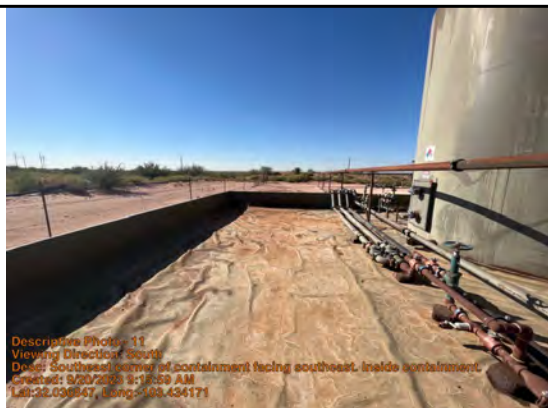
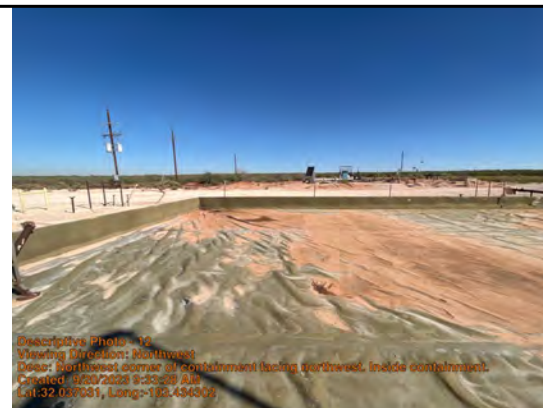
9:29 Inspected both inside and outside walls of containment and did not find any compromising damage or unexpected breaches. No unexpected staining on soil outside the containment or from area of breach, which has been delineated.

Inspection of liner around and between equipment and tanks, inside containment did not yield any damage, breaches, or areas of concern with liner.

Northwest corner of containment facing southeast. North end outside containment.

Southwest corner of containment facing southwest. Inside containment.

Southeast corner of containment facing southeast. Inside containment.

Northwest corner of containment facing northwest. Inside containment.

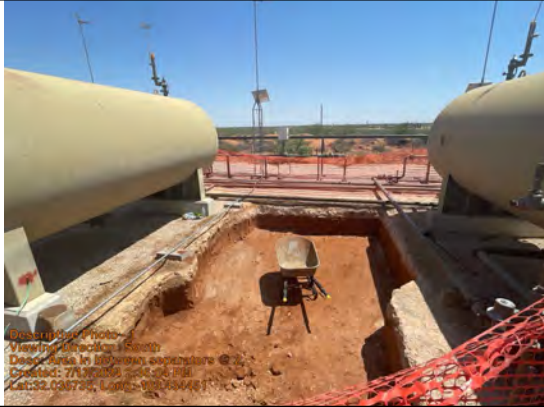
Area in between separators @ 2'

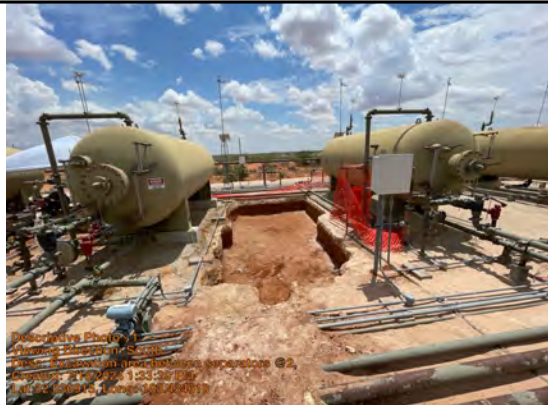
Excavation area between separators @2'

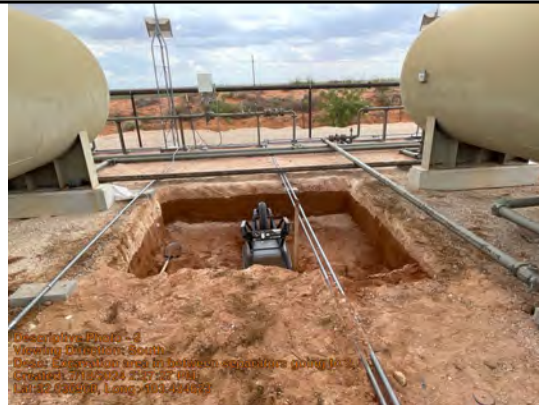
Excavation area in between separators going to 2'

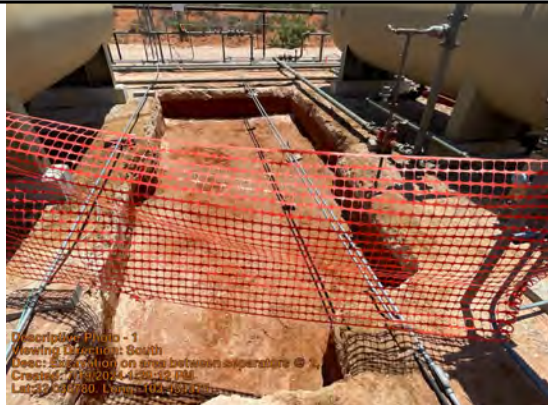
Excavation on area between separators @ 2'

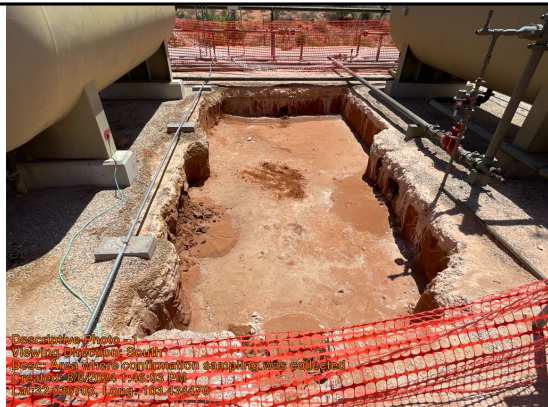
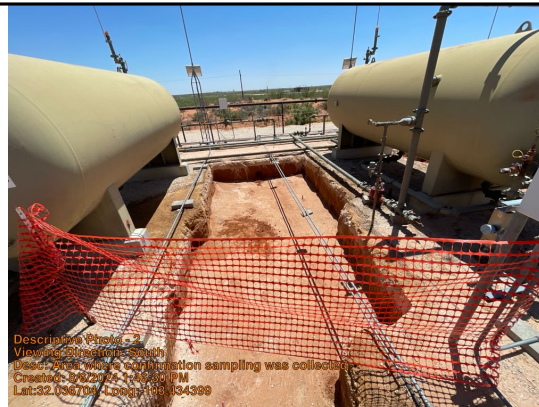
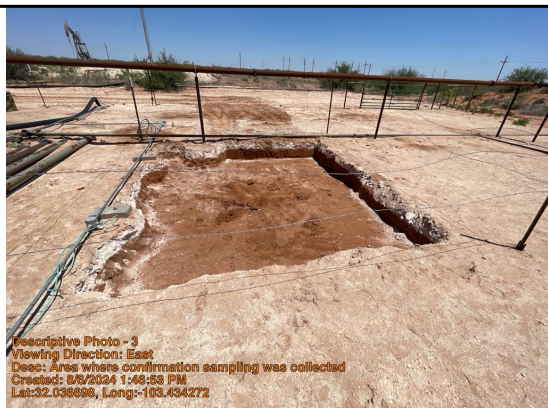
Area where confirmation sampling was collected
