**Closure Report**  
**Dayton Water Recycle**  
**Eddy County, New Mexico**  
**Incident ID: NAPP2230640215**  
**Unit G Sec 27 T18S R26E**  
**32.719355°, -104.368382°**

**Produced Water Release**  
**Point of Release: Tank Overflow**  
**Release Date: 10.30.2022**  
**Volume Released: 5 barrels of Produced Water**  
**Volume Recovered: 5 barrels of Produced Water**

**Re: Closure Report  
Dayton Water Recycle  
Silverback Operating II, LLC  
Site Location: Unit G, S27, T18S, R26E  
(Lat 32.719355°, Long -104.368382°)  
Eddy County, New Mexico**

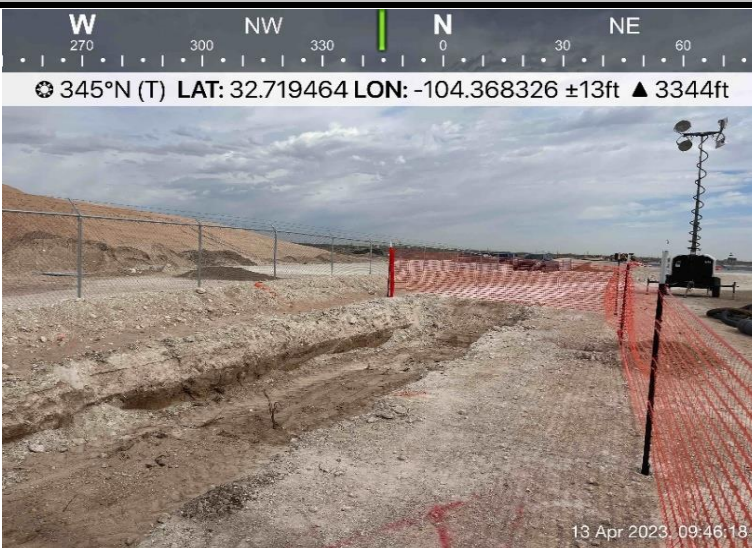
**Photograph No. 3****Facility:** Dayton Water Recycle**County:** Eddy County, New Mexico**Description:**

View North, area of CS-5 through CS-7.

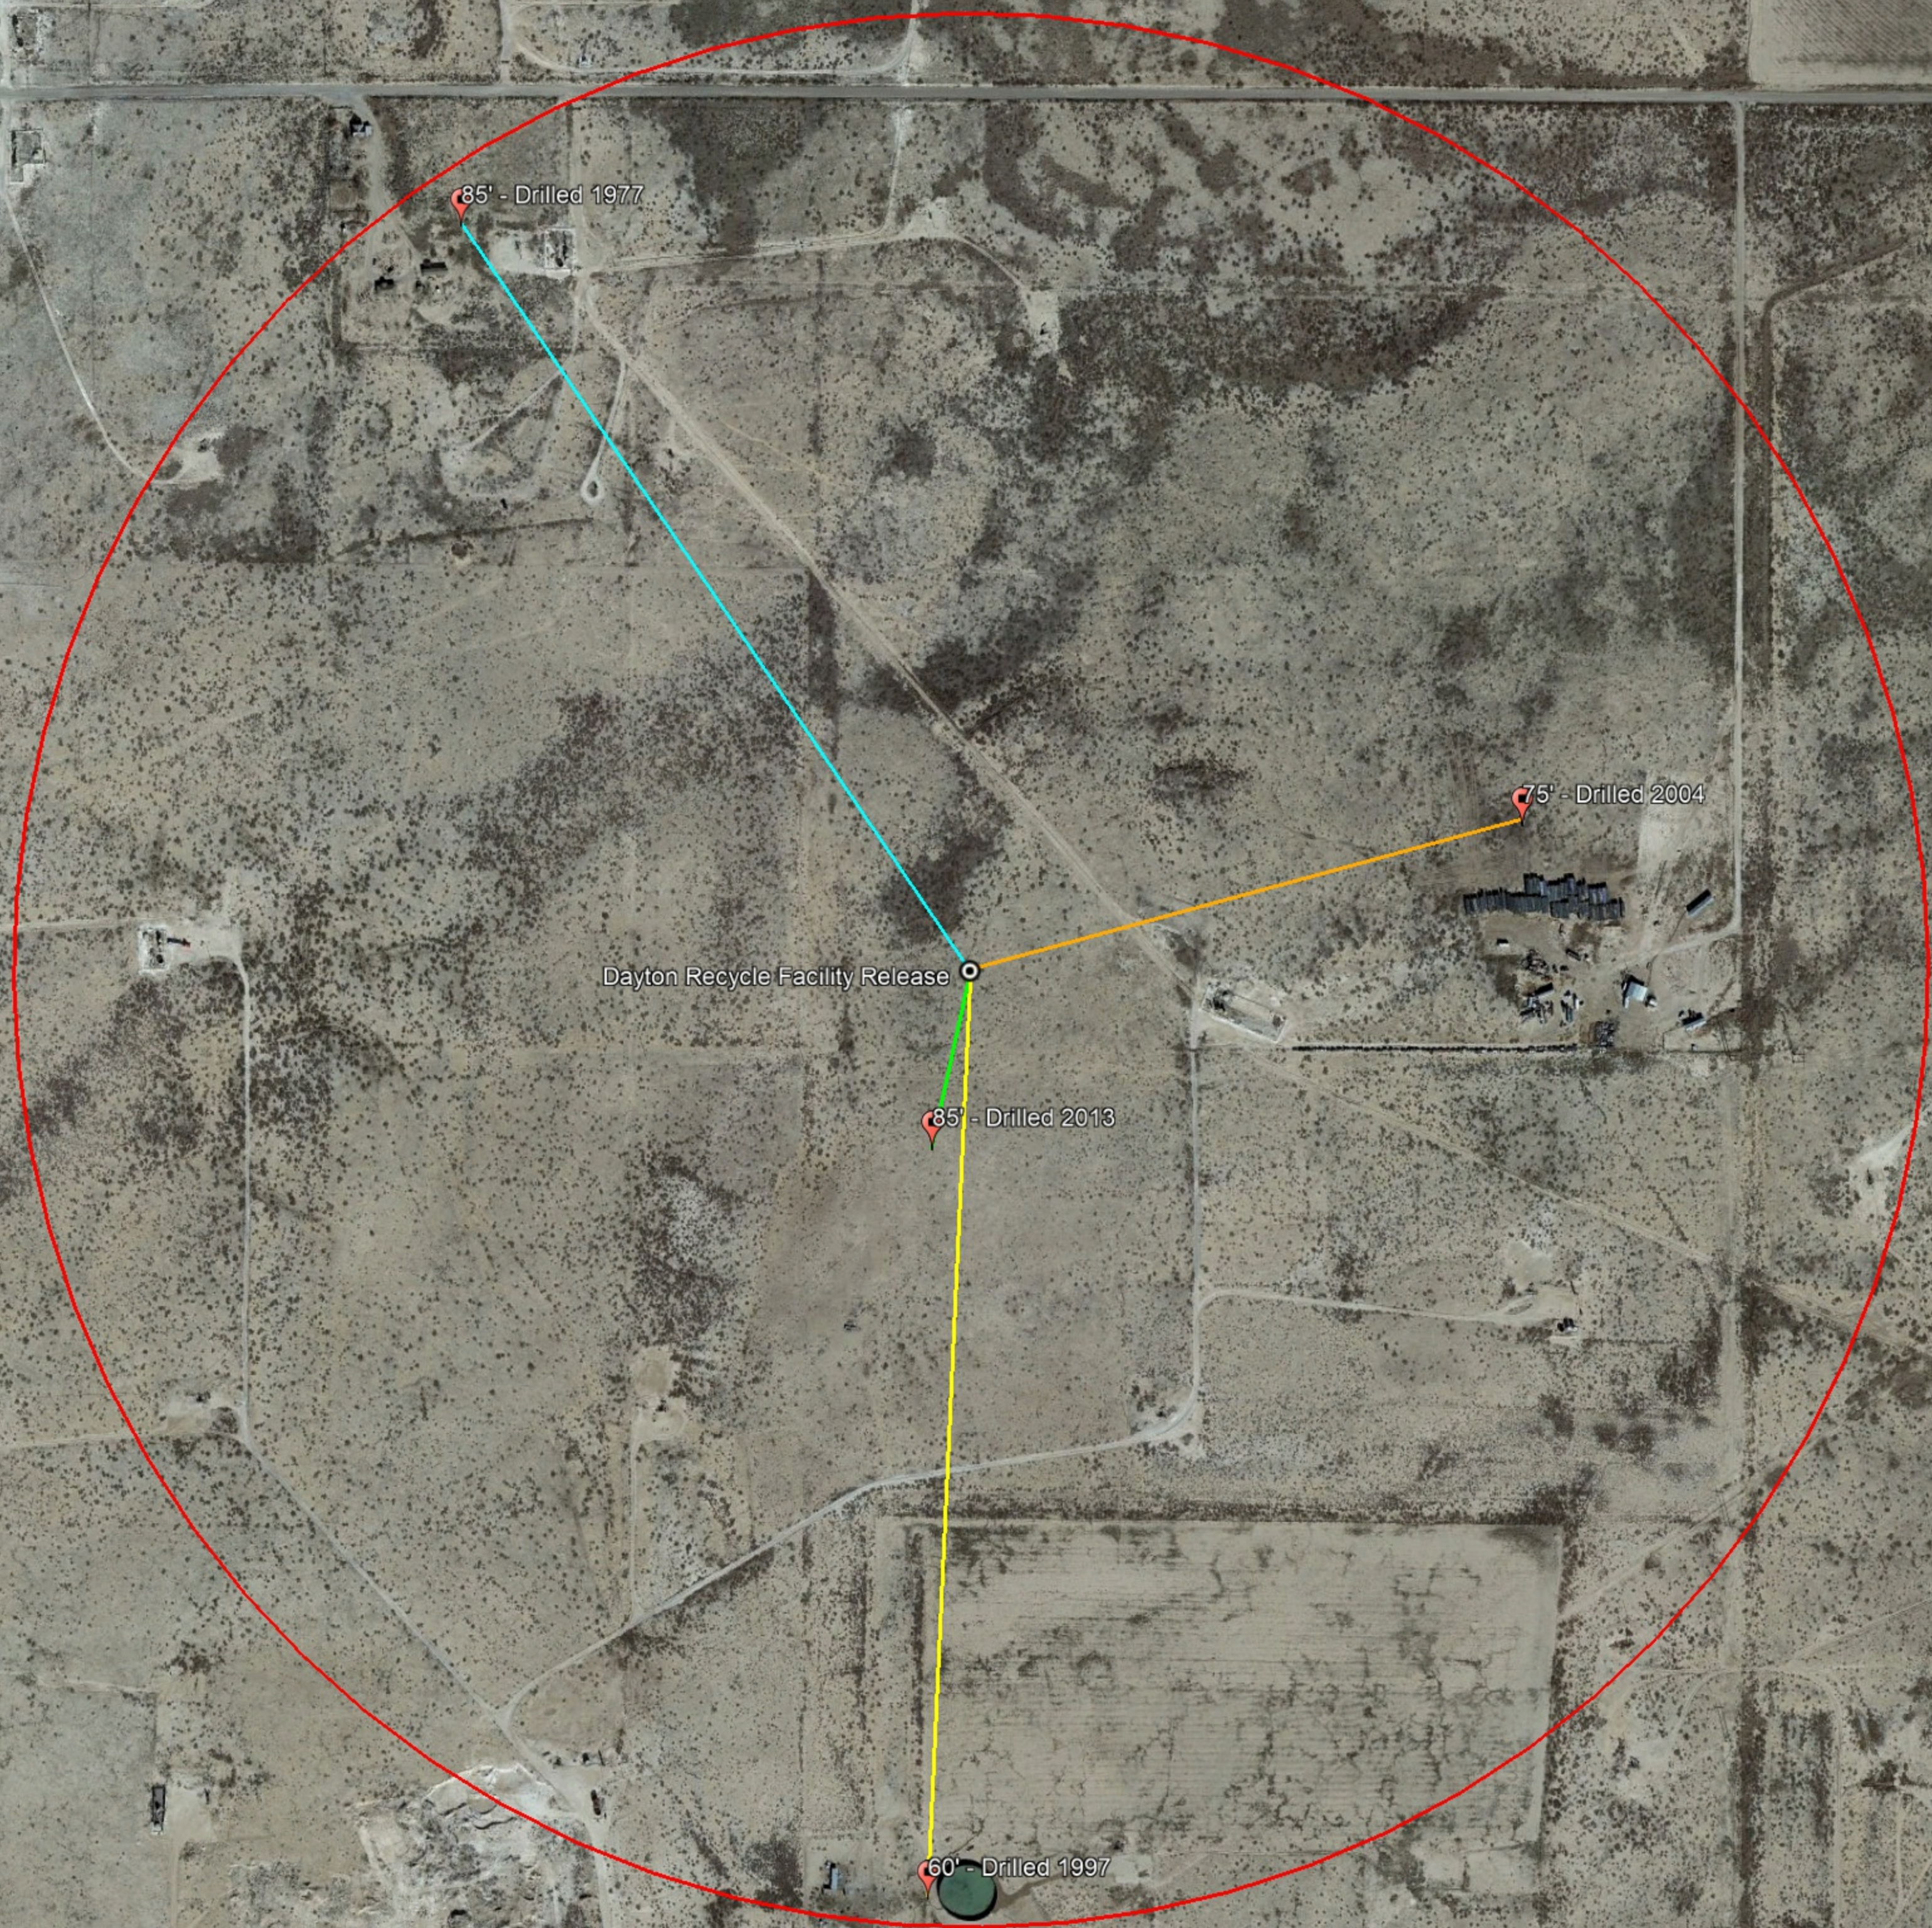
The site is located within a low karst area. Based on a review of the New Mexico Office of State Engineers and USGS databases, four (4) known water features are within a 0.50-mile radius of the location. The nearest identified well is approximately 0.10 miles South of the site in S28, T18S, R26E and was drilled in 2013. The well has a reported depth to groundwater of 85' feet below the ground surface (ft bgs). The following closest well is approximately 0.30 miles East of the site in S27, T18S, R26E and was drilled in 2004. The well has a reported depth to groundwater of 75' feet below the ground surface (ft bgs). The third closest well is approximately 0.47 miles Northwest of the site in S27, T18S, R26E and was drilled in 1977. The well has a reported depth to groundwater of 85' feet below the ground surface (ft bgs). The fourth closest well is approximately 0.49 miles South of the site in S27, T18S, R26E and was drilled in 1997. The well has a reported depth to groundwater of 60' feet below the ground surface (ft bgs). The spill is within approximately 460' of a freshwater well. A copy of the associated Summary Report is attached in Appendix D.

Nearest water well

- 0.10 Miles
- 0.30 Miles
- 0.47 Miles
- 0.49 Miles
- 0.50 Mile Radius
- Dayton Recycle Facility Release
- NMSEO Water Well
