Closure Report
Corvo Federal 3H Flowline (06.28.24)
Lea County, New Mexico
Incident ID: nAPP2418437320
Unit M Sec 29 T24S R32E
32.18188611°, -103.70257778°

**Re:** Closure Report

Corvo Federal 3H Flowline (06.28.24)

Concho Operating, LLC Incident ID: nAPP2418437320

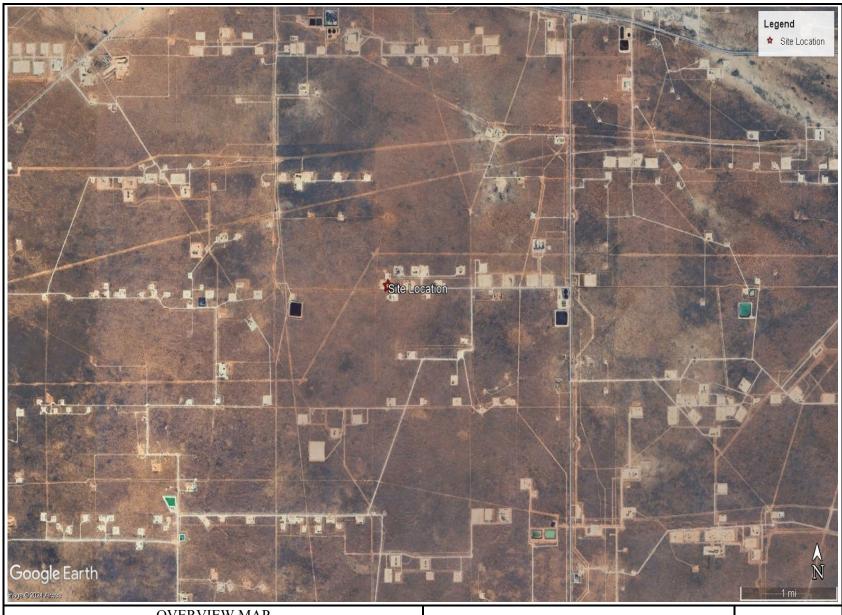
FIGURE 1

OVERVIEW MAP COG OPERATING, LLC CORVO FEDERAL 3H FLOWLINE (06.28.24) LEA COUNTY, NEW MEXICO 32.18188611°, -103.70257778°

On behalf of Concho Operating, LLC (COG), Carmona Resources, LLC has prepared this letter to document site assessment activities for the Corvo Federal 3H Flowline (06.28.24). The site is located at 32.18188611°, -103.70257778° within Unit M, S29, T24S, R32E, in Lea County, New Mexico (Figures 1 and 2).

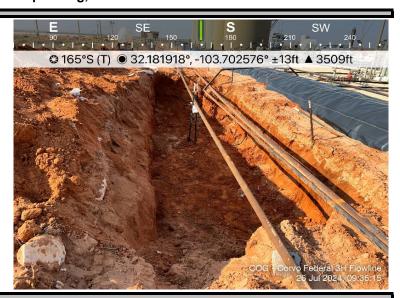
### Photograph No. 1

View South, area of CS-1 and CS-2.

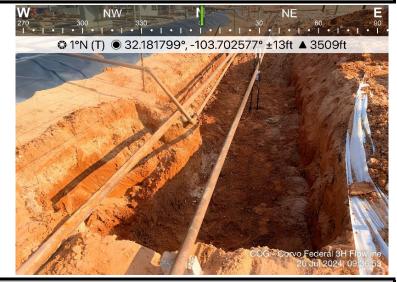
### Photograph No. 2

View North, area of CS-1 and CS-2.

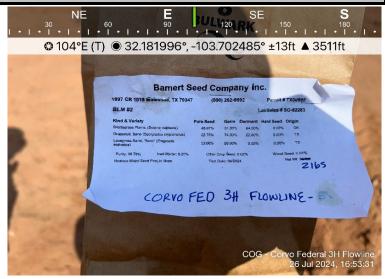
### Photograph No. 3

View of seed mixture for reclamation activities.

The site was re-seeded on July 26, 2024. The seed mixture was spread by hand. Topsoil matching the surrounding areas was raked over on top of the seed after being broadcasted. The seed mixture used was the BLM Seed Mix #4 (See attachments in Appendix F). See Figure 5 for the reclamation area.

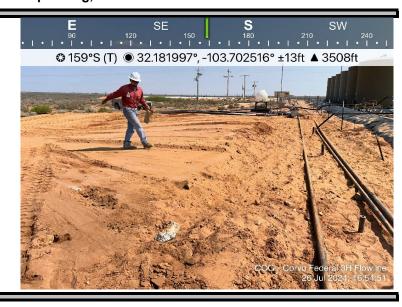
# Photograph No. 1

View South, of reclamation activities.
