**PROMETHEUS CTB PAD D
CLOSURE REQUEST**

**API NO. 30-025-48763
Unit Letter O, Section 22, Township 24S, Range 33E
LEA COUNTY, NEW MEXICO**

**DATE OF RELEASE: 04/26/2023
INCIDENT NO. NAPP2312327651**

Subject: Closure Request for Tap Rock Operating – Prometheus CTB Pad D
API No. 30-025-48763
Incident No. NAPP2312327651
Legal Unit Letter O, Section 22, Township 24 South, Range 33 East
Lea County, New Mexico

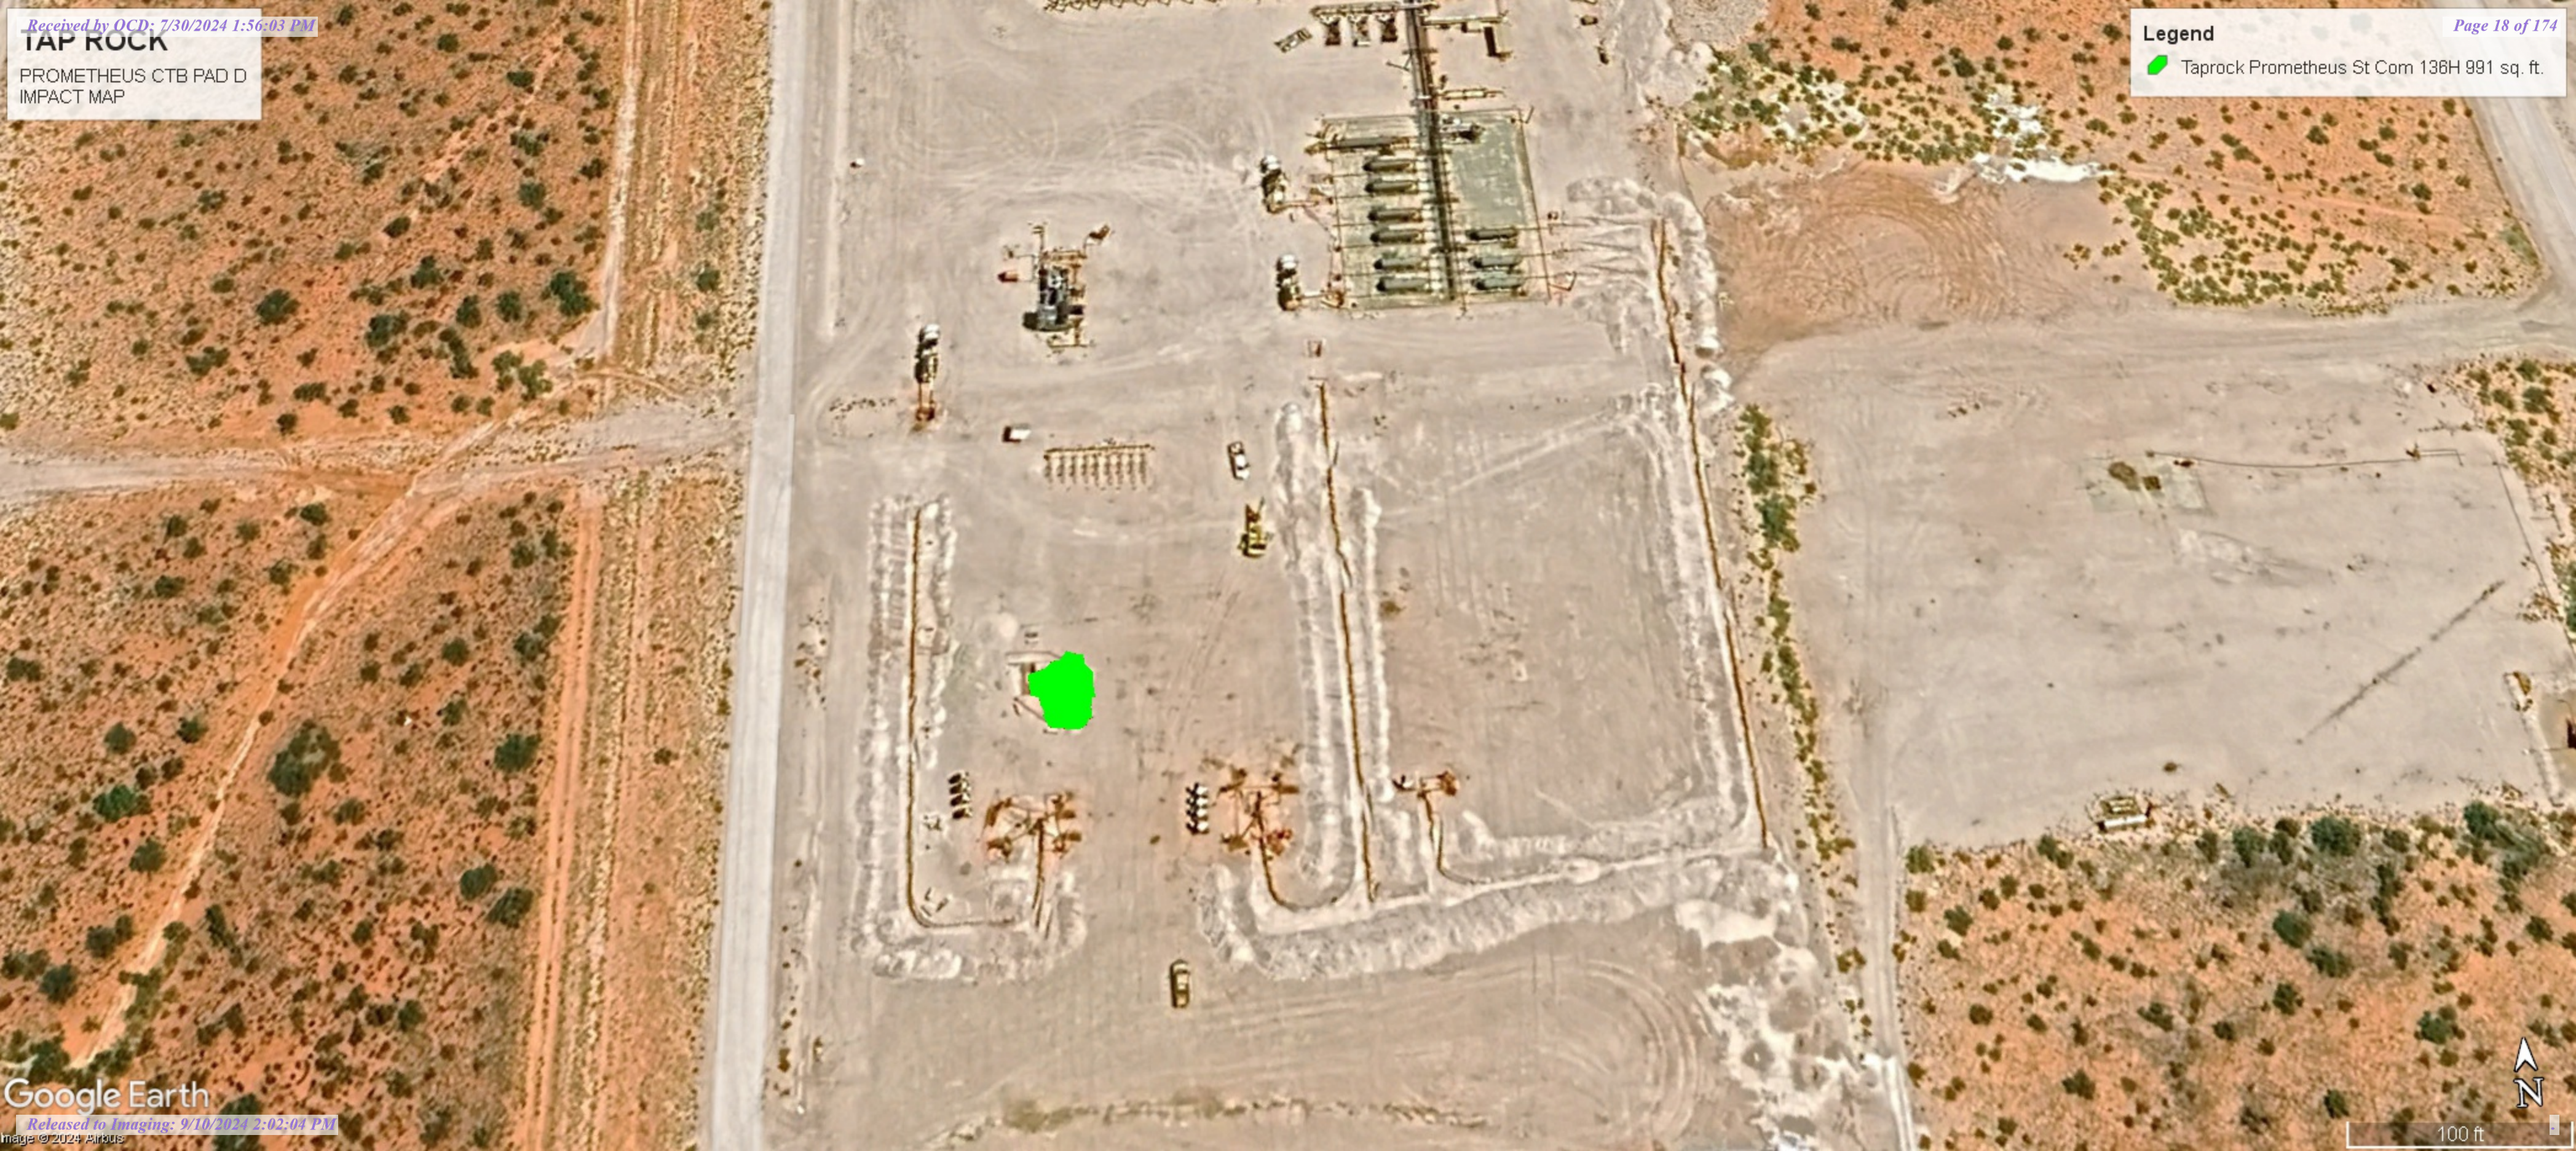
Received by OCD: 7/30/2024 1:56:03 PM
TAP ROCK
PROMETHEUS CTB PAD D
IMPACT MAP

Upon discovery of the release, ESS was notified and dispatched to location to conduct an environmental site assessment of the produced water release. It was determined, after measuring the area of impact, that approximately 15.83 barrels of produced water, with no fluid able to be recovered, had been released onto the pad of the Prometheus 136H. Initial site photos and measuring of the impacted area were conducted. Please see the initial site photos attached.

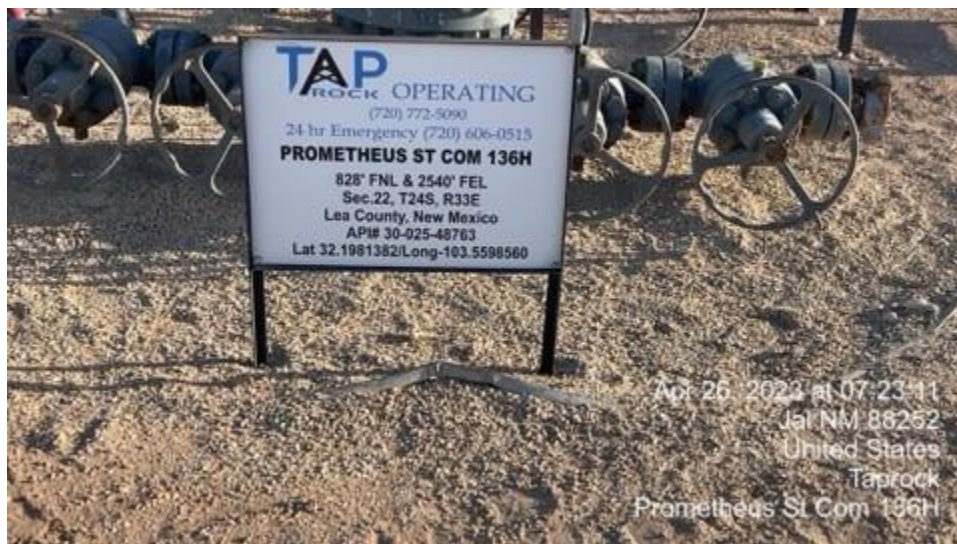
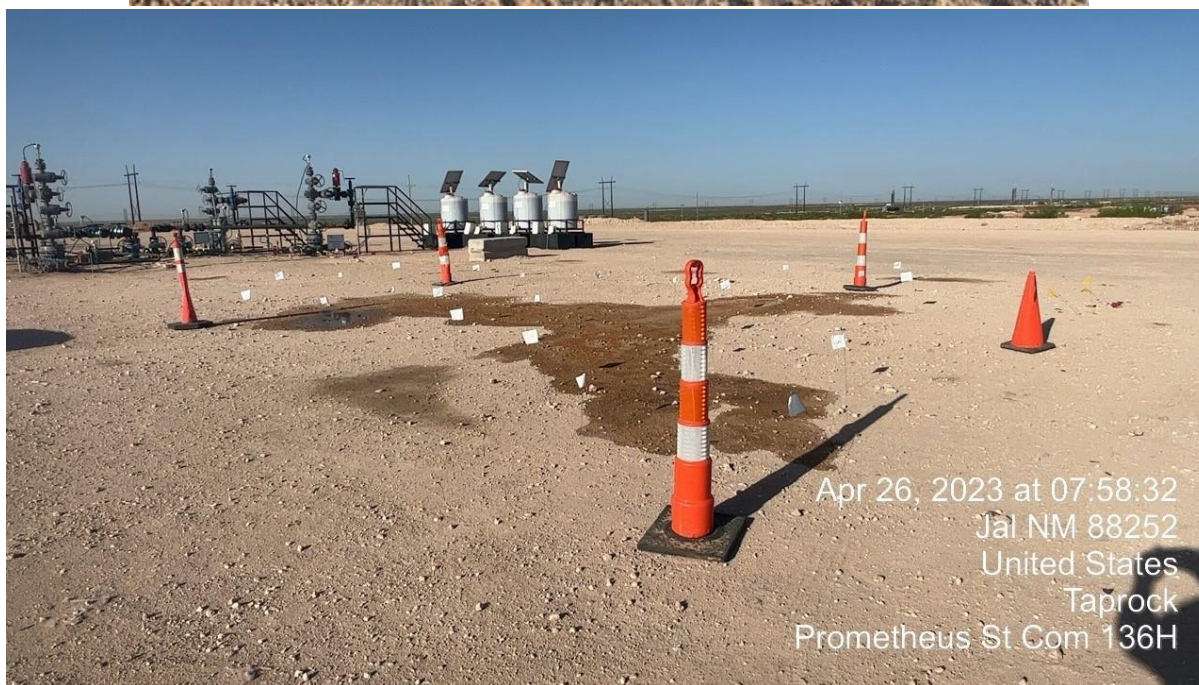
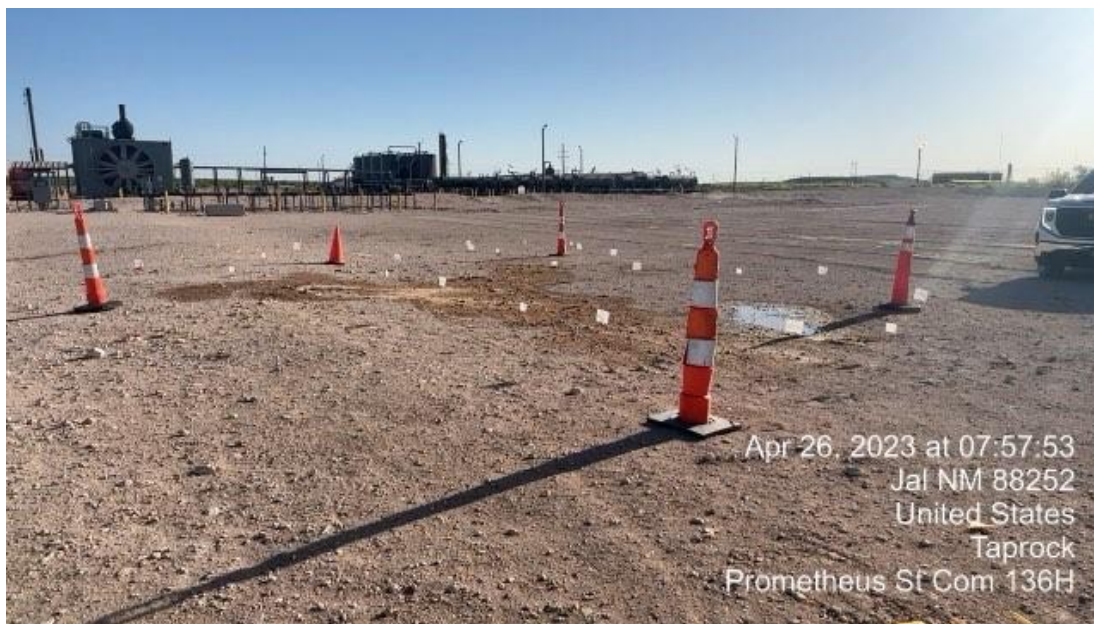
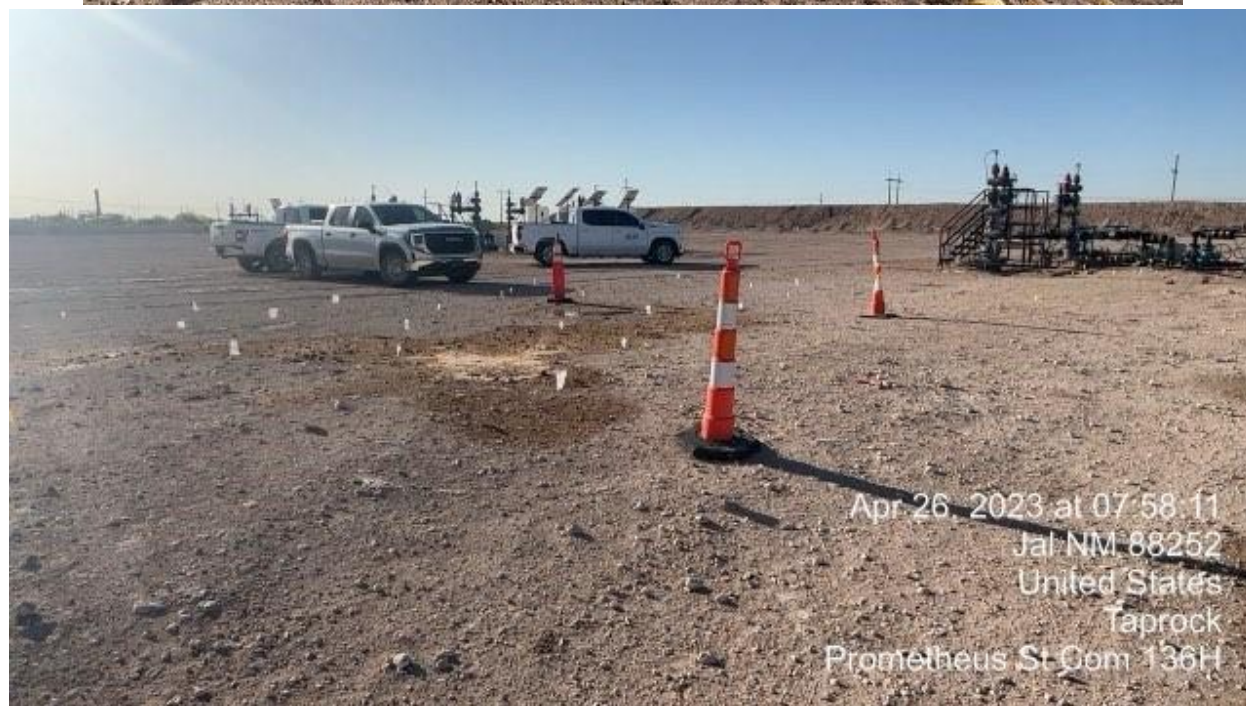
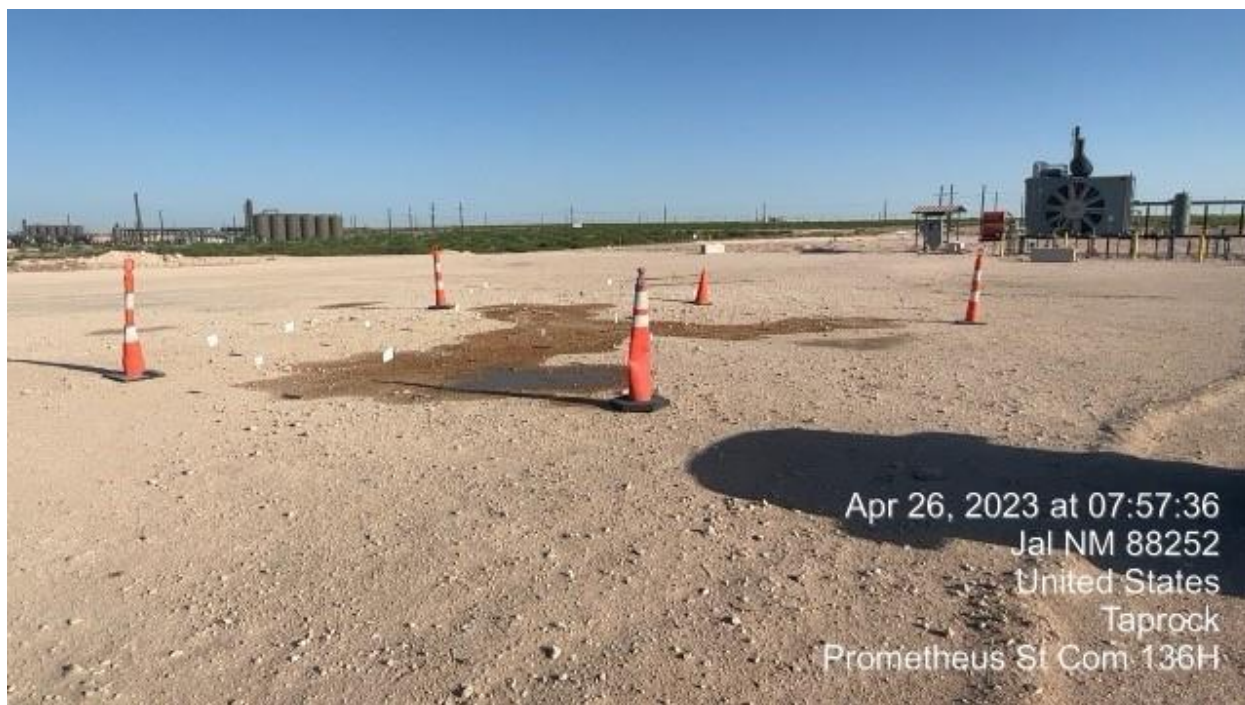
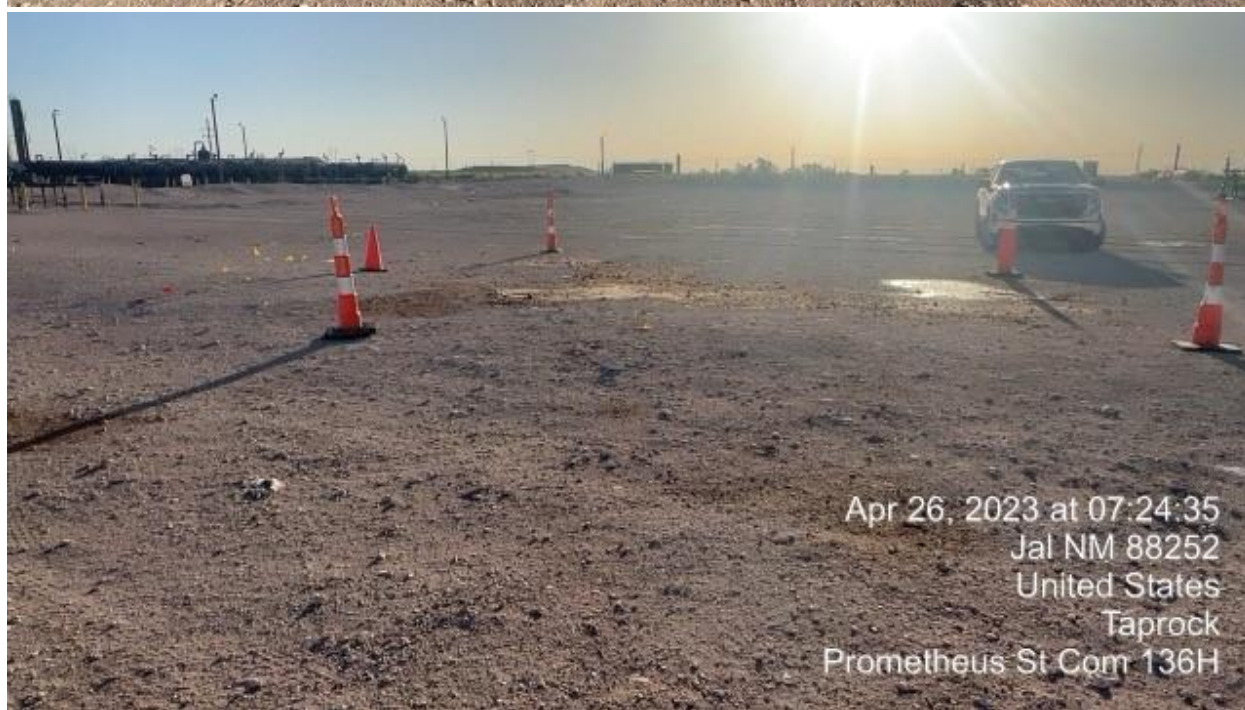
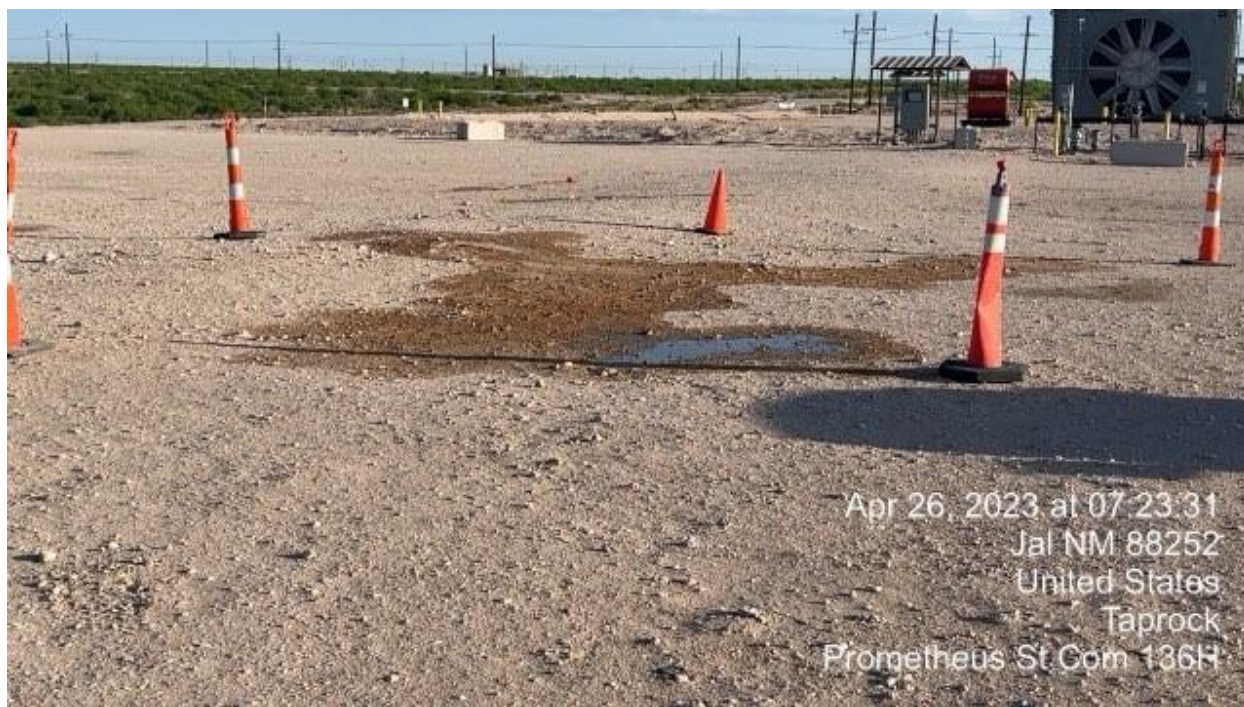
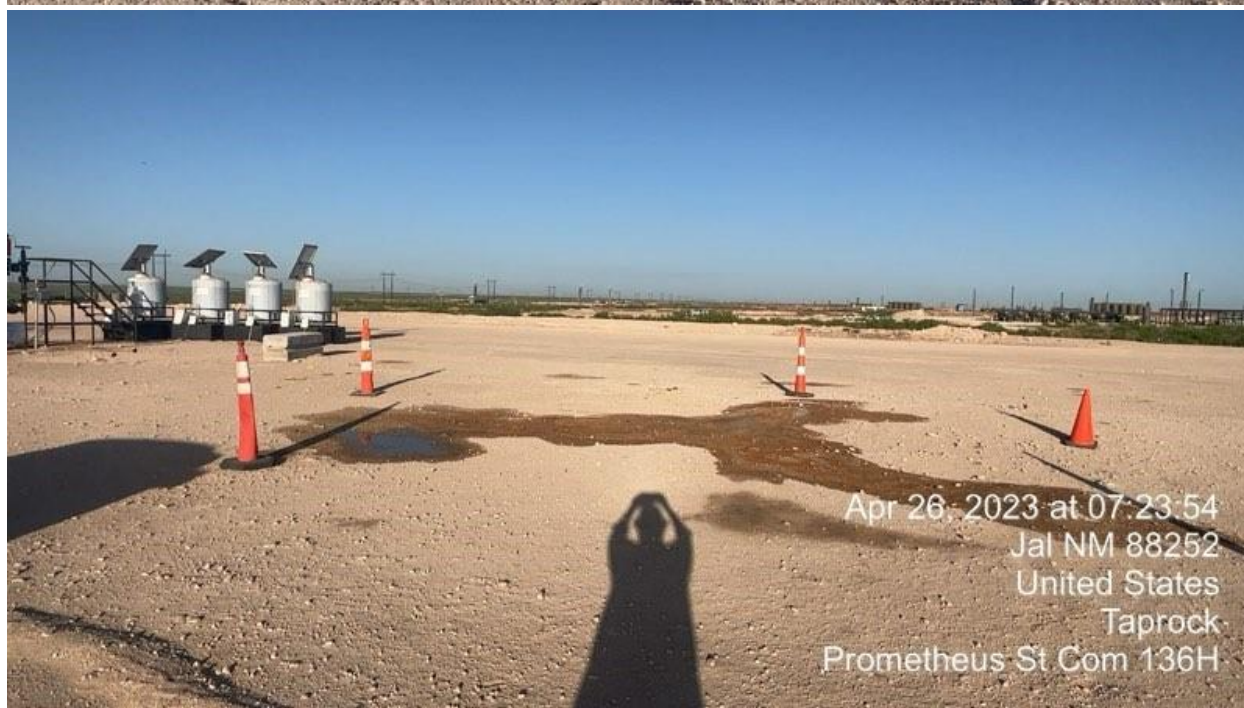
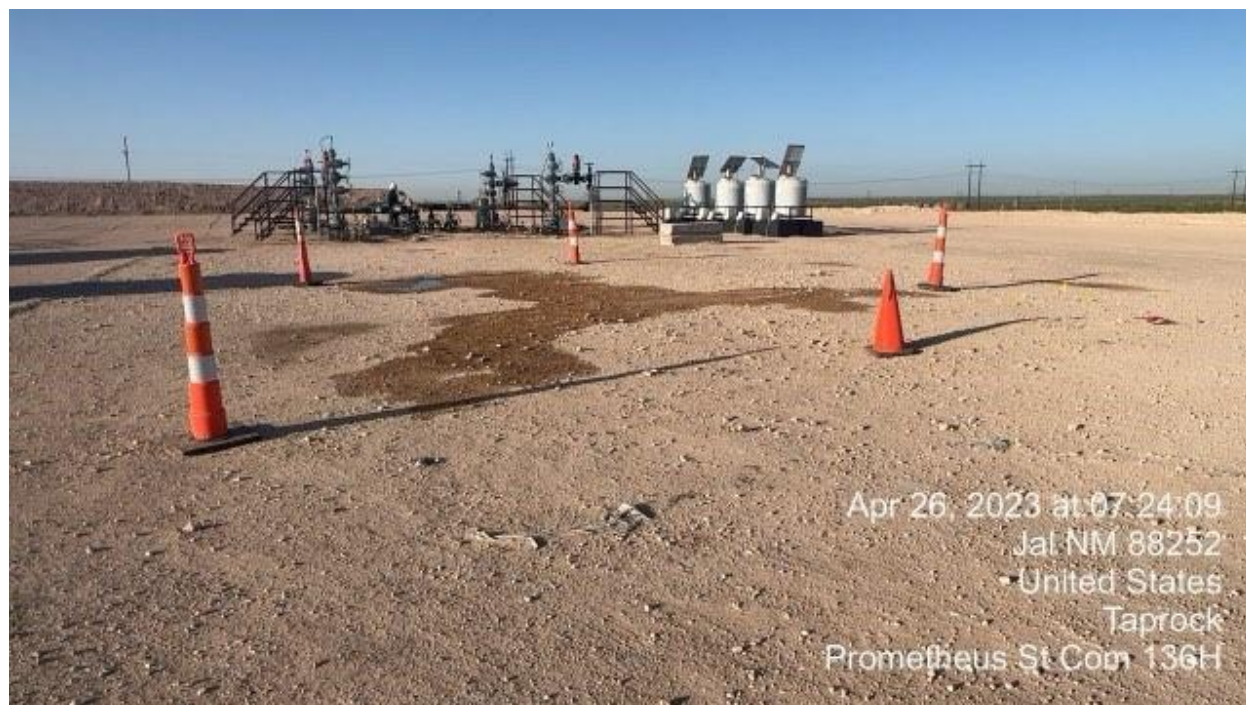
INITIAL SITE PHOTOS

On April 26th, 2023, a buried flowline leaked causing fluid to surface on the well pad of the Prometheus 136H. The well was immediately shut-in and a hydrovac crew was dispatched to uncover the line and make repairs.

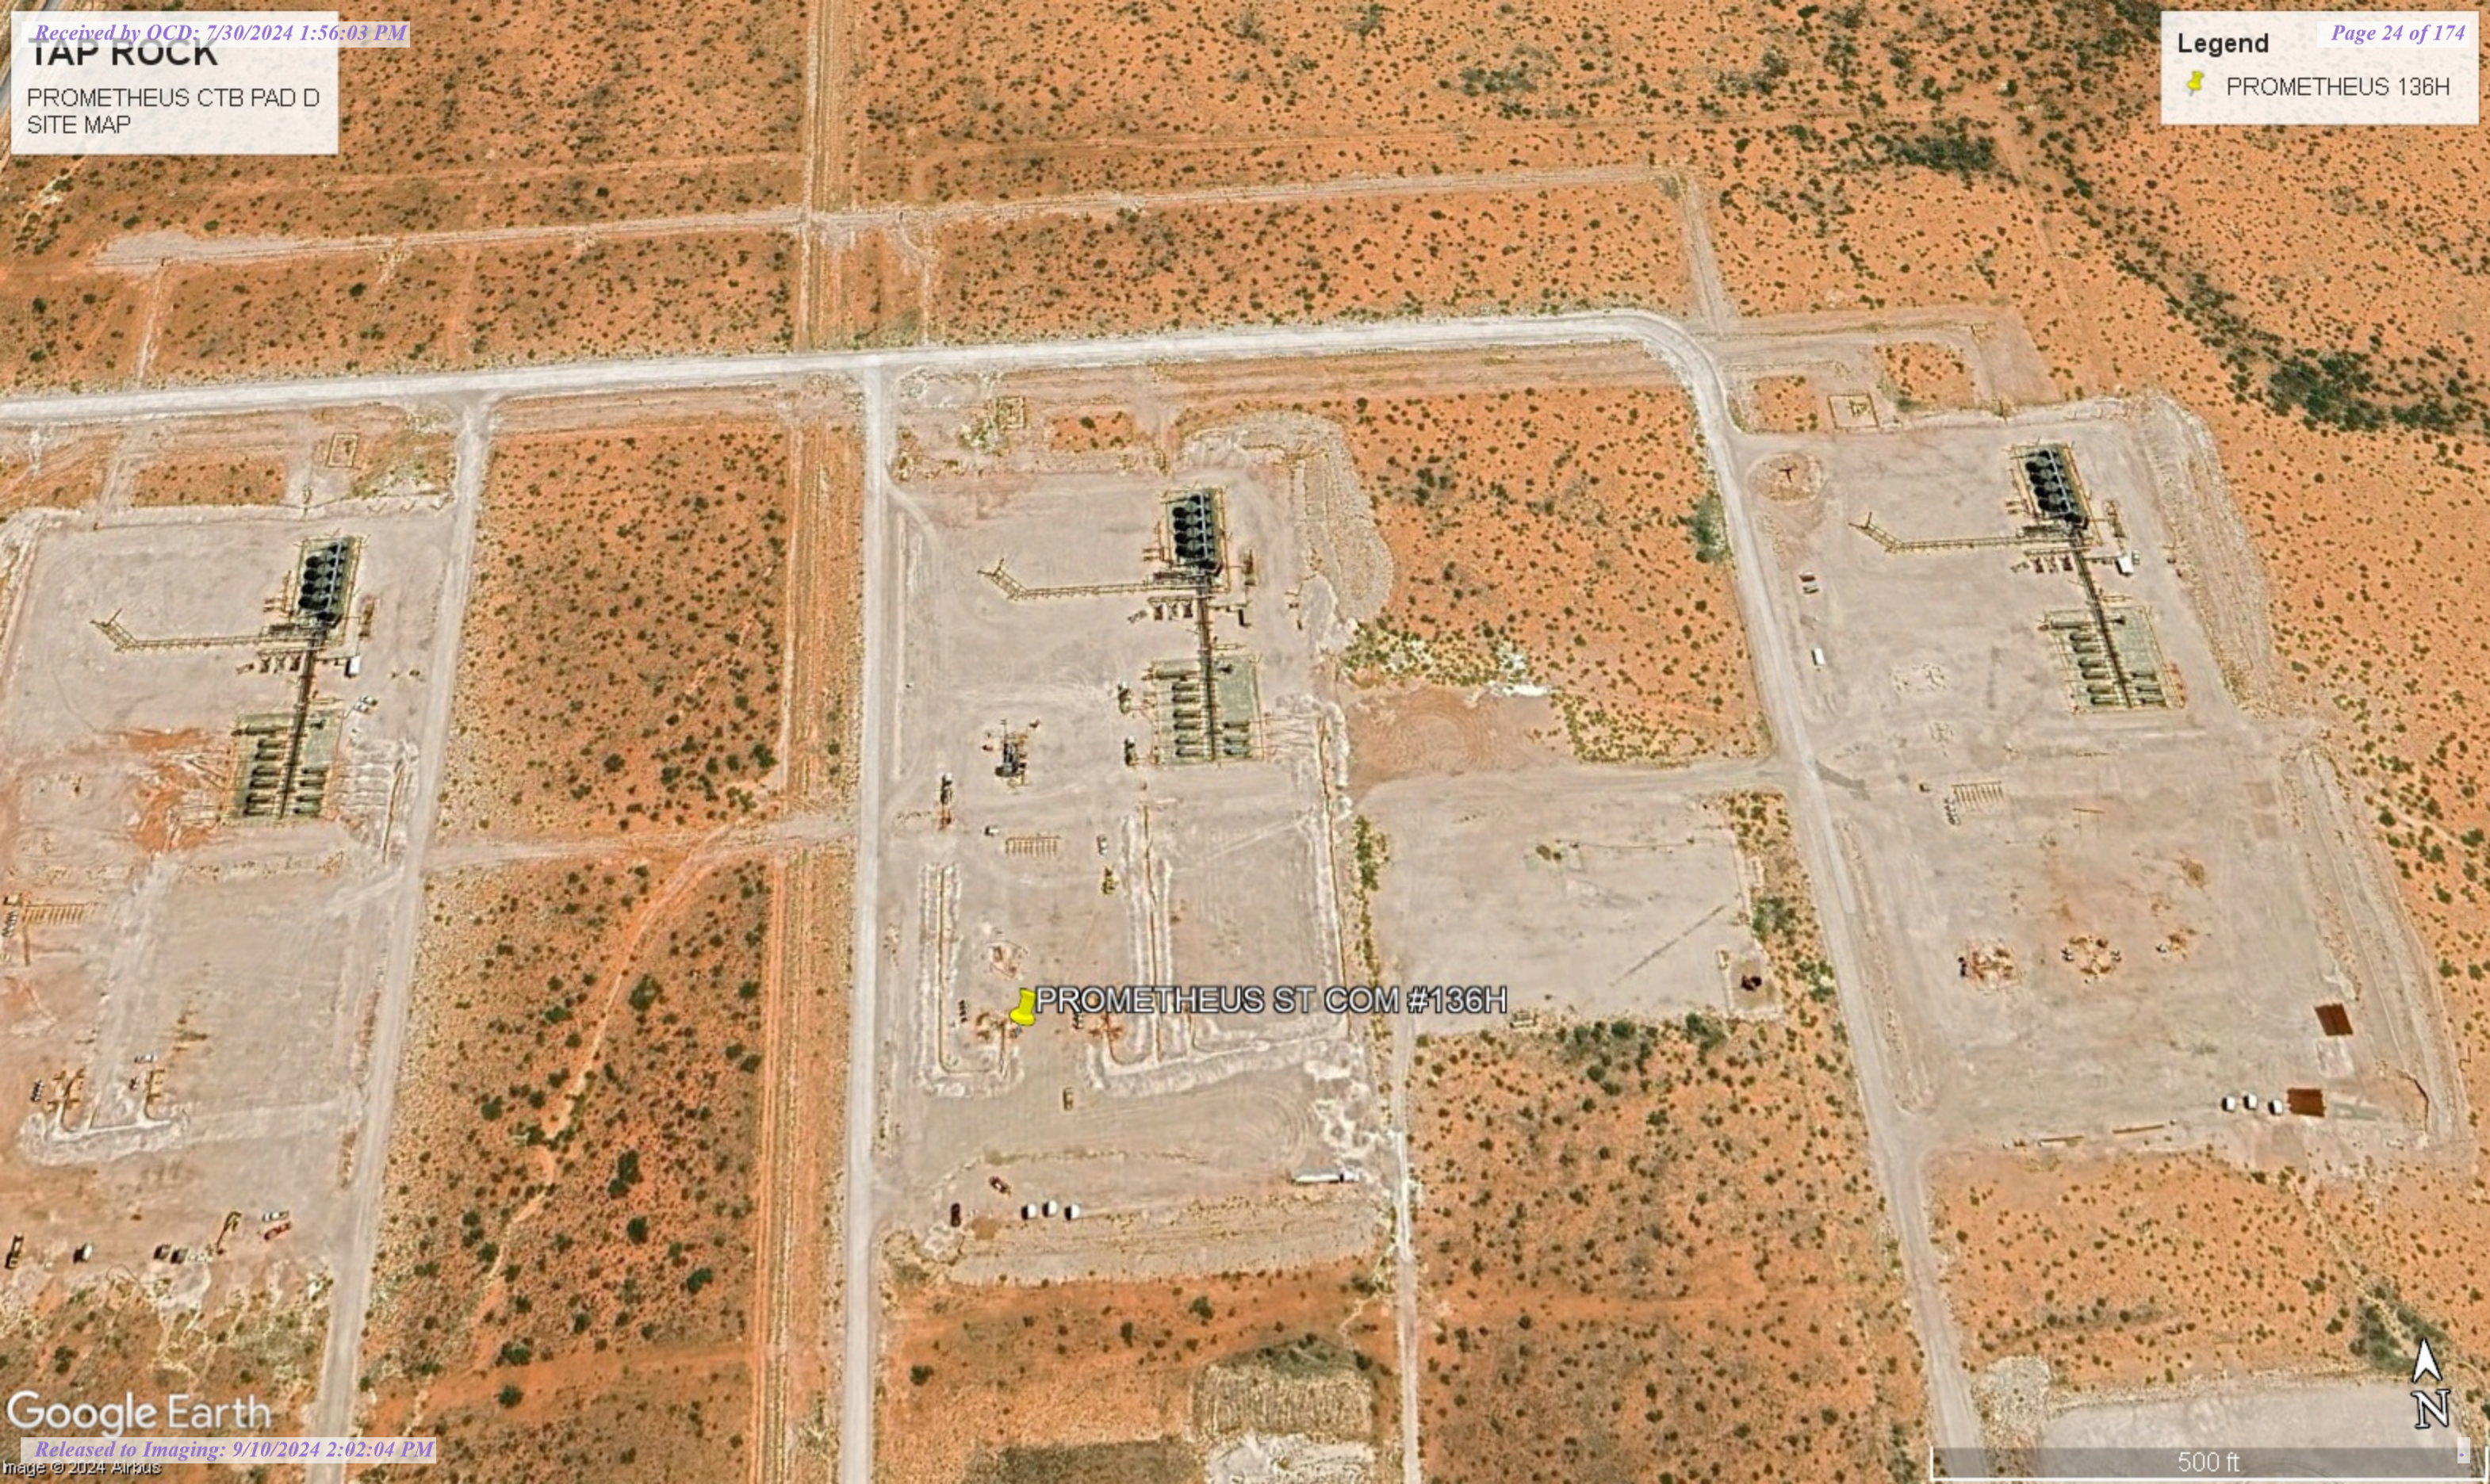
TAP ROCK
PROMETHEUS CTB PAD D
SITE MAP

The release at the Prometheus 136H occurred on State Land and is located at 32.1981382 latitude and -103.55985600 longitude, 25.2 miles northwest of Jal, New Mexico. The legal description of the site is Unit Letter O, Section 22, Township 24 South, and Range 33 East. This site is located in Lea County, New Mexico. Please see the site schematic attached.

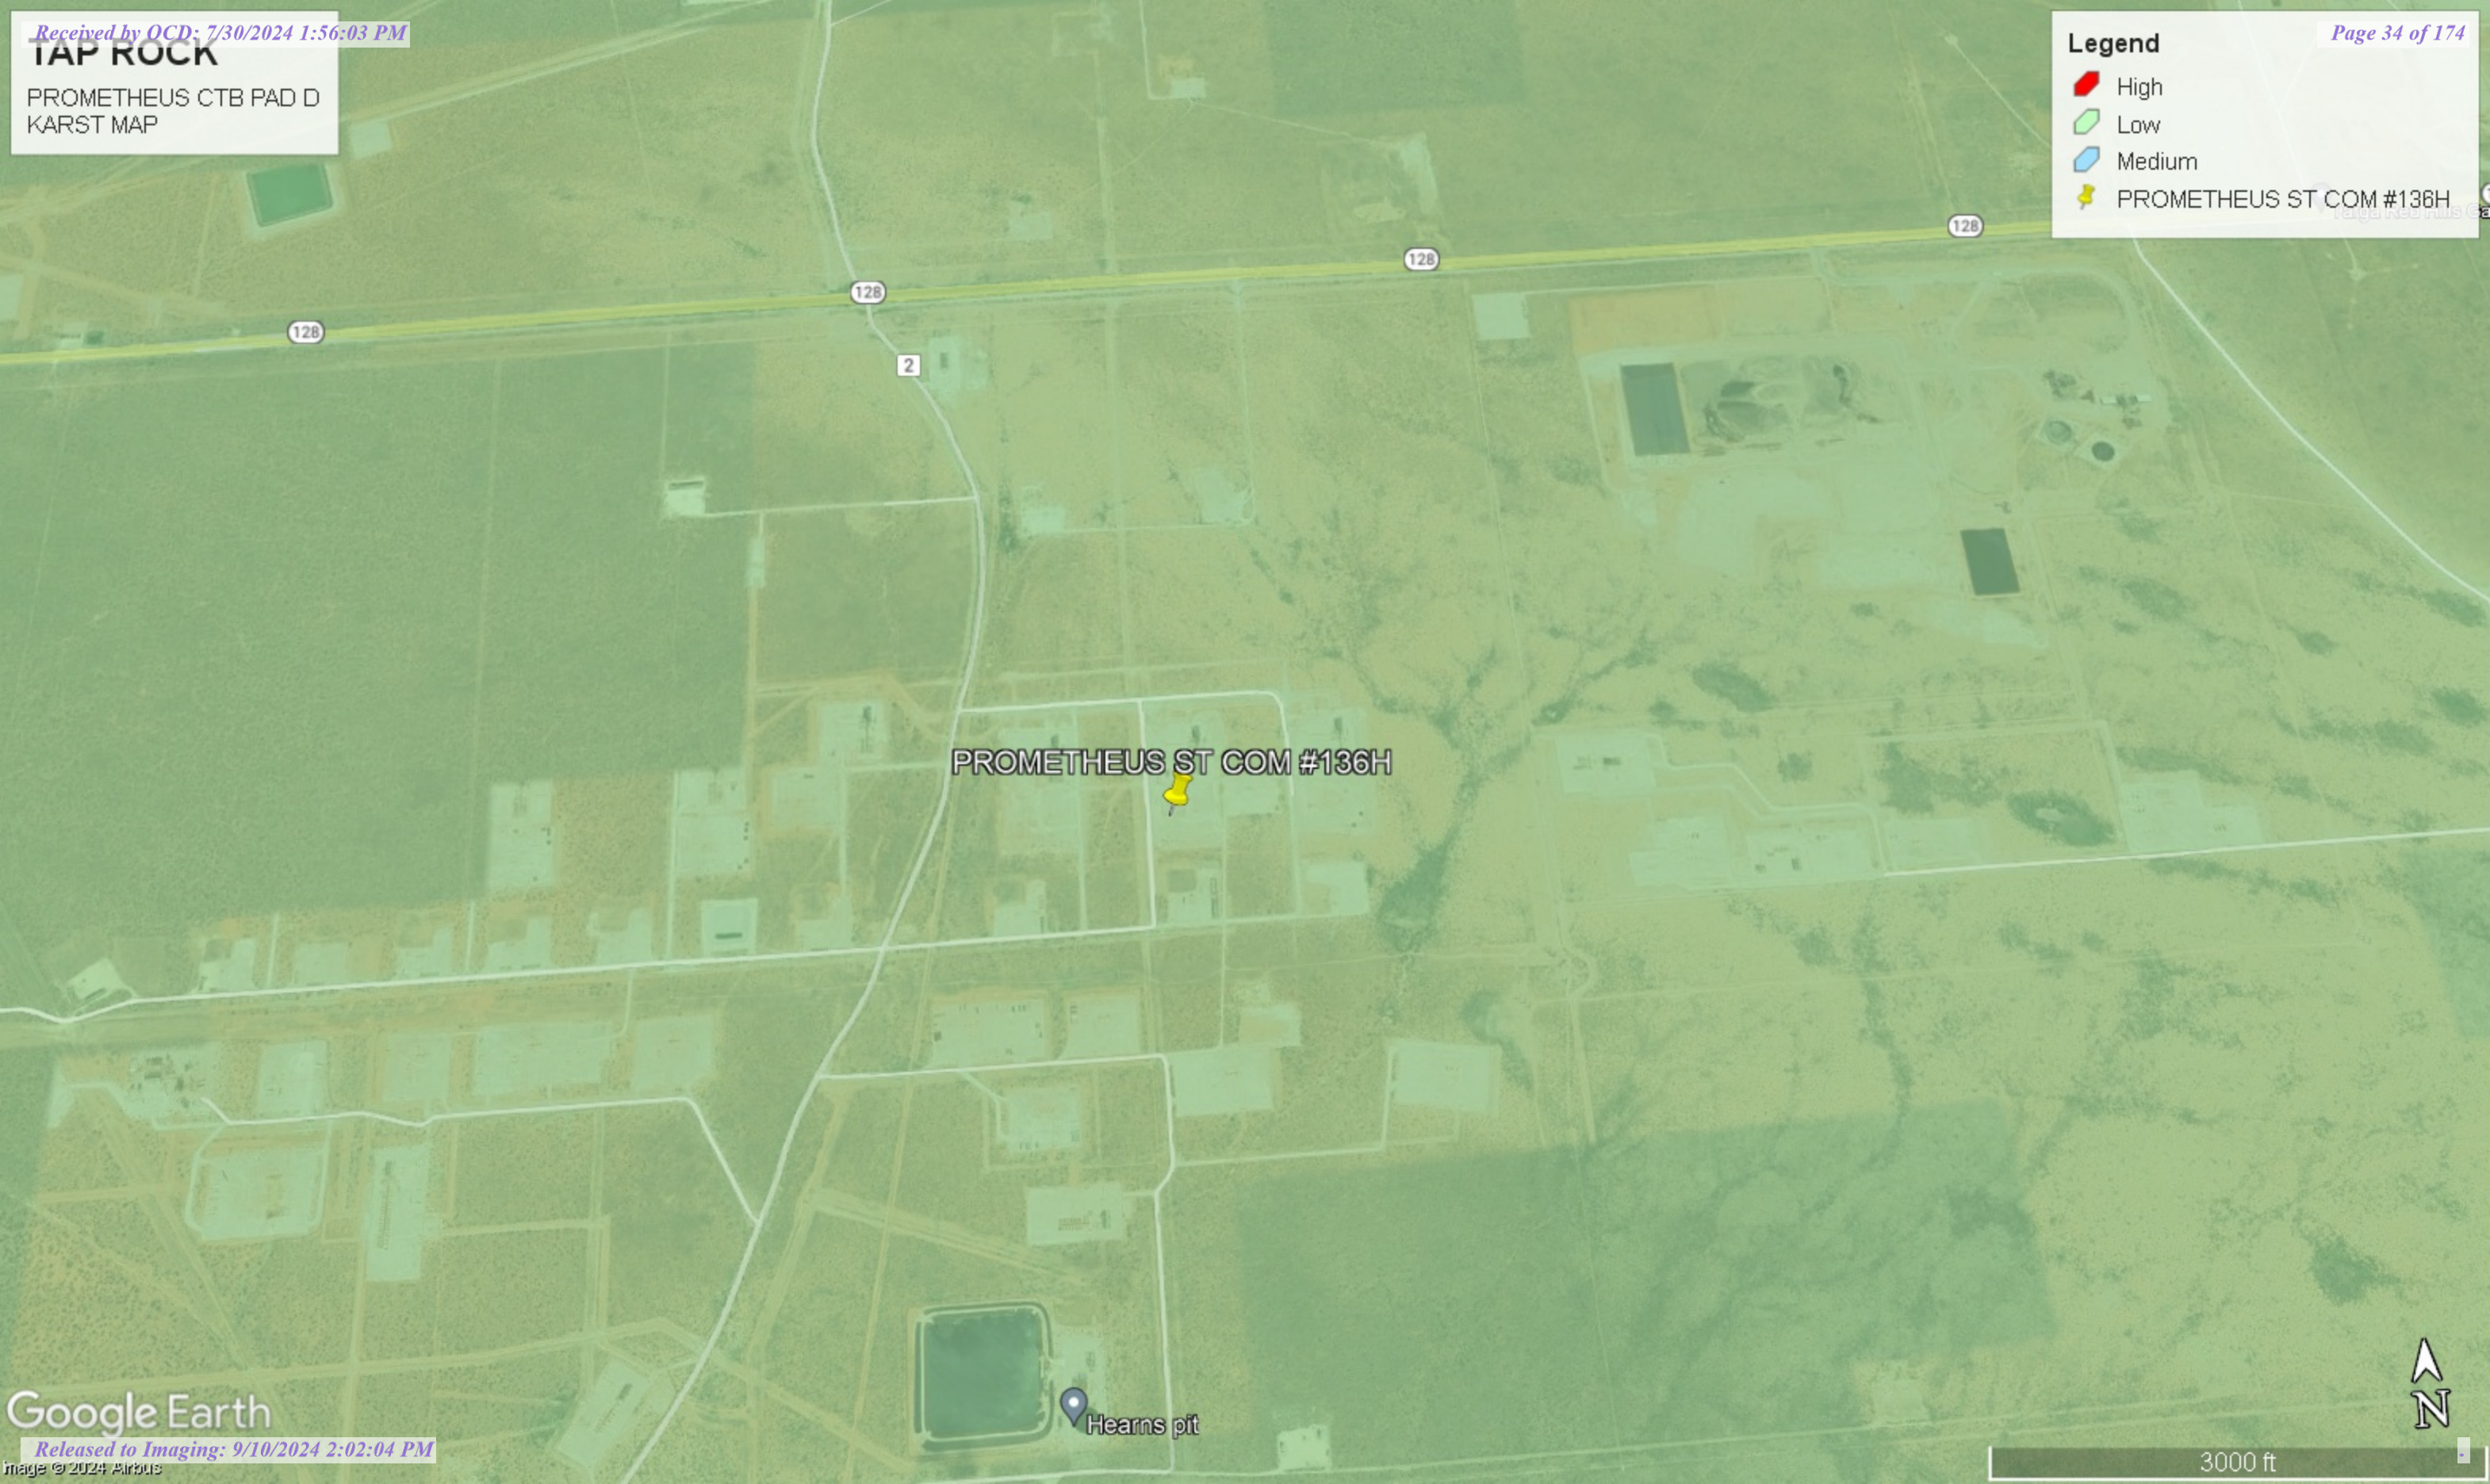
There is "low potential" for Karst Geology to be present near the Prometheus 136H site, according to the *United States Department of the Interior, Bureau of Land Management*. Please find the Karst Map attached herein.

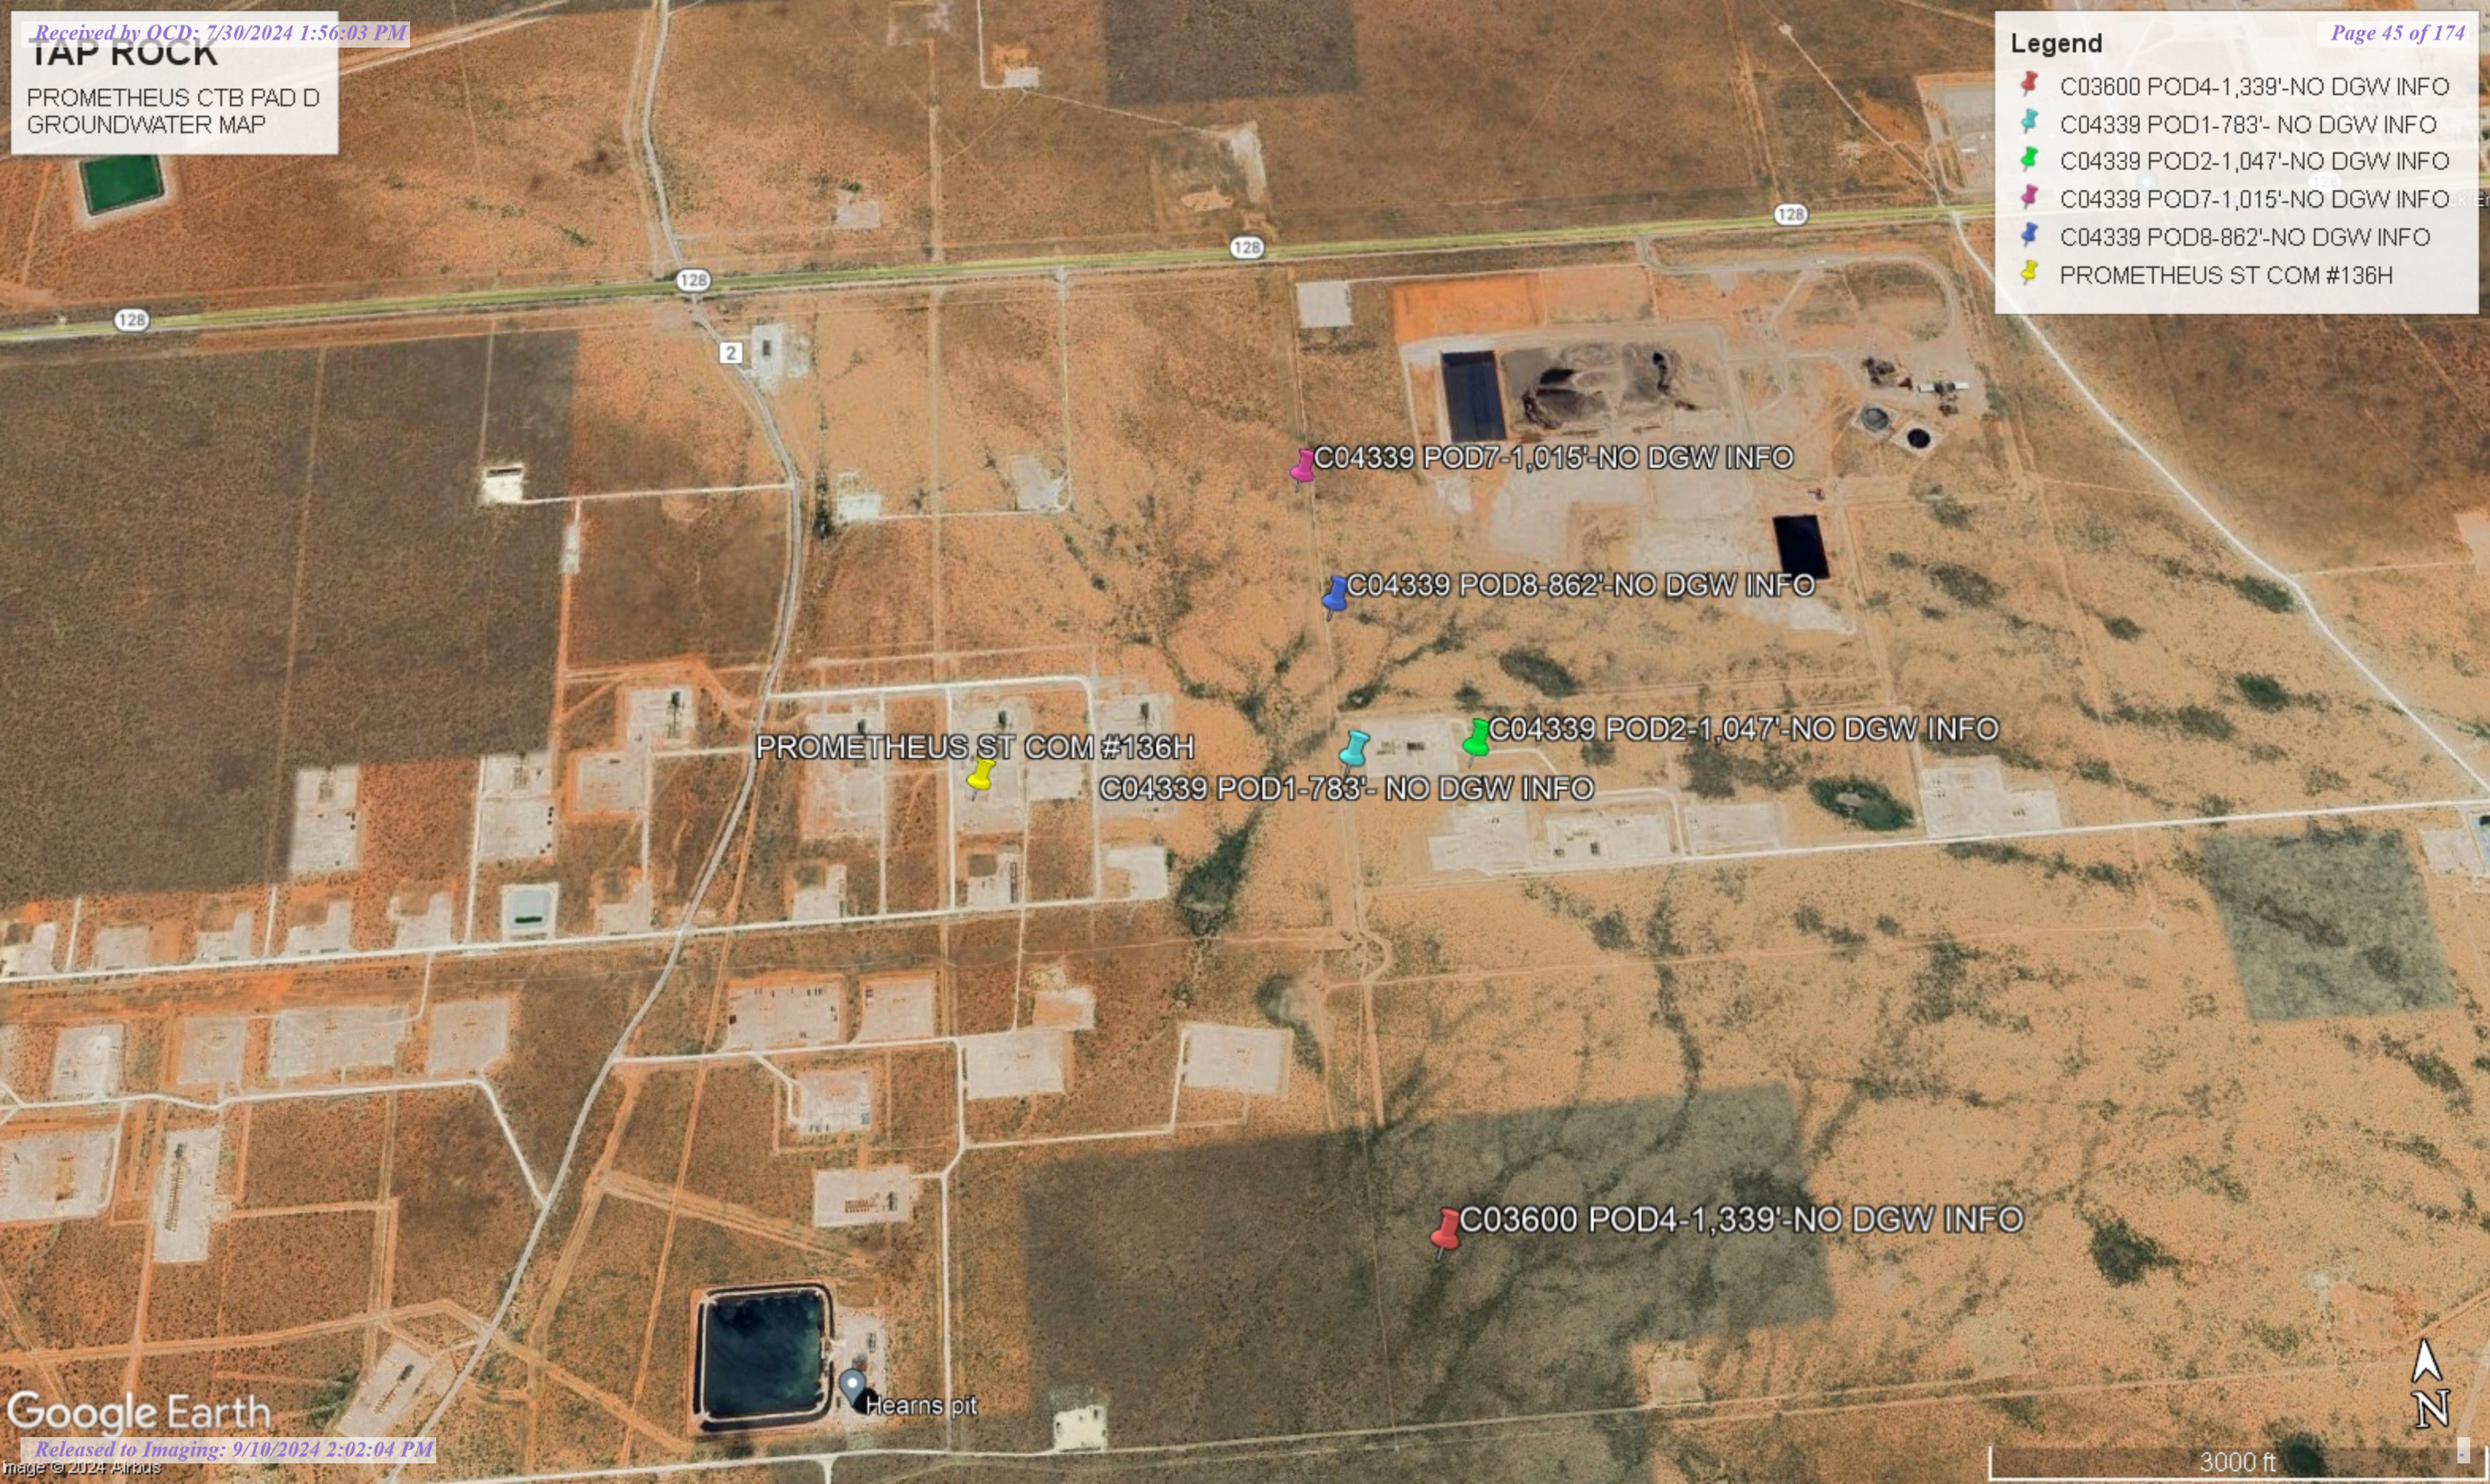
The nearest and most recent water well to site according to the *New Mexico Office of the State Engineer* is C04339 POD1, drilled in 2019 with a well depth of 47 feet and no groundwater data available. This well is 783 yards from the site. The second well is C04339 POD8, drilled in 2019 with a well depth of 30 feet and no groundwater data available. This well is 862 yards from the site. The third well is C04339 POD7, drilled in 2019 with a well depth of 43' and no groundwater data available, 1,015 yards from the site. The fourth well is C04339 POD2, drilled in 2019 with no well depth or groundwater data available. This well is 1,047 yards from the site. The fifth well is C03600 POD4, drilled in 2013 with no well depth or groundwater data available, 1,339 yards from the site. An extended groundwater search was conducted using the *OSE POD Location Mapping System* and it has been determined that no other wells were found within a ½ mile radius of the Prometheus 136H release. Please find the NMOSE, OSE POD, and groundwater map attached to this report.

- C03600 POD4-1,339'-NO DGW INFO
- C04339 POD1-783'- NO DGW INFO
- C04339 POD2-1,047'-NO DGW INFO
- C04339 POD7-1,015'-NO DGW INFO
- C04339 POD8-862'-NO DGW INFO
- PROMETHEUS ST COM #136H

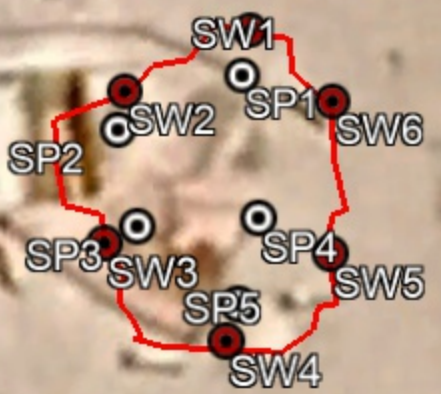
A total of 5 vertical sample points were placed along with 6 horizontal sample points. Each sample point was then sampled by use of backhoe and trackhoe in 1' and 2' intervals. Bottom hole samples were then submitted to the lab for confirmation. Please see the delineation sample data below, with the lab data indicated in yellow. Attached to this report you will find the sample data, delineation sample map, and the lab analysis.

- HORIZONTAL SAMPLE POINTS
- ◻ Taprock Prometheus St Com 136H 991 sq. ft.
- VERTICAL SAMPLE POINTS

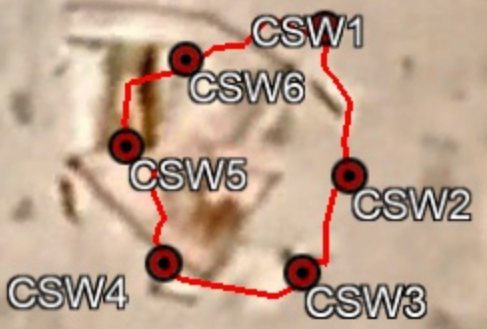
- EXCAVATION AREA
- SIDEWALL COMPOSITES
