Pima Environmental Services, LLC  
5614 N. Lovington Hwy.  
Hobbs, NM 88240  
575-964-7740

August 25, 2024

**Re: Site Assessment, Remediation, and Closure Report  
Firecracker State Battery  
API No. N/A  
GPS: Latitude 32.8311001 Longitude -104.1433201  
UL "O", Sec. 14, T17S, R28E  
Eddy County, NM  
NMOCD Ref. No. NAPP2415638717**

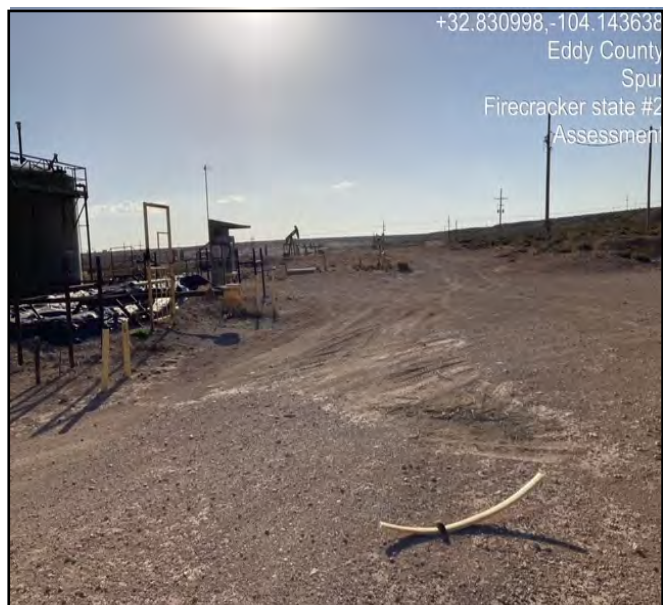
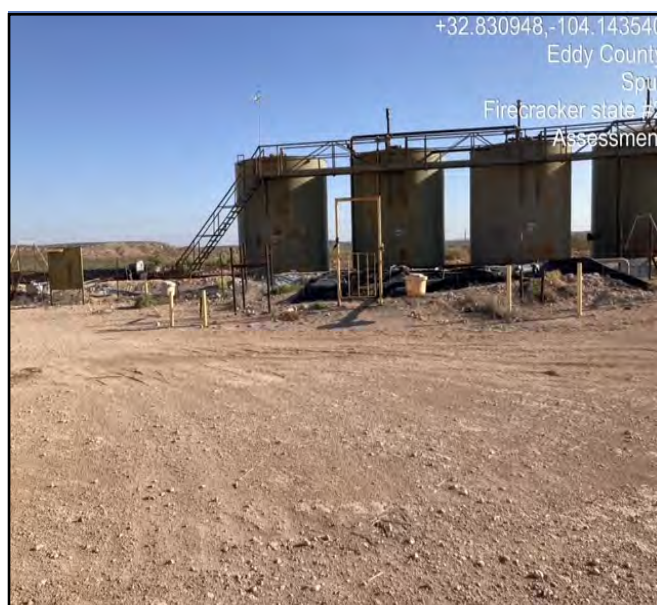
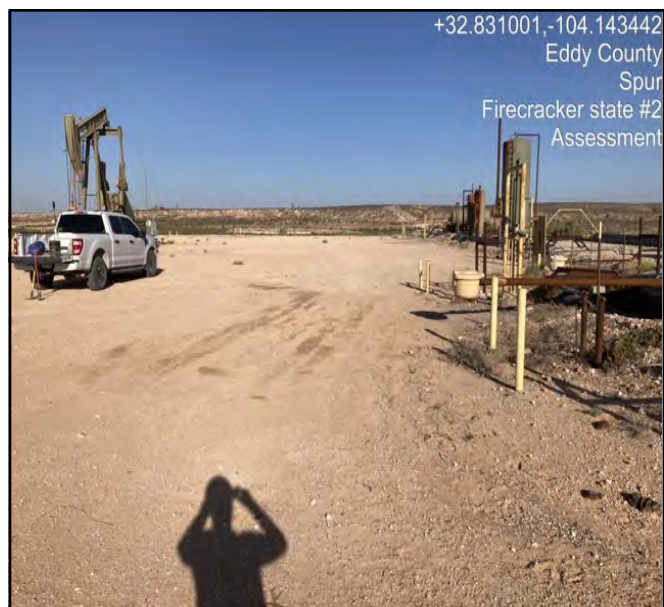
Photo showing the excavation area.

From August 5 to August 12, Pima deployed a manual shoveling crew along with a hydrovac truck to excavate the area, including soil sample locations S1-S3, to a depth of 3.5 feet below ground surface (bgs). The excavated zone covered approximately 500 square feet, resulting in the removal of roughly 55 cubic yards of contaminated soil. All contaminated materials were safely transported to Lea Land, an NMOCD-approved disposal facility.

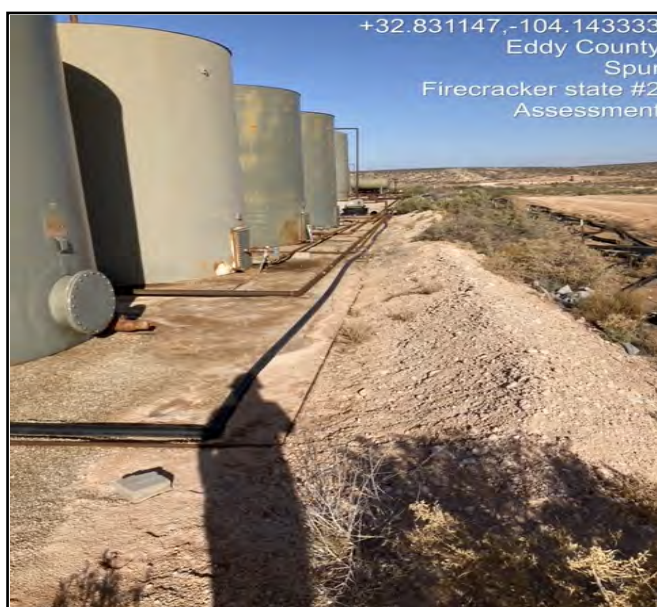
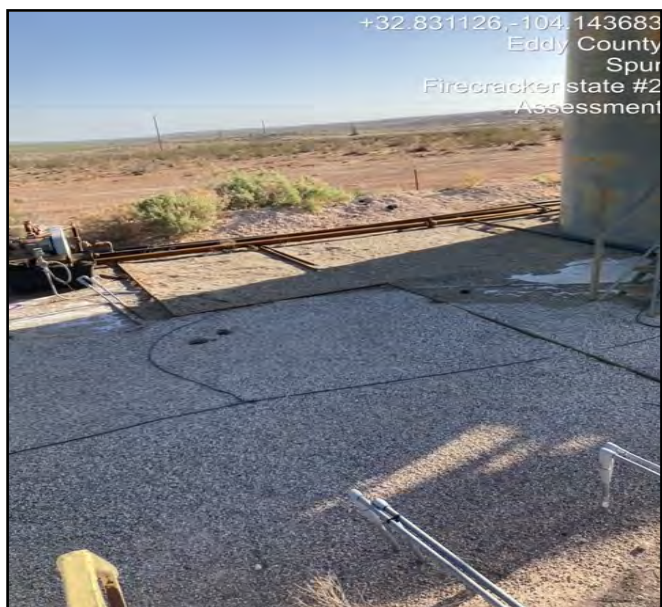
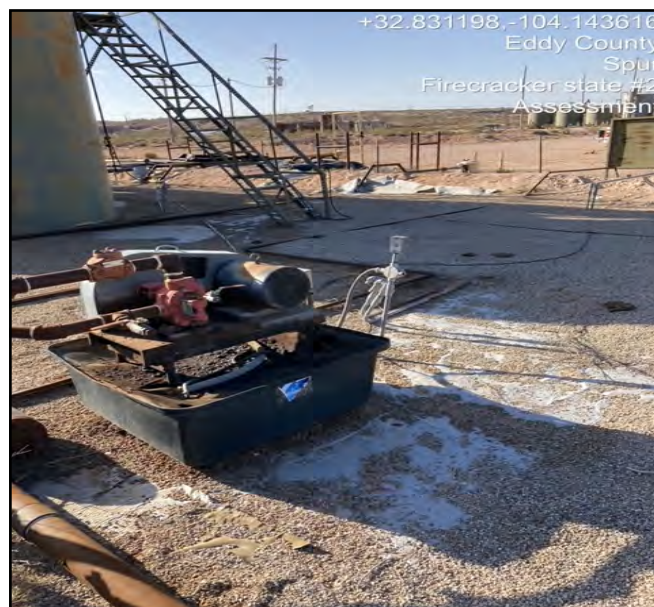
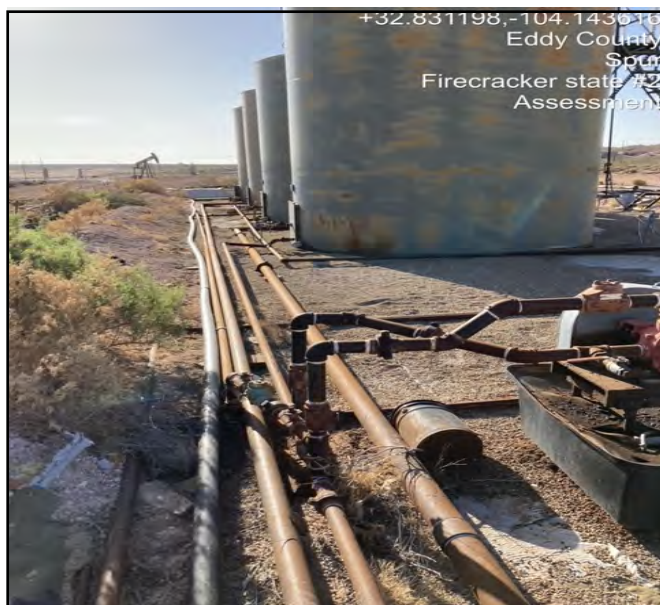
Photograph showing the lined containment area prior to the commencement of gravel removal.

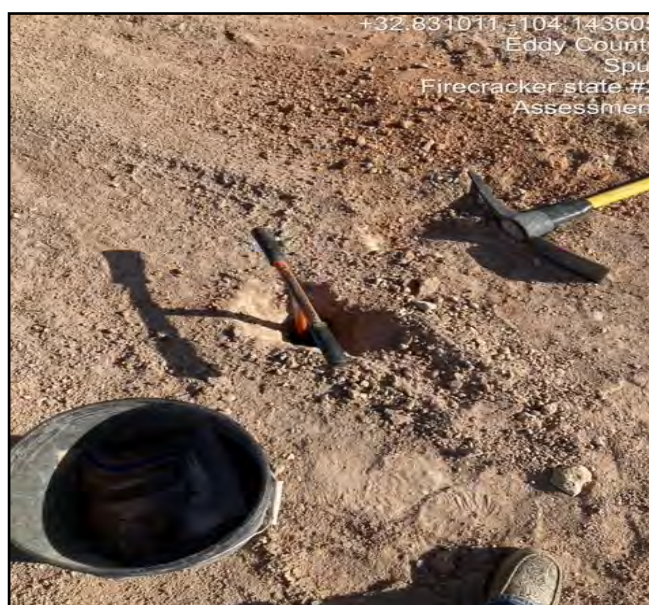
Photograph of hand auger going into the ground to collect samples.

Each soil sample consisted of a grab sample from the impacted area, specifically representing an area not exceeding 200 square feet. A total of fifteen (15) samples were collected for laboratory analysis, targeting total chloride using EPA Method 300.0; benzene, toluene, ethylbenzene, and total xylenes (BTEX) using EPA Method 8021B; and motor, diesel, and gasoline range organics (MRO, DRO, and GRO) using EPA Method 8015D. All samples were placed into laboratory-supplied glassware, properly labeled, and stored on ice until delivered to Envirotech Laboratories in Farmington, New Mexico (Appendix C).

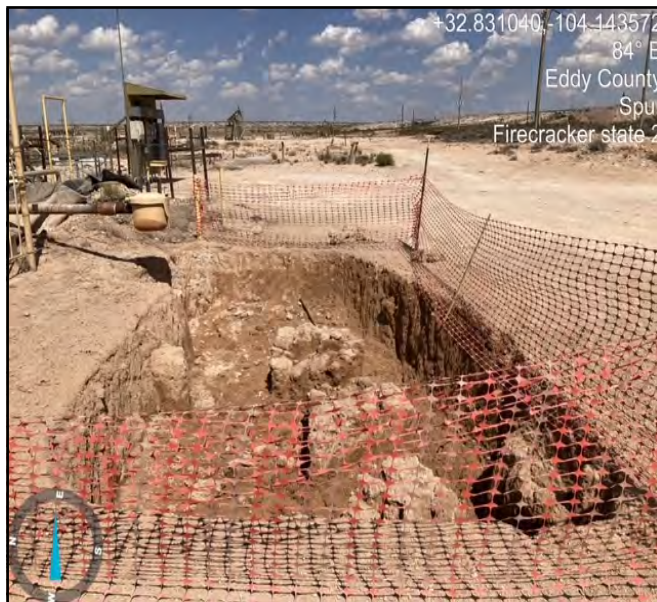
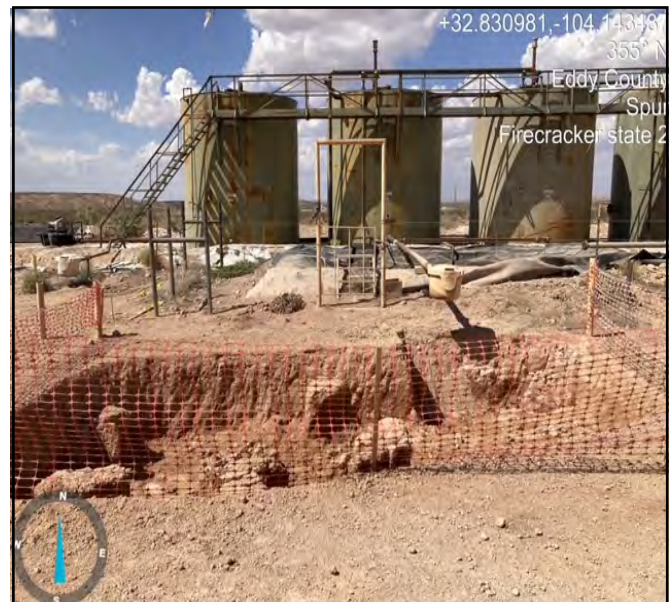
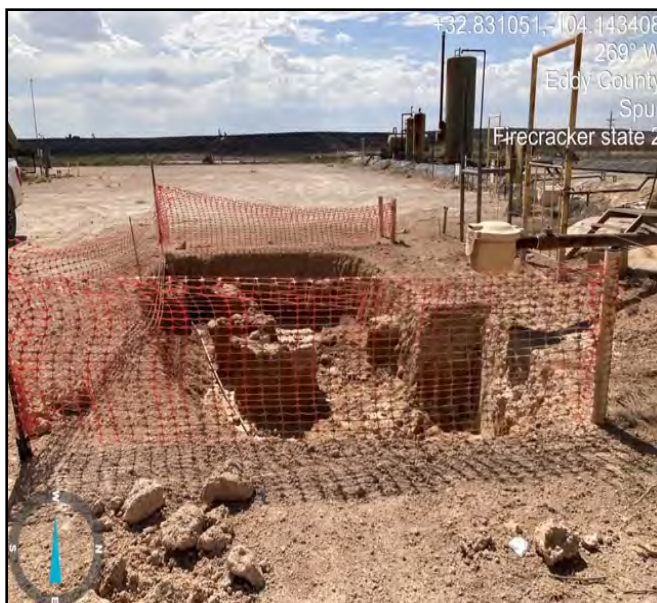
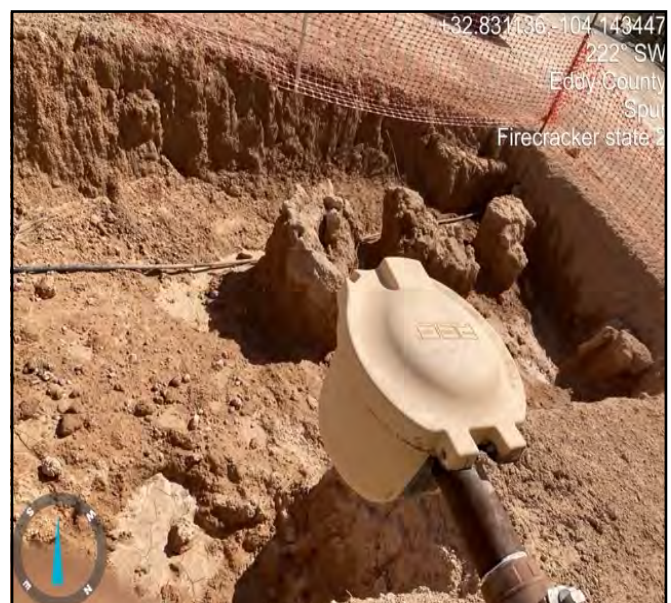
## Excavation

Showing the excavation process outside the containment facing Northeast.

Showing the excavation process outside the containment facing North.

Showing the excavation process outside the containment facing West.

Showing the excavation process outside the containment facing Southwest.

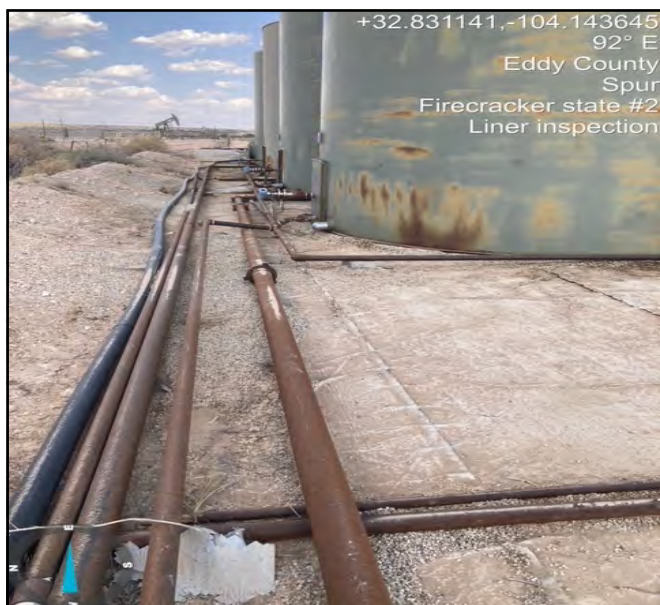
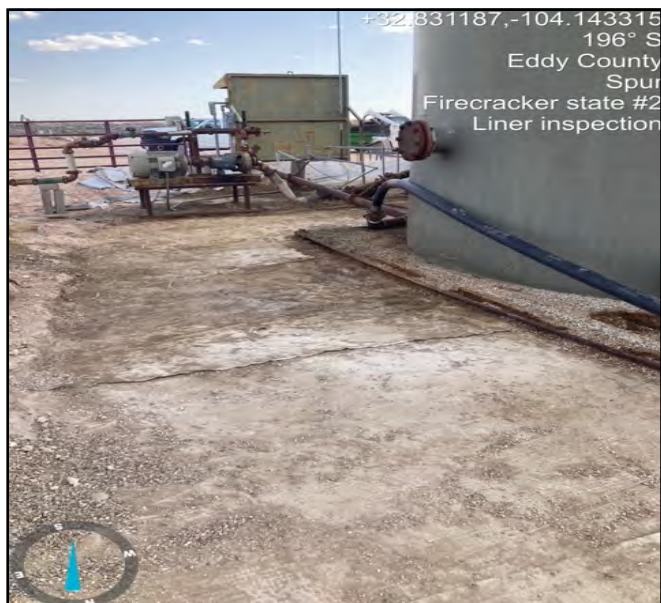
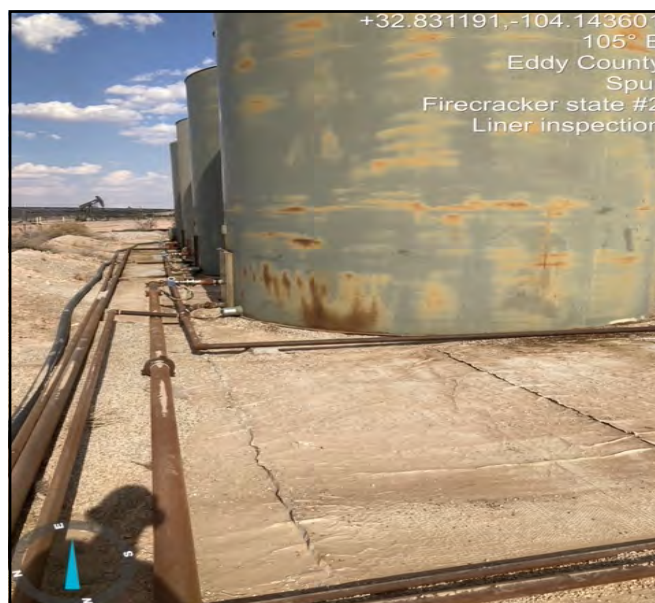
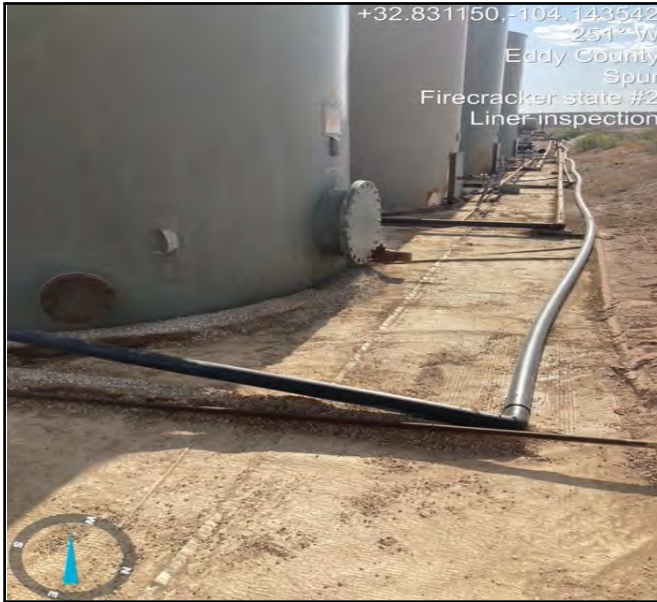
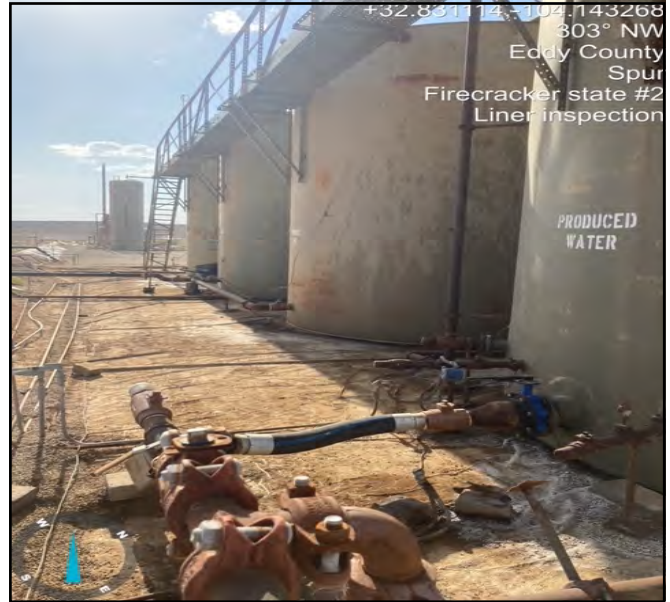
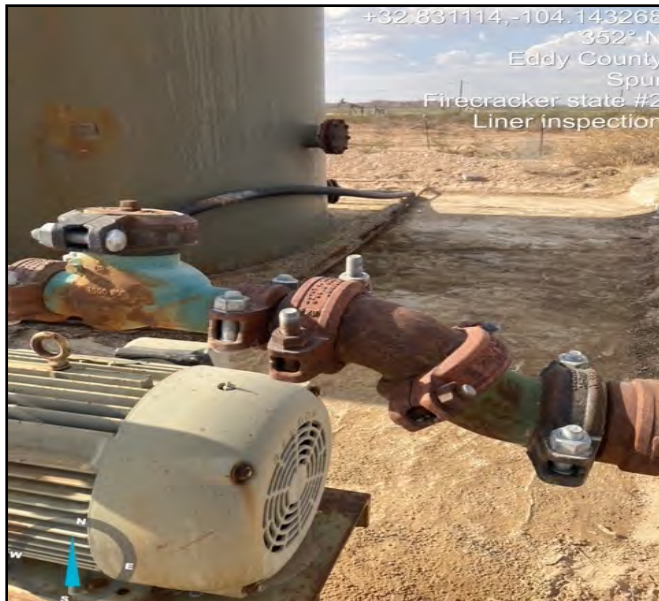
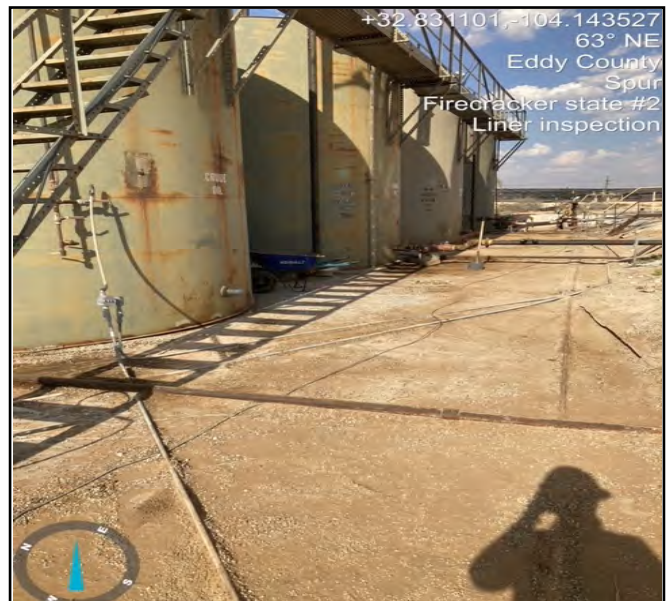
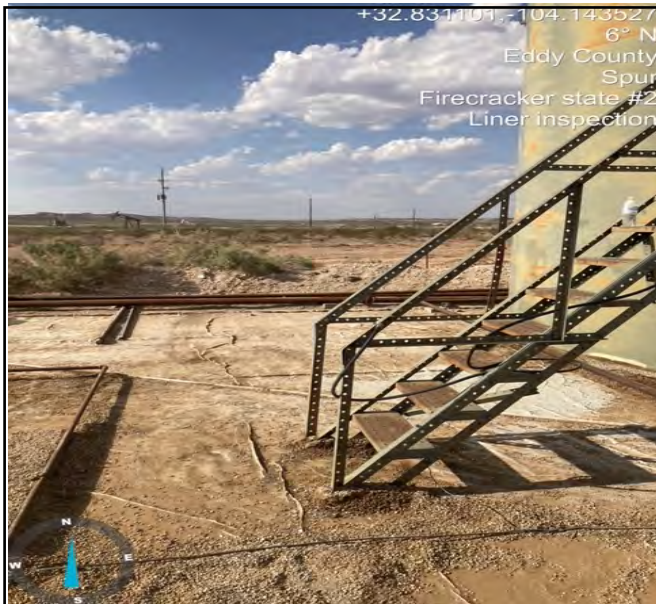
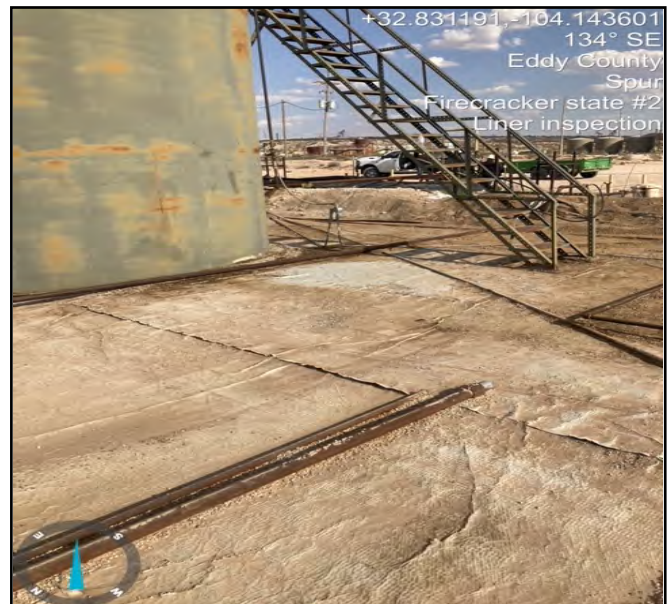
## Liner Inspection

Photo post gravel removal revealing the liner underneath the contaminated gravel facing East

Photo post gravel removal revealing the liner underneath the contaminated gravel facing West

Photo post gravel removal revealing the liner underneath the contaminated gravel facing South

Photo post gravel removal revealing the liner underneath the contaminated gravel facing East.

Photo post gravel removal revealing the liner underneath the contaminated gravel facing Northwest

Photo post gravel removal revealing the liner underneath the contaminated gravel facing North

Photo post gravel removal revealing the liner underneath the contaminated gravel facing Northeast

Photo post gravel removal revealing the liner underneath the contaminated gravel facing Southeast

On August 13, 2024, after sending the 48-hour notification via email, Pima Environmental conducted a liner inspection at the Firecracker. We concluded that this liner and containment maintained its integrity and was able to retain the fluids. The liner inspection form and photographic documentation can be found in Appendix D.

Visualization	Yes	No	Comments
Is there a tear in the liner?		X	
Are there holes in the liner?		X	
Is the liner retaining any fluids?		X	
Does the liner have integrity to contain a leak?	X

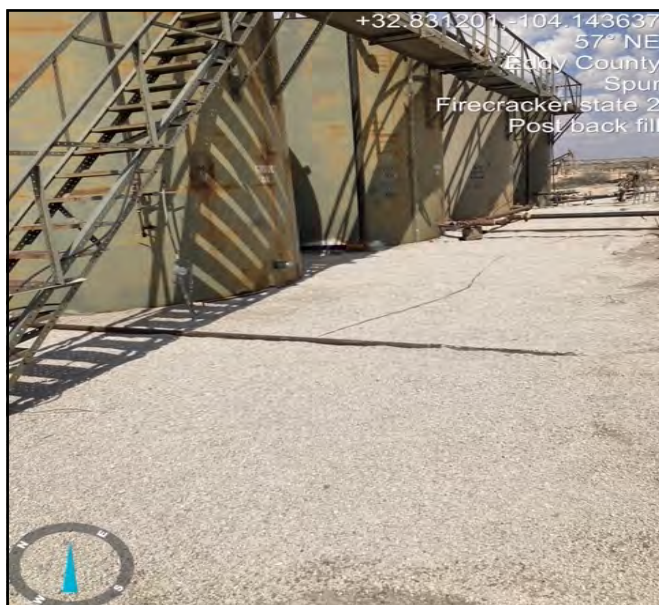
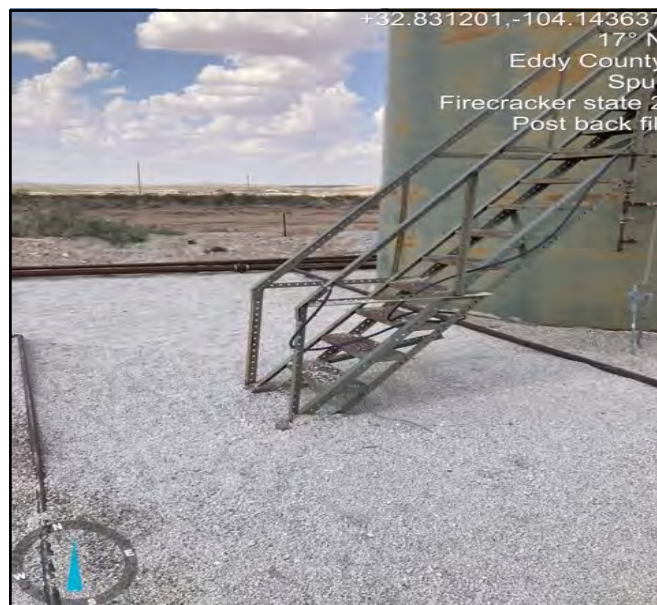
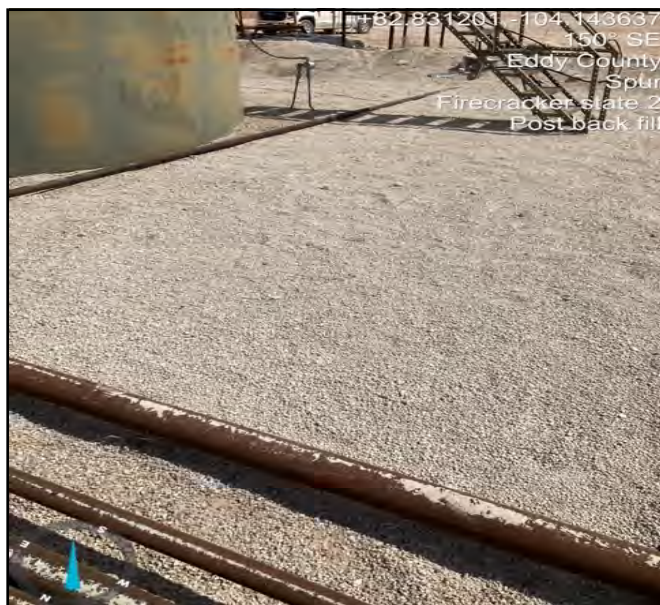
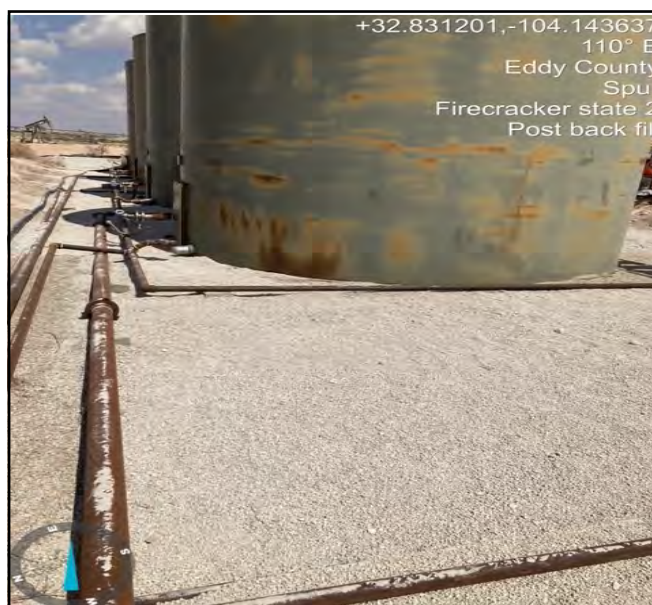
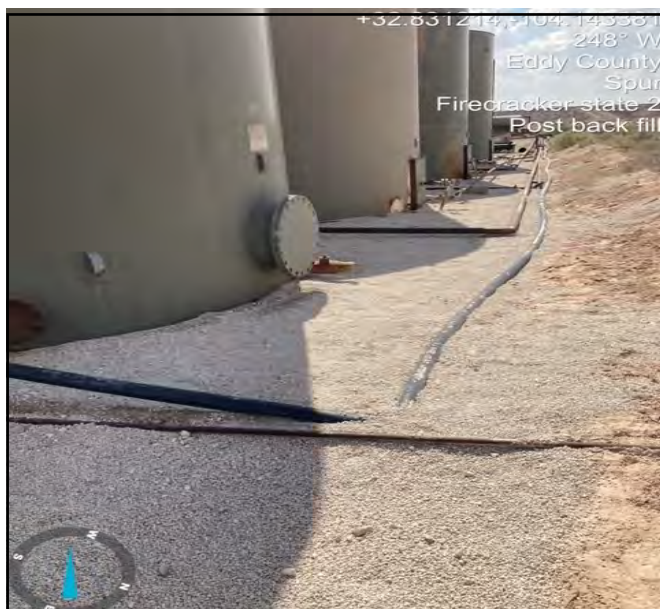
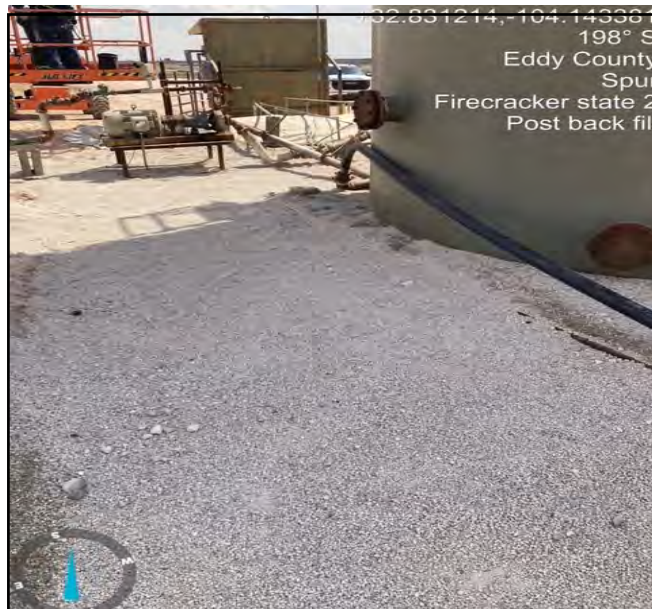
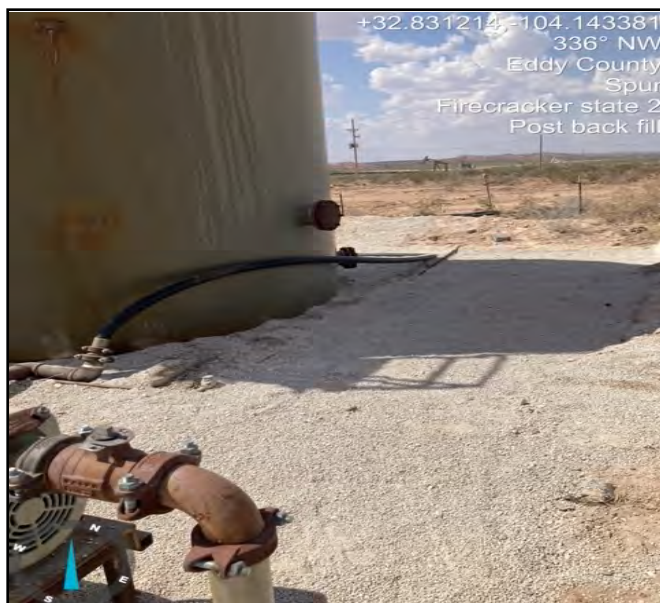
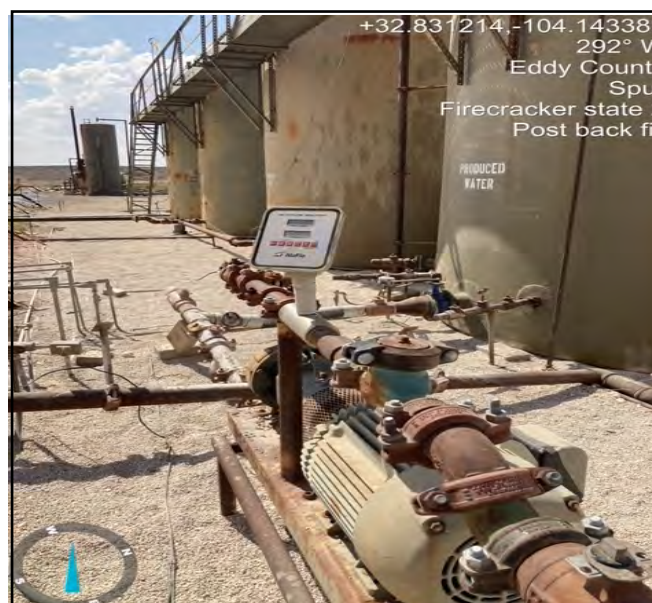
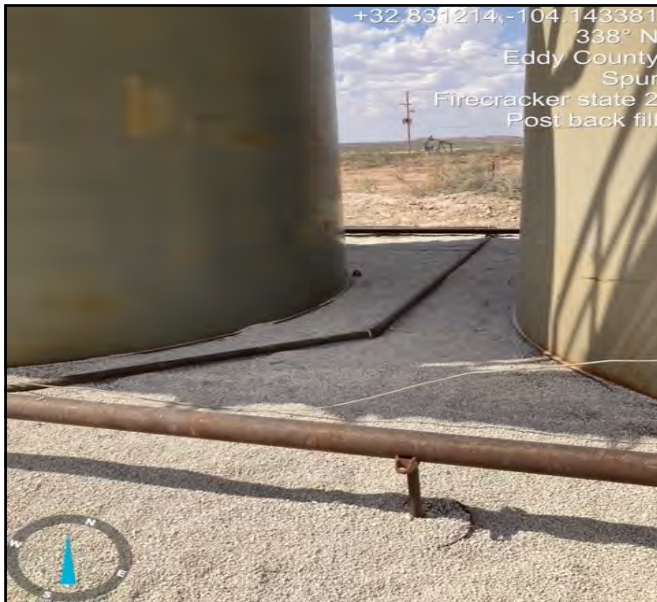
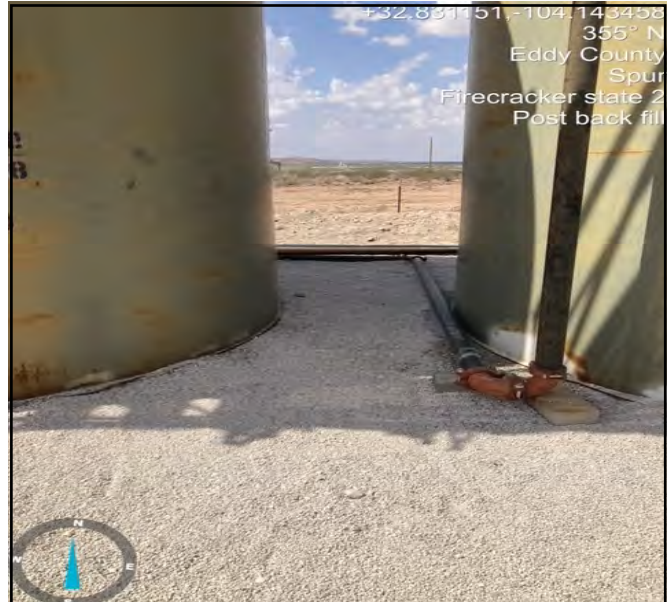
## Post Backfill

Photograph depicting the containment area subsequent to being backfilled with clean material facing Northeast

Photograph depicting the containment area subsequent to being backfilled with clean material facing North.

Photograph depicting the containment area subsequent to being backfilled with clean material facing Southeast

Photograph depicting the containment area subsequent to being backfilled with clean material facing East

Photograph depicting the containment area subsequent to being backfilled with clean material facing West.

Photograph depicting the containment area subsequent to being backfilled with clean material facing South.

Photograph depicting the containment area subsequent to being backfilled with clean material facing Northwest.

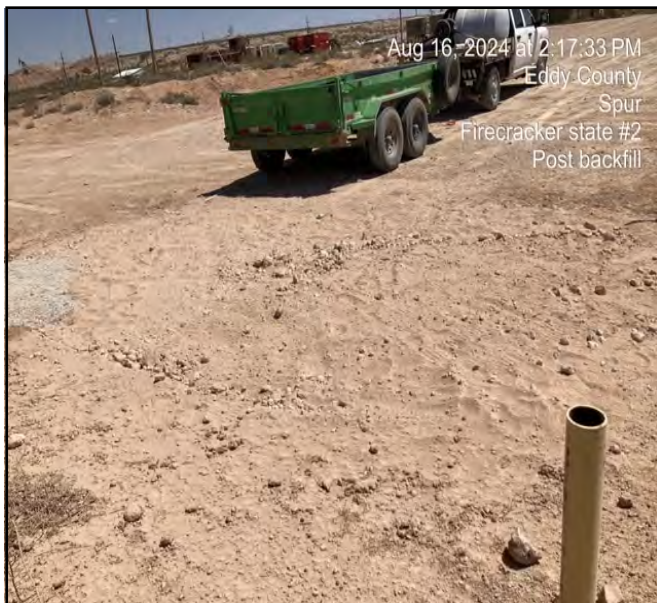
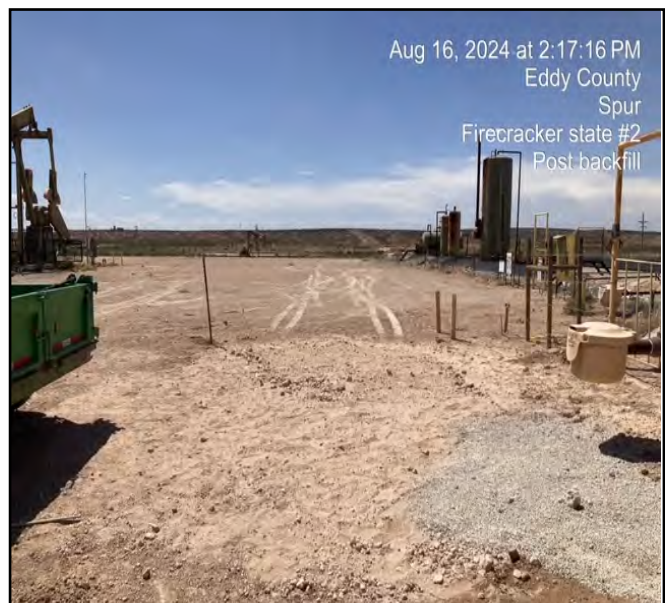
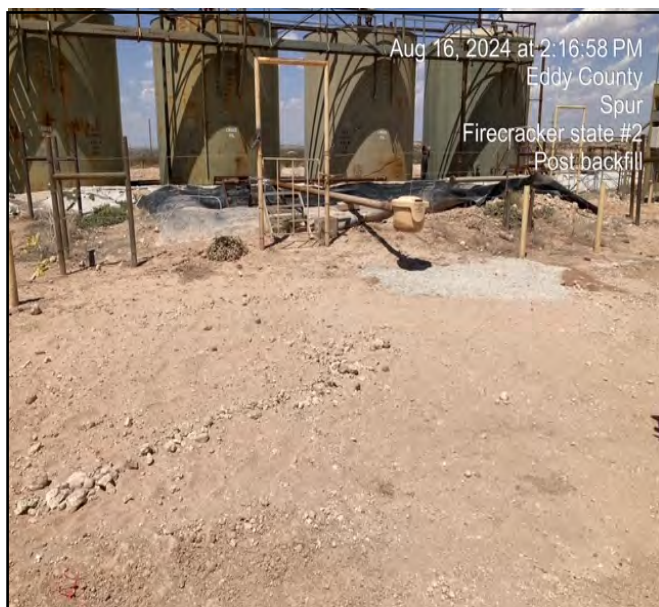
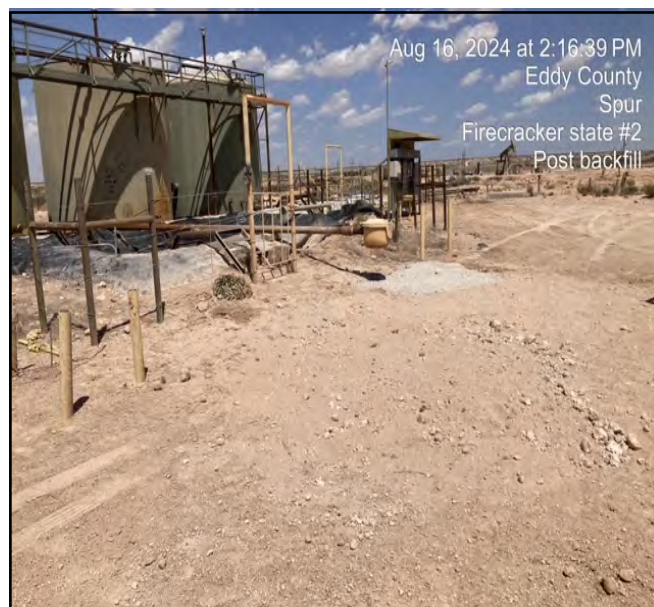
Photograph depicting excavated area subsequent to being backfilled with clean material.
