Re: Site Assessment, Remediation, and Closure Request
Stonewall 9 Fee #1H
API No. 30-015-40925
GPS: Latitude 32.66874 Longitude -104.39443
UL "M", Sec. 9, T19S, R26E
Eddy County, NM
NMOCD Ref. No. nAPP2317229661

Paragon Environmental, LLC (Paragon) has been contracted by Spur Energy Partners (Spur) to perform a spill assessment, conduct remediation activities for the release site known as the Stonewall 9 Fee #1H (Stonewall). Details of the release are summarized below:

Liner Inspection Form

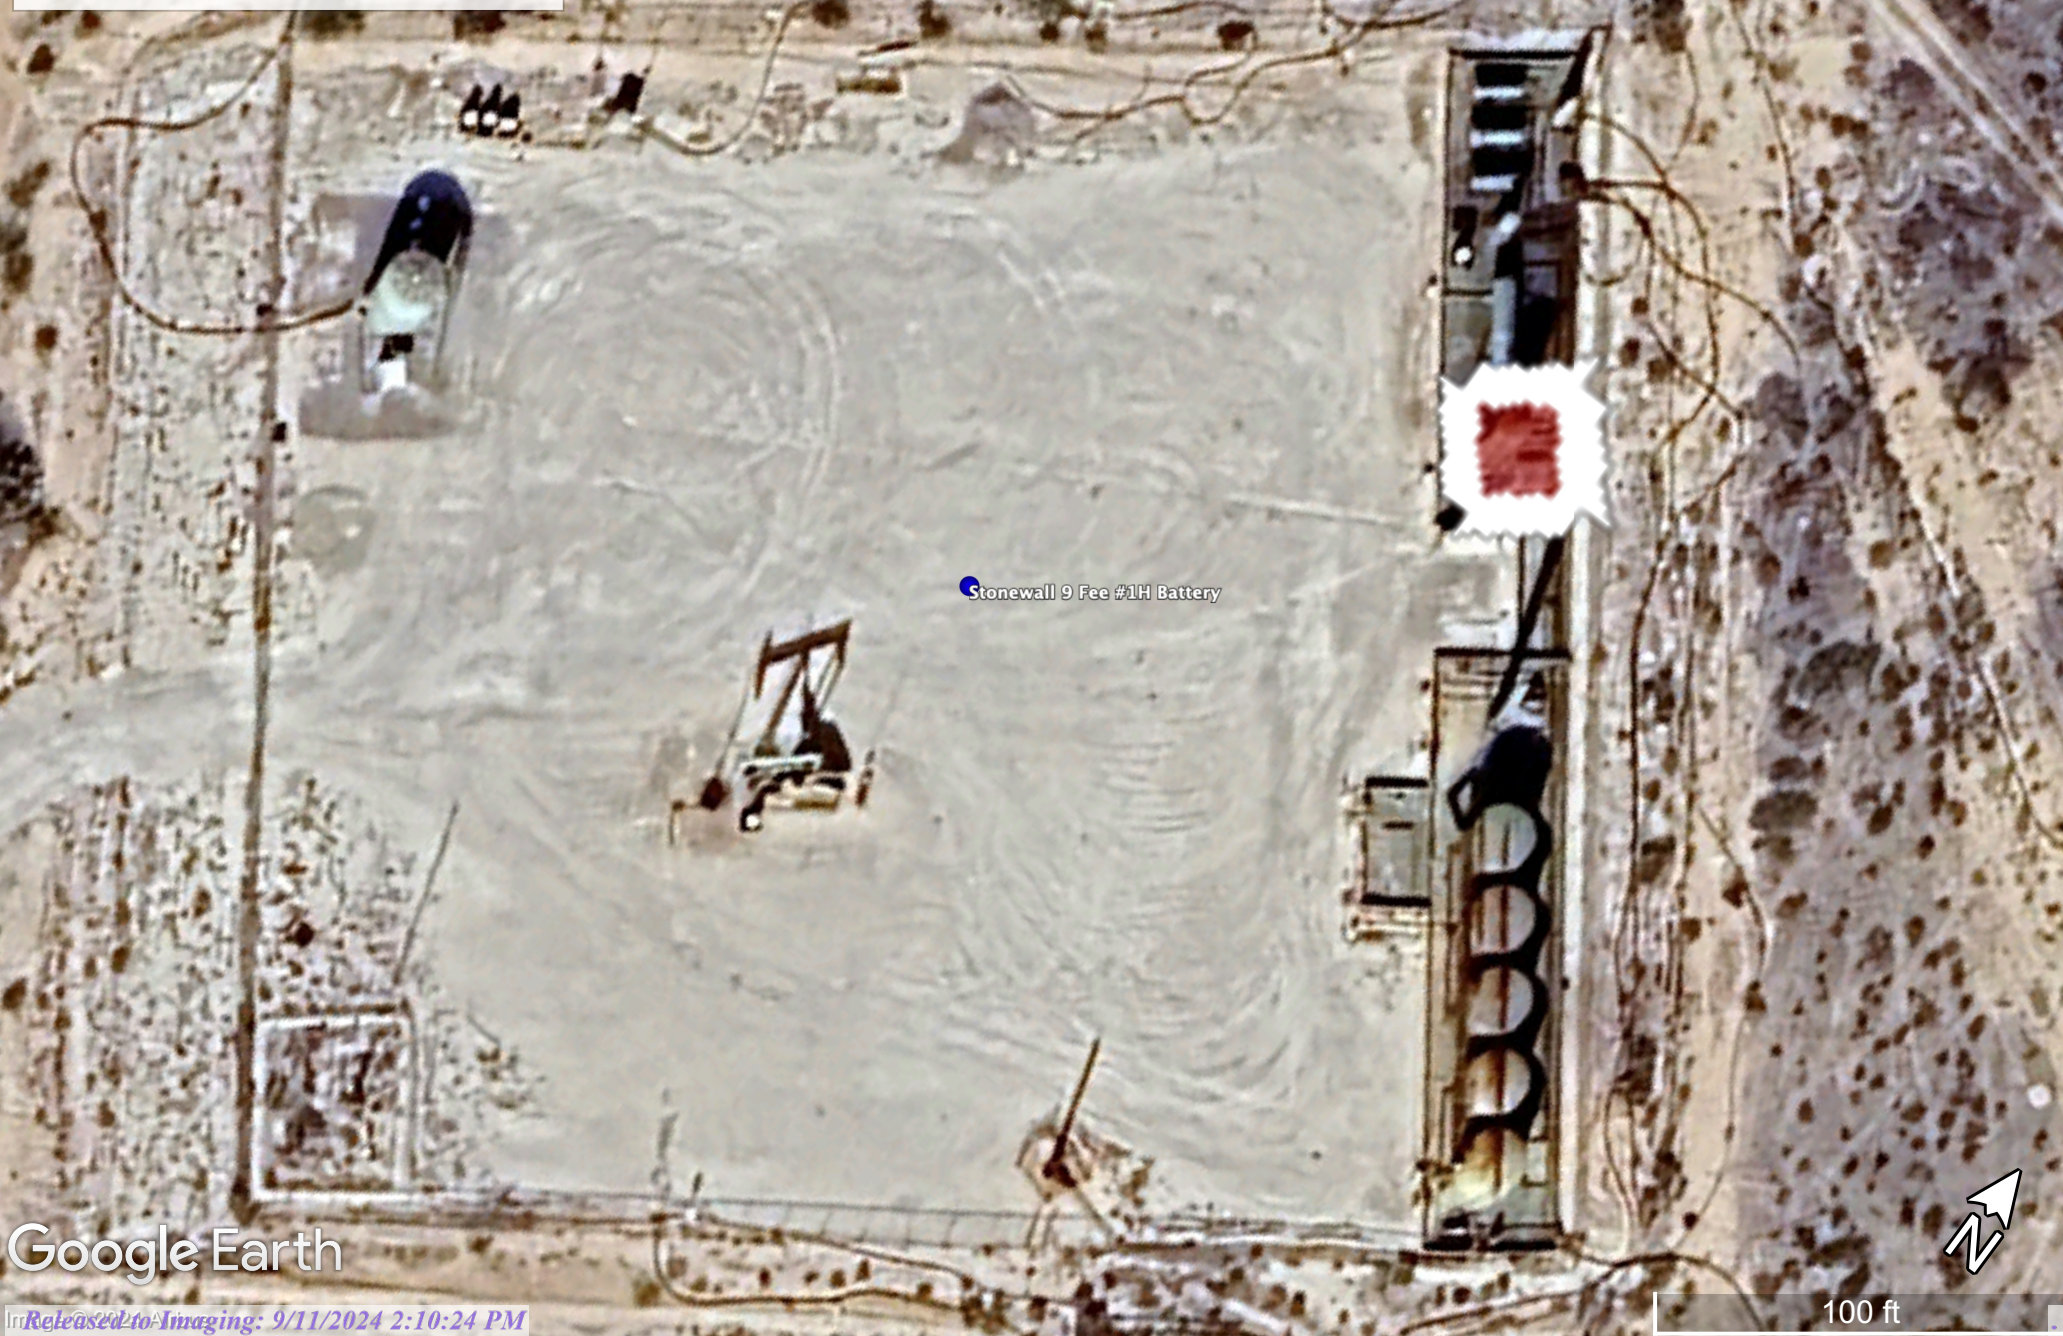
Stonewall 9 Fee #1H
API# 30-015-40925
Eddy County, NM
Site Map

On June 22, 2023, Paragon conducted an initial site assessment. During the initial site assessment there was obvious staining on the liner from the spill. The affected area covered approximately 890 S/F. There were no signs outside the containment that the liner had been breached. Therefore, no samples were taken.

Spill Area 890 S/F
-

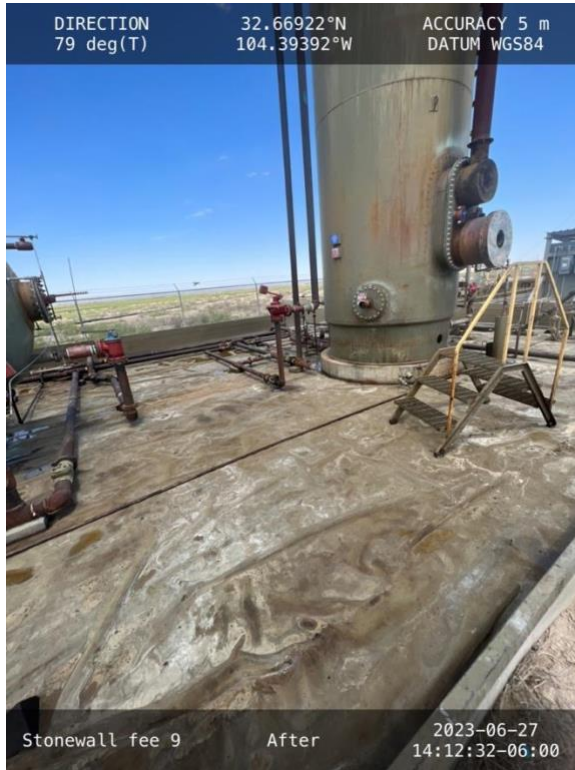
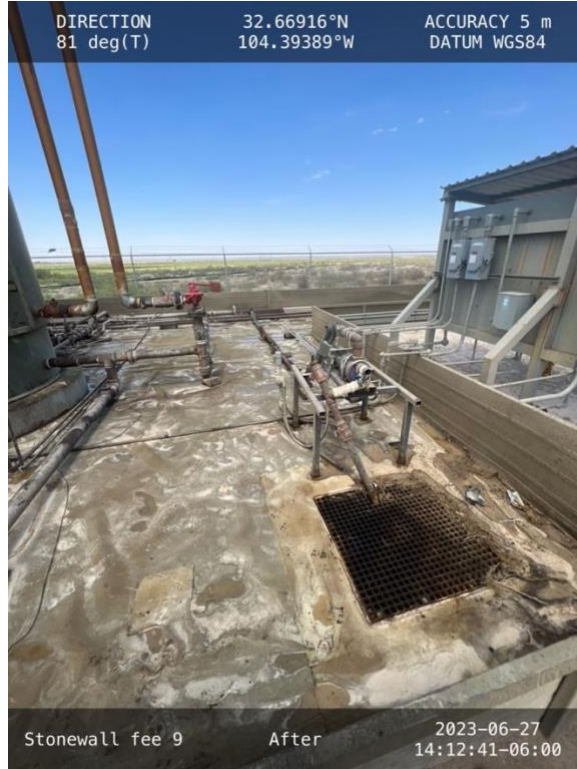
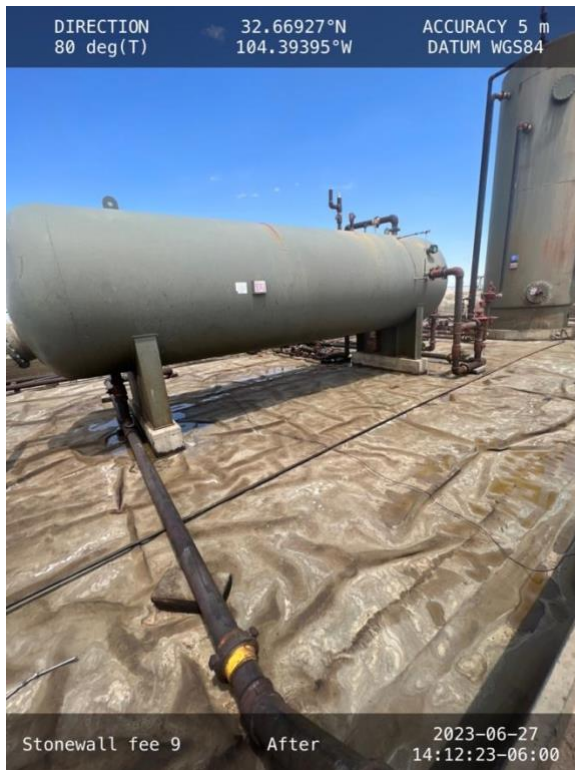
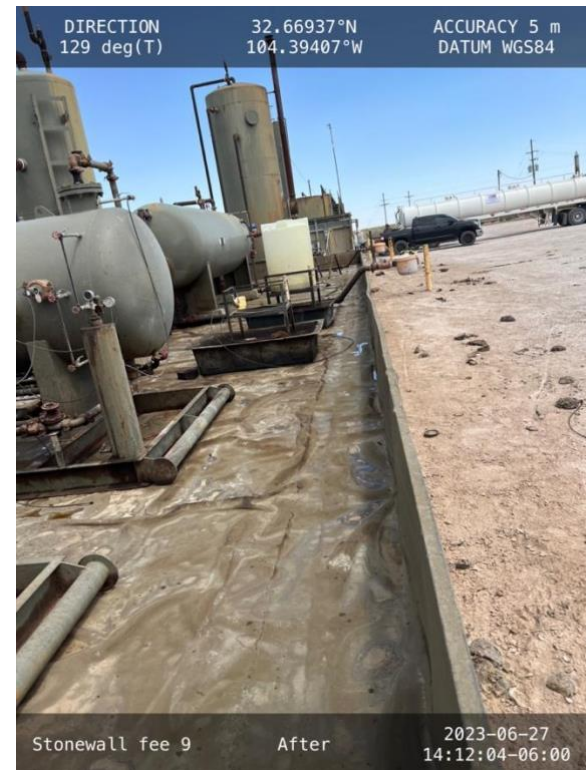
Photographic Documentation
Liner Clean

On June 23, 2023, Paragon mobilized personnel and equipment to conduct remedial activities. We initially sprayed the affected area with a degreaser. We then power washed and squeegeed the runoff so that a vacuum truck could capture the fluids.

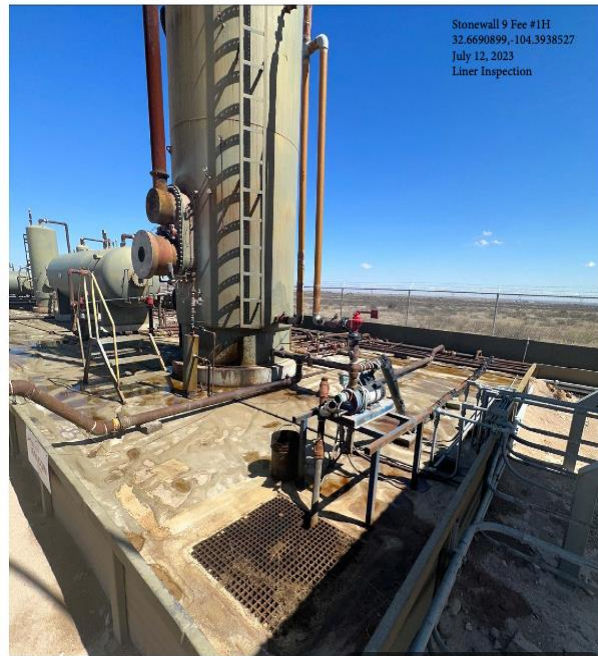
Liner Inspection

On July 12, 2023, Paragon returned to the site to conduct a liner inspection. A 48-hour notification was sent to the NMOCD on July 7, 2023. The inspection concluded that the liner was intact and in good condition. The integrity of the liner has the ability to contain spills. See Appendix C for the email notification and liner report.

Visualization	Yes	No	Comments
Is there a tear in the liner?	<input type="checkbox"/>	<input checked="" type="checkbox"/>	
Are there holes in the liner?	<input type="checkbox"/>	<input checked="" type="checkbox"/>	
Is the liner retaining any fluids?	<input type="checkbox"/>	<input checked="" type="checkbox"/>	
Does the liner have integrity to contain a leak?	<input checked="" type="checkbox"/>	<input type="checkbox"/>
