Closure Report
Fez Fee 11H Battery (04.23.24)
Lea County, New Mexico
Incident ID: NAPP2411548364
Unit D Sec 9 T25S R35E
32.150928°, -103.379856°

Crude Oil Release
Point of Release: Flare Fire
Release Date: 04.23.2024
Volume Released: 0.1 barrels of Crude Oil
Volume Recovered: 0 barrels of Crude Oil

**Re: Closure Report
Fez Fee 11H Battery (04.23.24)
Concho Operating, LLC
Incident # NAPP2411548364
Site Location: Unit D, S09, T25S, R35E
(Lat 32.150928°, Long -103.379856°)
Lea County, New Mexico**

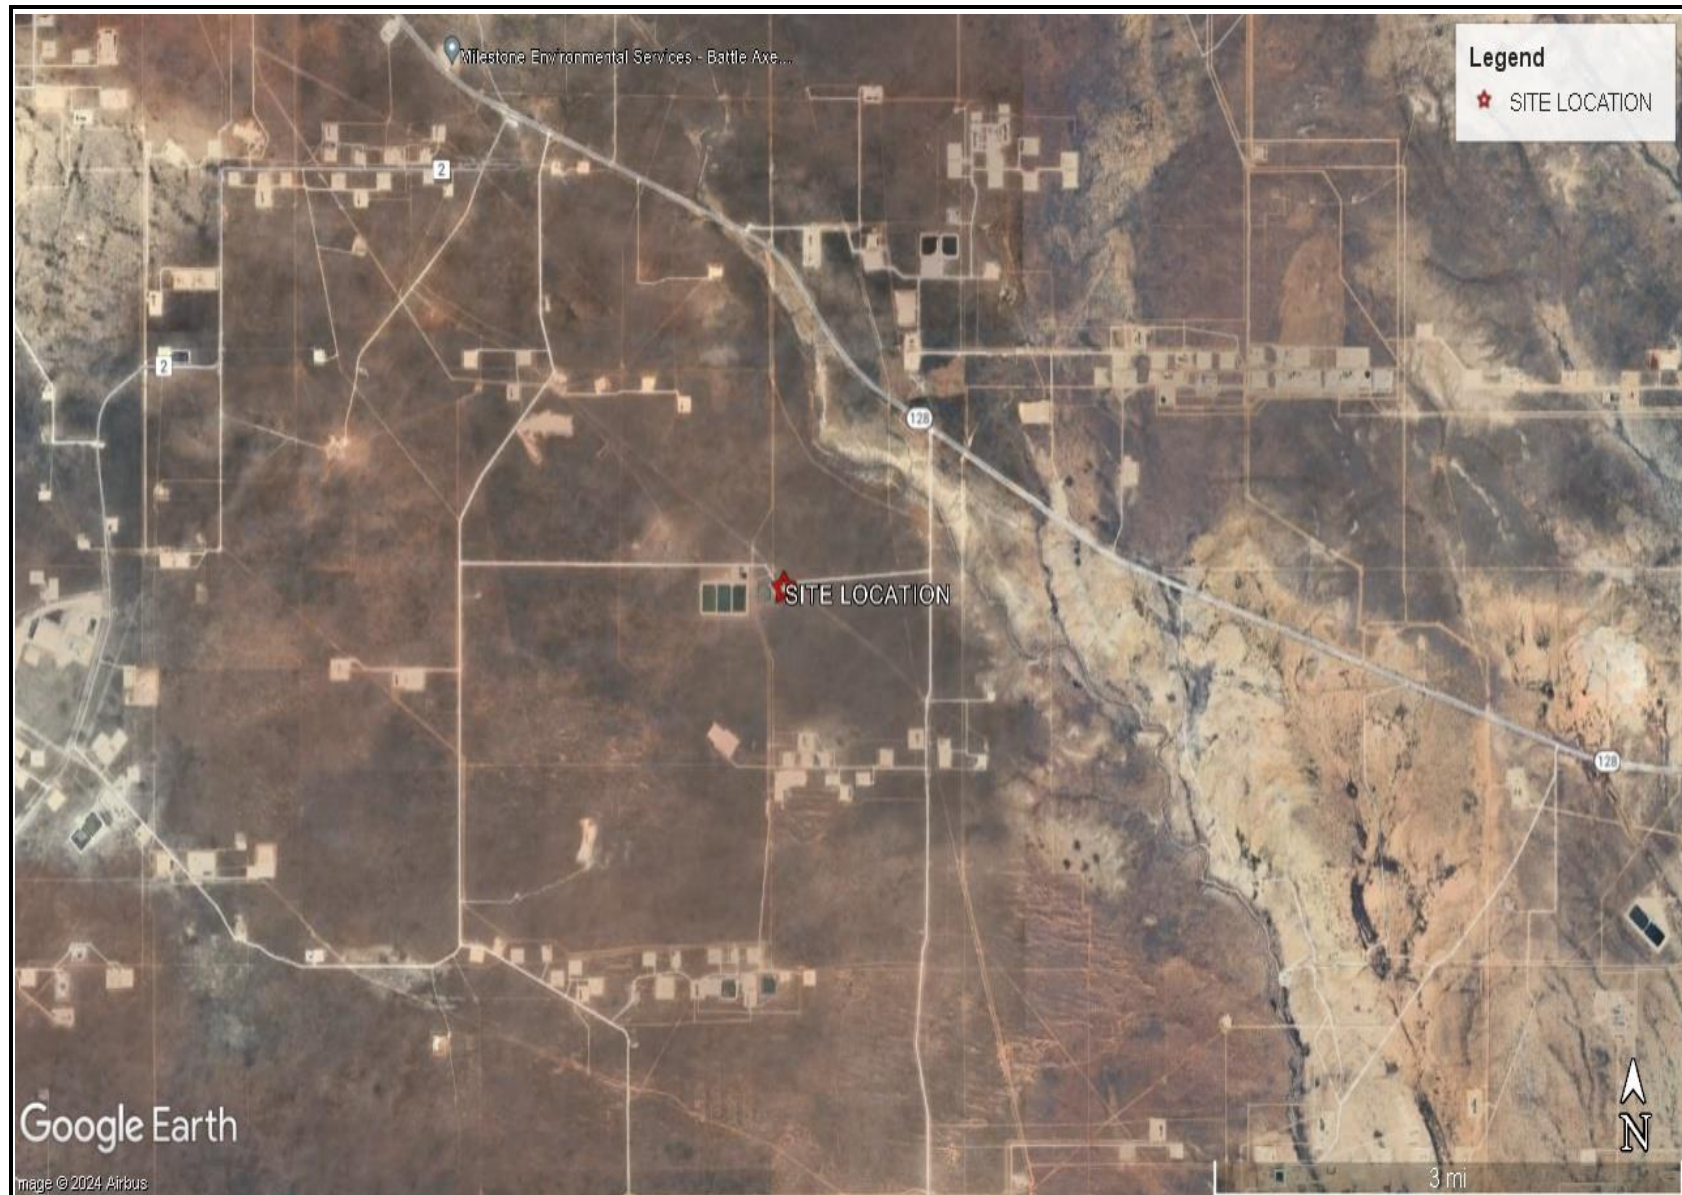
FIGURE 1

OVERVIEW MAP
COG OPERATING, LLC
FEZ FEE 11H BATTERY (4.23.24)
LEA COUNTY, NEW MEXICO
32.150928°, -103.379856°

On behalf of Concho Operating, LLC. (COG), Carmona Resources, LLC has prepared this letter to document site activities for the Fez Fee 11H Battery (04.23.24). The site is located at 32.150928°, -103.379856° within Unit D, S09, T25S, and R35E, in Lea County, New Mexico (Figures 1 and 2).

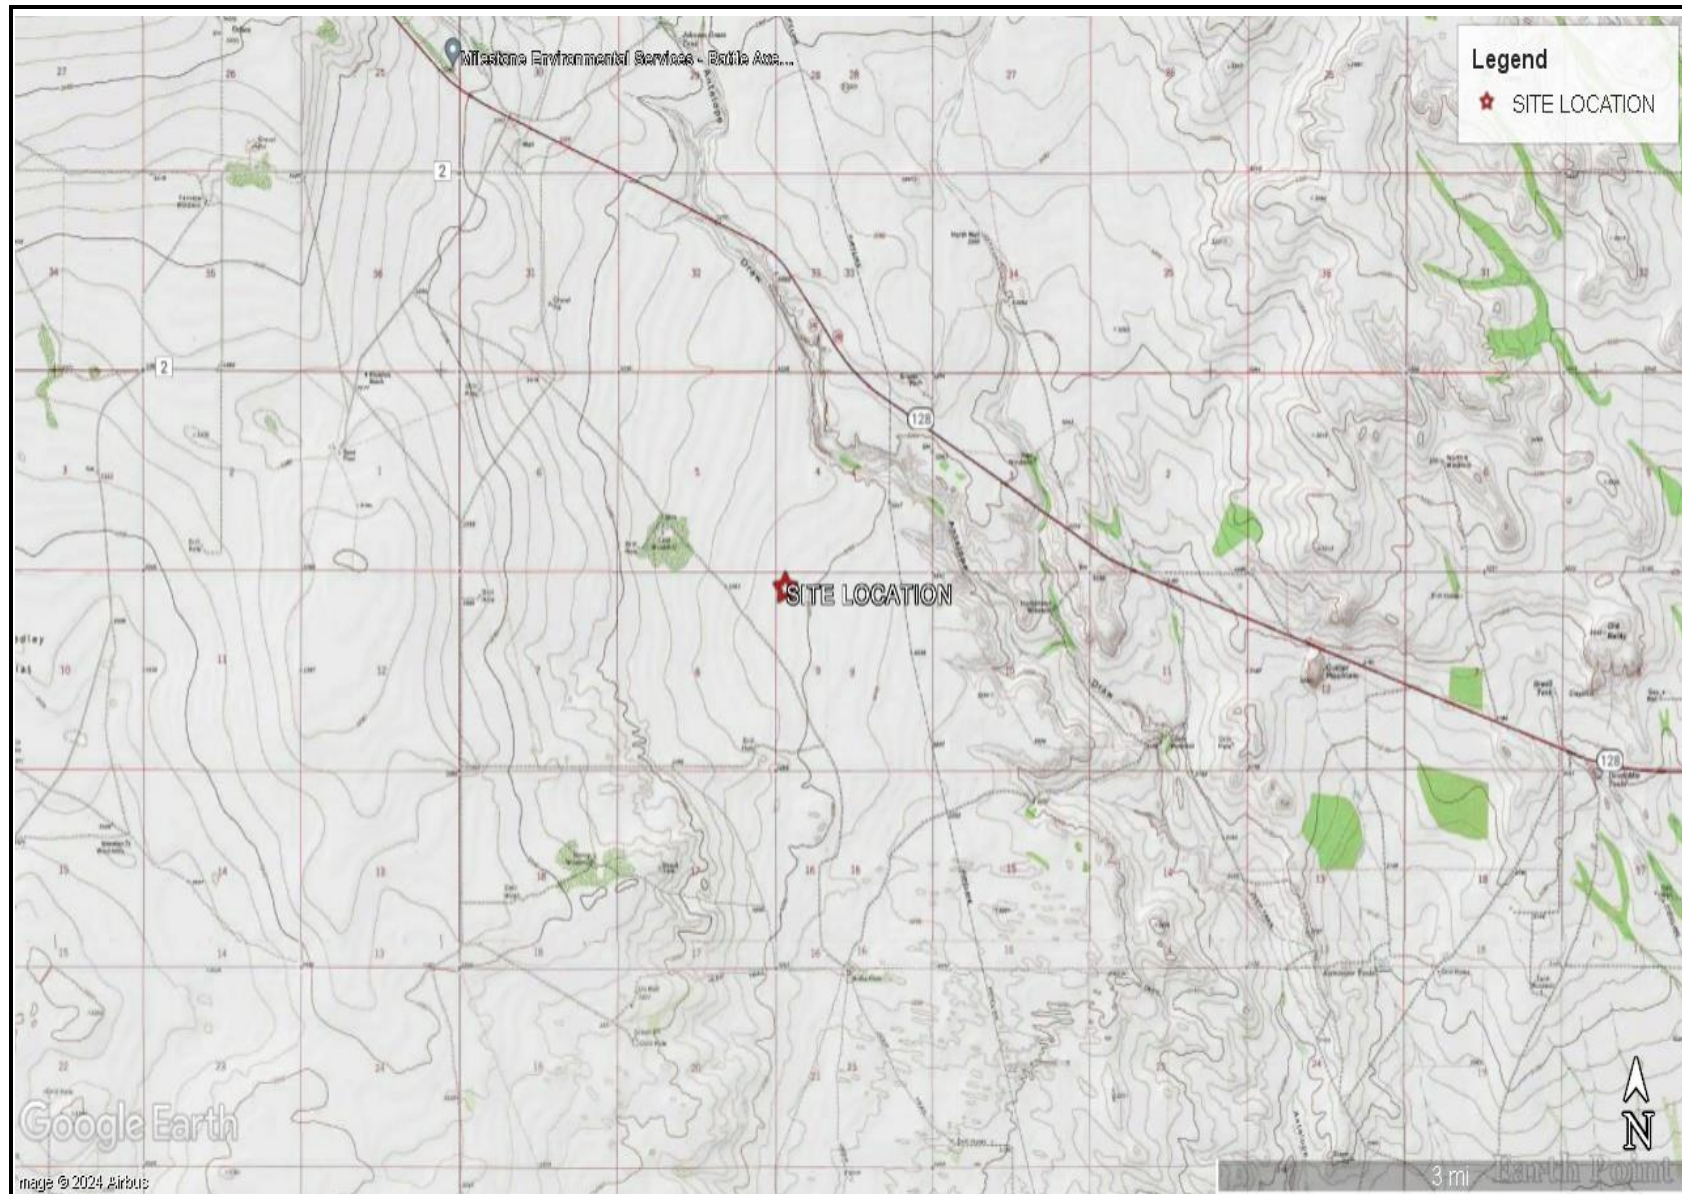
FIGURE 2

TOPOGRAPHIC MAP
COG OPERATING, LLC
FEZ FEE 11H BATTERY (4.23.24)
LEA COUNTY, NEW MEXICO
32.150928°, -103.379856°

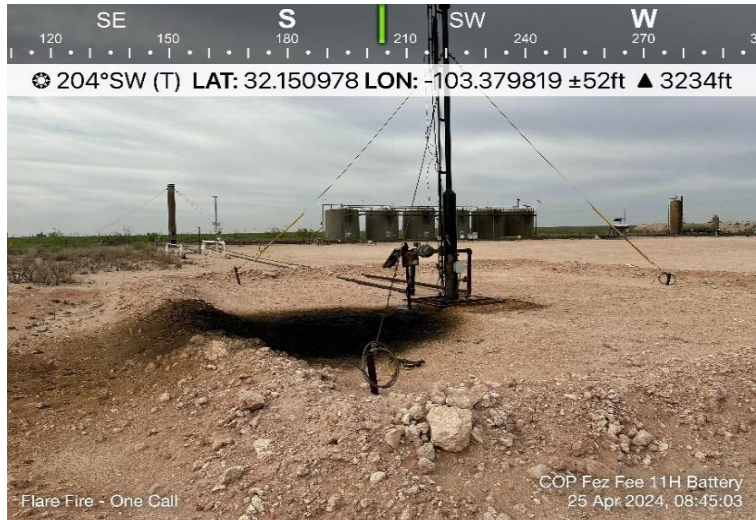
View Southwest, area affected by flare fire.

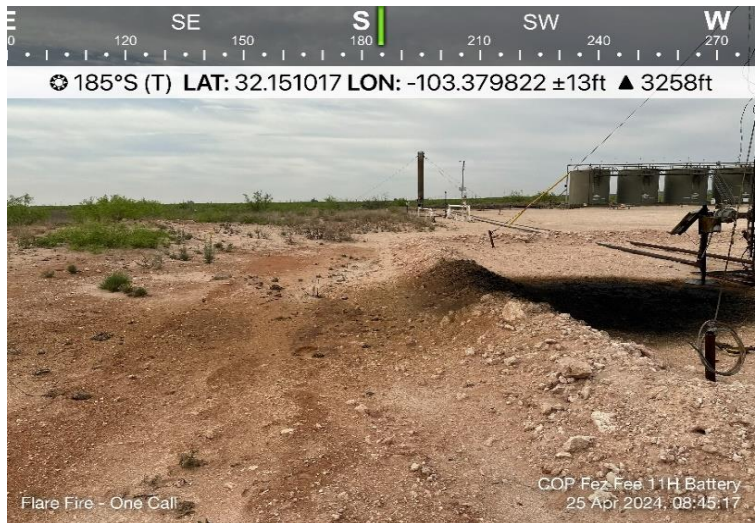
Photograph No. 8

View South, area affected by flare fire.

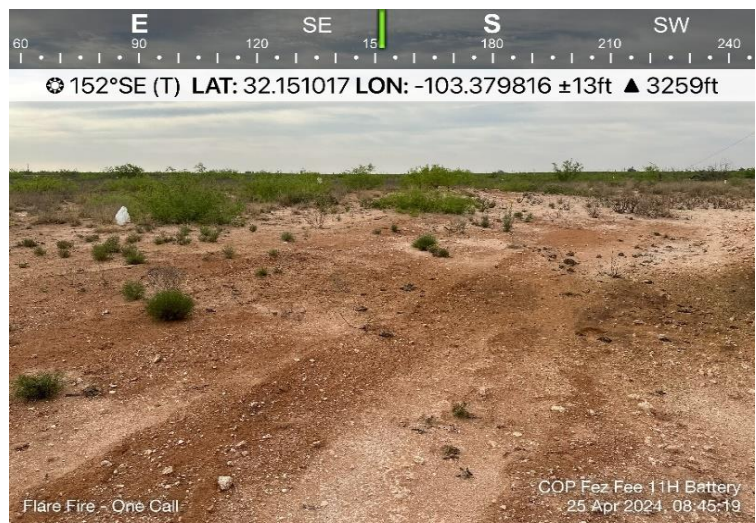
Photograph No. 3

View Southeast, area affected by flare fire.

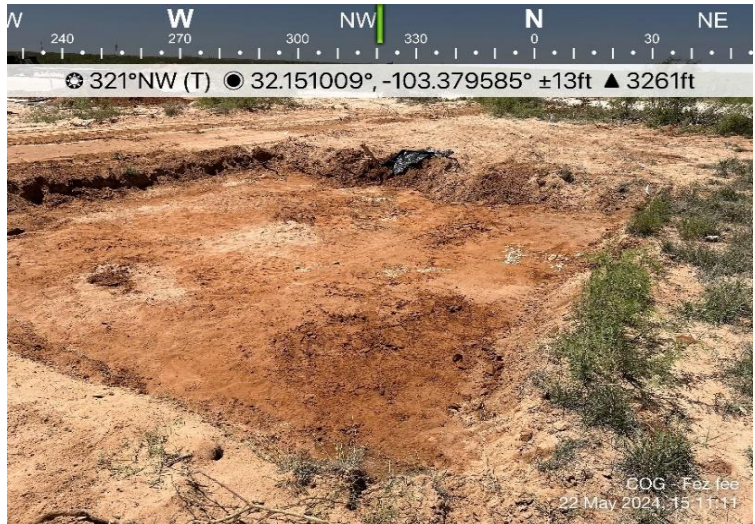
View Northwest, area of CS-1 and CS-2.

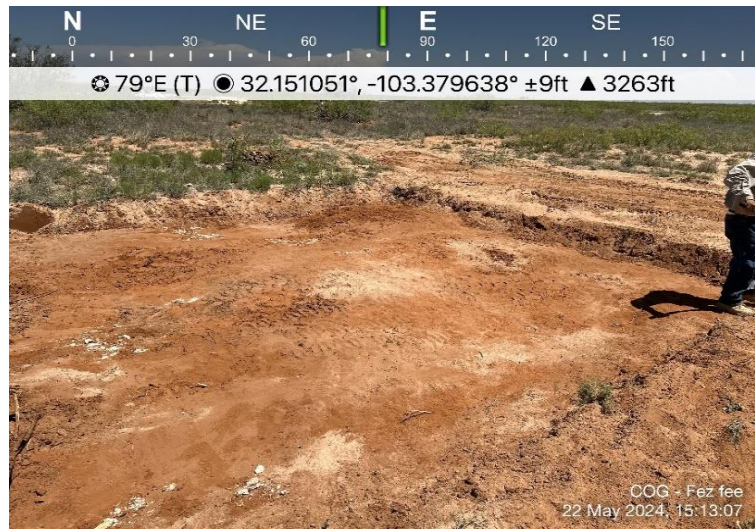
Photograph No. 8

View East, area of CS-1 and CS-2.

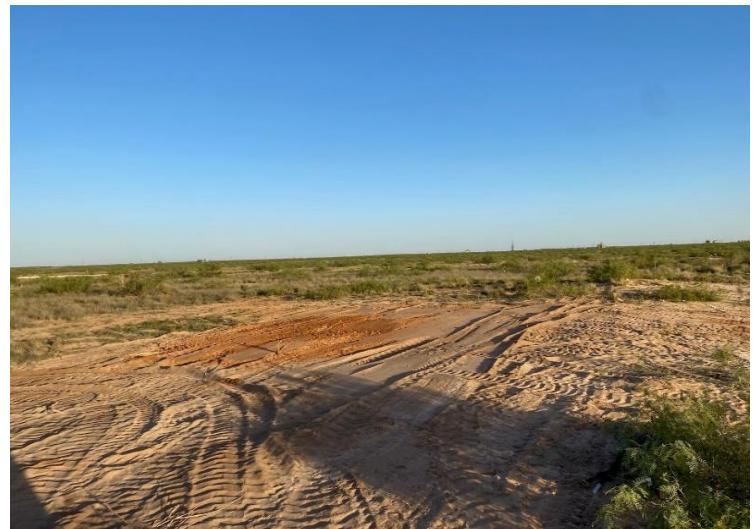
Photograph No. 6

View of the backfilled excavation after reseeded by hand broadcast.

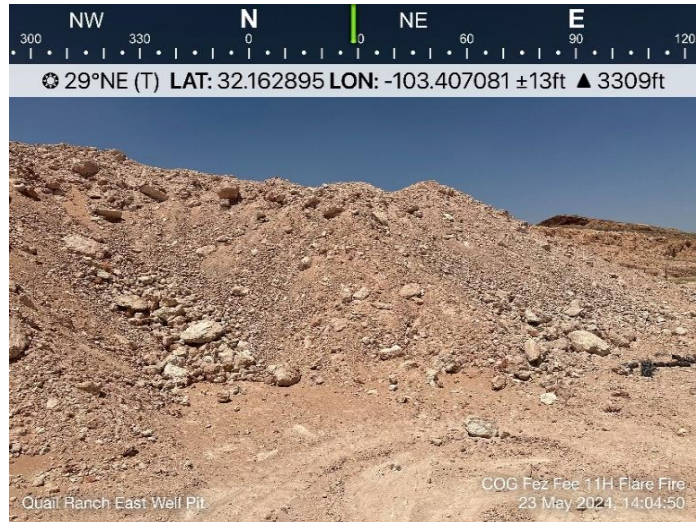
View Northeast, Quail Ranch East Well Pit stockpile.

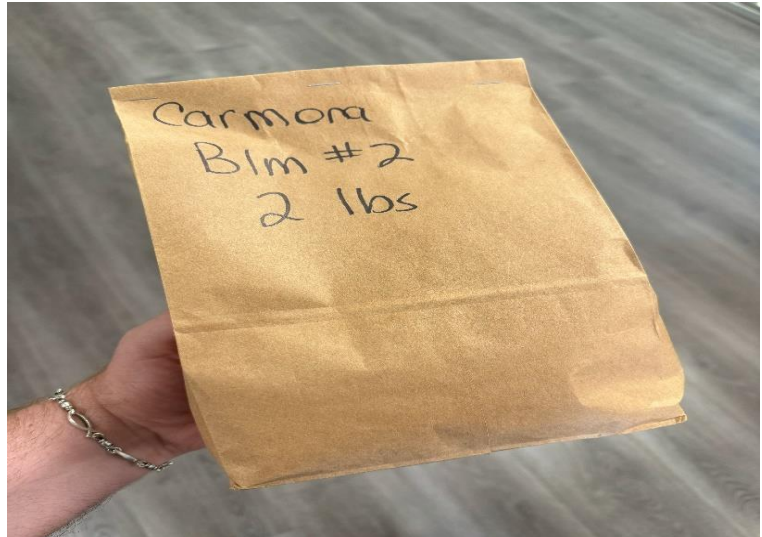
Photograph No. 8

View of the bag of BLM Seed mixture #2 used for the reseed.
