**Re: Remediation Report and Closure Request**

Nordhaus #2A  
San Juan County, New Mexico  
Hilcorp Energy Company  
NMOCD Incident No: nAPP2416532213

Hilcorp Energy Company  
Remediation Report and Closure Request  
Nordhaus #2A

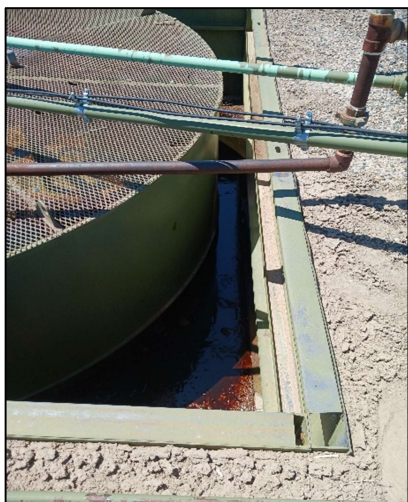
On June 12, 2024, a release of produced water and trace oil from a below grade tank (BGT) at the production well (API: 30-045-23586), located at latitude 36.91699°, North and longitude 107.75264° West, occurred due to corrosion at the base of the tank. This failure resulted in the BGT releasing produced water and trace oil into the unlined secondary containment cribbing. Hilcorp immediately implemented corrective action by dispatching a vacuum truck to remove the retained fluids from the containment crib and the BGT prior to the BGT's extraction. In total, approximately 36.75 barrels (bbls) of produced water with trace oil were released, of which approximately 30 bbls were recovered using a vacuum truck from the BGT and cribbing.

Photograph: 1                      Date: 6/12/2023  
Description: Initial release - Cribbing containment  
View: South

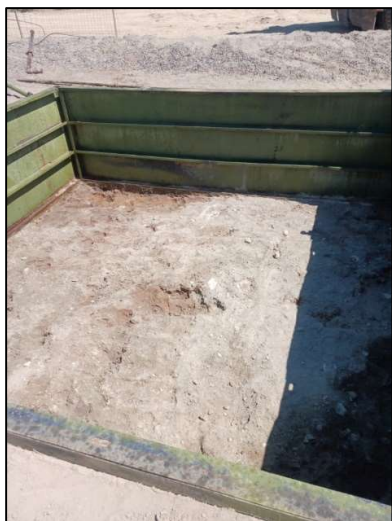
Photograph: 3                      Date: 6/13/2024  
Description: Post remedial activities  
View: North

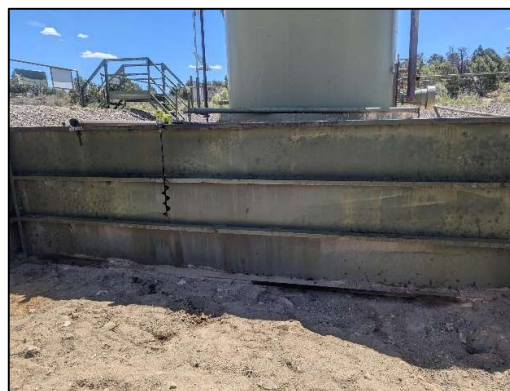
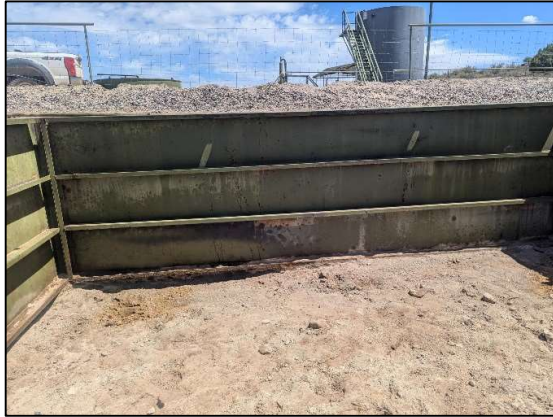
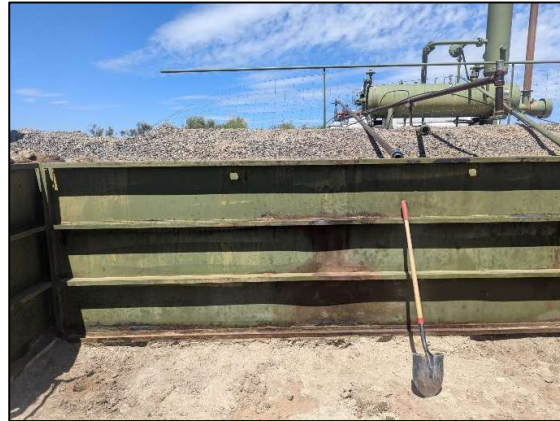
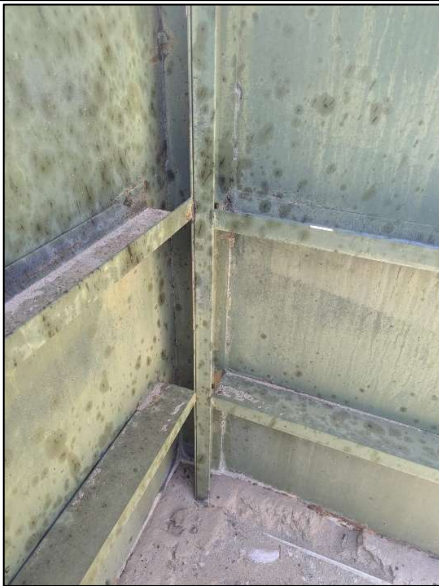
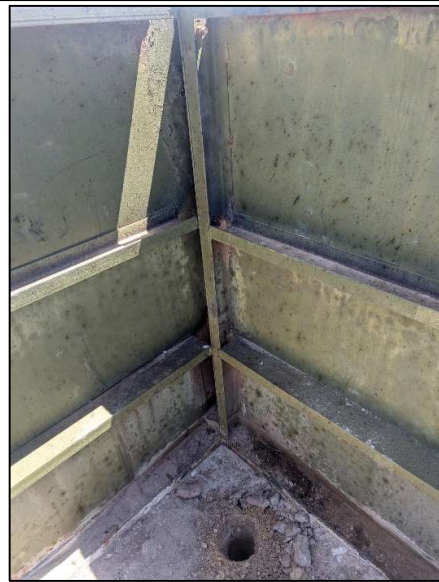
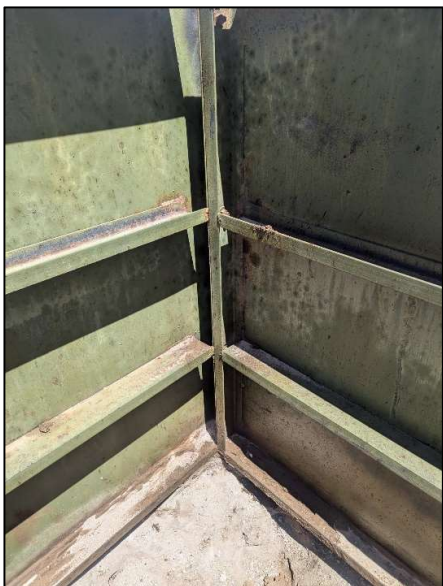
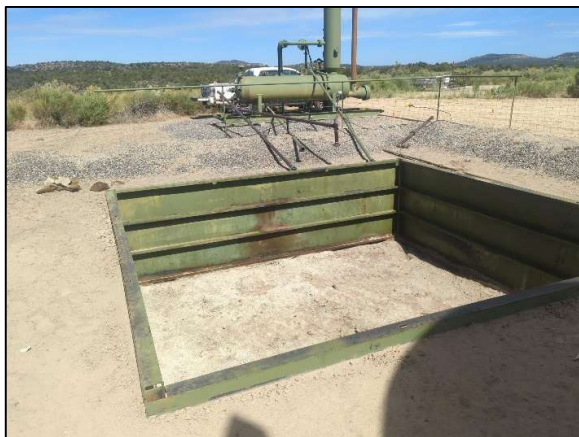
On June 19, 2024, Hilcorp retained Ensolum to collect soil samples to assess potential soil impacts resulting from the release at the Site. Four hand auger sample locations were advanced (HA01 through HA04) from the corners of the BGT cribbing to assess COC concentrations where the produced water had the highest probability of infiltration. A total of 8 samples were collected from HA01 through HA04 at 5 feet bgs and 6 feet bgs. In addition, a composite floor sample (FS01) was collected from the cribbing floor surface to evaluate the entire area. All soil samples were field screened for the presence of organic vapors using a calibrated photoionization detector (PID) and chloride using Hach® QuanTab® test strips, with results noted in Table 1.

Photograph: 4                      Date: 6/19/2024  
Description: Sampling activities  
View: East

Photograph: 5  
Description: Sampling activities  
View: North

Photograph: 6  
Description: Sampling activities  
View: West

Photograph: 7  
Description: Sampling activities  
View: Southeast Corner

Photograph: 8  
Description: Sampling activities  
View: Southwest Corner

Photograph: 9  
Description: Sampling activities  
View: Northeast Corner

Photograph: 10  
Description: Sampling activities  
View: Northwest Corner

Photograph: 11  
Description: Sampling activities  
View: West

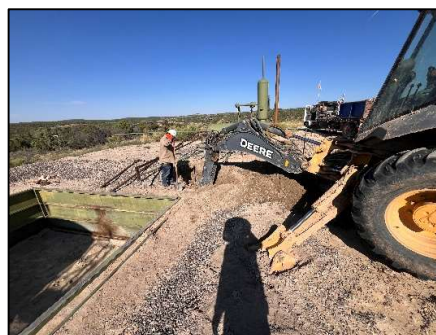
On July 17, 2024, two potholes stepping out approximately 6 feet to the north and to the west of boring HA02 were advanced to approximately 6 feet bgs. The potholes were sampled at 5 feet bgs and 6 feet

bgs to confirm lateral delineation of the noted impacts at HA02. Analytical results indicated all COC concentrations were below the NMOCD Closure Criteria.

Photograph: 12  
Description: Potholing activities for delineation  
confirmation  
View: West

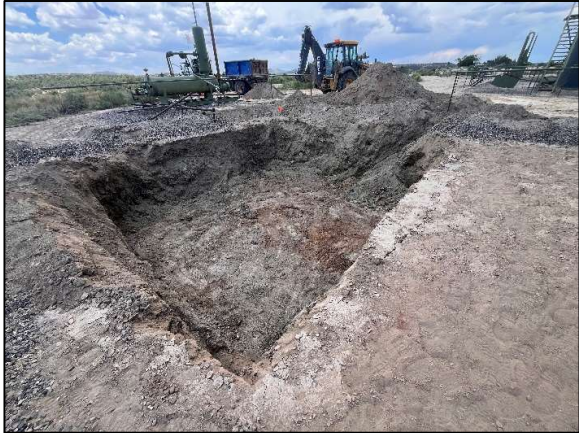
Photograph: 13

As a result, the BGT cribbing was subsequently removed on July 17, 2024 and the identified impacts in the vicinity of HA02 were excavated to collect confirmation soil samples from the Site. The resulting excavation dimensions were 20 feet by 20 feet and extended approximately 6 feet bgs. A total of three composite confirmation side wall samples (SW01, SW02, and SW03) and two floor samples (FS02 and FS03) were collected and analyzed for the COCs (Figure 2). The five-point composite samples were collected by placing five equivalent aliquots of soil into a 1-gallon, resealable plastic bag and homogenizing the samples by thoroughly mixing.

Description: Excavation activities

View: Northwest
