Amended Closure Report
ABO Plant W. Inlet & Abo Plant W. Inlet 2
Incident #(s): nAPP2207742550 & nAPP2218749539
Eddy County, New Mexico
Unit D Sec 10 T18S R27E
32.768683°, -104.272269°

Condensate Release

Point of Release: 12" Power seal Clamp Release Date: 02/24/2022 & 07/01/2022

Re: Amendment to Closure Report

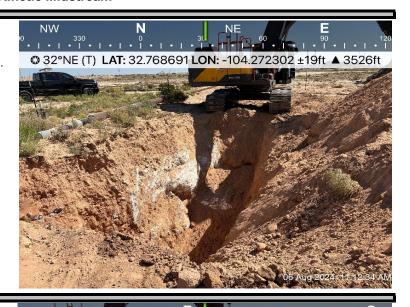
View Northeast, area of CS-1.

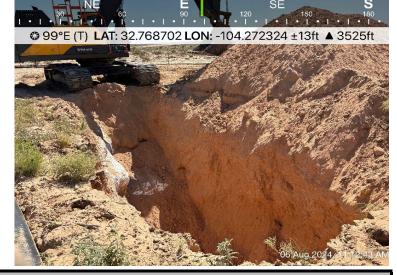
Photograph No. 2

View East, area of CS-1.

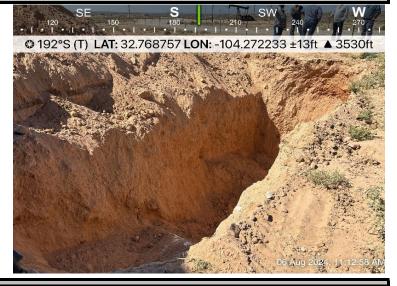
Photograph No. 3

View South, area of CS-1 & CS-2.
