**LONE TREE DRAW 13 STATE COM #2H**  
**Incident ID nAPP2104831006**

**Remediation Closure Report**

Prepared for Devon Energy Production, LP --- Prepared by Pima Environmental Services, LLC

**Re: Remediation Closure Report**  
**Lone Tree Draw 13 State Com #002H**  
**API No. 30-015-40372**  
**GPS: Latitude 32.487372 Longitude -104.149953**  
**ULSTR – D – 13 – 21 – 27E      0 FNL 0 FEL      Eddy County, NM**  
**NMOCD Incident ID nAPP2104831006**

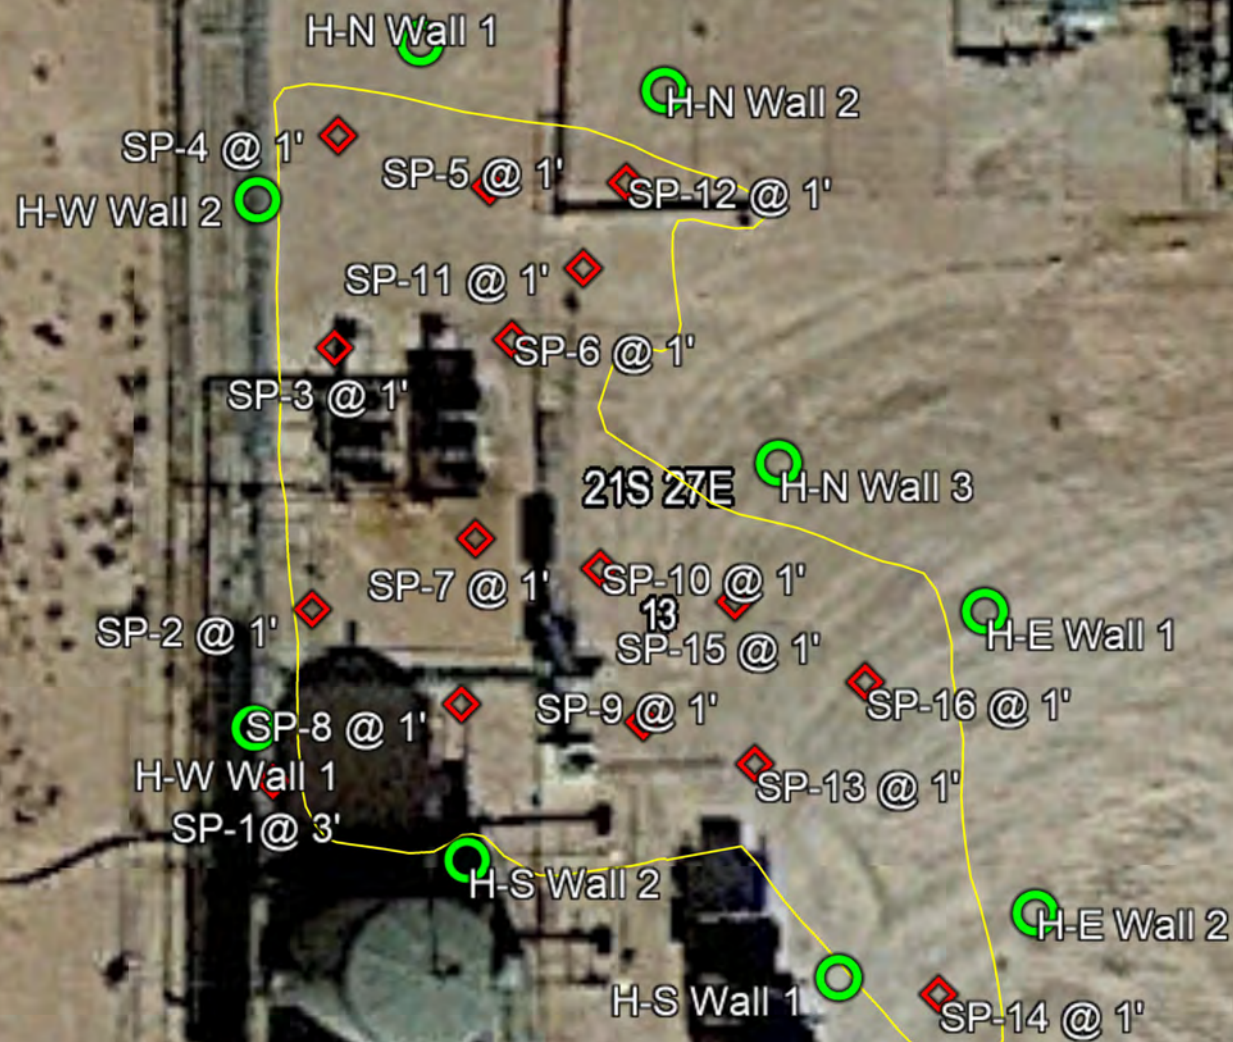
Figure 4- Previous Site Map

Lone Tree Draw 13 St 2H  
D-13-21S-27E  
Previous Site Map  
NAPP2104831006

- Excavation 1
- Horiz Extent
- Vert Extent

Resubmit report by 7/25/24. The rejected C-141 can be found in the OCD Online: Permitting - Action Status, under the Application ID: 158761. Please review and make the required correction(s) prior to resubmitting. If you have any questions why this application was rejected or believe it was rejected in error, please contact me prior to submitting an additional C-141. A Previous Site Map and Previous Data Table can be found in Figures 4 and 5.

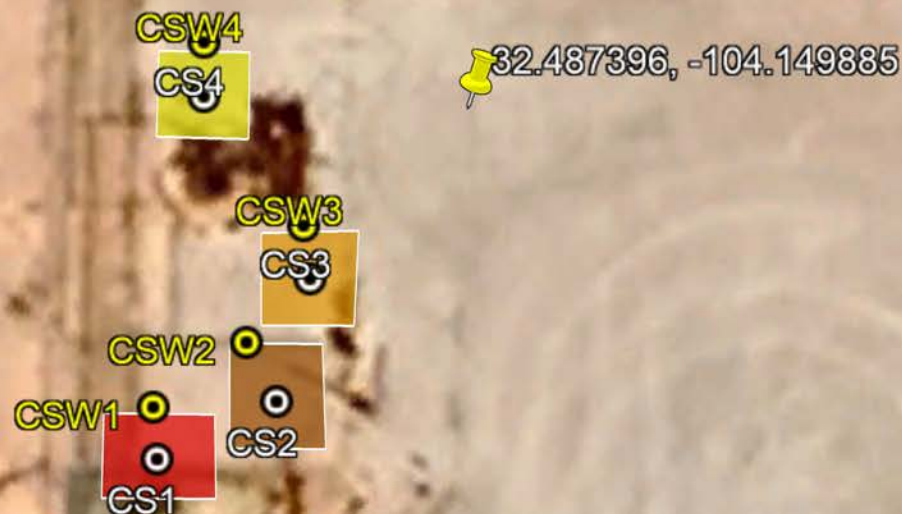
Figure 6- Confirmation Sample Map

Devon Energy  
API #30-015-40372  
Eddy County, NM  
nAPP2104831006  
Confirmation Sample Map

- Composite base samples
- Composite wall samples
- SP-1 area - 150 sqft
- SP-3 area - 126 sqft
- SP-7 area - 141 sqft
- SP-8 area - 156 sqft

On August 9, 2024, after Devon submitted a 48-hour sampling notification, confirmation samples were collected from the excavated areas. A total of 4 composite base samples were collected, and 4 composite wall samples were collected. All samples were put on ice, jarred, and delivered to Envirotech Analytical Laboratories, an NMOCD-approved laboratory for official analysis for all constituents listed in Table 1 19.15.29.12 NMAC. The results of this sampling event can be seen in the following data table. A corresponding Confirmation Sample Map can be found in Figure 5.

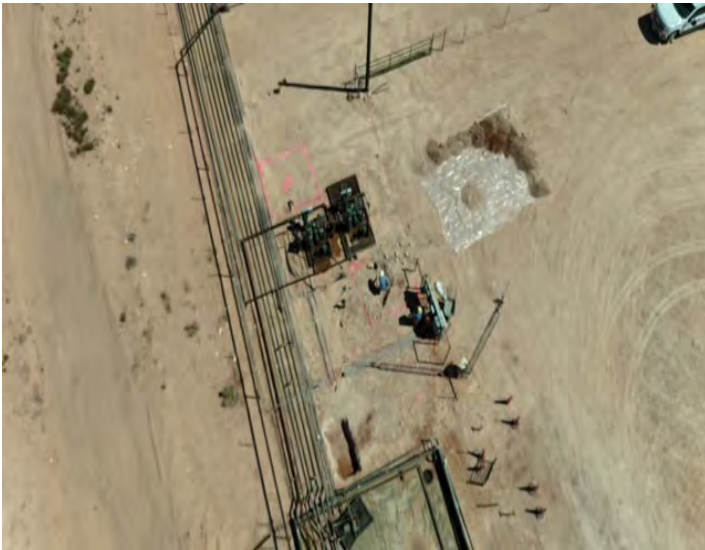
Excavation aerial view

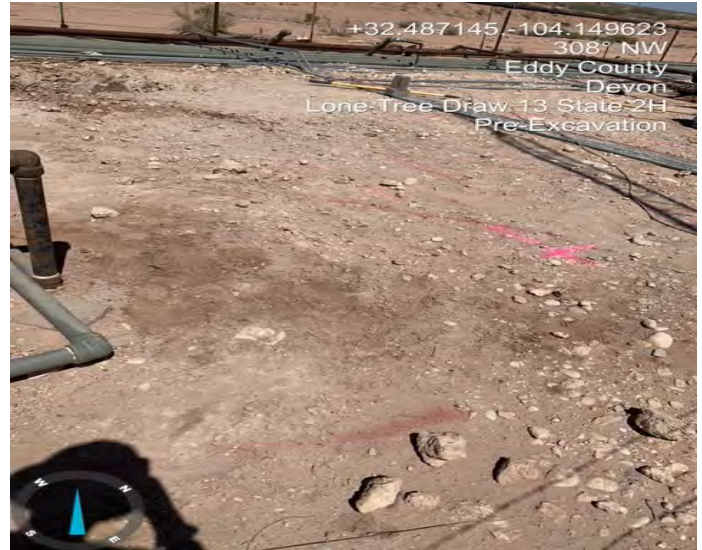
Begin excavation north of pumps

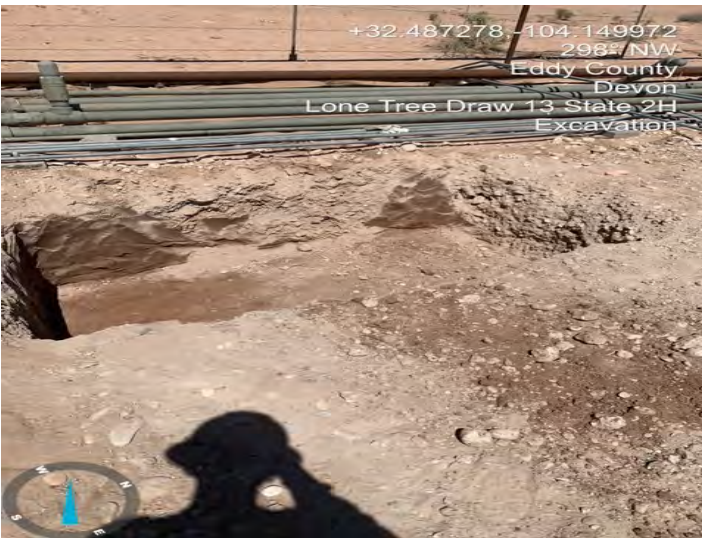
Excavation north of battery

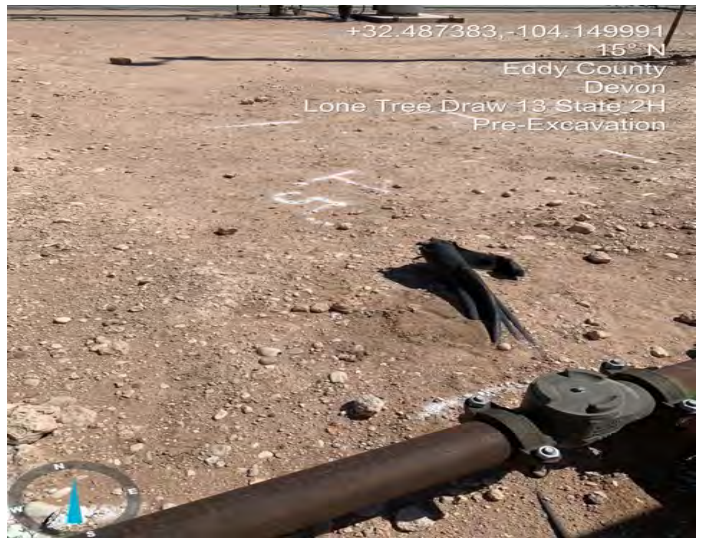
Excavation north of pumps

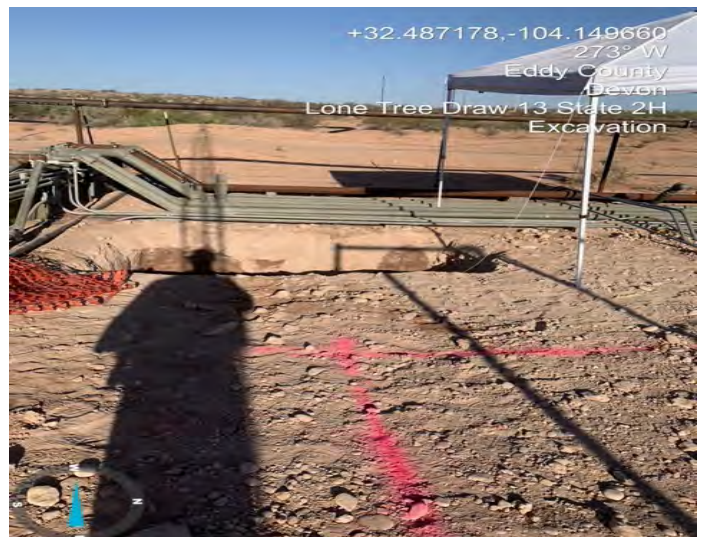
Excavation north side of battery

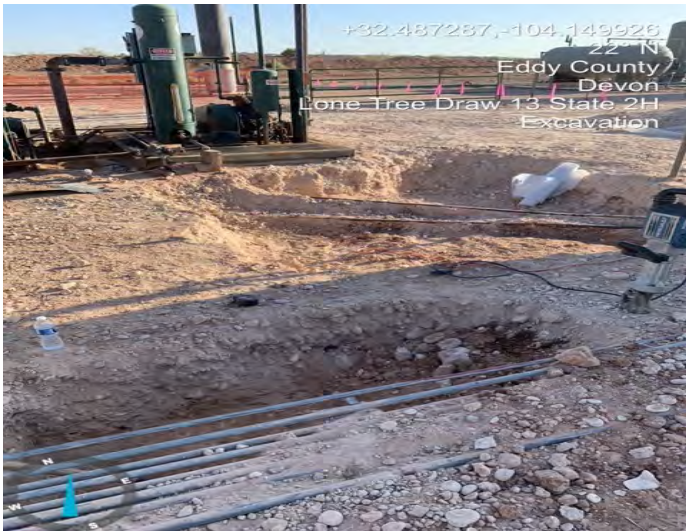
Excavation south of pumps

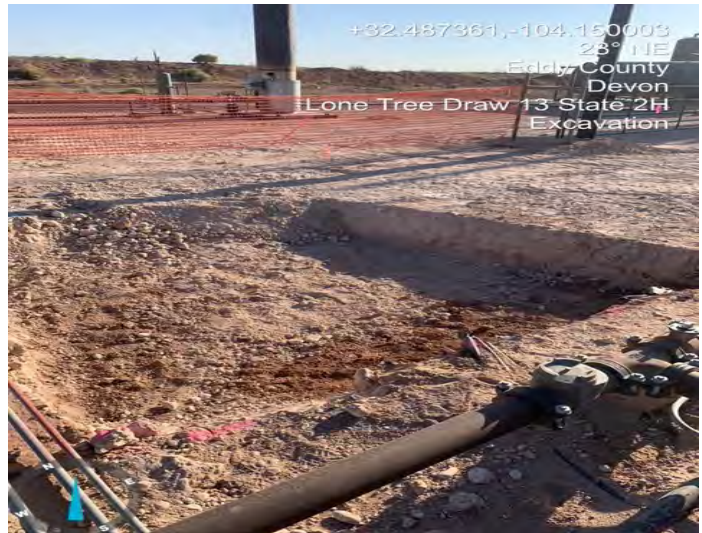
Excavation north of pumps

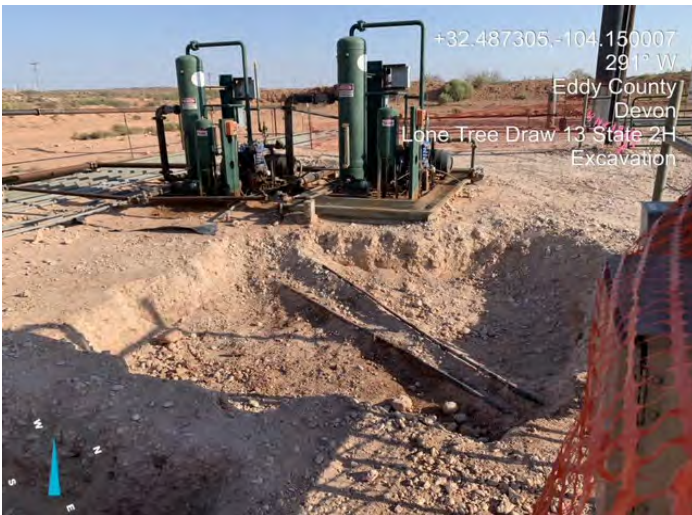
Excavation south of pumps

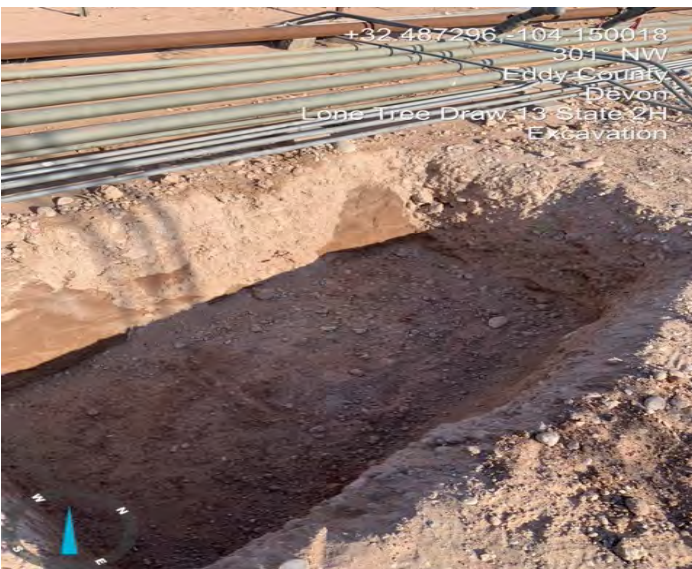
Excavation north of battery

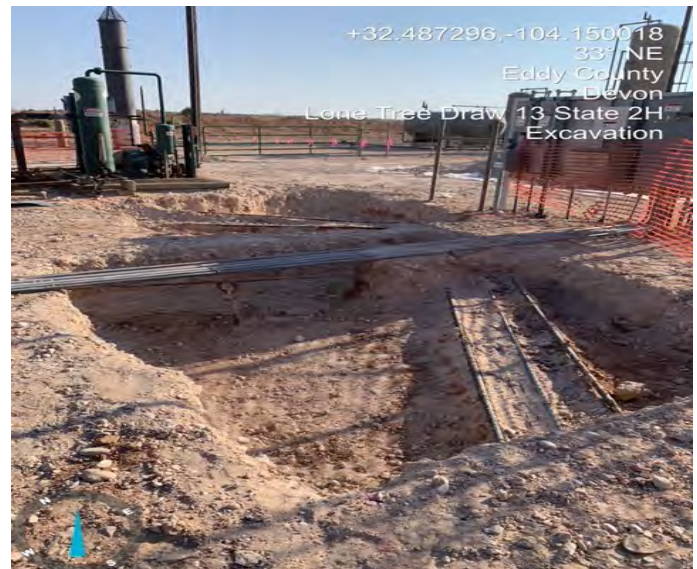
Excavation west of panel

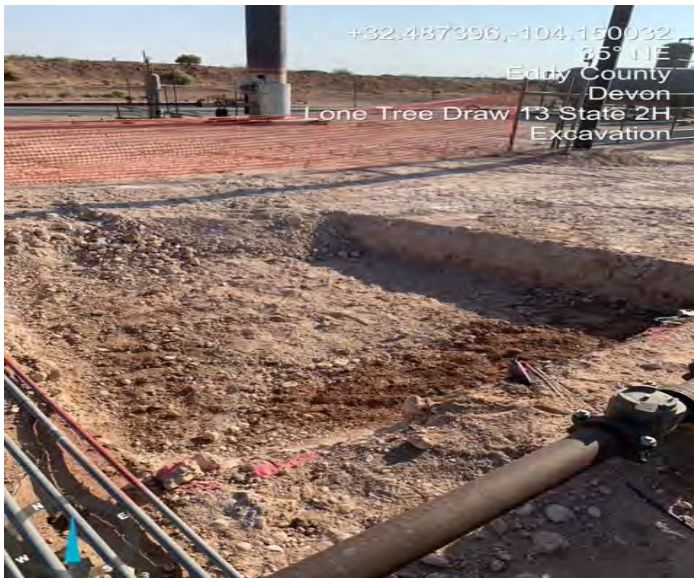
Excavation north of pumps

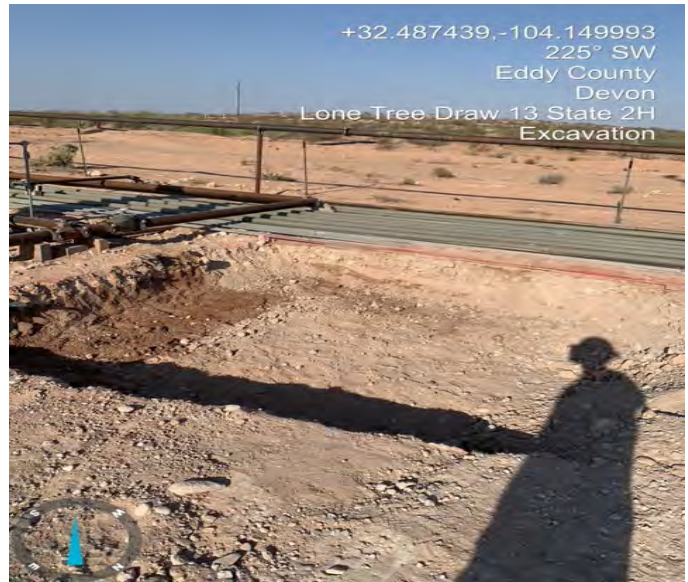
Excavation north of pumps

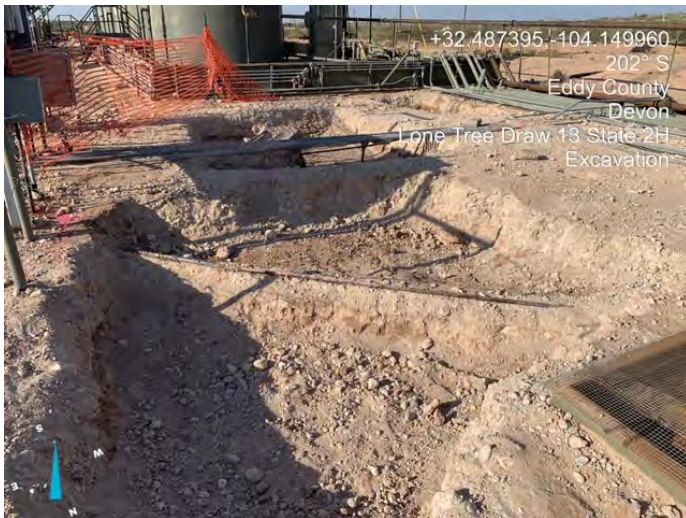
Excavation west of panel

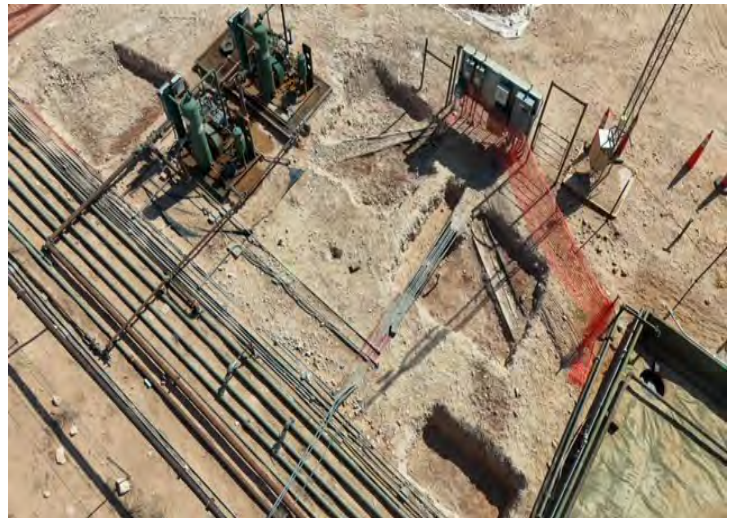
Excavation aerial view

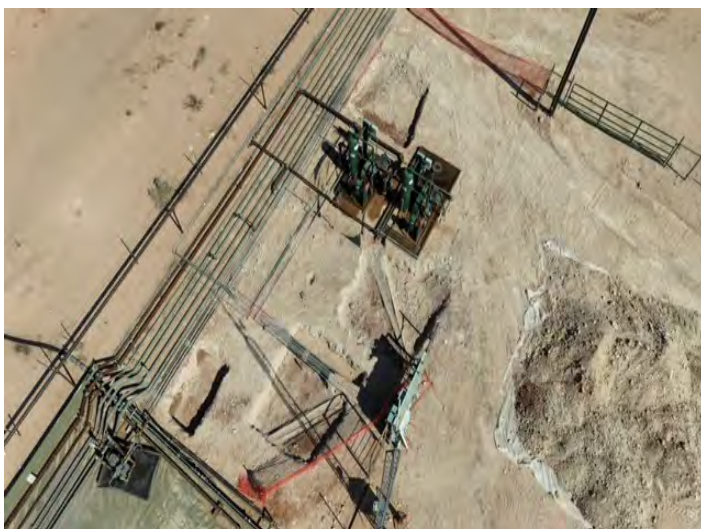
Excavation aerial view

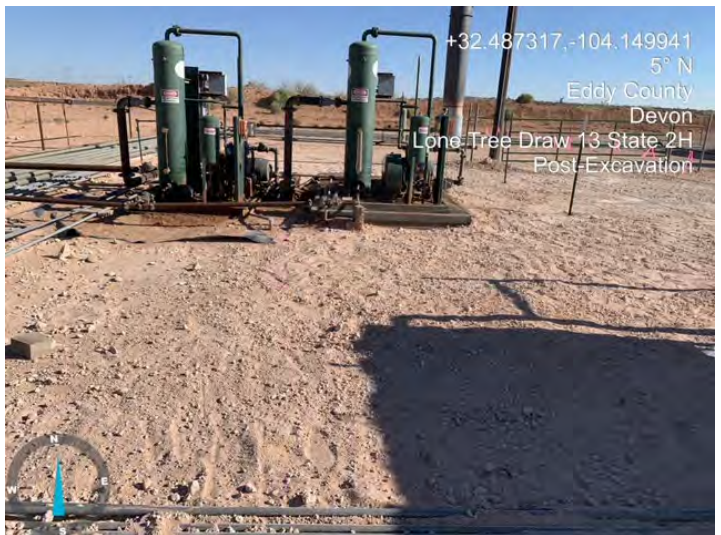
Backfill south of pumps

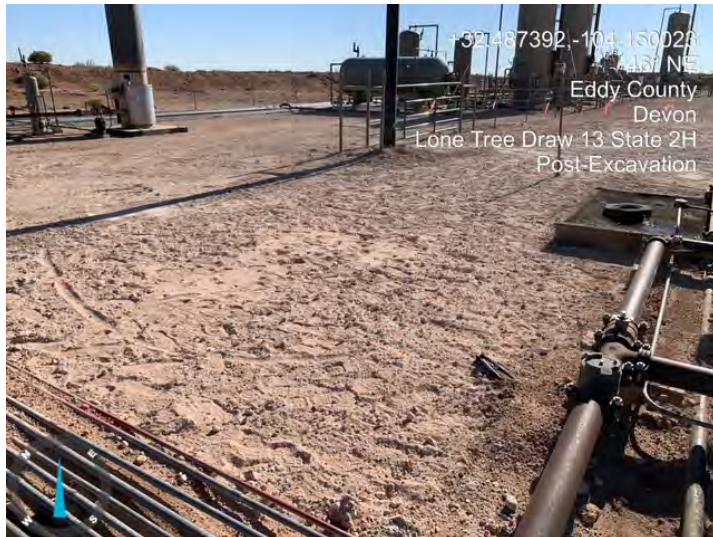
Backfill north of pumps

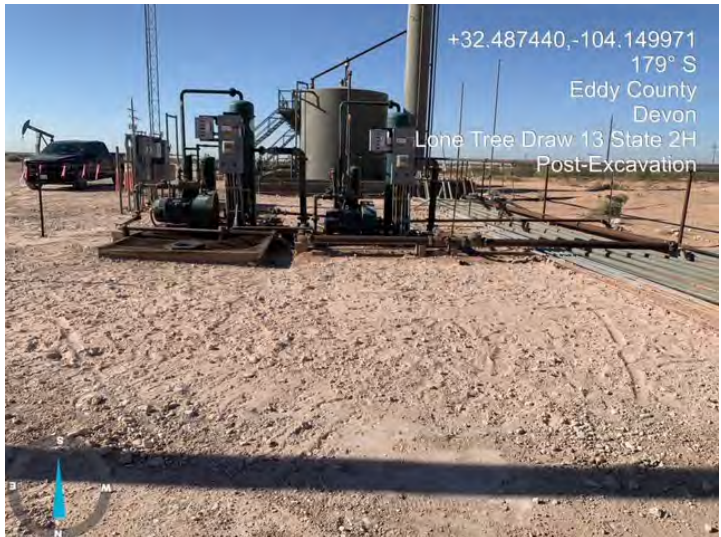
Backfill north of pumps
