Re: Closure Request

MCA Unit 2-F Production Header Incident Number nPAC0609340050 Lea County, New Mexico

Maverick Permian, LLC Closure Request MCA Unit 2-F Production Header

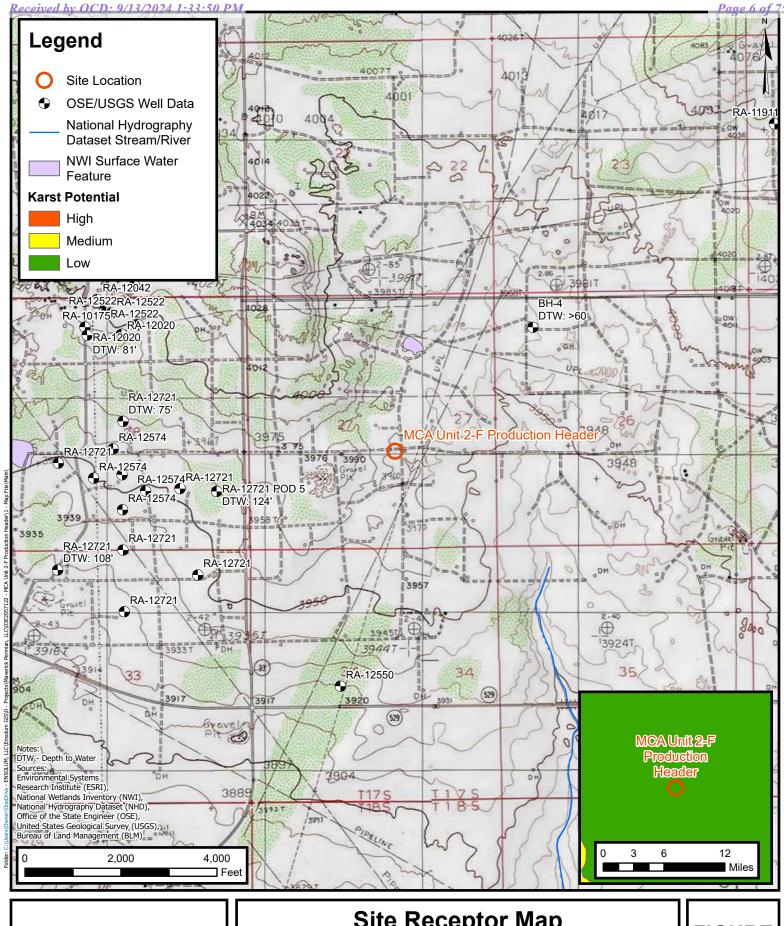
Site Receptor Map

The Site was characterized to assess applicability of Table I, Closure Criteria for Soils Impacted by a Release, of Title 19, Chapter 15, Part 29 (19.15.29) of the New Mexico Administrative Code (NMAC). Results from the characterization are summarized below and detailed in the NMOCD permitting portal Form C-141 Site Characterization section. Potential Site receptors are identified on Figure 1.

via air rotary drilling rig, and no groundwater was encountered. Additionally, New Mexico Office of the State Engineer (NMOSE) well RA-12721 POD 5, was located approximately 0.7 miles southwest of the Site. The well was drilled during April 2020 and has a reported depth to groundwater of 124 feet bgs. The referenced well records are included in Appendix A. All wells used for depth to groundwater determination are presented on Figure 1.

The closest continuously flowing or significant watercourse is greater than 300 feet from the Site. The Site is greater than 200 feet from a lakebed, sinkhole, or playa lake and greater than 300 feet from an occupied residence, school, hospital, institution, church, or wetland. The Site is greater than 1,000 feet to a freshwater well or spring and is not within a 100-year floodplain or overlying a subsurface mine. The Site is not underlain by unstable geology (low potential karst designation area). Site receptors are identified on Figure 1.

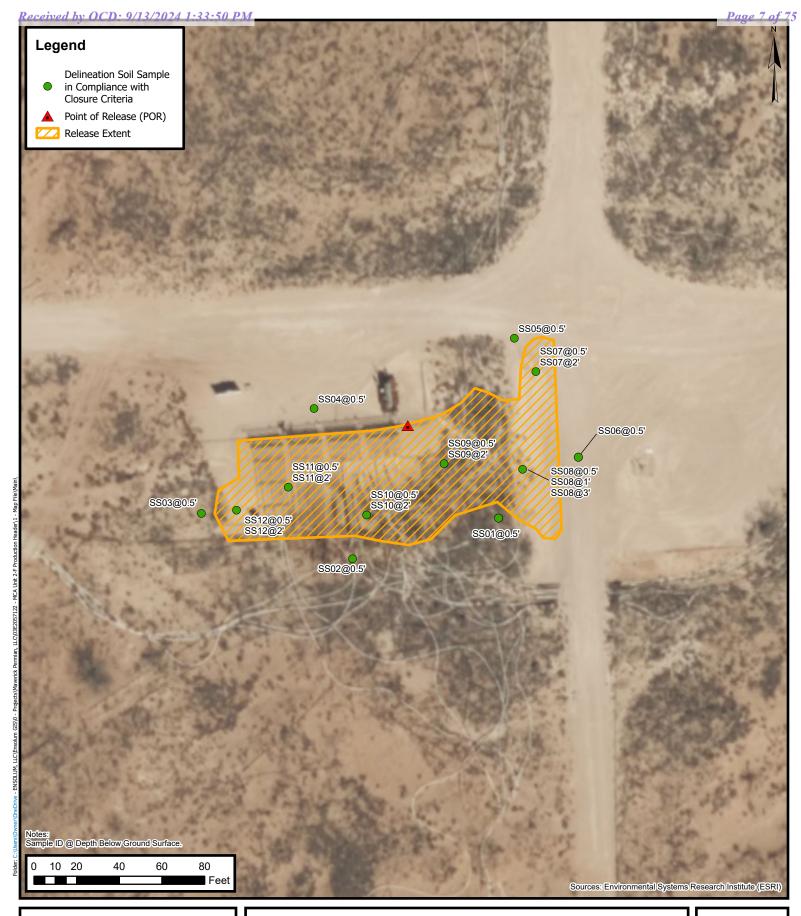
Assessment Soil Sample Locations

During June 2024, Maverick contracted Ensolum to complete assessment activities at the Site to evaluate the historical release area based on information provided on the Form C-141 and visual observations. Assessment soil samples SS01 through SS06 were collected around the documented historical release area from a depth of 0.5 feet bgs to confirm the lateral extent of the surface release. Assessment soil samples were collected within the release extent at sample points SS07 through SS12 at depths ranging from 0.5 feet to 3 feet bgs, to assess for the presence or absence of impacted soil. The soil samples were field screened for volatile aromatic hydrocarbons (VOCs) utilizing a calibrated photoionization detector (PID) and chloride Hach® chloride QuanTab® test strips. The release extent and assessment soil sample locations were mapped utilizing a handheld Global Positioning System (GPS) unit and are depicted on Figure 2. Photographic documentation was completed during the Site visit and a photographic log is included in Appendix B.

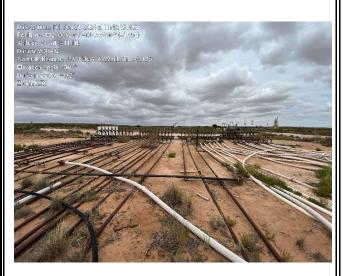
Photograph 1 Date: June 21, 2024

Description: Historical release area

View: Northeast

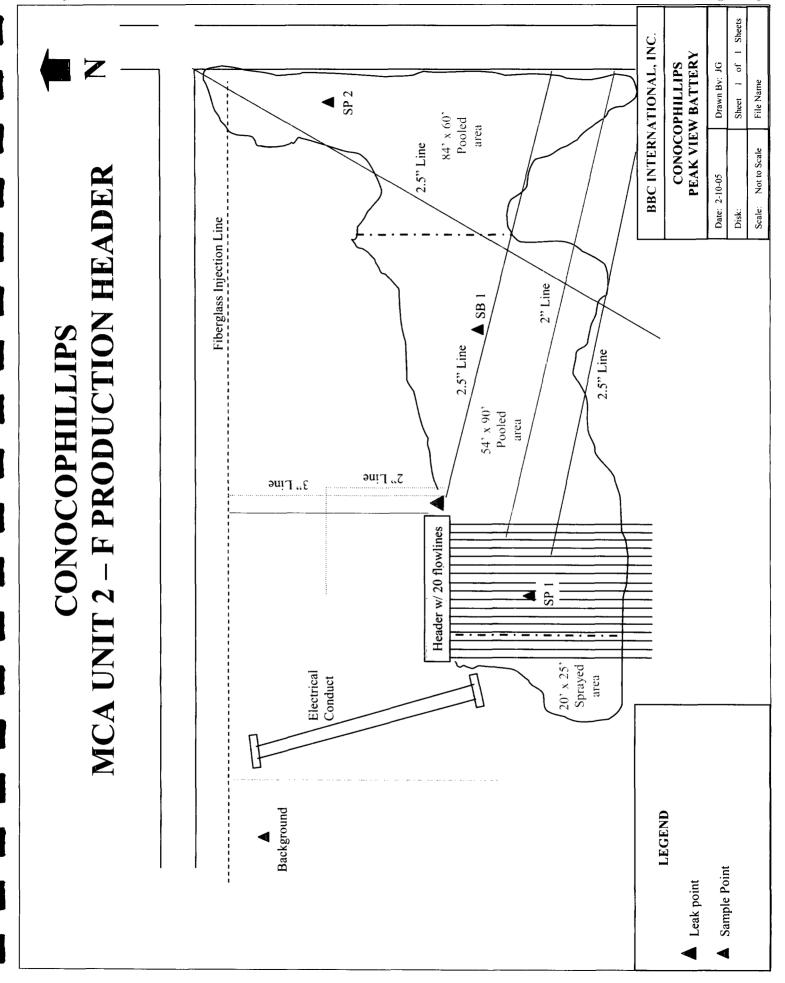
The leak area measures approximately 54 feet by 90 feet at the center, 84 feet by 60 feet on the west side, with a smaller sprayed area on the east side that measures approximately 20 feet by 25 feet. A sketch of the leak area including the sample points can be reviewed in Appendix II of this report. Site photographs can be viewed in Appendix III of this report. The surface soil is red sand and caliche. There is no water source within 1,000 feet of the site. There is no surface water within 1,000 feet of the site. Based on data from the ground water monitoring well located at the Maljamar Plant, depth to ground water is approximately 90 feet.

On August 31, 2005, BBC personnel conducted an investigation of the site. A soil boring was drilled near the center of the leak area using BBC's tractor mount drilling rig, to a total depth of 10 feet. Four samples were taken from the soil boring; one each at one foot, three feet, five feet, and ten feet. The samples were taken to Cardinal Laboratories for analysis. Laboratory analysis for SB1 @ 1' is: GRO – non-detect, DRO – 937 ppm, Chlorides 768 ppm, Benzene – non-detect, Toluene – non-detect, Ethyl Benzene – non-detect, Total Xylenes – non-detect. Laboratory analysis for SB1 @ 3' is: Chlorides 736 ppm. Laboratory analysis for SB1 @ 10' is: GRO – non-detect, DRO – 82.9 ppm, Chlorides 192 ppm, Benzene – non-detect, Toluene – non-detect, Ethyl Benzene – non-detect, Total Xylenes – non-detect. Laboratory analytical results for this sampling event can be reviewed in Appendix I of this report. The location of the soil boring and other sample points can be viewed on the site diagram in Appendix II of this report.
