Pima Environmental Services, LLC
5614 N. Lovington Hwy.
Hobbs, NM 88240
575-964-7740

August 25, 2024

Re: Site Assessment, Remediation, and Closure Report
Folk Federal 14 Flow Line
API No. 30-015-38171
GPS: Latitude 32.836534 Longitude -104.090665
UL "H", Sec. 17, T17S, R29E
Eddy County, NM
NMOCD Ref. No. NAPP2410636699

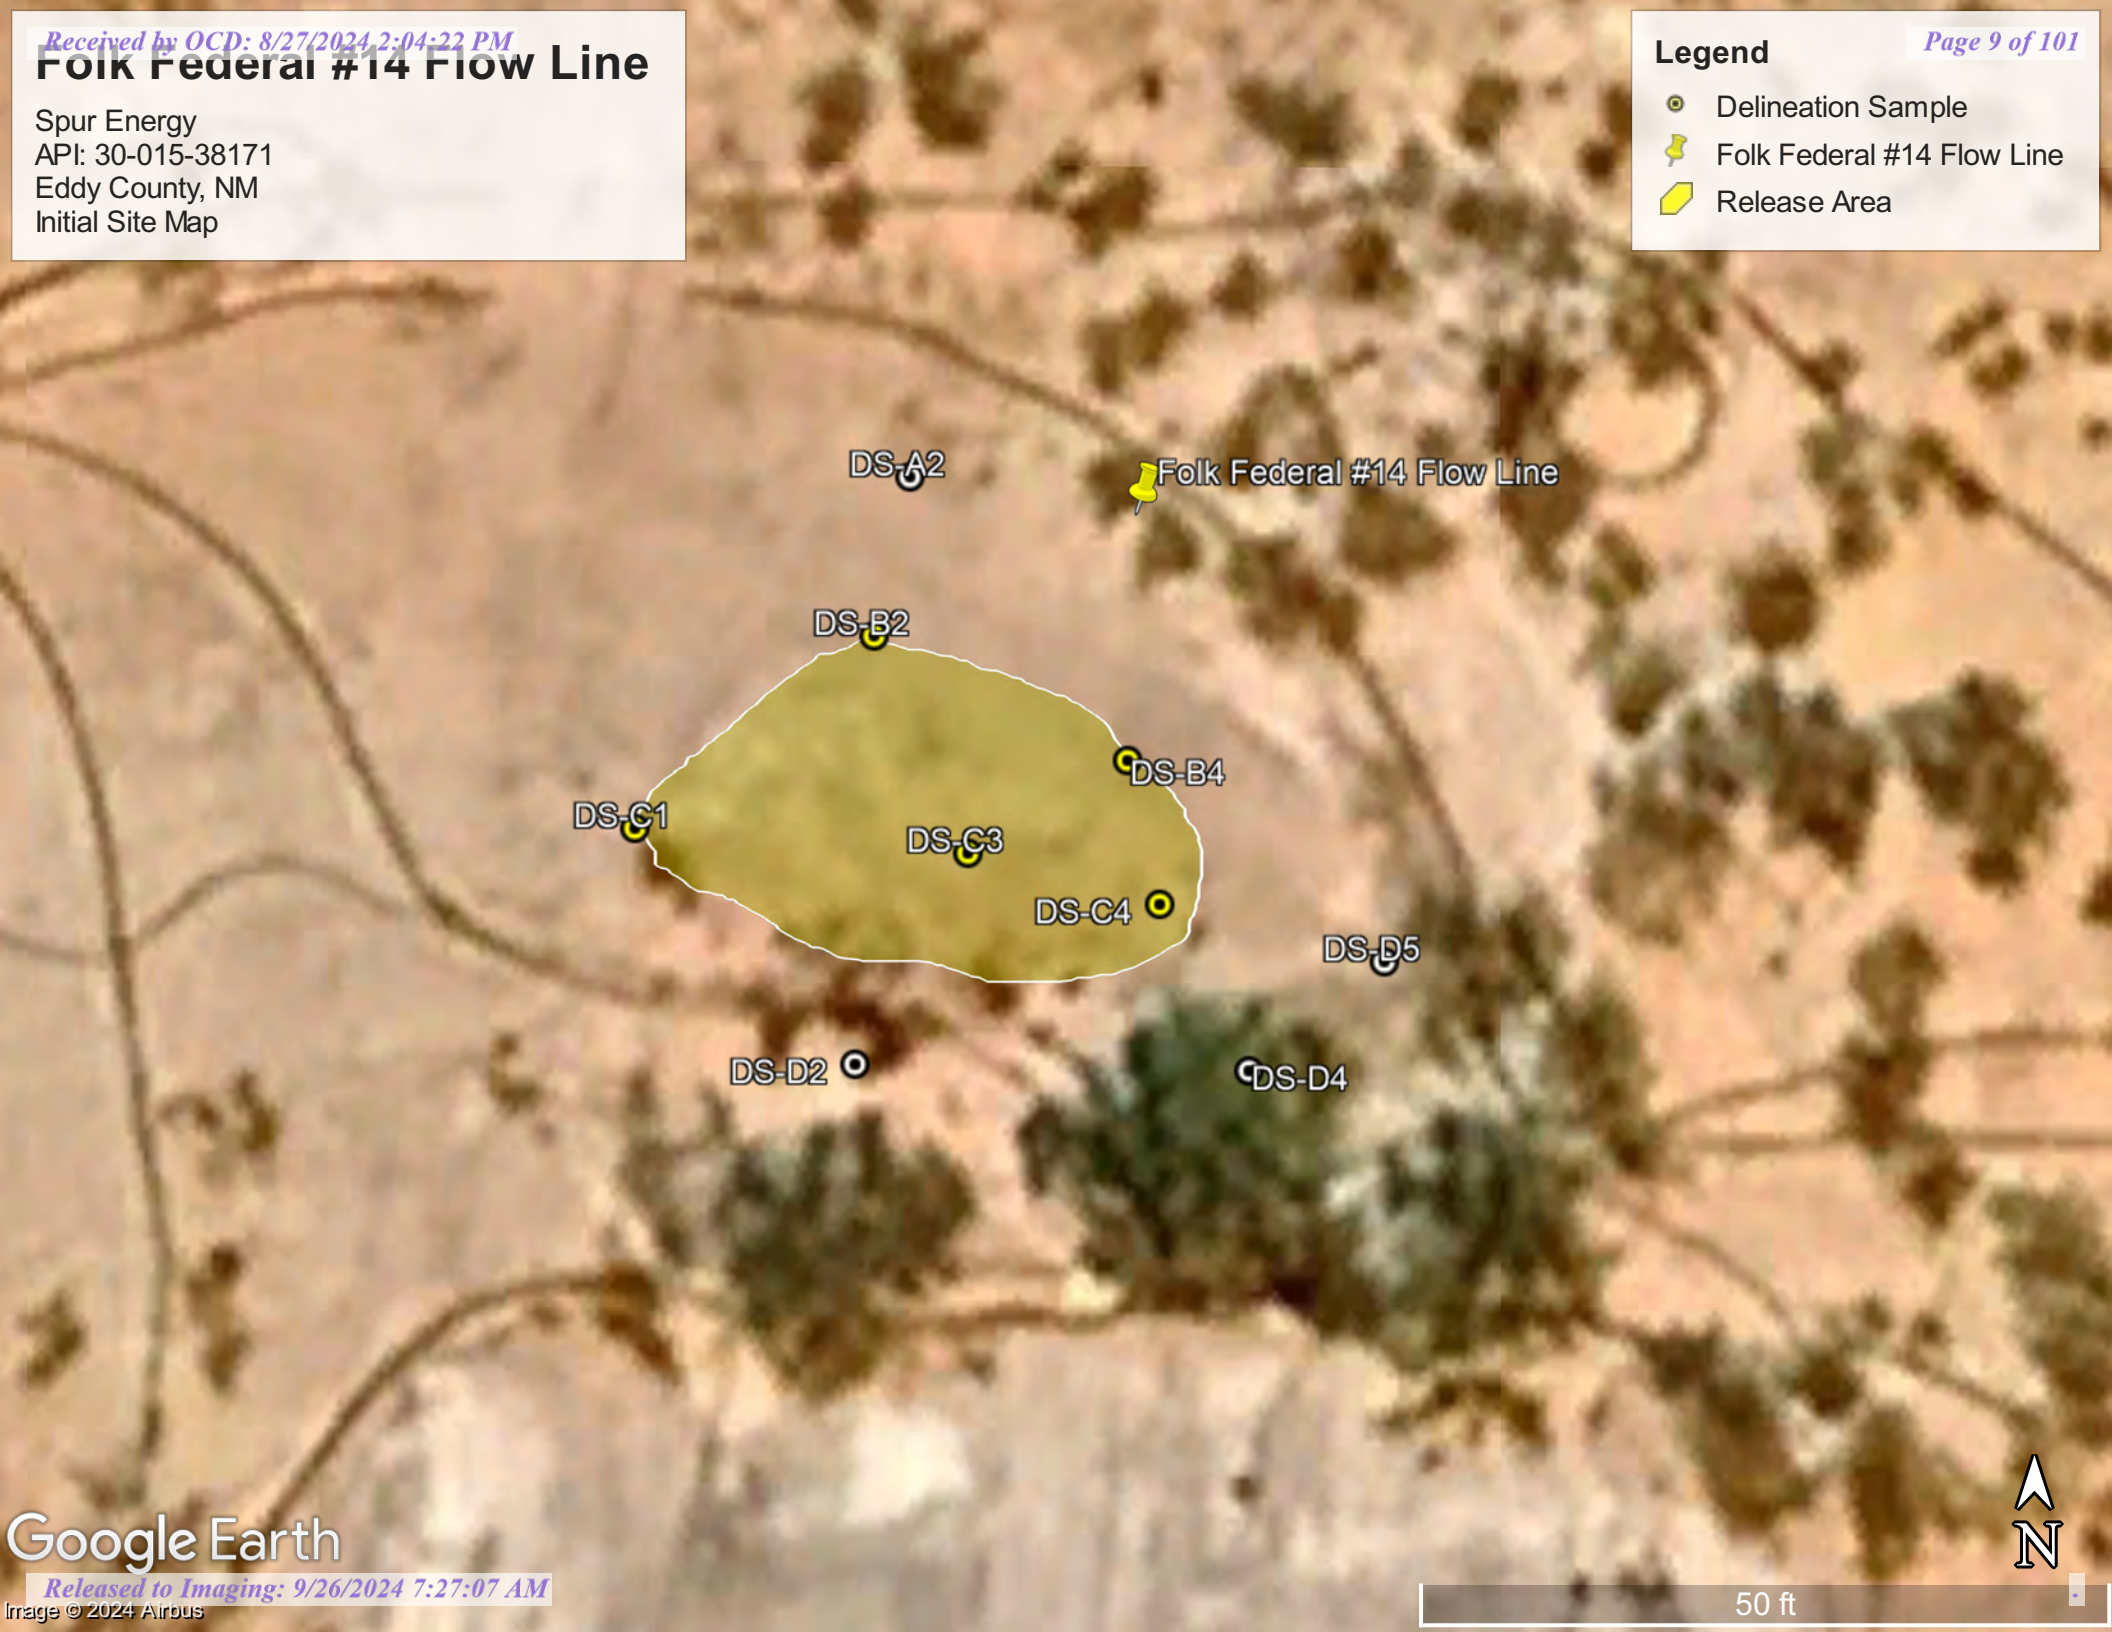
Spur Energy
API: 30-015-38171
Eddy County, NM
Confirmation Site Map

Release Area

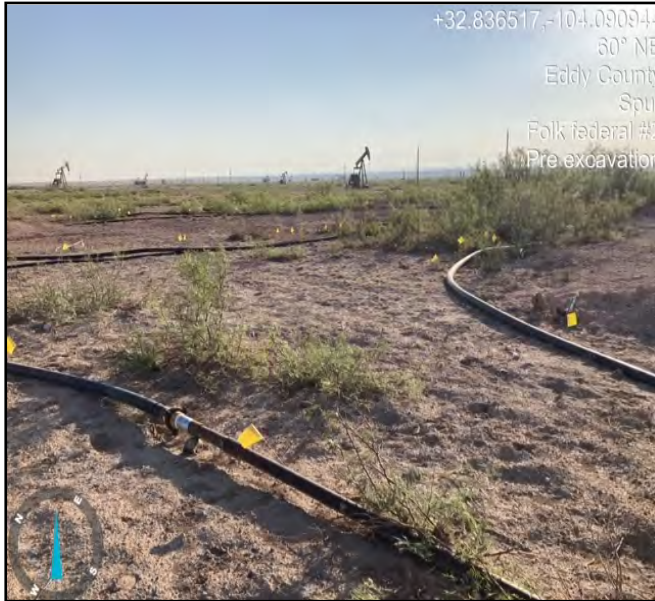
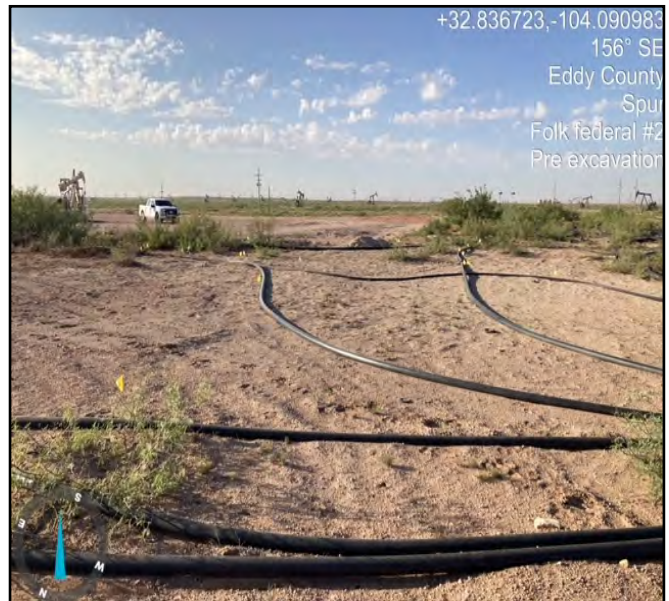
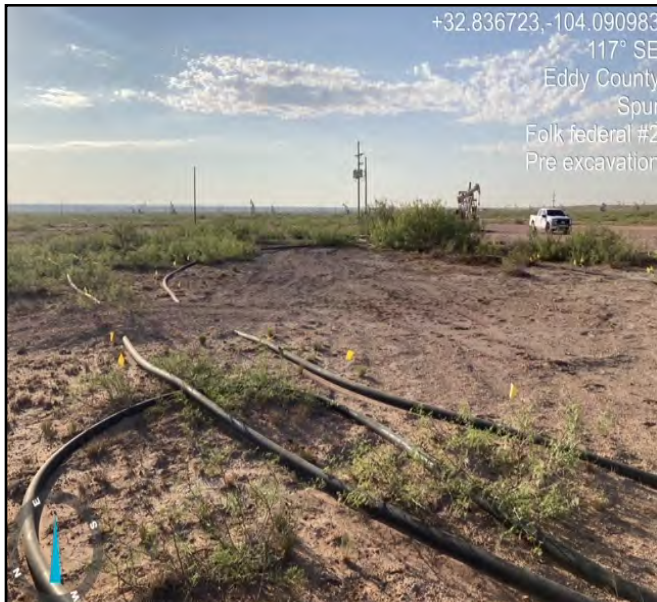
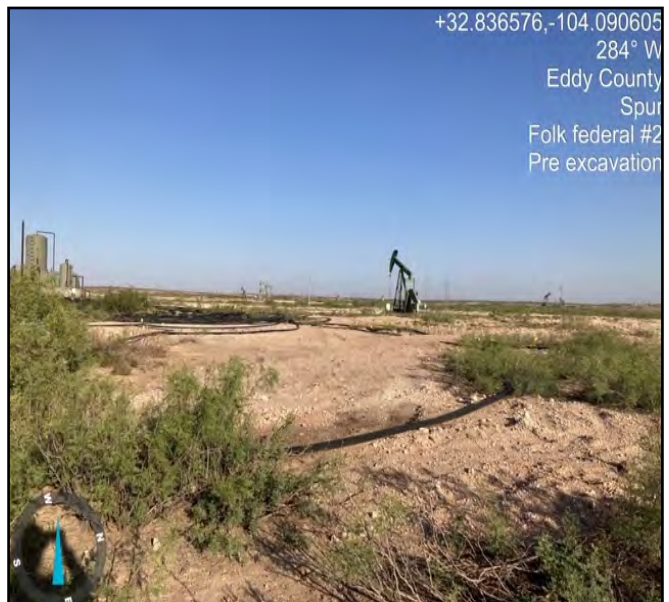
PHOTO LOG TYPE: Pre-Excavation

Photograph showing the release area prior to the commencement of excavation facing Northeast

Photograph showing the release area prior to the commencement of excavation facing Southeast

Photograph showing the release area prior to the commencement of excavation facing West

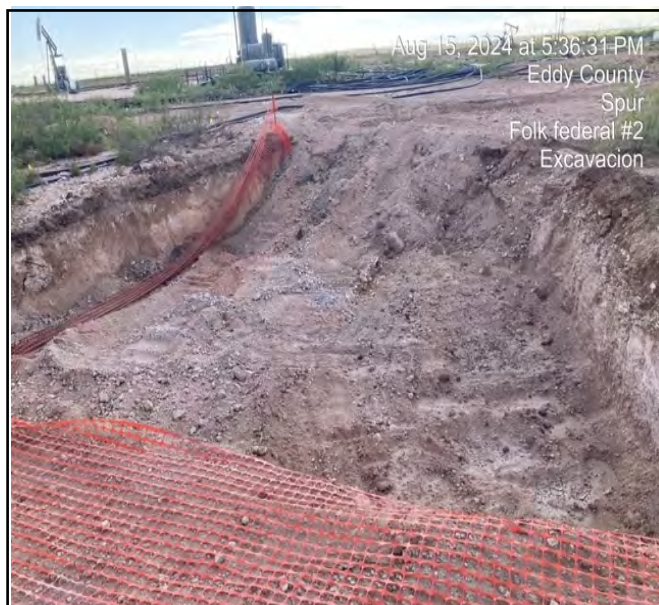
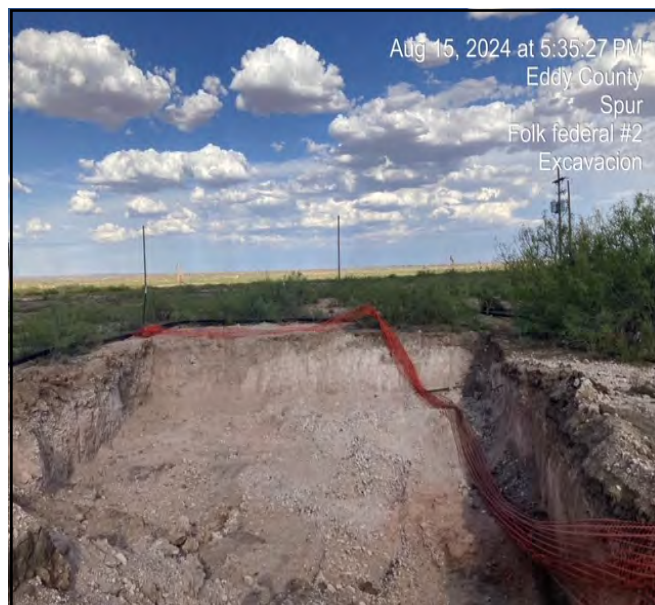
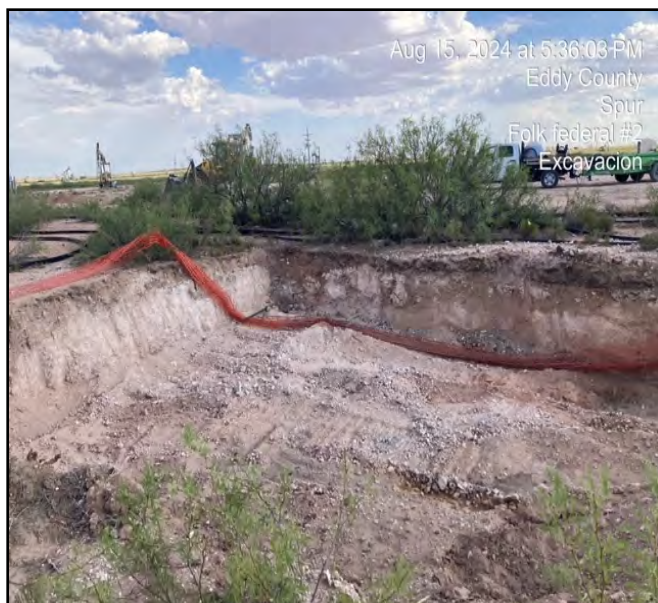
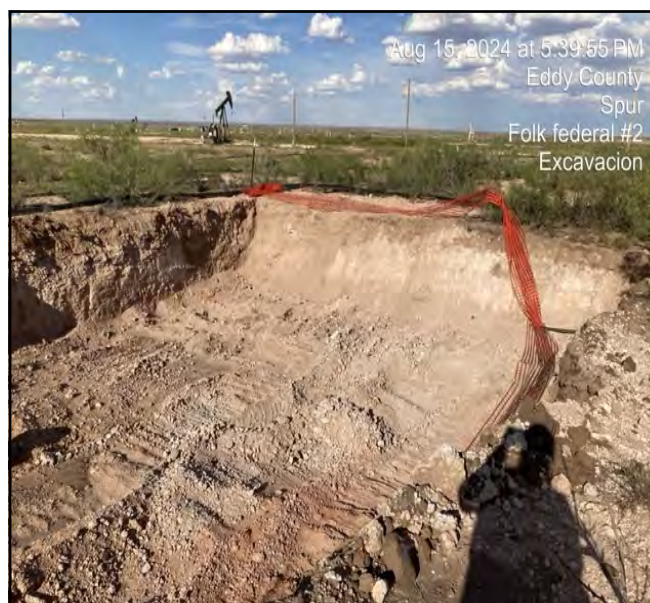
Photograph showing the progress of the excavation.

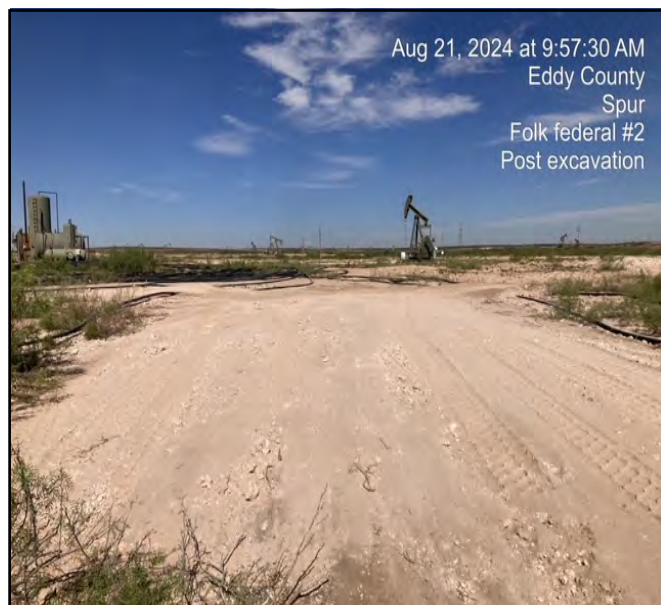
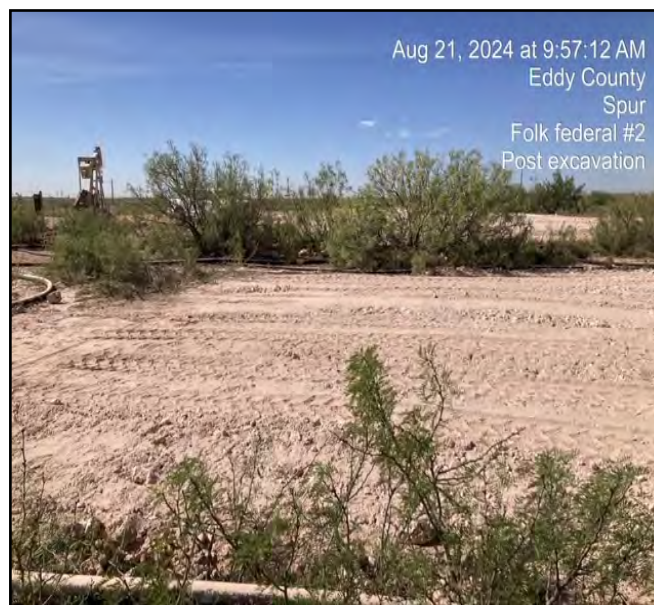
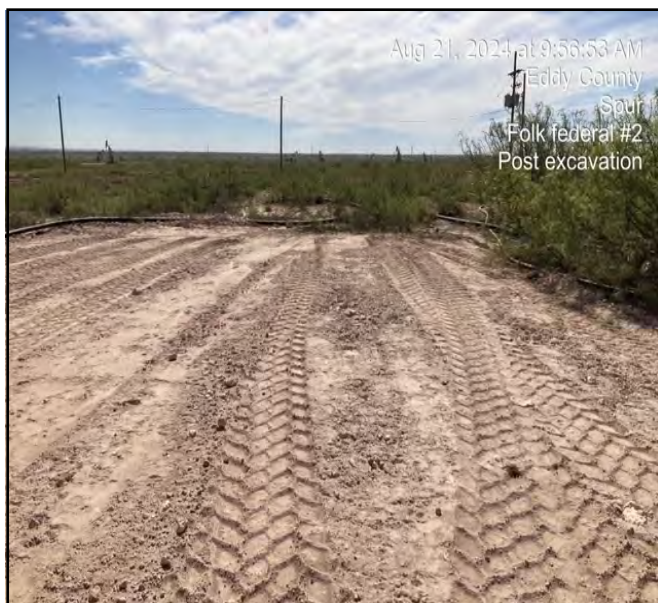
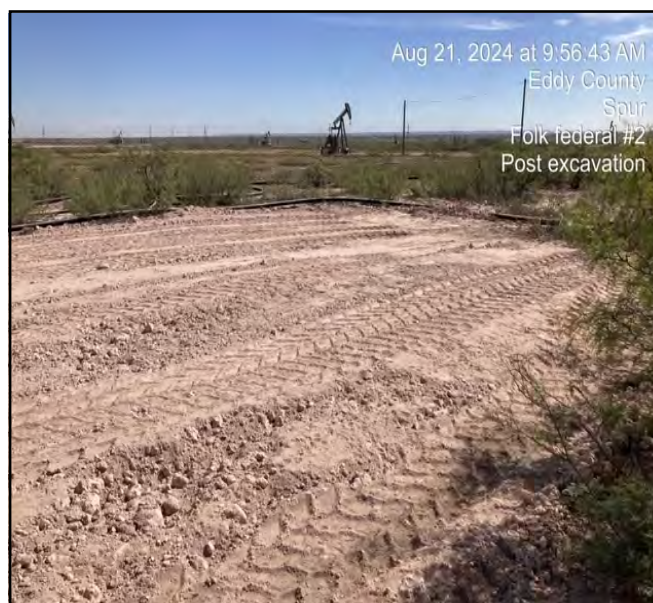
Photograph shows the excavation is complete and backfilled with clean material.

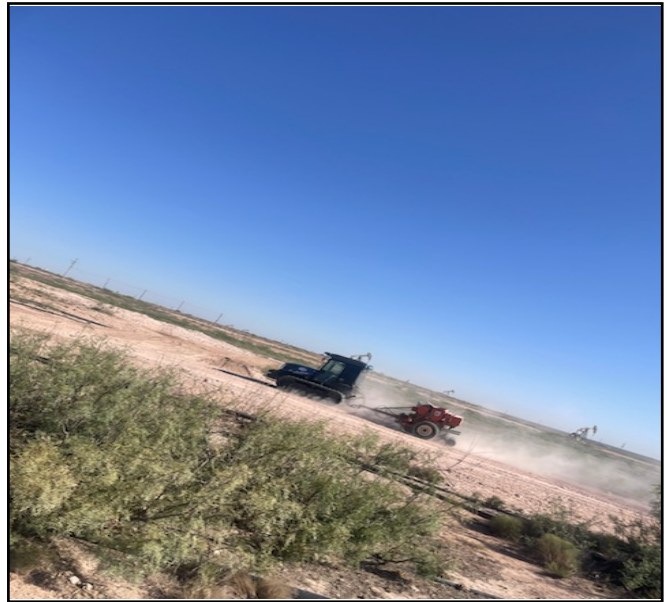
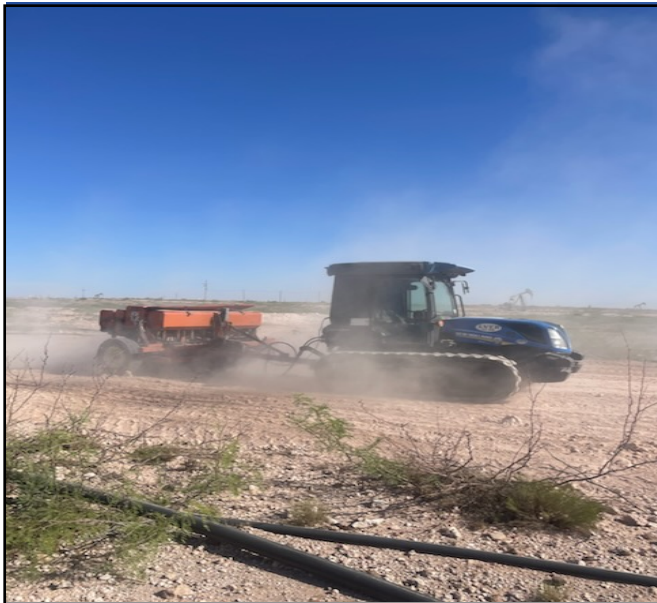
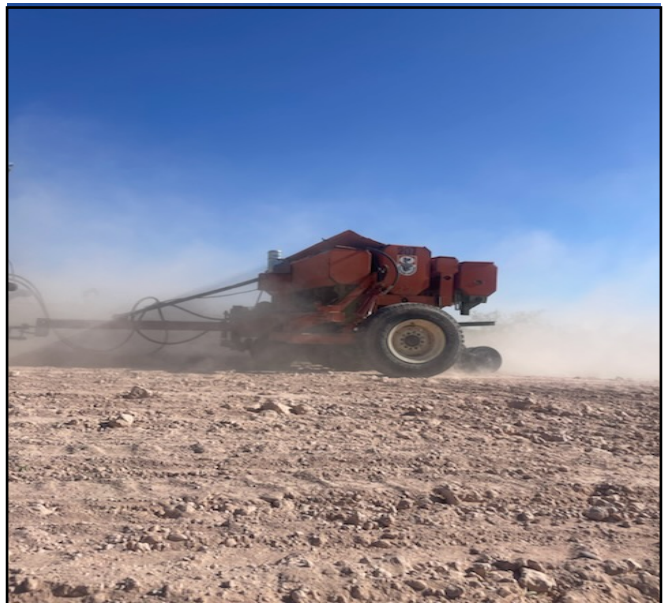
Seeding in progress.

On August 22, 2024, MMX returned to the Folk site to initiate seeding activities. A BLM-approved LPC blend was applied over the previously excavated area. Due to the anticipated lack of moisture in the later months of the year, it was determined that seeding at this time would provide the best opportunity for sustainable growth in the area affected by the Folk release. A picture of the seeding blend is included in Appendix D.
