Closure Report
Myox 6D State Com CTB (12.24.23)
Incident ID: NAPP2402529595
Unit D Sec 06 T26S R28E
Eddy County, New Mexico
32.0781°, -104.1320°

Produced Water Release
Point of Release: Equipment Failure
Release Date: 12.24.2023
Volume Released: 7.8258 Barrels of Produced Water
Volume Recovered: 7.8 Barrels of Produced Water

Re: Closure Report
Myox 6D State Com CTB (12.24.23)
Concho Operating, LLC
Incident ID: NAPP2402529595
Site Location: Unit D, S6, T26S, R28E
(Lat 32.0781°, Long -104.1320°)
Eddy County, New Mexico

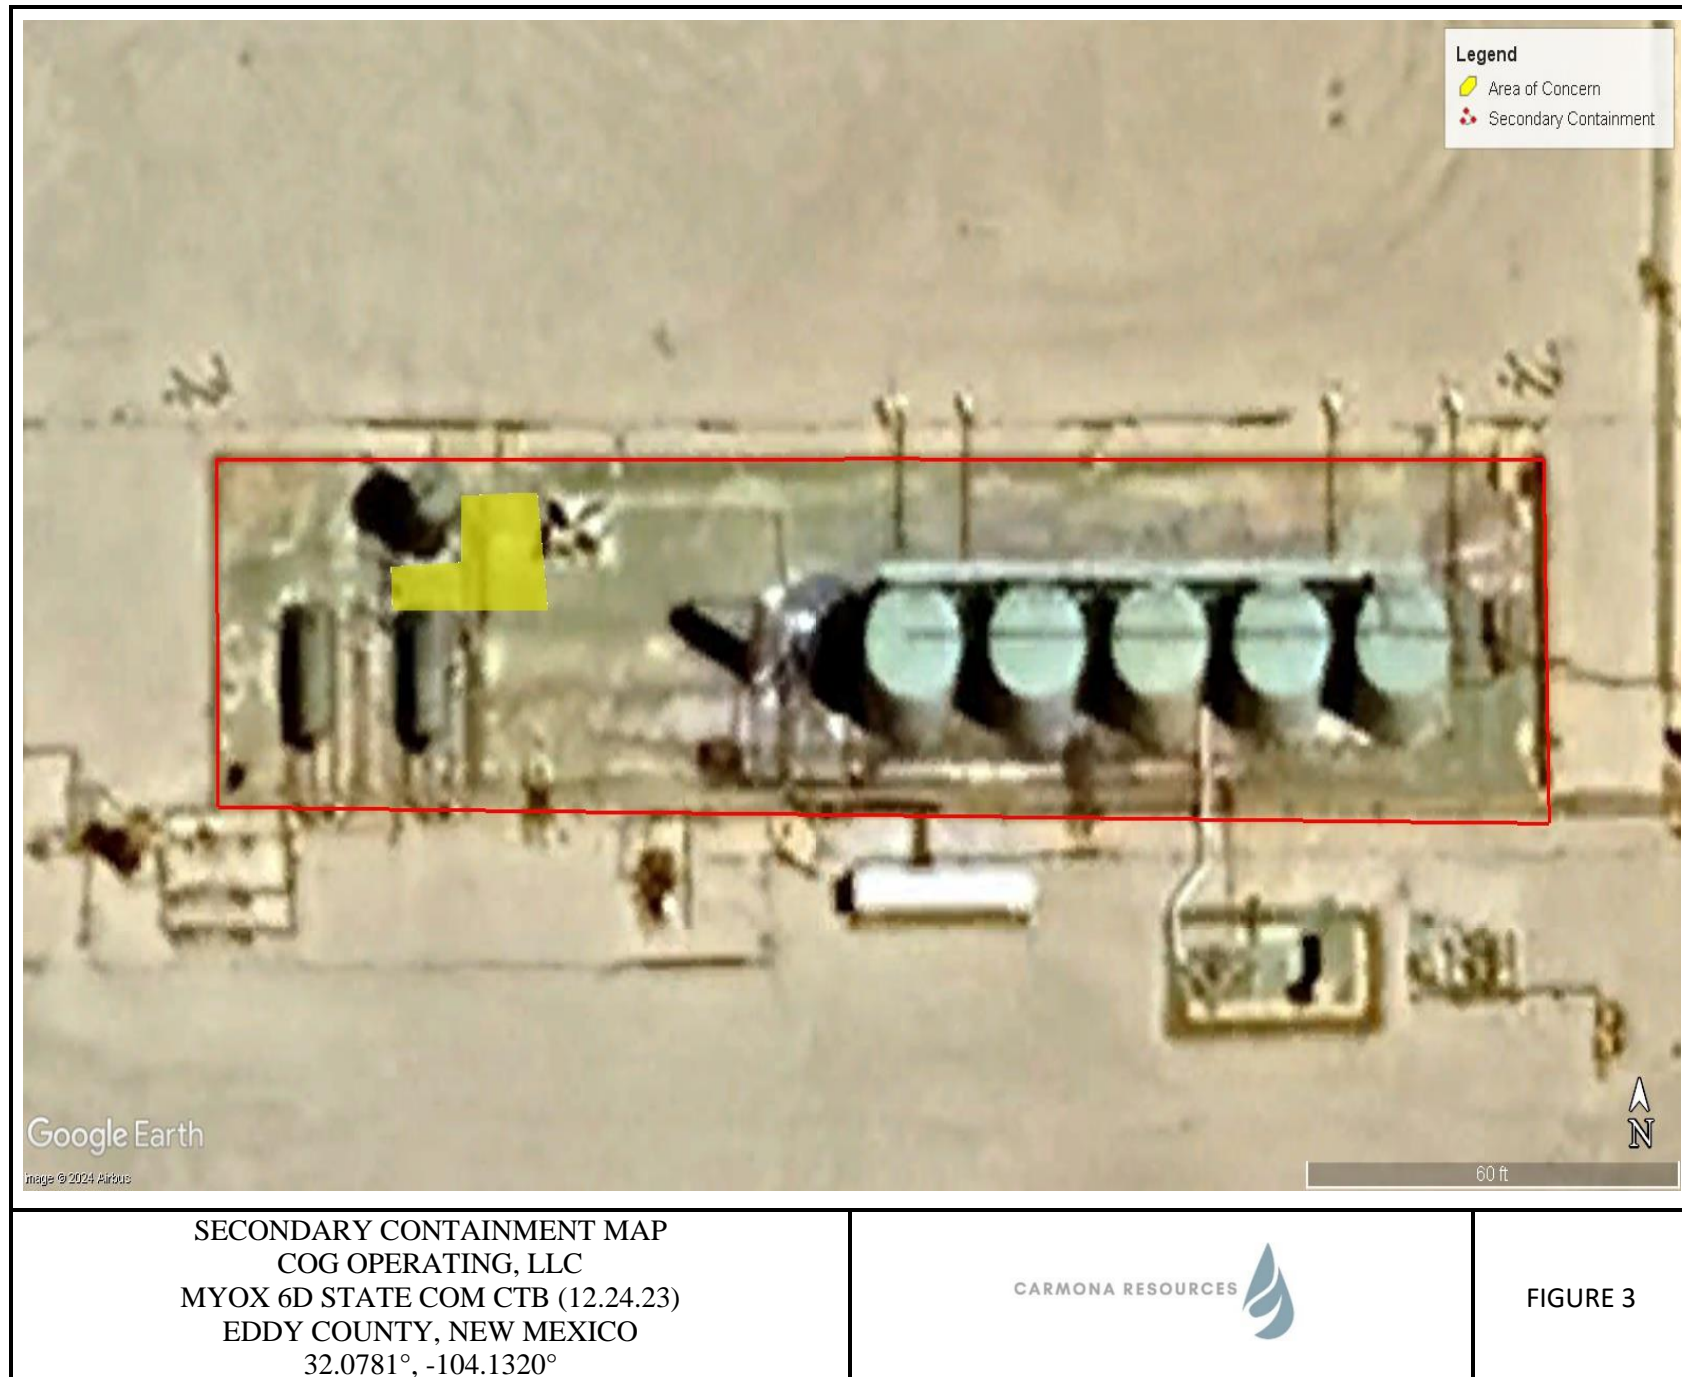
FIGURE 3 SECONDARY CONTAINMENT MAP

Based on the initial C-141 obtained from the New Mexico Oil Conservation Division (NMOCD), the release was discovered on December 24, 2023, caused by a leak on the hammer union due to corrosion. It resulted in the release of approximately seven point eight two five eight (7.8258) barrels of produced water, and seven point eight (7.8) barrels of produced water were recovered inside the lined facility. See Figure 3. The initial C-141 form is attached in Appendix B.
