RE: Actions Completed to Address Closure Report Denial, Miss Sue 12-23S-27E RF #202H (Miss Sue) Release, Eddy County, New Mexico

On behalf of San Mateo Midstream, Souder, Miller & Associates (SMA) has prepared this Letter Report describing actions taken to address the rejection of the Spill Closure Report prepared by Vertex Resource Service Inc. (Vertex) and dated February 14, 2023. This Letter Report details the additional horizontal delineation and collection of background samples completed at the Miss Sue 12-23S-27E RB #202H Site (incident # nAPP2234143030) to obtain final closure.

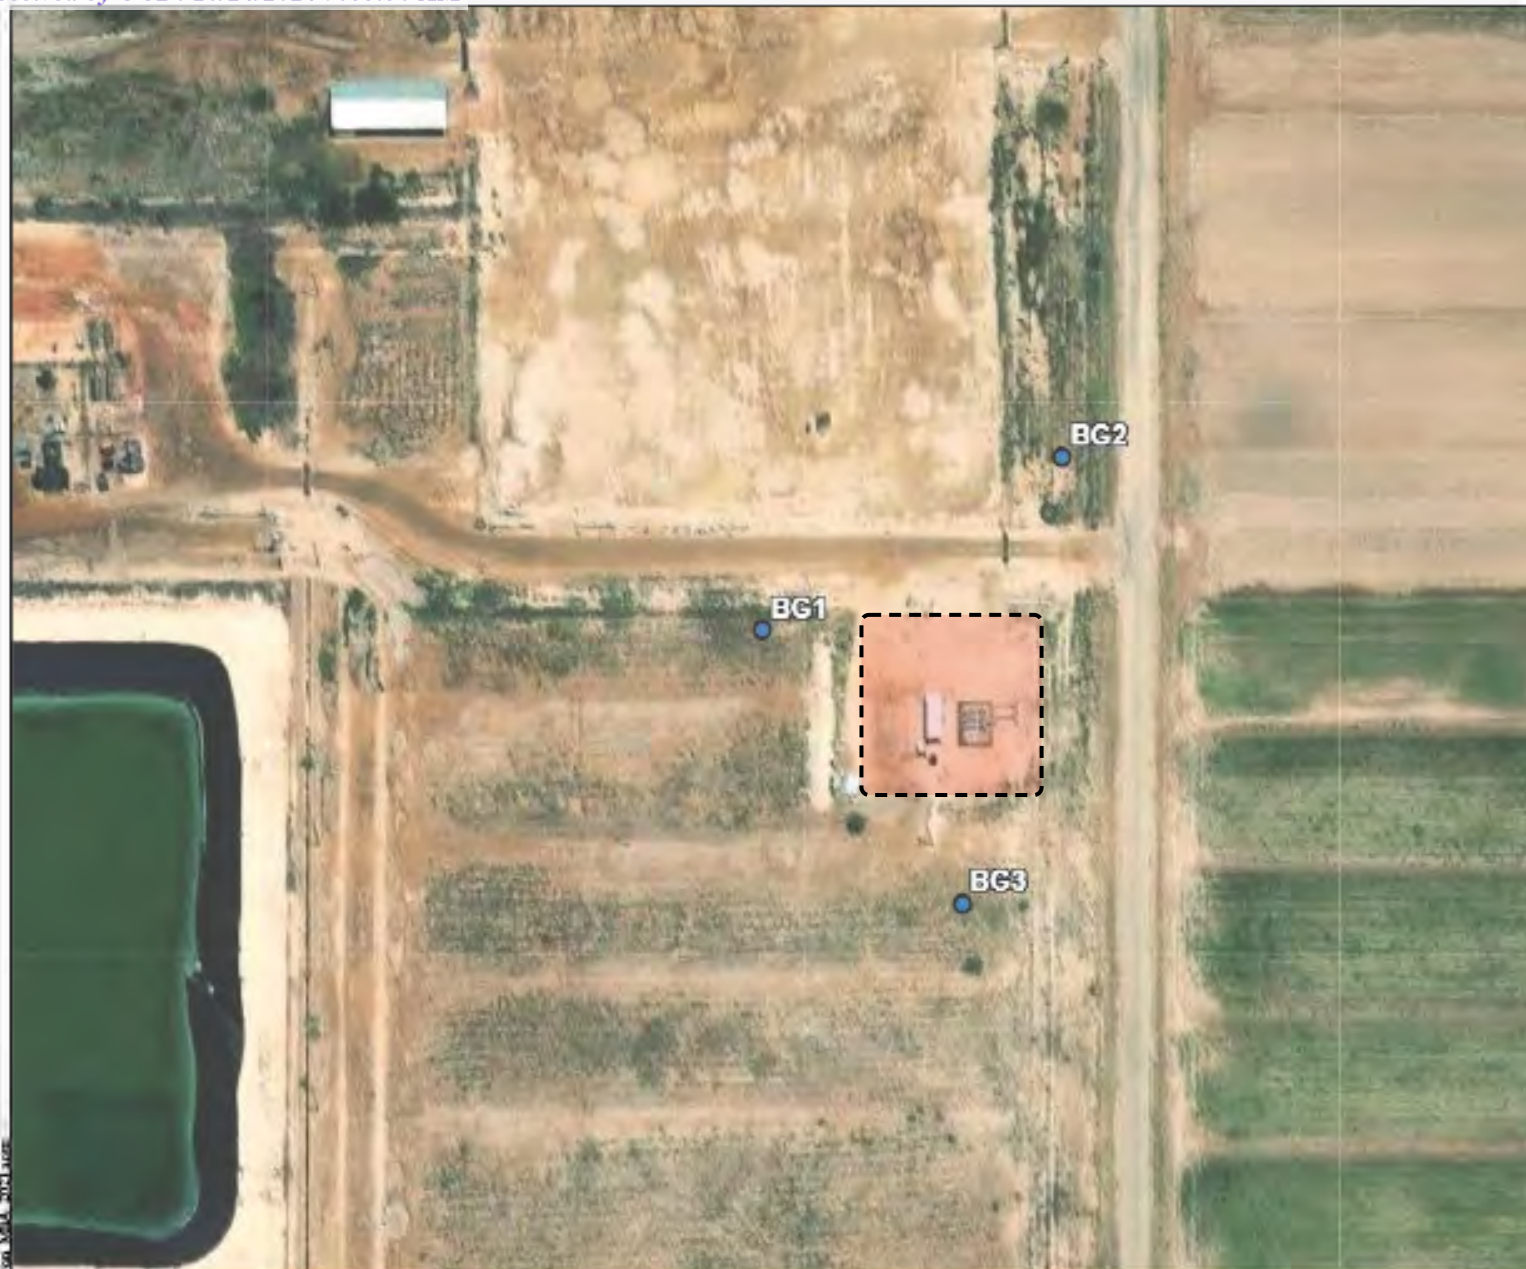
FIGURES

Legend Sample Locations

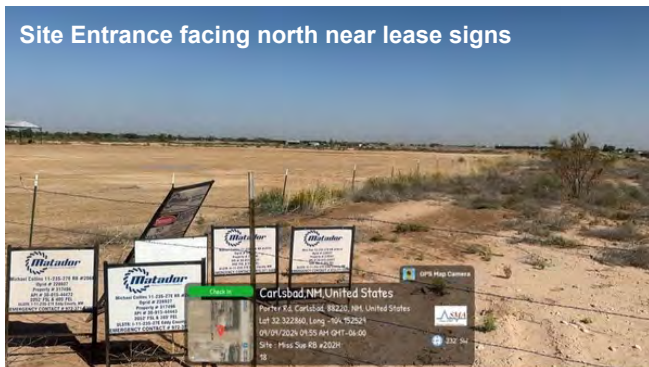
Site Entrance facing north near lease signs

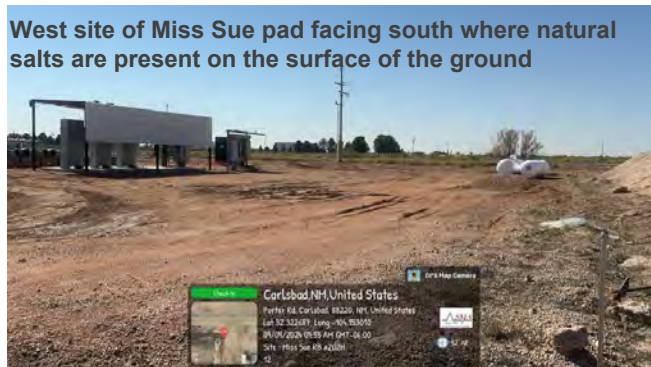
West site of Miss Sue pad facing south where natural salts are present on the surface of the ground

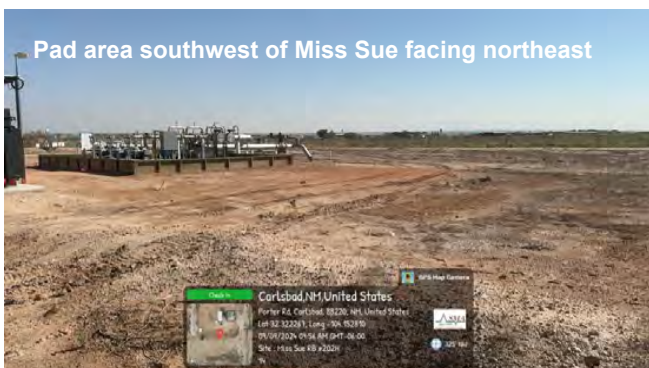
Pad area southwest of Miss Sue facing northeast

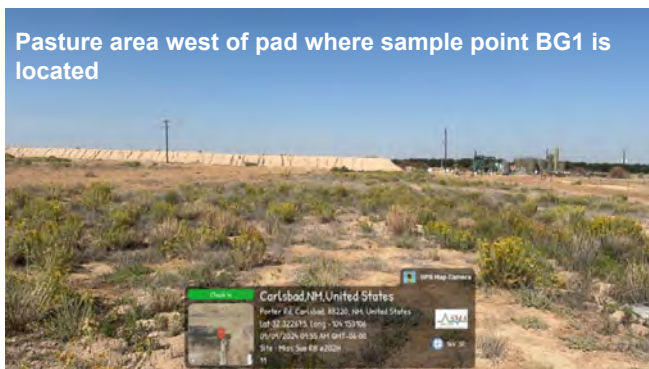
Pasture area west of pad where sample point BG1 is located

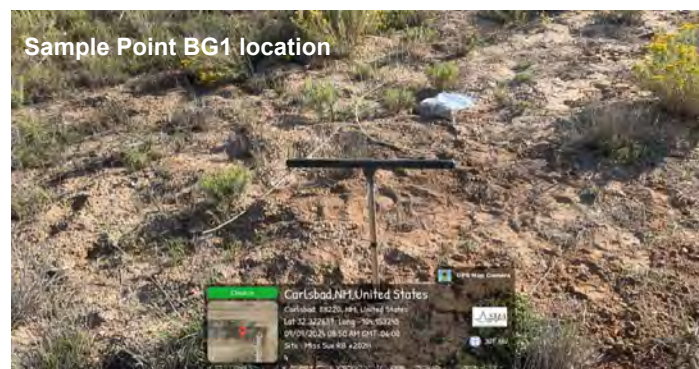
Sample Point BG1 location

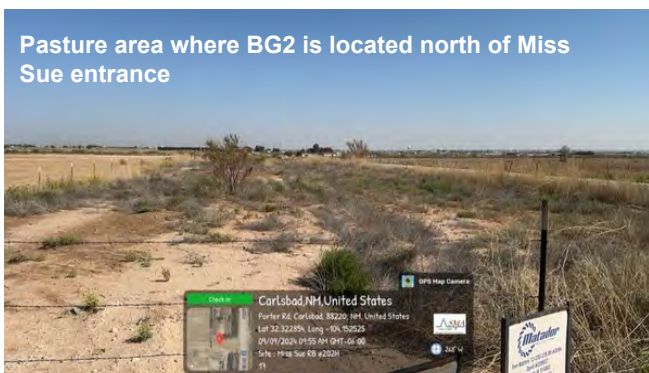
Pasture area where BG2 is located north of Miss Sue entrance

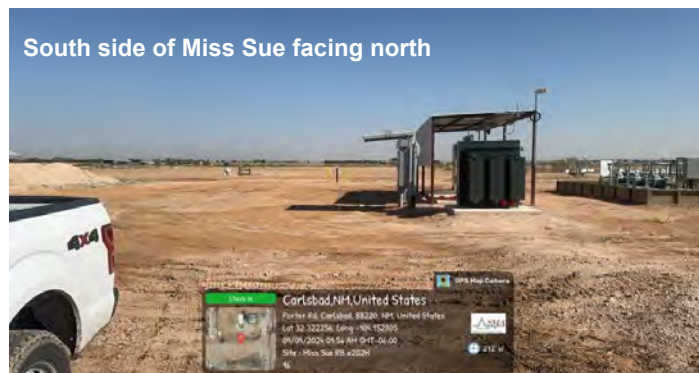
South side of Miss Sue facing north

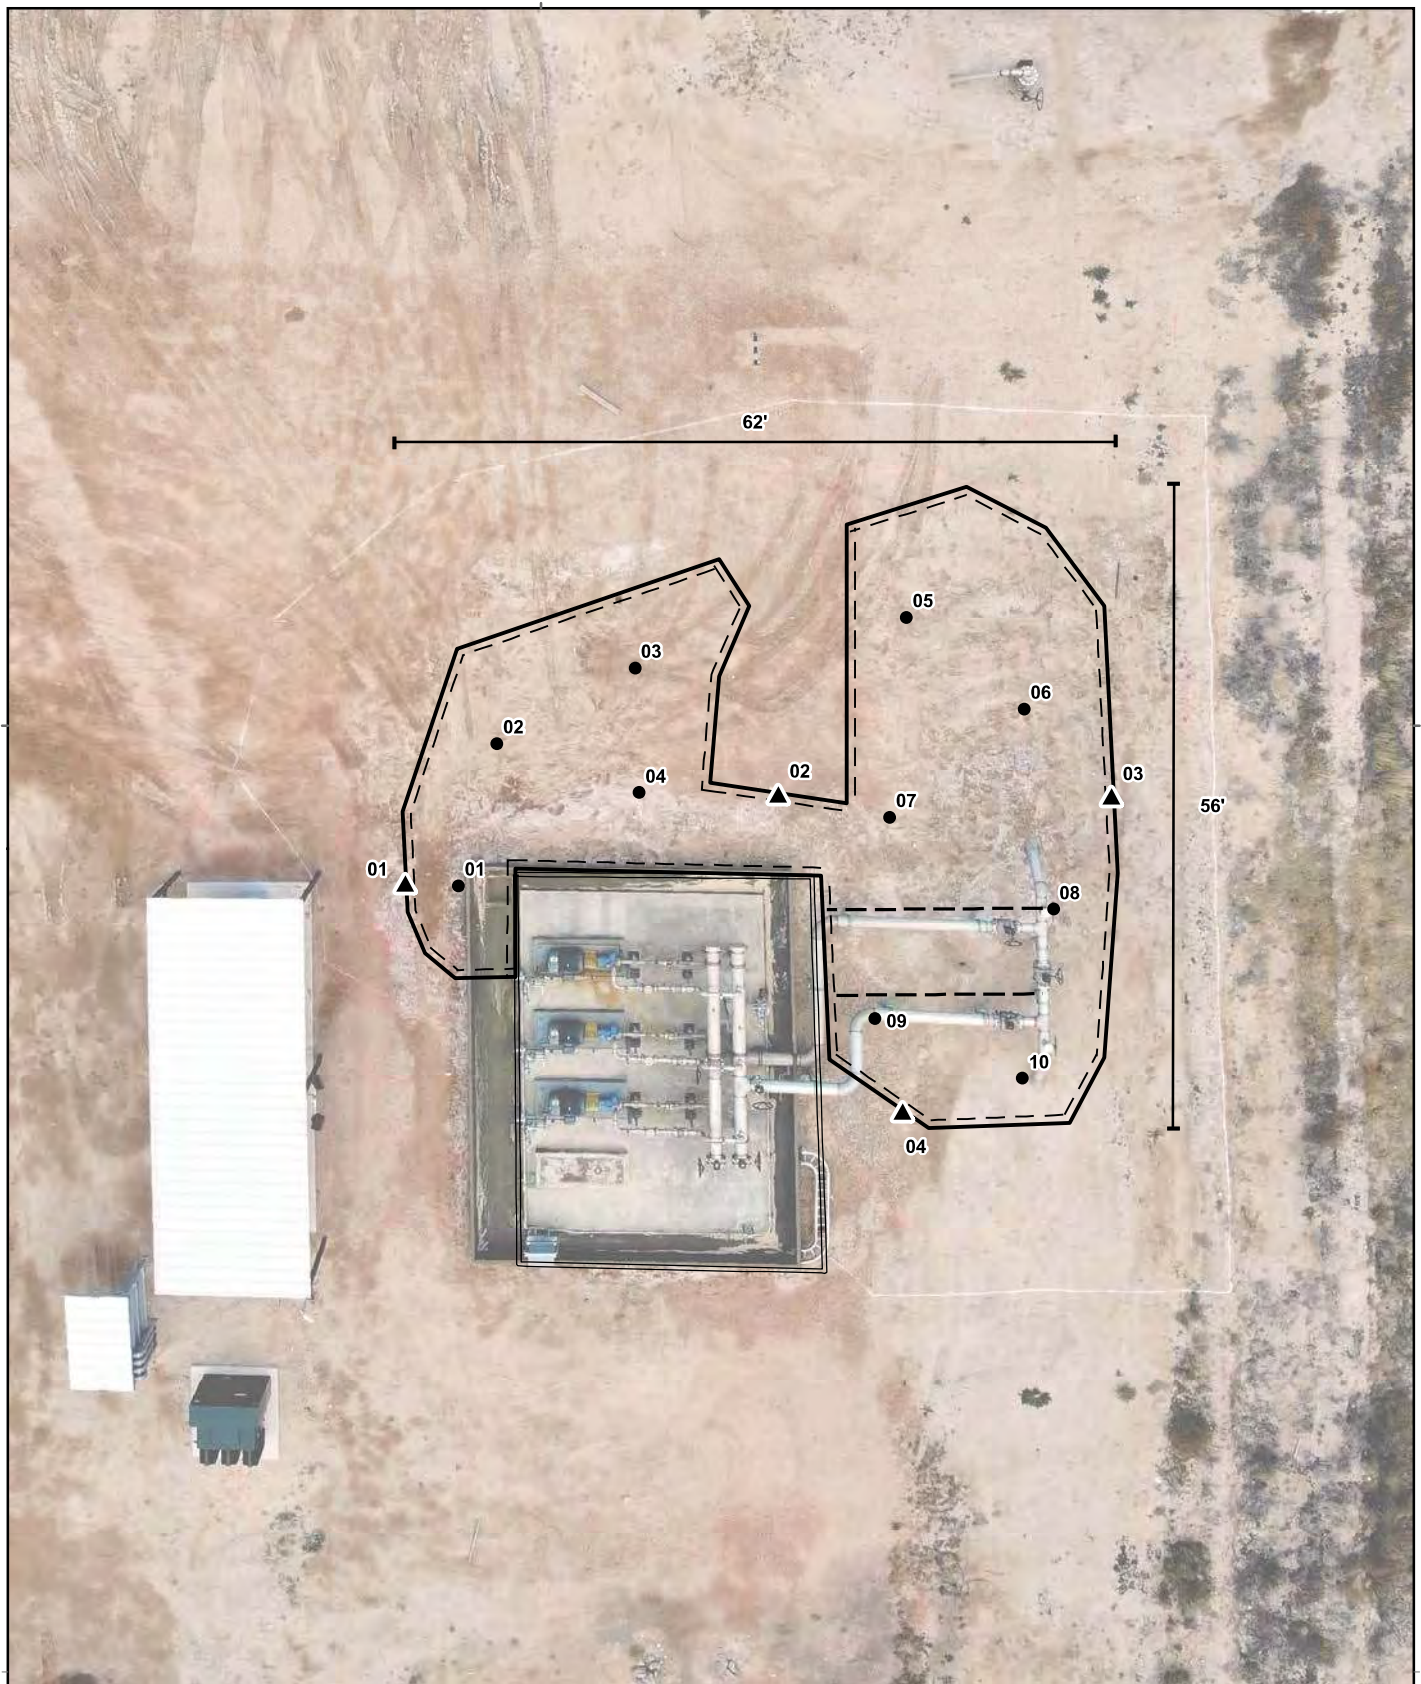
Document Path: G:\1-Projects\US PROJECTS\Matador Resources\22E-04178\Figure 2 Excavation Schematic (Miss Sue).mxd

- Base Sample (Prefixed by "BS23-")
- ▲ Wall Sample (Prefixed by "WS23-")
- Pipeline (Aboveground)
- Excavation to 0.25' (~1,950 sq. ft.)
- Containment

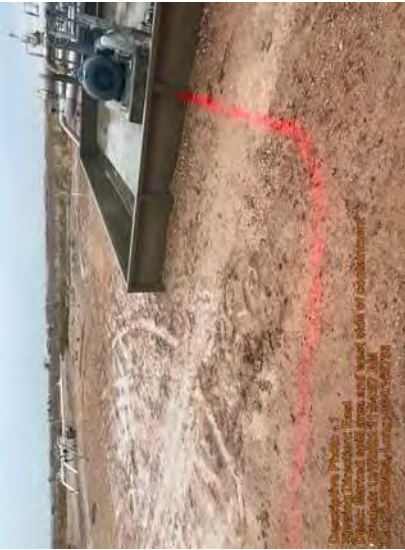
<p>Observed on 10/24/22 Location: The marked spill area Spill: Unknown spill area, west side of containment Photograph taken at 12:57 PM Camera: iPhone 12 Pro Max (120MP)</p></div> <div>Marked spill area and west side of containment</div>	<div>Viewing Direction: South</div> <div>

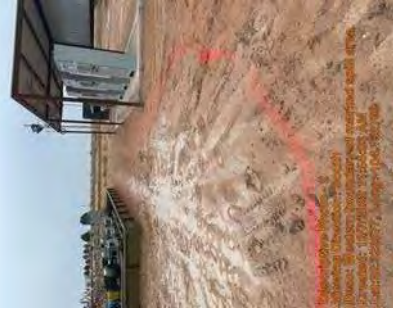
<p>Observed on 10/24/22 Location: The marked spill area Spill: Unknown spill area, west side of containment Photograph taken at 12:57 PM Camera: iPhone 12 Pro Max (120MP)</p></div> <div>Western boundary of marked spill area</div>
<div>Viewing Direction: East</div> <div>

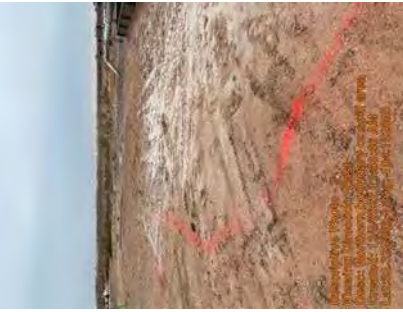
<p>Observed on 10/24/22 Location: The marked spill area Spill: Unknown spill area, west side of containment Photograph taken at 12:57 PM Camera: iPhone 12 Pro Max (120MP)</p></div> <div>Northern boundary or spill area</div>	<div>Viewing Direction: East</div> <div>

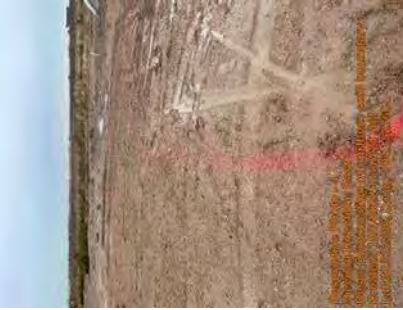
<p>Observed on 10/24/22 Location: The marked spill area Spill: Unknown spill area, west side of containment Photograph taken at 12:57 PM Camera: iPhone 12 Pro Max (120MP)</p></div> <div>Continuation of northern spill boundary</div>

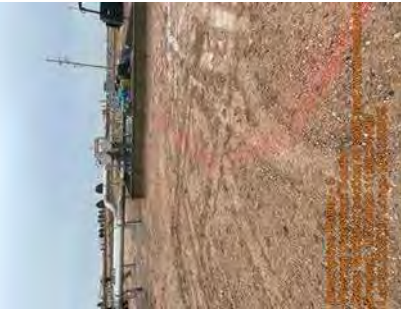
<p>Descriptive Photo - 8 Viewing Direction: South Date: 12/8/2022 11:54:54 AM Location: Spill area, Containment Wall</p>

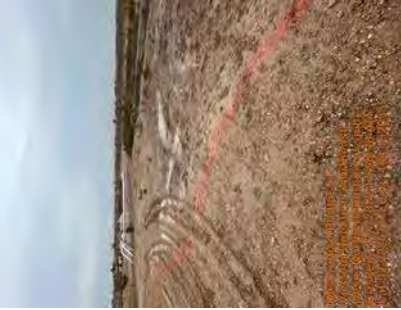
<p>Descriptive Photo - 9 Viewing Direction: Northeast Date: 12/8/2022 11:54:54 AM Location: Spill area, Containment Wall</p>
Northern section of spill and north wall of containment	Northern portion of spill
Viewing Direction: South	Viewing Direction: West

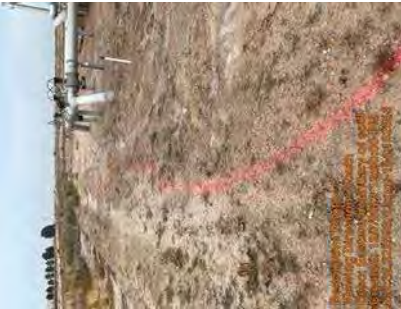
<p>Descriptive Photo - 10 Viewing Direction: South Date: 12/8/2022 11:54:54 AM Location: Spill area, Containment Wall</p>

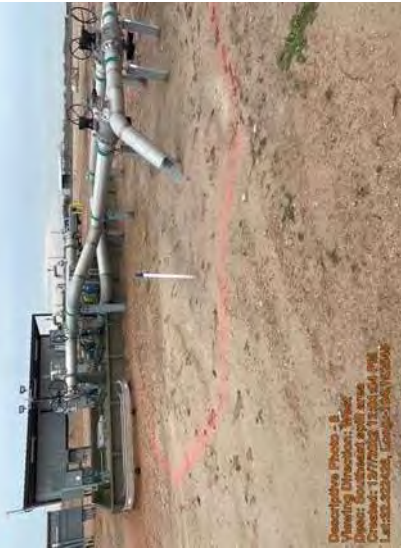
<p>Descriptive Photo - 11 Viewing Direction: West Date: 12/8/2022 11:54:54 AM Location: Spill area, Containment Wall</p>
Eastern boundary of spill	Southeast spill area and eastern containment wall

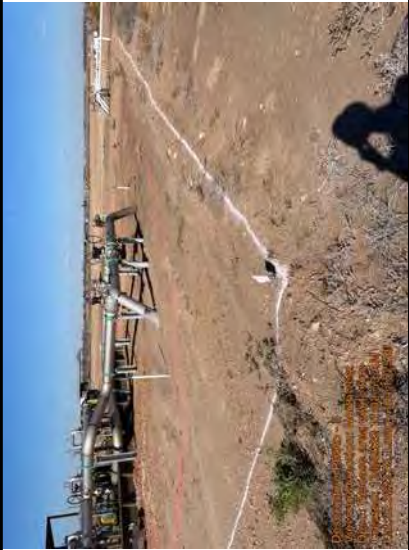
Release area white line	
Viewing Direction: West

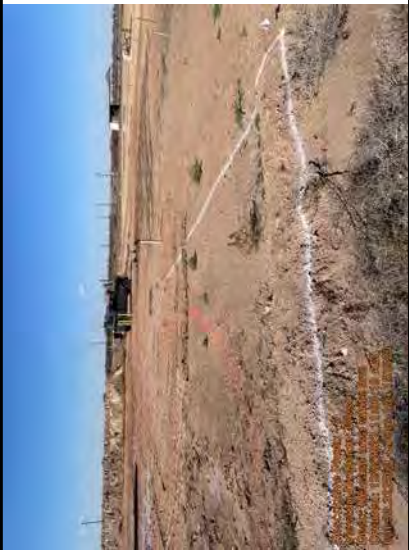
Release area white line

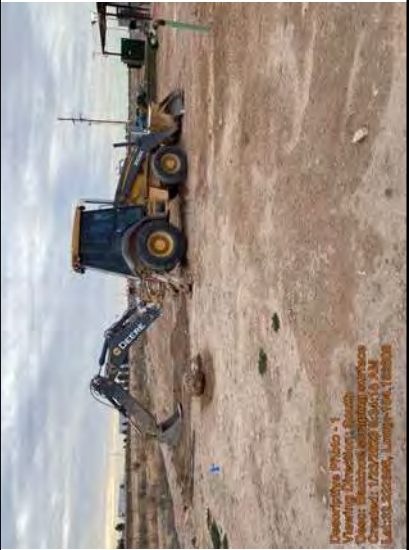
<p>Site Photo - 1 Viewing Direction: South Object: Backhoe scraping surface Created: 1/23/2023 10:29 AM Location: 322371, Long-104, 160734</p></div> <div>Backhoe scraping surface</div>	<div>Viewing Direction: Northeast</div> <div>

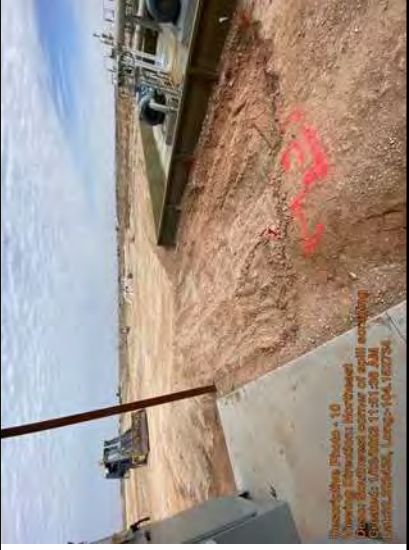
<p>Site Photo - 10 Viewing Direction: Northeast Object: Southwest corner of spill scraping Created: 1/23/2023 11:21 AM Location: 322371, Long-104, 160734</p></div> <div>Southwest corner of spill scraping</div>
<div>Viewing Direction: Southwest</div> <div>

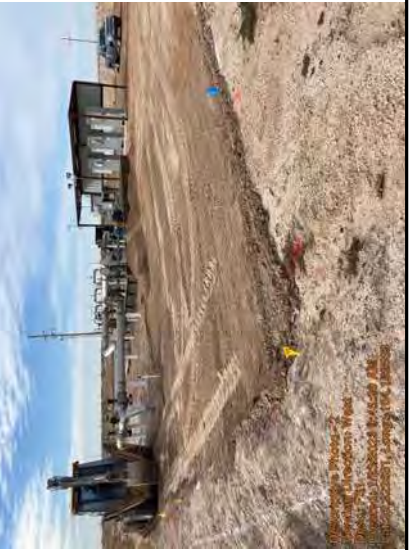
<p>Site Photo - 2 Viewing Direction: West Object: Backhoe at site Created: 1/23/2023 10:29 AM Location: 322371, Long-104, 160734</p></div> <div>FS1</div>	<div>Viewing Direction: Northeast</div> <div>

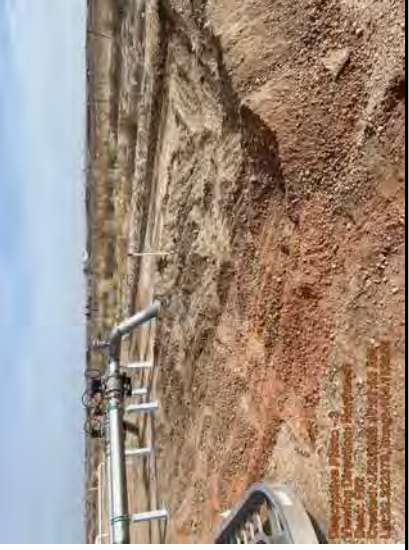
<p>Site Photo - 3 Viewing Direction: Northeast Object: Pipes and spill area Created: 1/23/2023 11:21 AM Location: 322371, Long-104, 160734</p></div> <div>FS2</div>
