**Closure Report**  
**SRO State Com 046H**  
**Incident #: nAPP2416253712**  
**Eddy County, New Mexico**  
**Unit D Sec 05 T26S R28E**  
**32.0782°, -104.1158°**

**Crude Oil Release**  
**Point of Release: Tank Overflow**  
**Release Date: 05.13.24**  
**Volume Released: 9.1225 barrels of Crude Oil**  
**Volume Recovered: 9 barrels of Crude Oil**

**Re: Closure Report  
SRO State Com 046H  
Concho Operating, LLC  
Incident ID: nAPP2416253712  
Site Location: Unit D, S05, T26S, R28E  
(Lat 32.0782°, Long -104.1158°)  
Eddy County, New Mexico**

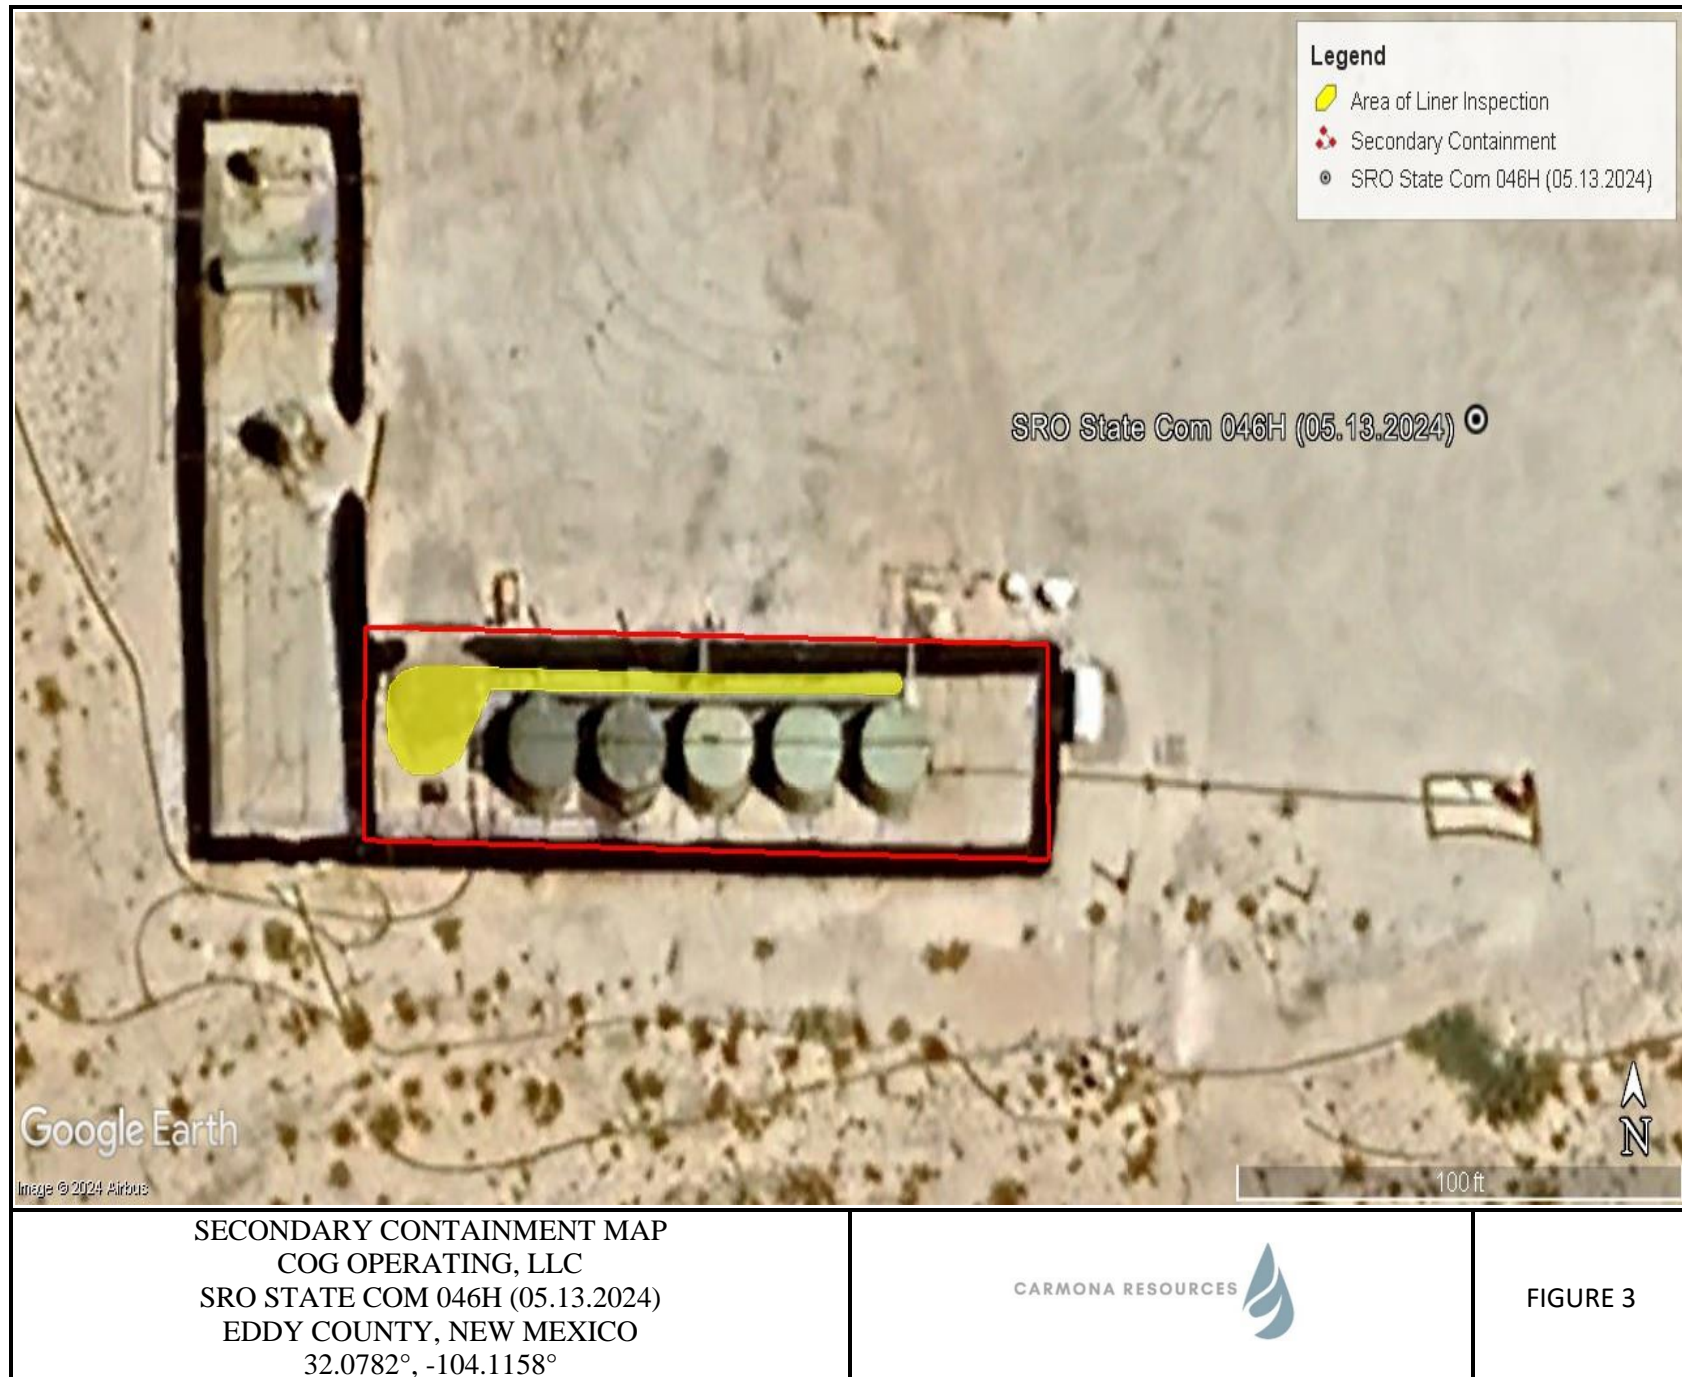
Based on the initial C-141 obtained from the New Mexico Oil Conservation Division (NMOCD), the release was discovered on May 13, 2024, due to a tank that overflowed. It resulted in approximately nine point one two two five (9.1225) barrels of crude oil and nine (9) barrels of crude oil recovered within the gravel lined facility. See Figure 3. The initial C-141 form is attached in Appendix B.

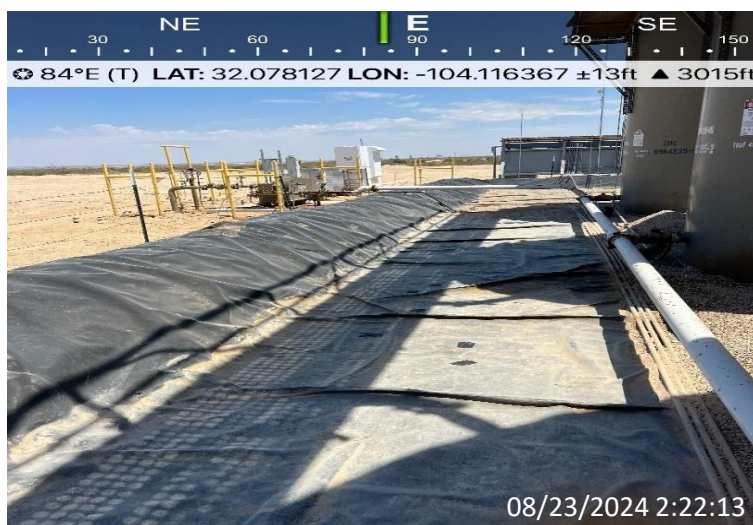
**PHOTOGRAPHIC LOG****Concho Operating, LLC****Photograph No. 1****Facility:** SRO State Com 046H (05.13.24)**County:** Eddy County, New Mexico**Description:**

View East of the intact liner after the pea gravel has been removed. Red outline is the area of the liner inspection.

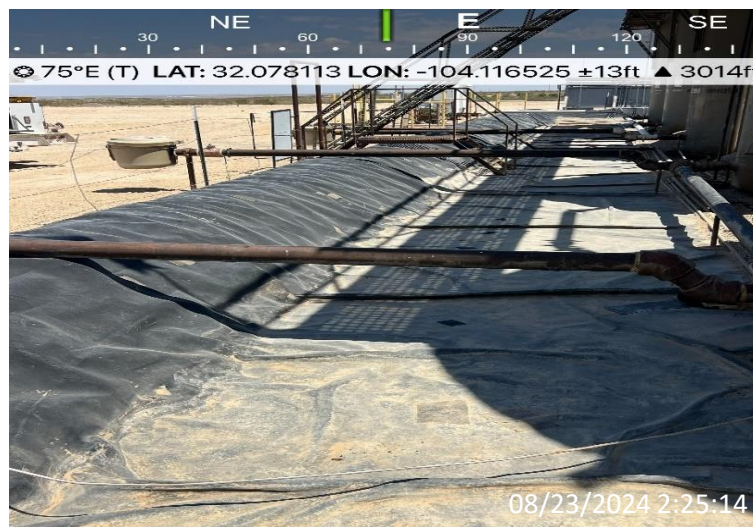
**Photograph No. 3****Facility:** SRO State Com 046H (05.13.24)**County:** Eddy County, New Mexico**Description:**

View East of the intact liner after the pea gravel has been removed. Red outline is the area of the liner inspection.

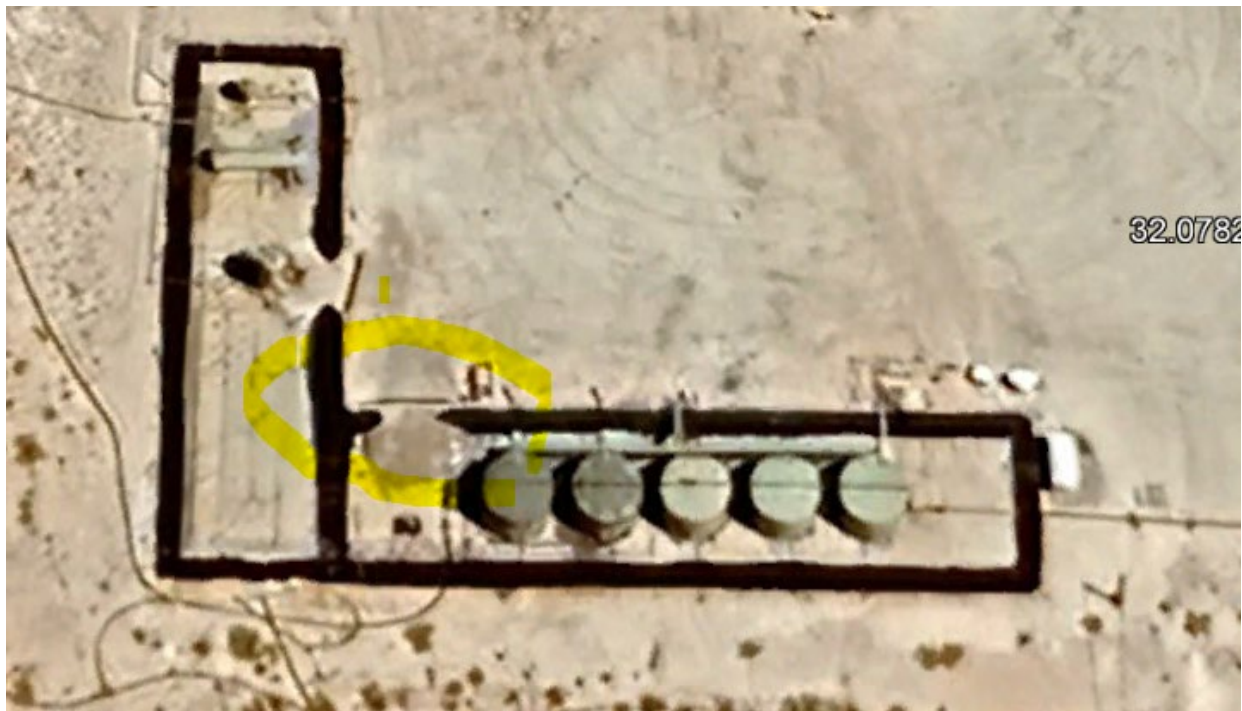
The highlighted area is the standard ramp built over the liner to ensure a safe access point inside the facility. It is built up and over the liner to ensure its integrity. Regarding the liner inspection, only the area affected by the release was inspected. All the impacted pea gravel was removed, and then the liner was cleaned, and then the inspection occurred following the NMOCD protocol.

I am reviewing the submitted liner report for NAPP2416253712 SRO STATE COM 046H and have a few questions for you: Why was only one side of the lined containment inspected? What is the area at the west side of the tank battery that looks like a pile of sand is over top the liner for? It appears the liner is breached in this area. Can you explain?
