M-28 LINE LEAK

Remediation Action Plan

NMOCD Incident No. nAPP2319359955
UL "O", Sec. 32, T18S, R30E
32.697537, -103.99317
Eddy County, New Mexico

September 26, 2024

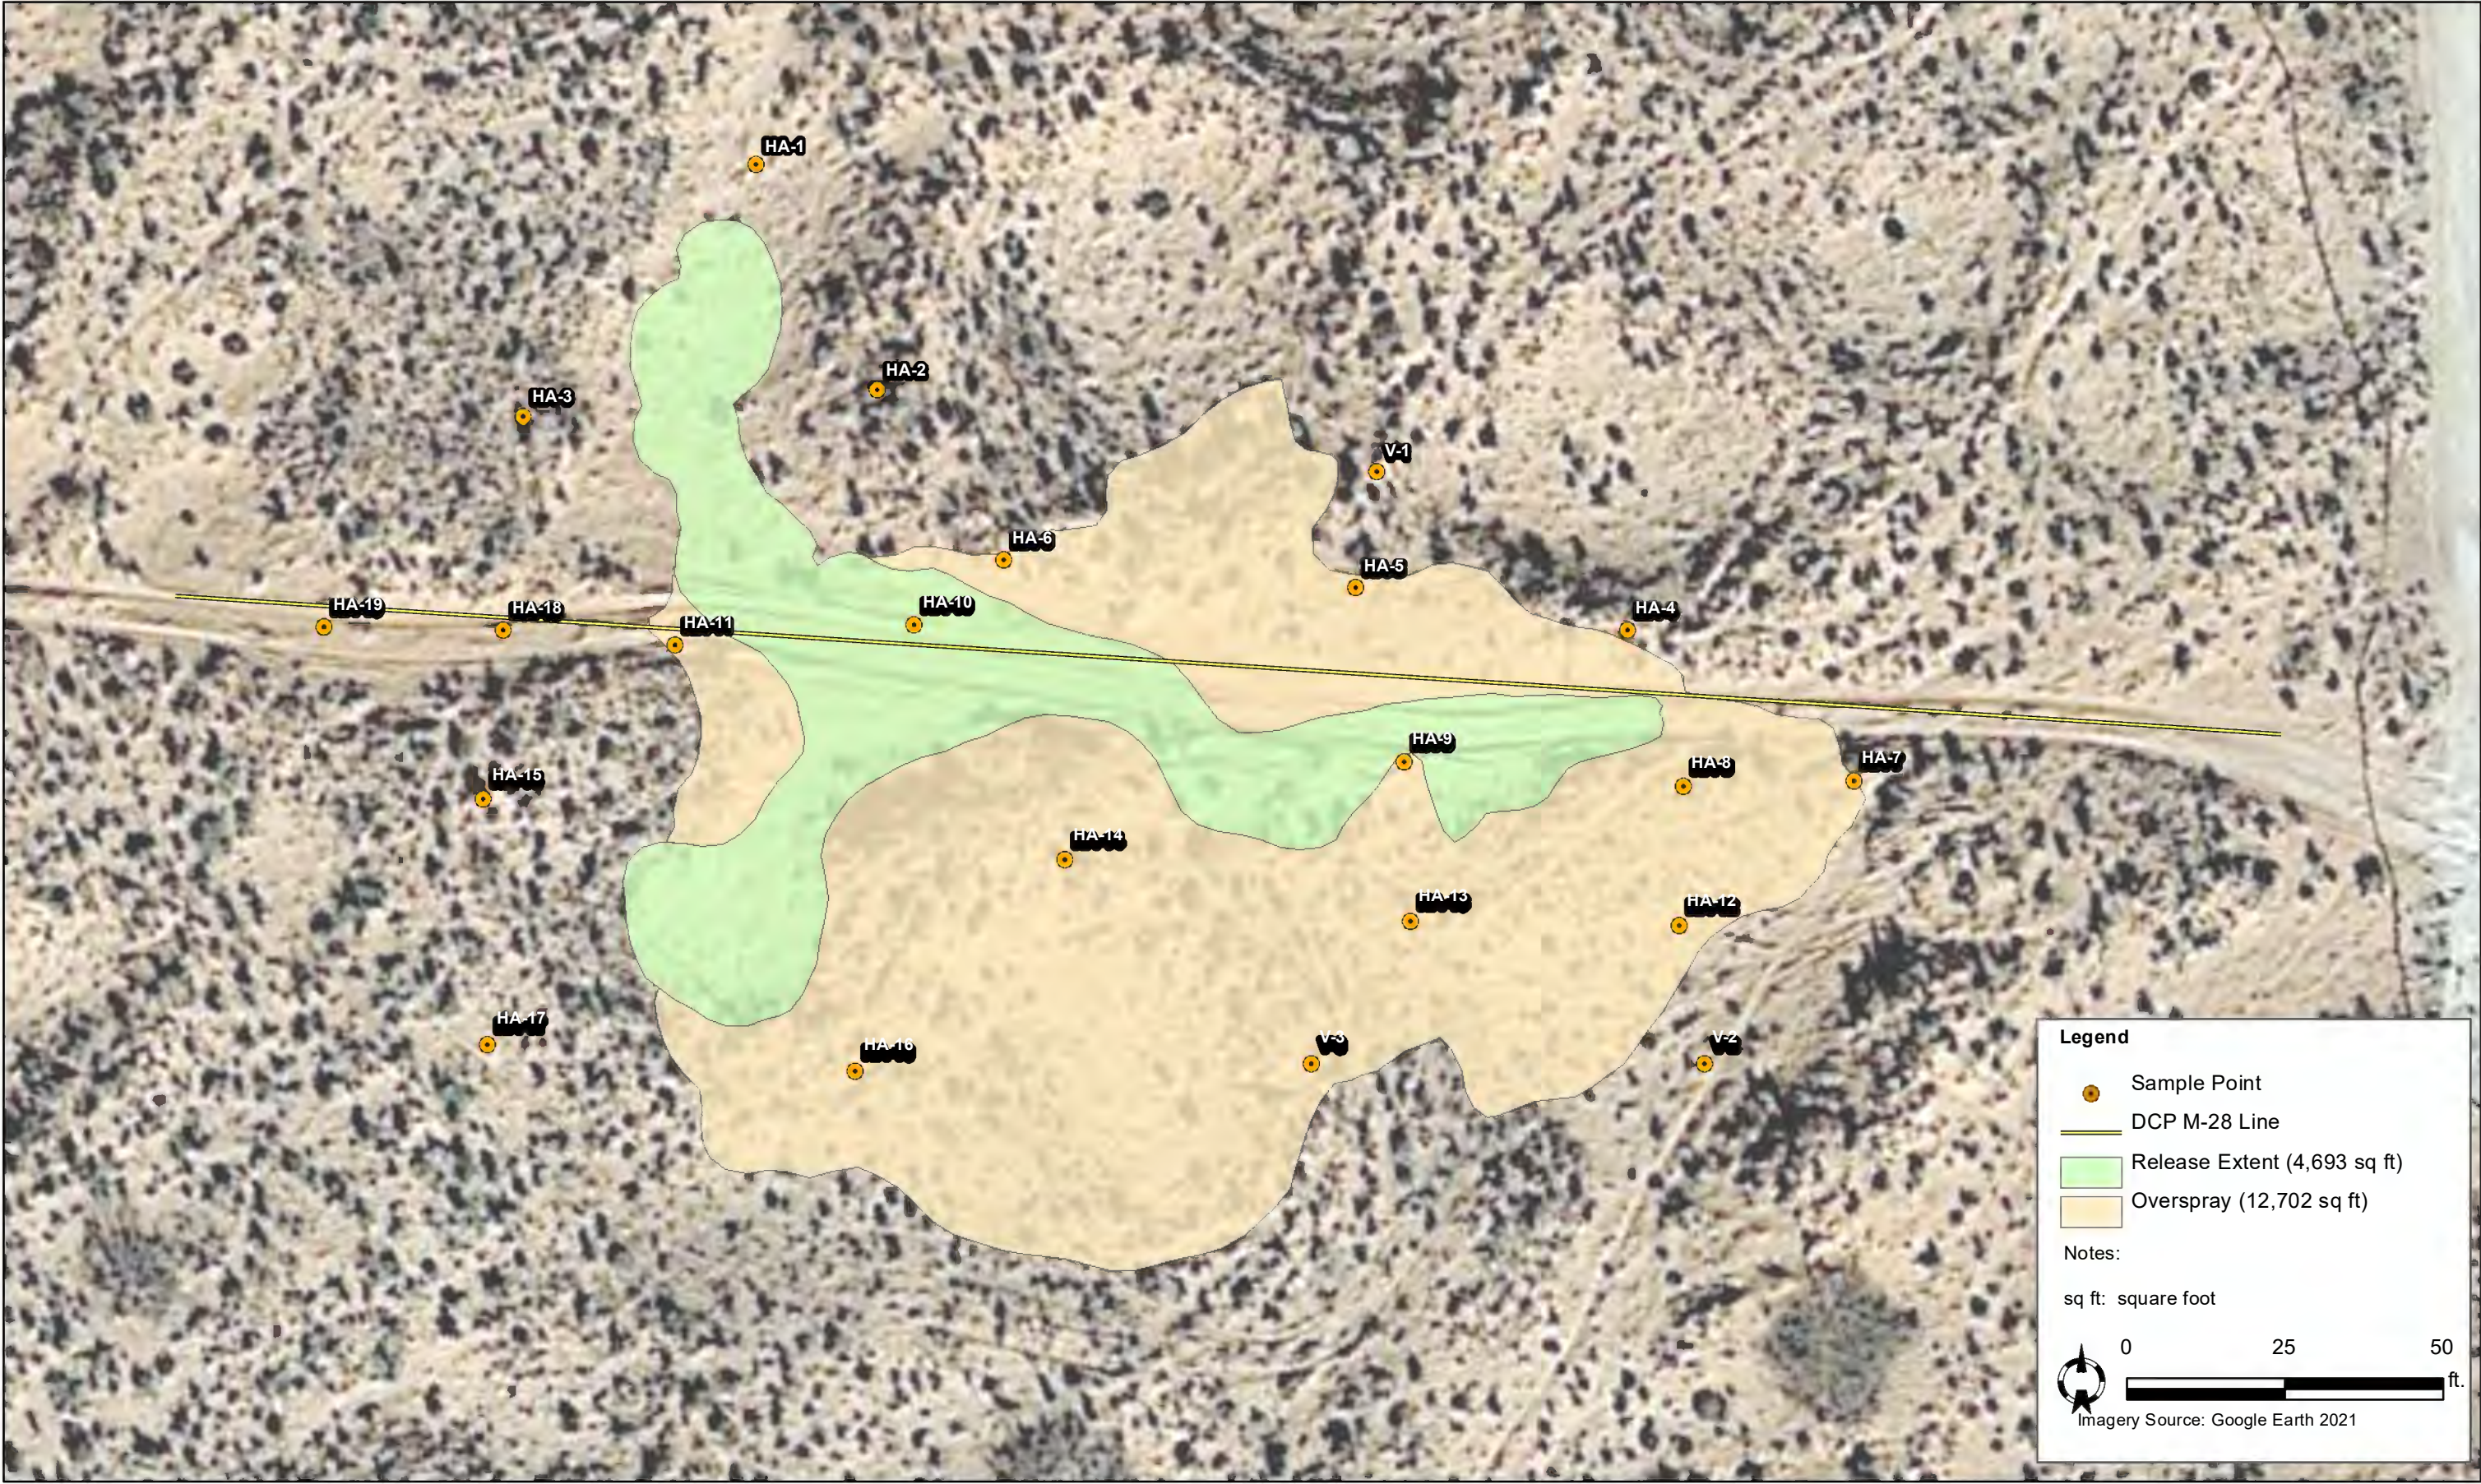
The attached Figure 5 illustrates the observed release and location of soil sample locations.
