**Re: Deferral Request  
Corral Canyon 8 Satellite  
Incident Numbers nAPP2407338357 & nAPP2421528352  
Eddy County, New Mexico**

XTO Energy, Inc  
Deferral Request  
Corral Canyon 8 Satellite

XTO Energy, Inc  
Corral Canyon 8 Satellite Battery  
Incident Number: nAPP2421528352, nAPP2407338357  
Unit J, Sec 08, T25S, R29E  
Eddy County, NM

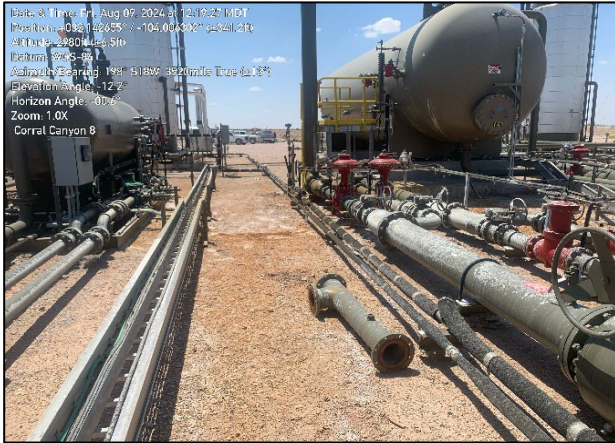
Photograph: 1      Date: 8/9/2024  
Description: Soil staining in release footprint.  
View: Southwest

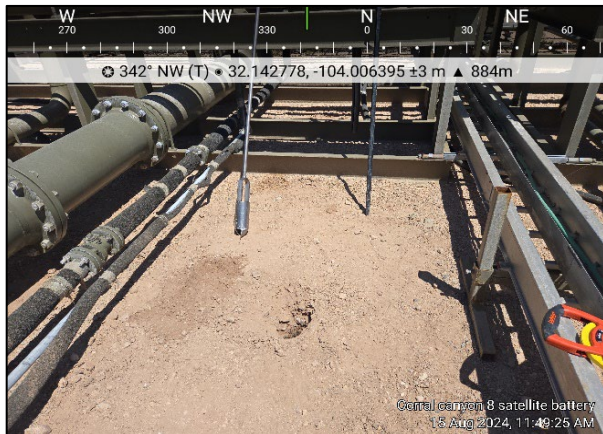
Photograph: 3      Date: 8/15/2024  
Description: Delineation and surface scrape activities.  
View: Northwest

Surface scraping of visibly stained soil was conducted in the release area to the maximum extent possible. Surface scraping activities were performed using hand tools, as no mechanical equipment could access the impacted soil due to active production equipment and surface pipelines. Approximately 30 cubic yards of stained soil was removed during the surface scraping activities. The impacted soil was transported and properly disposed of at the R360 Landfill Facility in Hobbs, New Mexico.

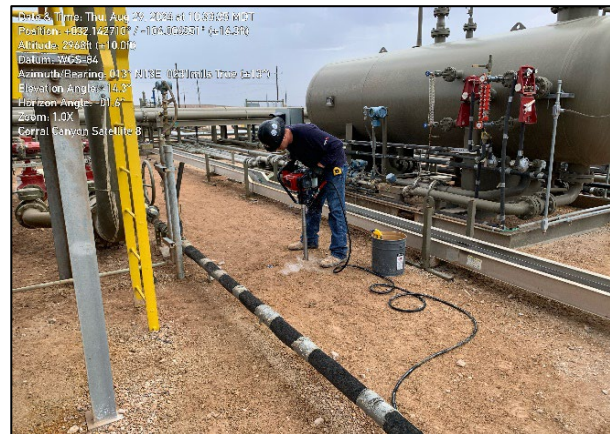
Photograph: 4      Date: 8/29/2024  
Description: Core drilling activities.  
View: Northeast
