**Re: Deferral Request
Corral Canyon 8 Satellite
Incident Numbers nAPP2407338357 & nAPP2421528352
Eddy County, New Mexico**

Ensolum, LLC (Ensolum), on behalf of XTO Energy, Inc. (XTO), has prepared this *Deferral Request* to document assessment, delineation, and soil sampling activities at the Corral Canyon 8 Satellite (Site). The purpose of the Site assessment and soil sampling activities was to assess for the presence or absence of impacts to soil following two produced water releases on the pad surface due to equipment failure. Based on field observations, field screening activities, and soil sample laboratory analytical results, XTO is submitting this *Deferral Request*, describing Site assessment and delineation activities that have occurred and requesting deferral of final remediation for Incident Numbers nAPP2407338357 & nAPP2421528352 until the Site is reconstructed, and/or the well pad is abandoned.

XTO Energy, Inc
Deferral Request
Corral Canyon 8 Satellite

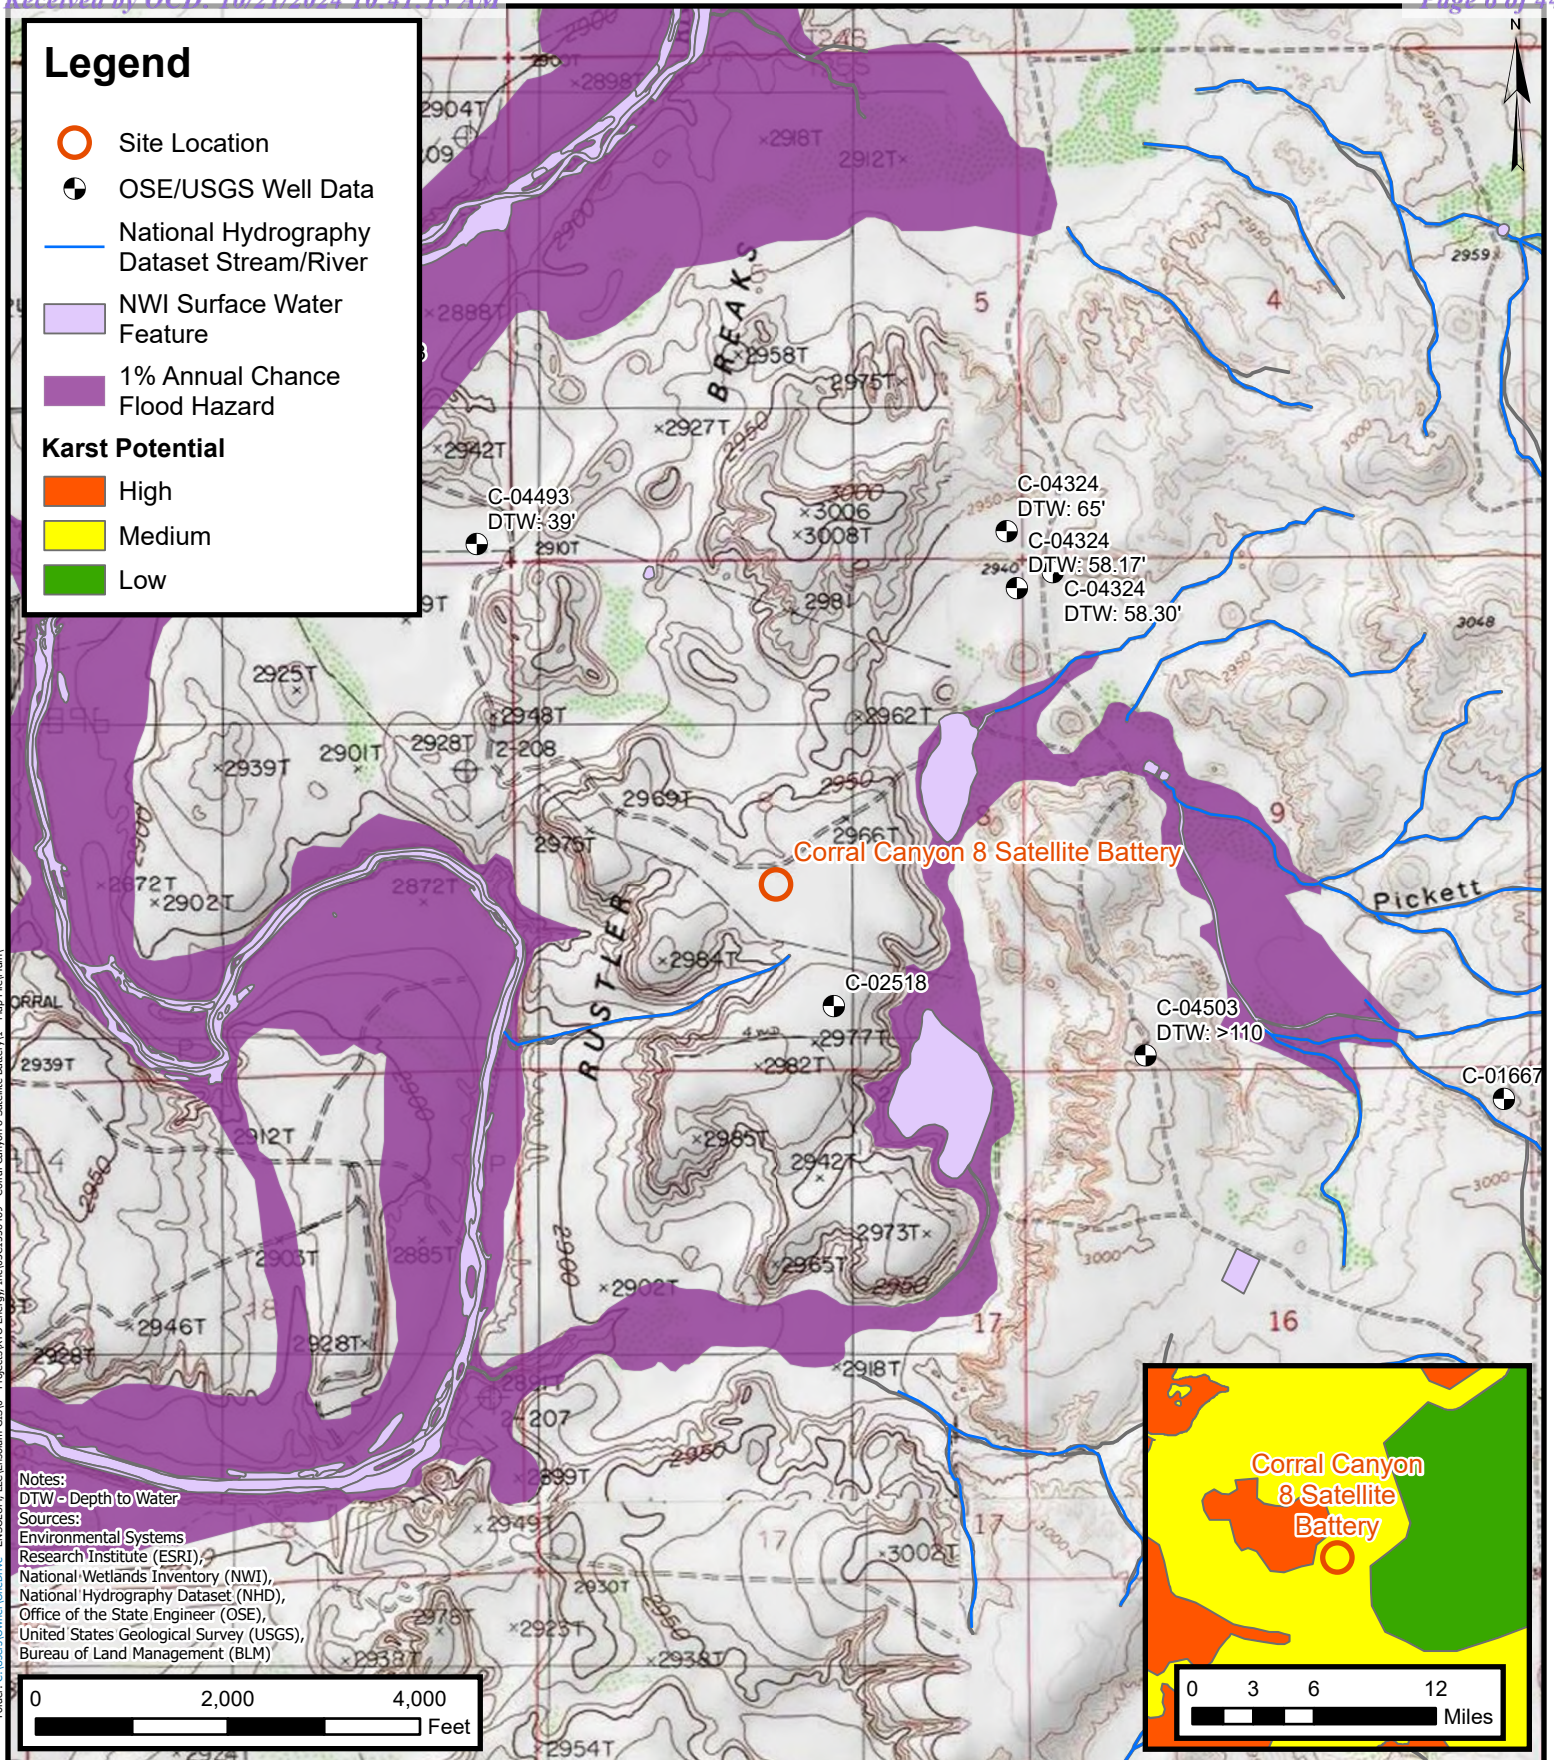
1

Depth to groundwater at the Site is greater than 100 feet below ground surface (bgs) based on data from a livestock watering well, permitted by the New Mexico Office of the State Engineer (C-2518) drilled on June 2, 1997. The livestock watering well was drilled 0.26 miles southeast of the Site to a depth of 462 feet bgs and was reported not to have encountered groundwater. All wells used to determine depth to groundwater are depicted on Figure 1. The Well Record and Log is included in Appendix A.

The closest continuously flowing or significant watercourse to the Site is a seasonal dry wash, located approximately 736 feet south of the Site. The Site is greater than 200 feet from a lakebed, sinkhole, or playa lake and greater than 300 feet from an occupied residence, school, hospital, institution, church, or wetland. The Site is greater than 1,000 feet to a freshwater well or spring and is not within a 100-year floodplain or overlying a subsurface mine. The Site is not underlain by unstable geology (medium potential karst designation area). Site receptors are identified on Figure 1.

Site Receptor Map

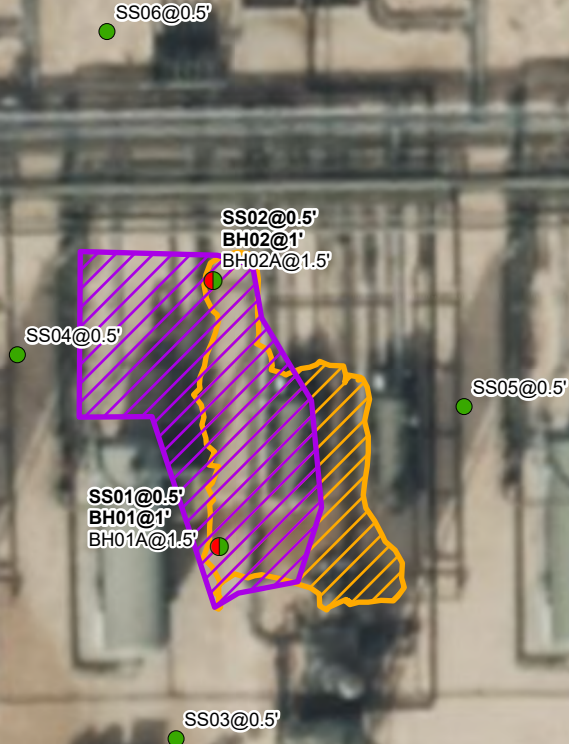
FIGURE
2

The release occurred on the well pad near production equipment and surface pipelines. XTO safety policy restricts soil disturbing activities within a 2-foot radius of any on-site production equipment. The estimated area of remaining impacted soil measures approximately 1,720 square feet and, assuming a 1.5-foot depth based on the delineation soil samples BH01A and BH02A, a total of approximately 96 cubic yards of chloride-impacted soil remains in place. The estimated area of remaining impacted soil and delineation soil sample locations are presented on Figure 2.

Notes:
Sample ID @ Depth Below Ground Surface.
Samples in bold indicate sample exceeded applicable closure criteria.

Delineation Soil Sample Locations

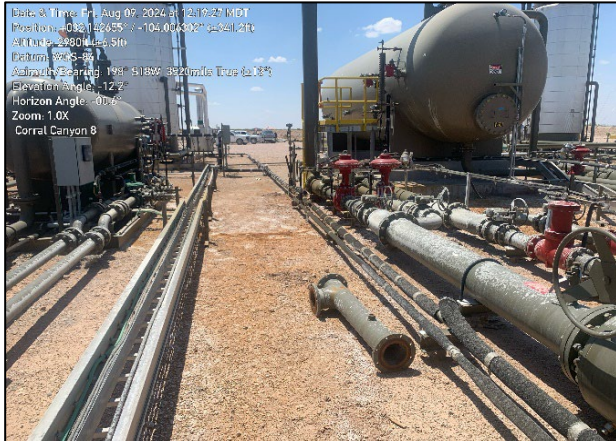
Photograph: 1 Date: 8/9/2024
Description: Soil staining in release footprint.
View: Southwest

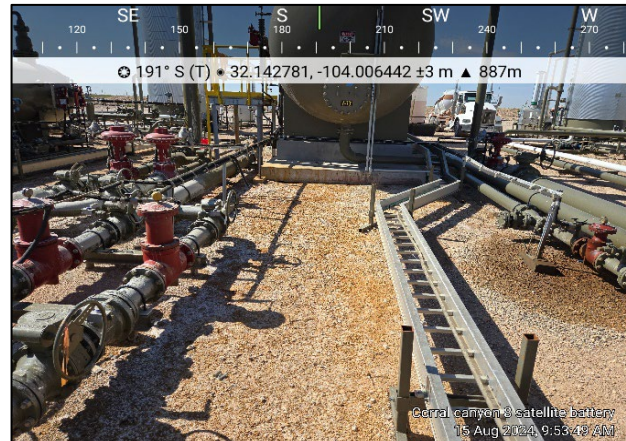
Photograph: 2 Date: 8/15/2024
Description: Soil staining in release footprint
View: South
