Closure Report Reposado 2 State 001H Incident #: nAPP2409940115 Eddy County, New Mexico Unit B Sec 02 T26S R29E 32.0780°, -103.9527°

Crude Oil & Produced Water Release Point of Release: Tank Overflow Release Date: 04.06.24

Volume Released: 2 barrels of Crude Oil & 29 barrels of Produced Water Volume Recovered: 2 barrels of Crude Oil & 29 barrels of Produced Water

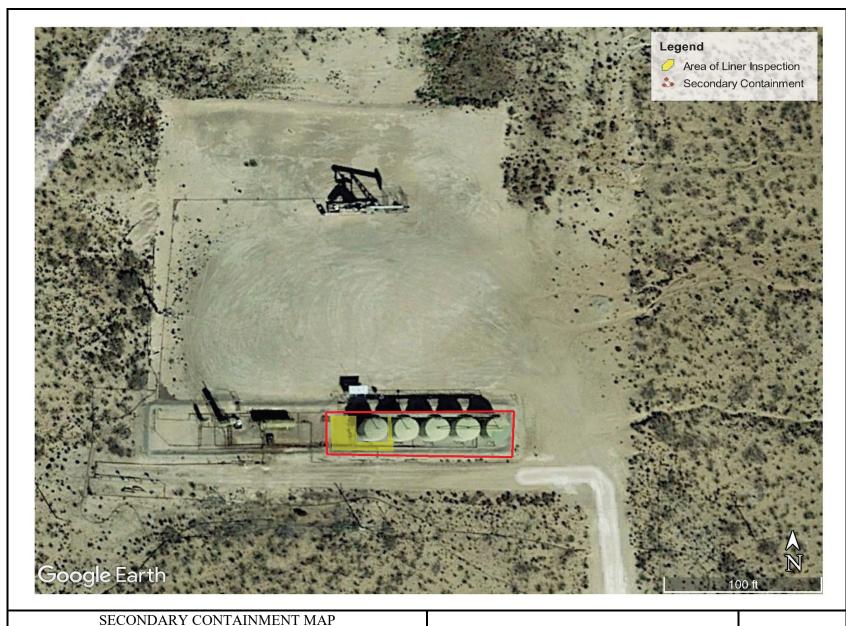
FIGURE 3

Based on the initial C-141 obtained from the New Mexico Oil Conservation Division (NMOCD), the release was discovered on April 6, 2024, caused by a tank overflow due to equipment malfunction. It resulted in approximately two (2) barrels of crude oil and twenty-nine (29) barrels of produced water being released, and two (2) barrels of crude oil and twenty-nine (29) barrels of produced water recovered within the gravel lined facility. See figure 3. The initial C-141 form is attached in Appendix B.

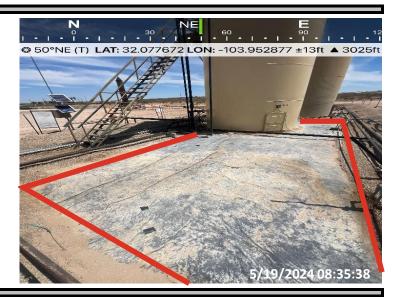
Photograph No. 1

View East of the intact liner after the pea gravel has been removed. Red outline is the area of the liner inspection.

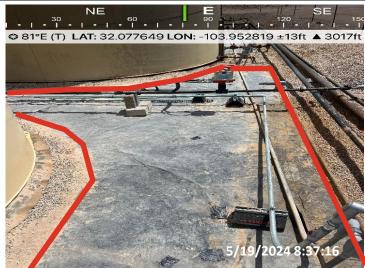
Photograph No. 2

View East of the intact liner after the pea gravel has been removed. Red outline is the area of the liner inspection.

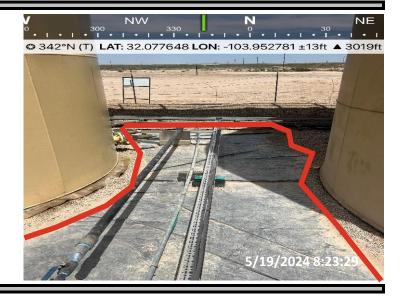
Photograph No. 3

View North of the intact liner after the pea gravel has been removed. Red outline is the area of the liner inspection.
