Re: Closure Request

Goldenchild 6 State SWD 001 Incident Number nAPP2422958386 Eddy County, New Mexico

XTO Energy, Inc Closure Request Goldenchild 6 State SWD 001

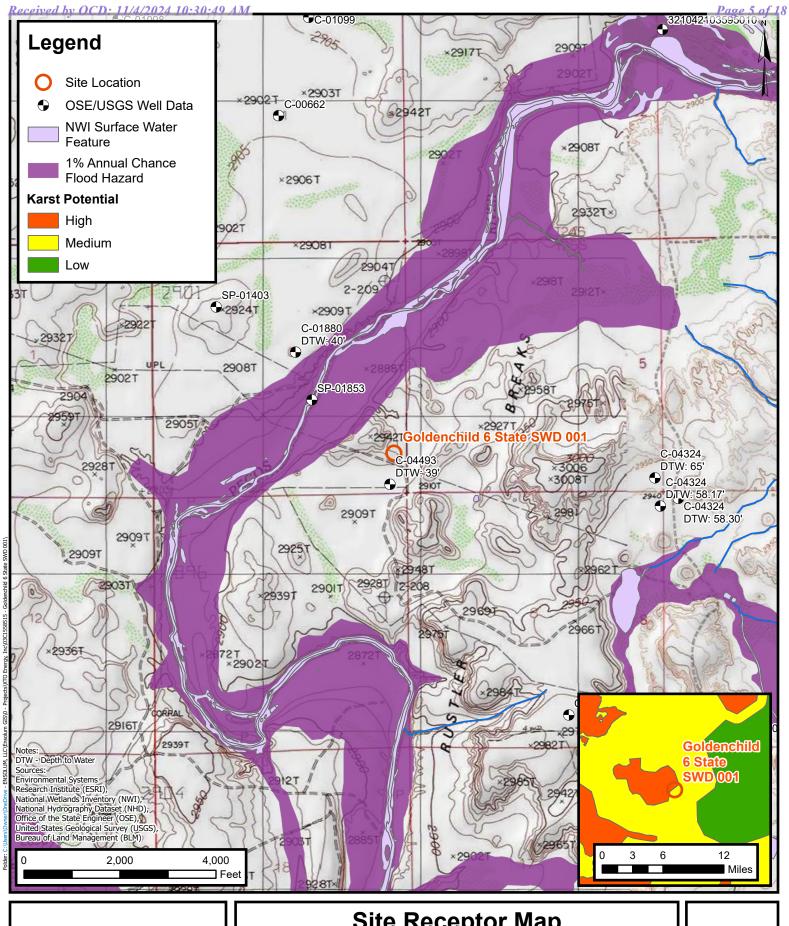
Site Receptor Map

The Site was characterized to assess the applicability of Table I Closure Criteria for Soils Impacted by a Release, of Title 19, Chapter 15, Part 29 (19.15.29) of the New Mexico Administrative Code (NMAC). Results from the characterization desktop review are presented below and potential Site receptors are identified on Figure 1.

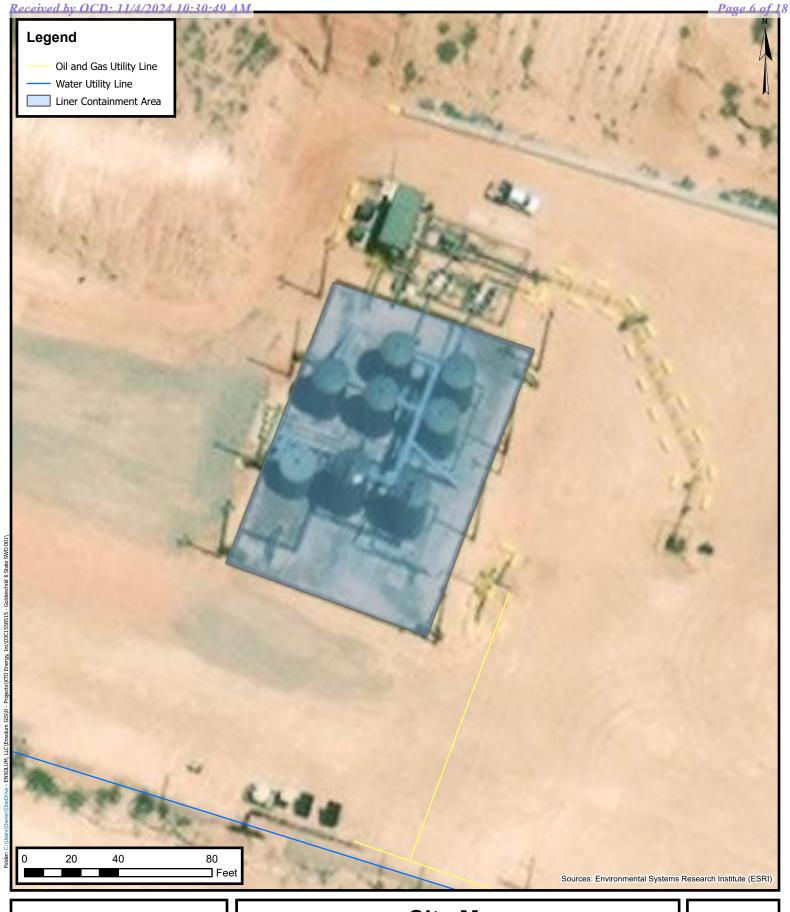
FIGURE 2

A 48-hour advance notice of the liner inspection was submitted on September 10, 2024. The lined containment was cleaned of all debris and power washed. On September 16, 2024, Ensolum personnel inspected the liner, and it was determined to be operating as designed. Upon inspection, no rips, tears, holes, or damage were observed. The liner was determined to be sufficient, and all released fluids had been recovered. A Site map of the liner is included in Figure 2. Photographic documentation of the inspection is included in Appendix B.

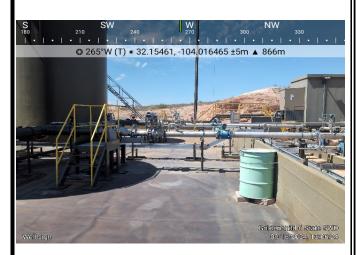
Photograph: 3 Date: 9/16/2024

Description: Liner Inspection Activities

View: West

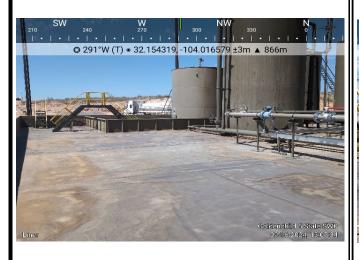
Photograph: 5 Date: 9/16/2024

Description: Liner Inspection Activities

View: West
