ZZ-1 LINE LEAK

Remediation Summary & Closure Report

NMOCD Incident No. nAPP2422124658
UL "P", Sec. 11, T18S, R27E
32.755311°, -104.241111°
Eddy County, New Mexico

November 12, 2024

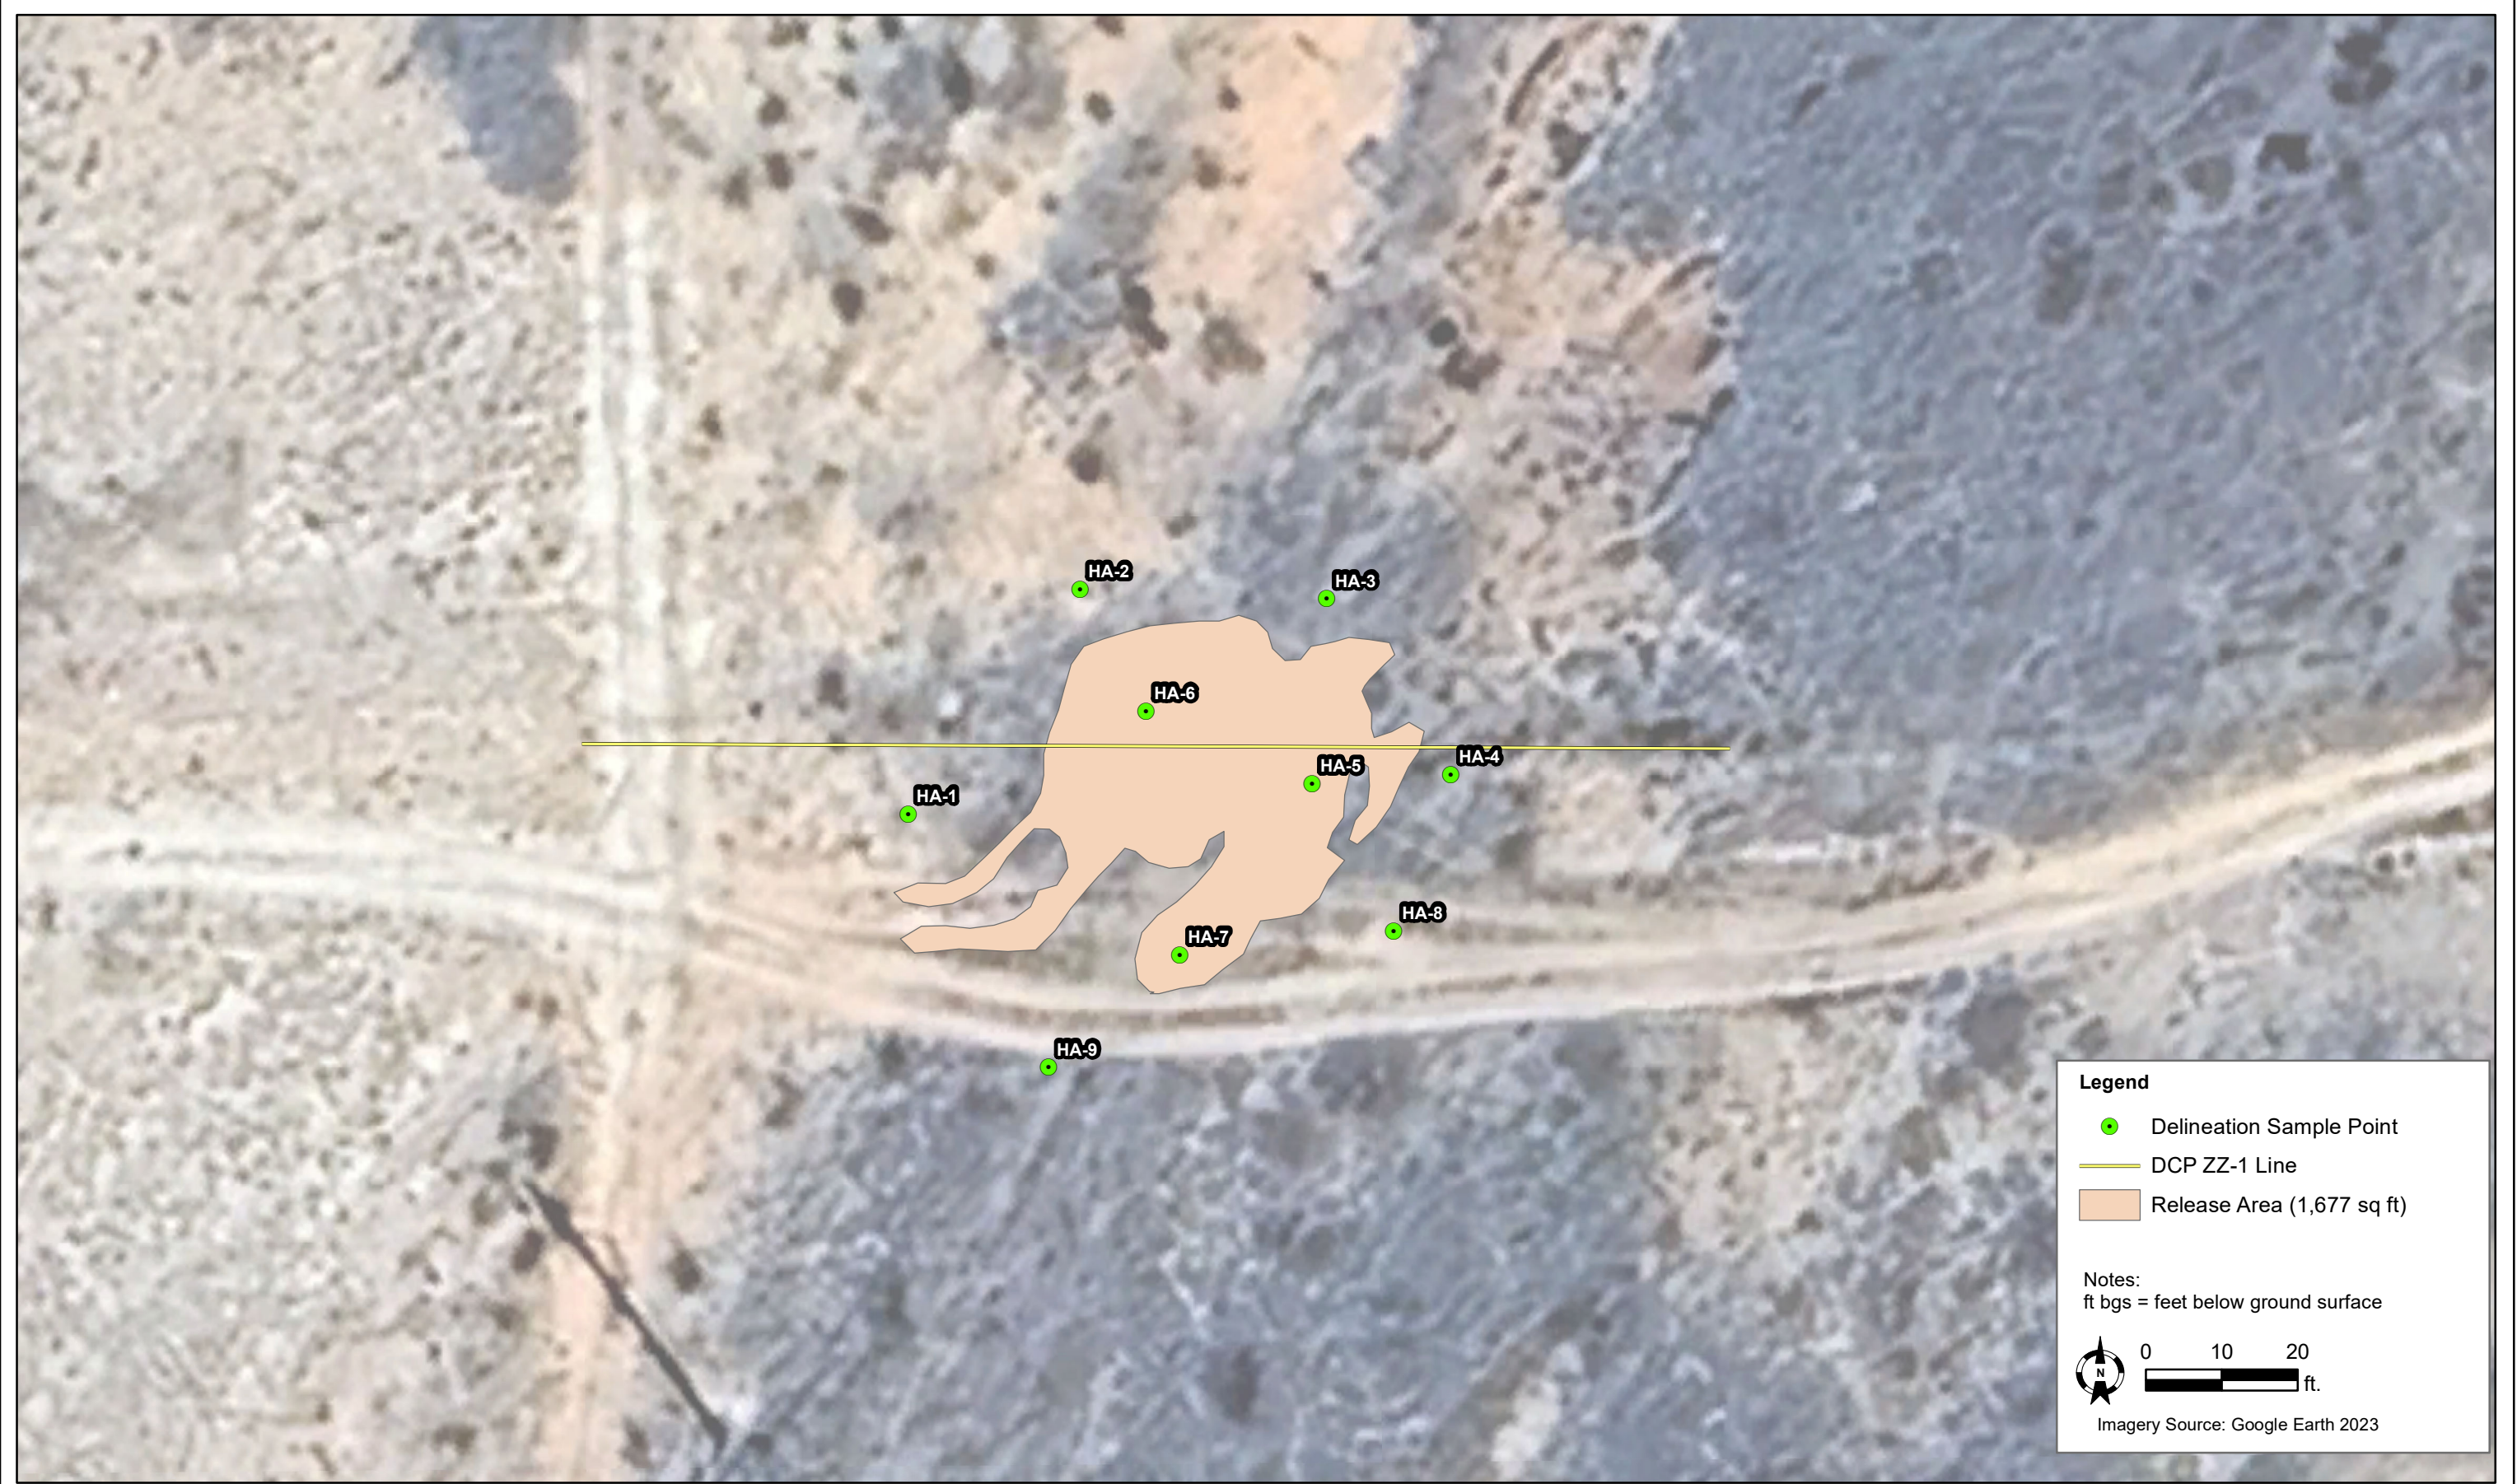
Figure
5

Delineation Overview Map
