**Re: Closure Request  
PLU 20 Brushy Draw West Battery  
Incident Number nAPP2423455892  
Eddy County, New Mexico**

XTO Energy, Inc  
Closure Request  
PLU 20 Brushy Draw West Battery

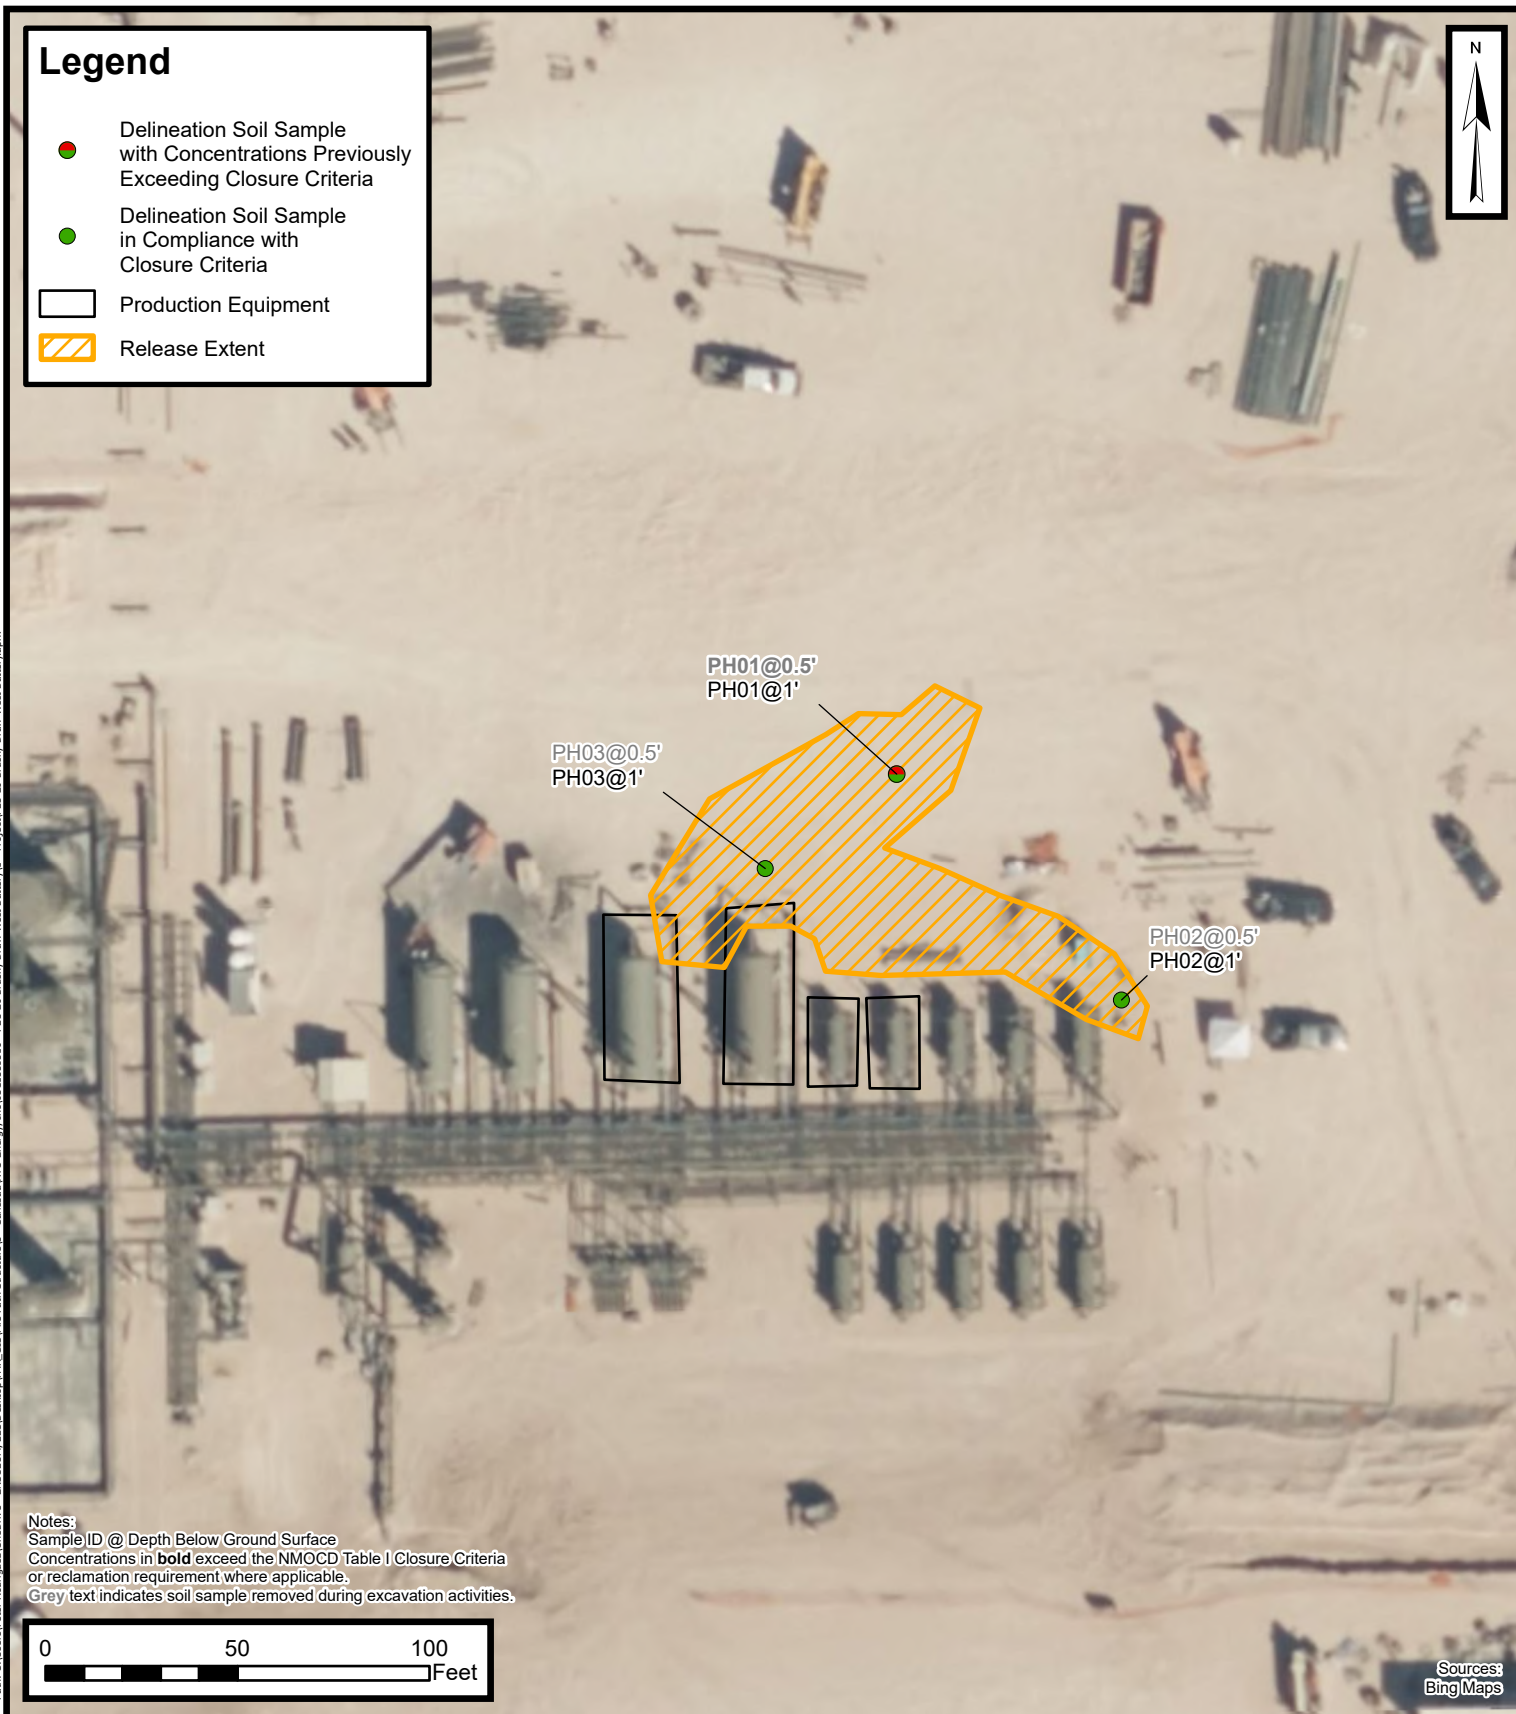
## Delineation Soil Sample Locations

XTO Energy, Inc  
PLU 20 Brushy Draw West Battery  
Incident Number: nAPP2423455892  
Unit 4, Sec 20, T25S, R30E  
Eddy County, New Mexico

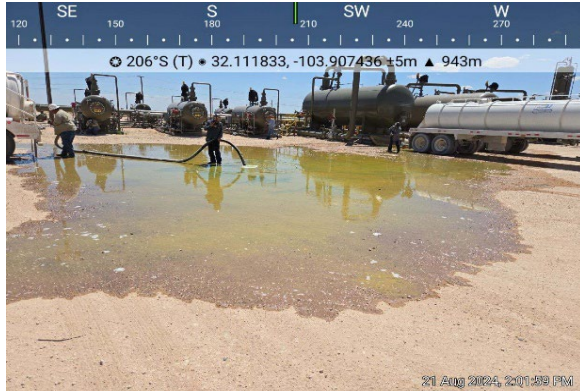
Photograph: 1  
Description: Initial release  
View: Southwest

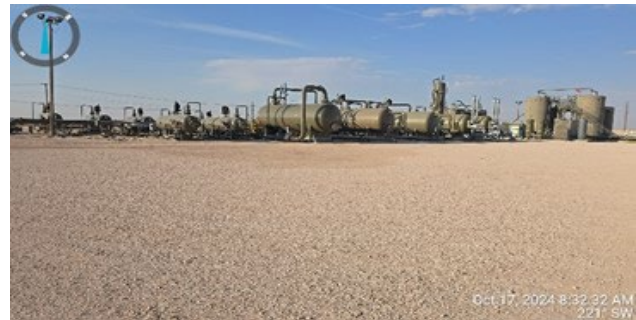
Photograph: 2  
Description: Soil staining in release footprint  
View: Southwest

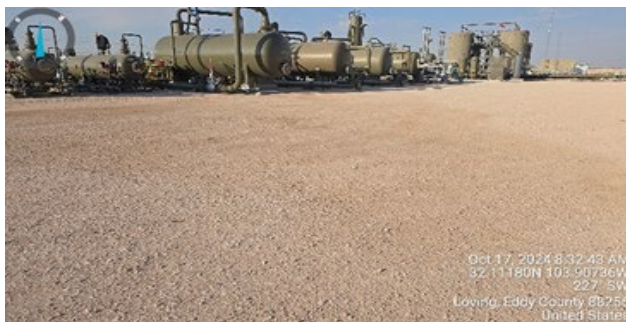
Photograph: 3  
Description: Soil staining in release footprint  
View: Southwest

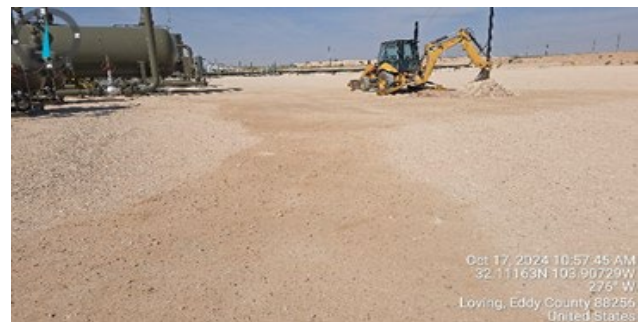
Photograph: 4  
Description: Delineation activities  
View: West

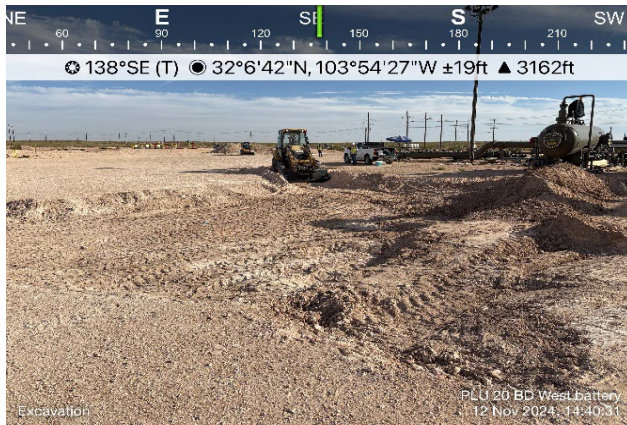
Photograph: 5                      Date: 11/12/2024  
 Description: Excavation activities  
 View: Southeast

Between November 11, 2024, and November 14, 2024, Ensolum personnel were onsite to oversee excavation activities of the impacted soil that was identified. Impacted soil was then excavated from the release area as indicated by laboratory analytical results, visible staining and field screening activities. Excavation activities were performed utilizing a backhoe and a transport vehicle. To direct excavation activities, Ensolum personnel field screened soil for VOCs and chlorides. Following removal of impacted soil to the maximum extent possible, Ensolum personnel collected 5-point composite soil samples representing no more than 200 square feet from the sidewalls and floor of the excavation and release extent. The 5-point composite soil samples were collected by placing five equivalent aliquots of soil into a 1-gallon, resealable plastic bag and homogenizing the samples by thoroughly mixing. Excavation soil samples FS01 through FS25 were collected from the floor of the excavation at a depth of 2 feet bgs. Excavation sidewall soil samples SW01 through SW04 were collected from the sidewalls of the excavation at depths ranging from ground surface to 2 feet bgs. The soil samples were collected, handled, and analyzed following the same procedures described above at Cardinal in Hobbs, New Mexico. The excavation extent and excavation soil sample locations are depicted in Figure 3.

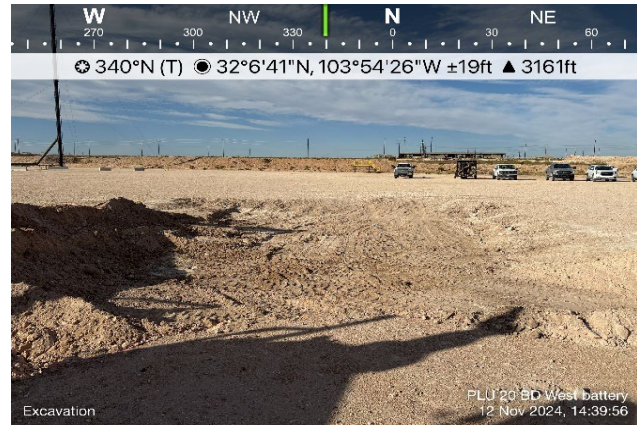
Photograph: 6                      Date: 11/12/2024  
 Description: Excavation activities  
 View: North

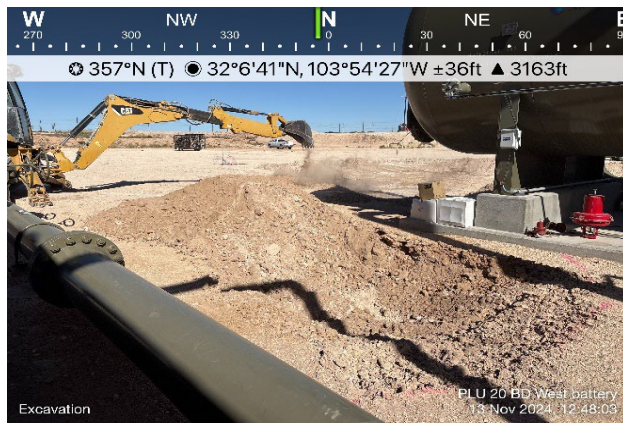
Photograph: 7                      Date: 11/13/2024  
 Description: Excavation activities  
 View: North

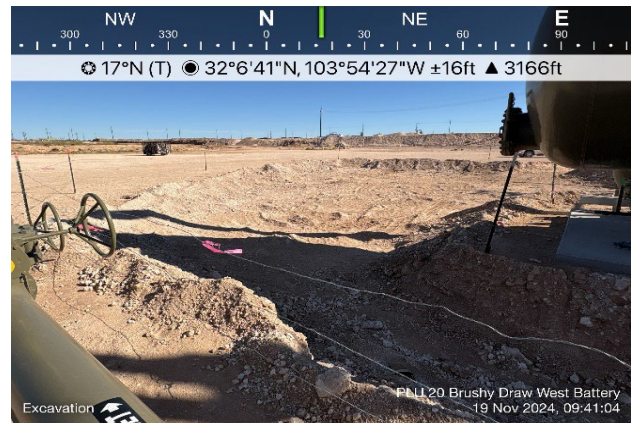
Photograph: 8                      Date: 11/19/2024  
 Description: Final Excavation Extent  
 View: North

Delineation and excavation activities were conducted at the Site to address the August 21, 2024, release of crude oil. Laboratory analytical results for the confirmation soil samples, collected from the final excavation extent, indicated that all COCs were compliant with the Site Closure. Based on the soil sample analytical results, no further remediation was required. XTO will backfill the excavation with material purchased locally and recontour the Site to match pre-existing site conditions.
