Remediation Summary & Soil Closure Request

Mewbourne Oil Company Devon 12-1 W2PI SWD Line

Eddy County, New Mexico
Unit Letter "D", Section 18, Township 25 South, Range 28 East
Latitude 32.13721 North, Longitude 104.13333 West
NMOCD Reference No. nAPP2424855148

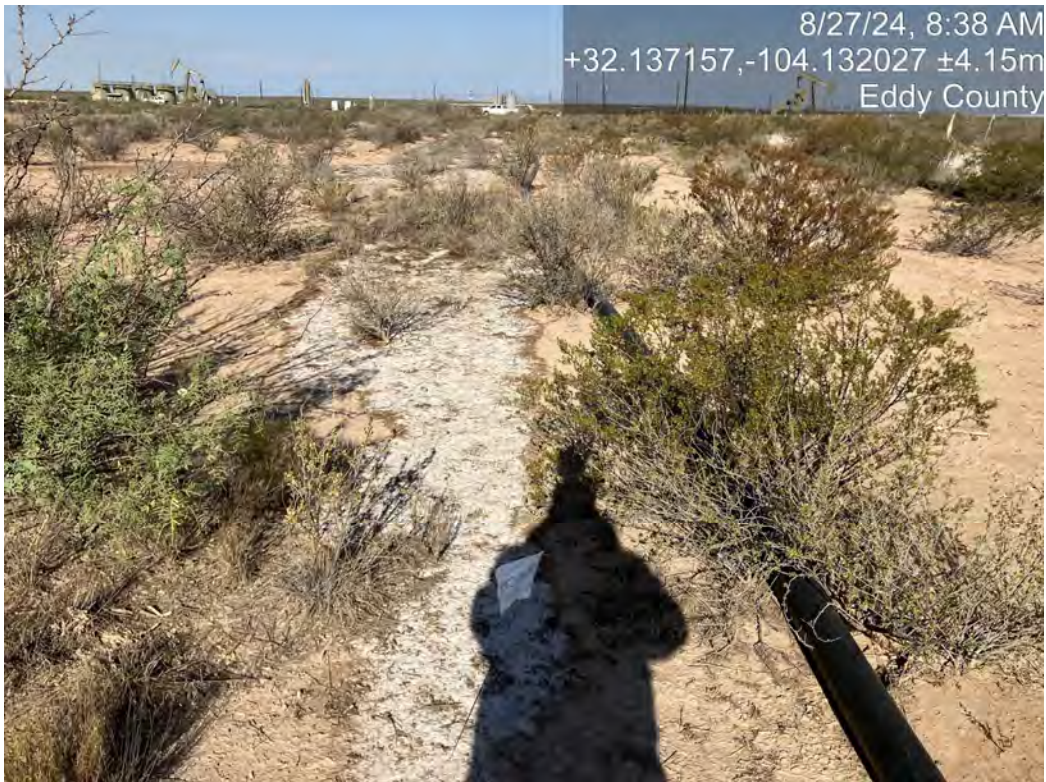
Photo Number: 1

<p>8/27/24, 8:38 AM +32.137157,-104.132027 ±4.15m Eddy County</p>
Photo Direction: West	
Photo Description: View of the affected area.

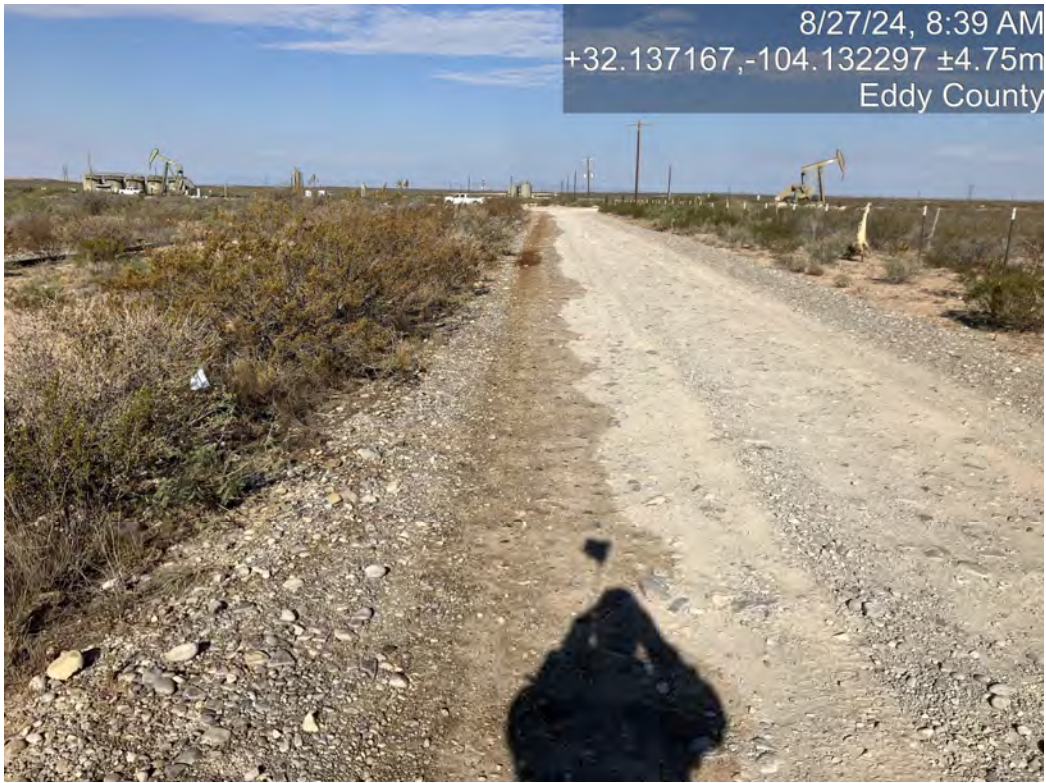
Photo Number: 2

<p>8/27/24, 8:39 AM +32.137167,-104.132297 ±4.75m Eddy County</p>
Photo Direction: West	
Photo Description: View of the affected area.

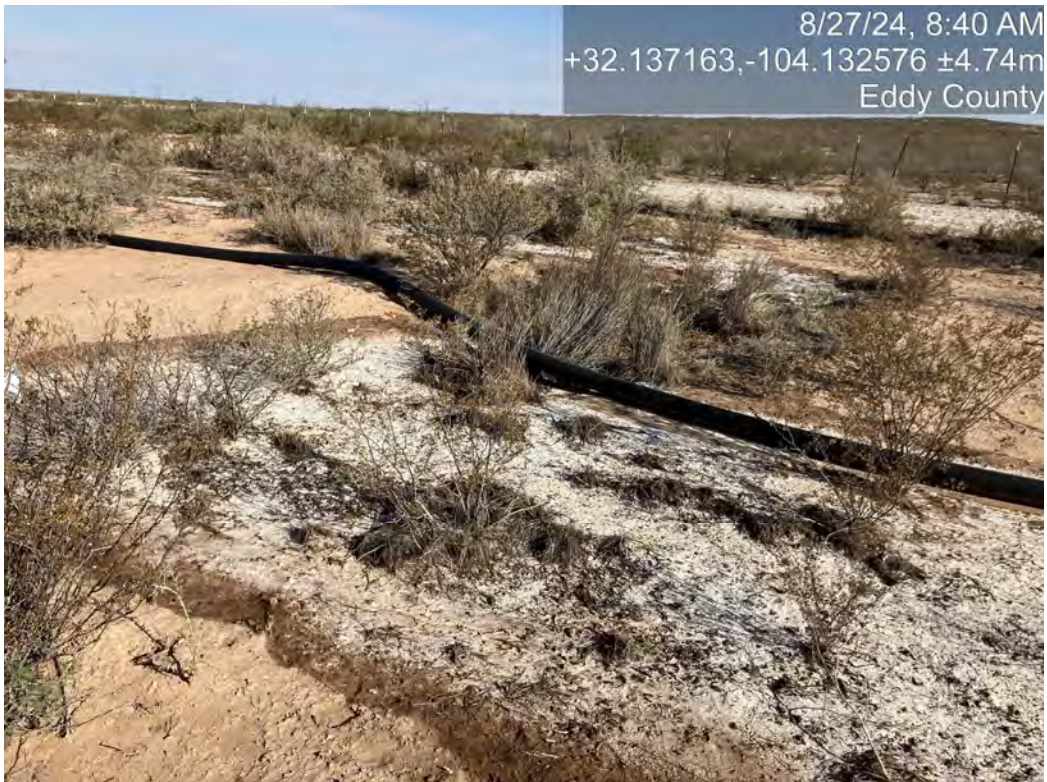
Photo Number: 3

Photo Direction: Northwest	
Photo Description: View of the affected area.

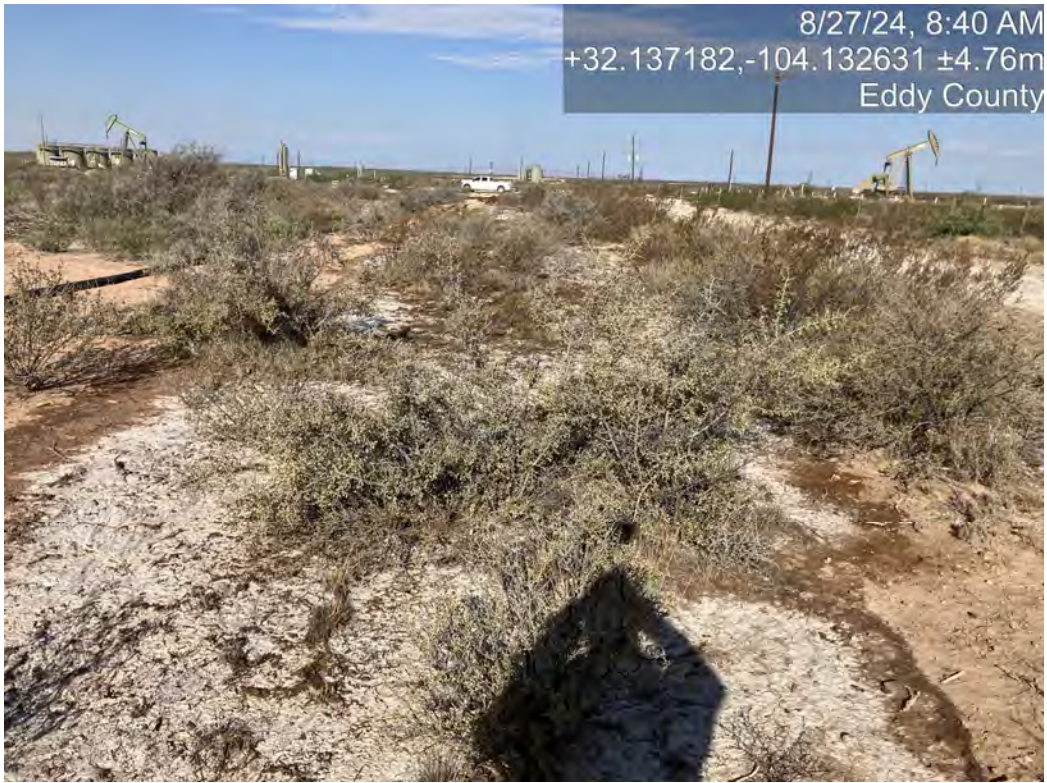
Photo Number: 4

Photo Direction: West	
Photo Description: View of the affected area.

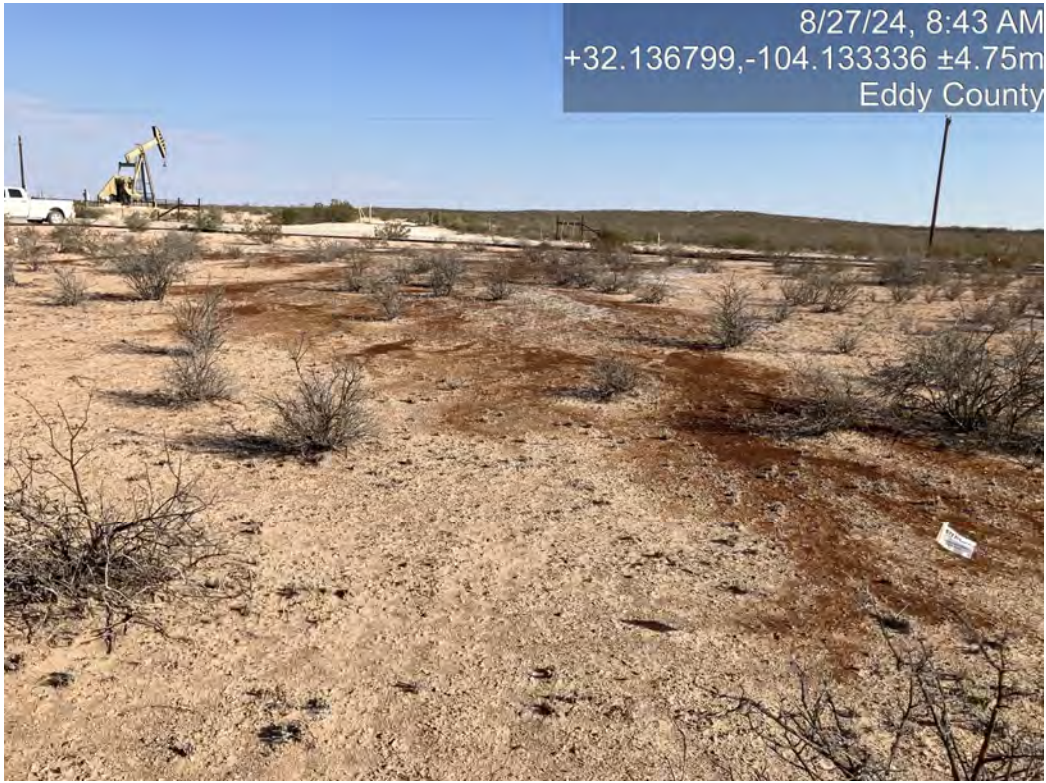
Photo Number: 8

<p>8/27/24, 8:43 AM +32.136799,-104.133336 ±4.75m Eddy County</p>
Photo Direction: Northwest	
Photo Description: View of the affected area.

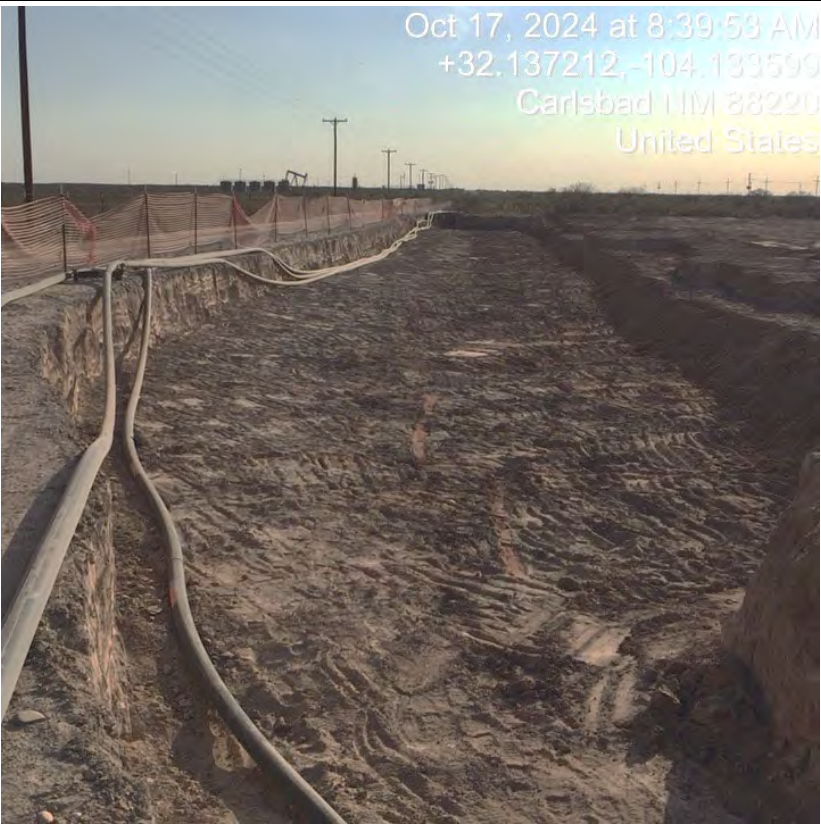
Photo Number: 9

<p>Oct 17, 2024 at 8:39:53 AM +32.137212,-104.133590 Carlsbad NM 88220 United States</p>
Photo Direction: East	
Photo Description: View of the excavated area.

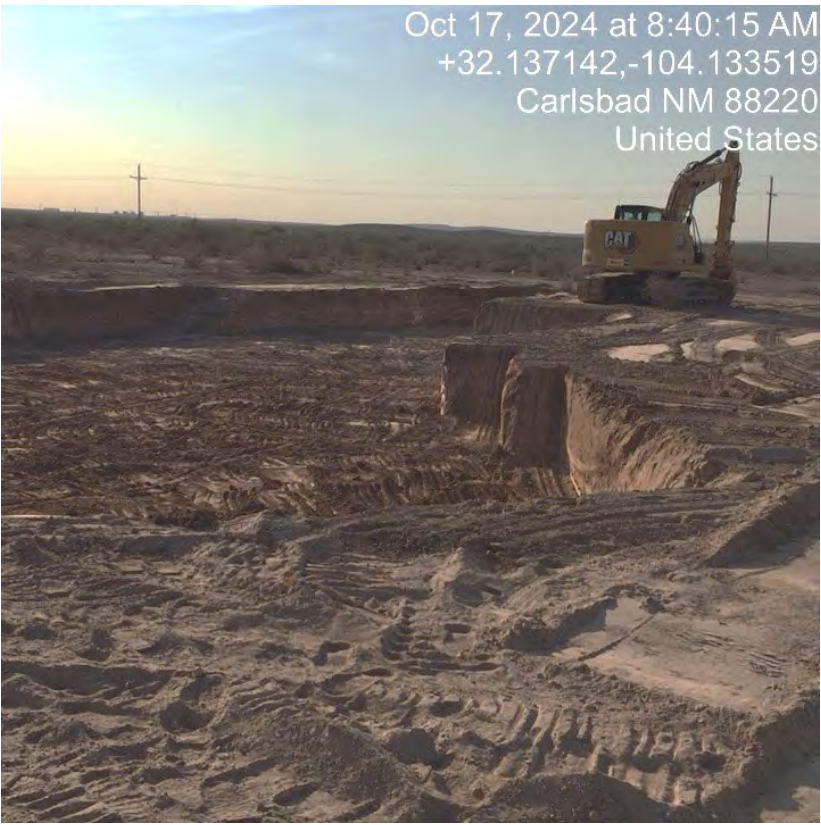
Photo Number: 10

<p>Oct 17, 2024 at 8:40:15 AM +32.137142,-104.133519 Carlsbad NM 88220 United States</p>
Photo Direction: South-Southwest	
Photo Description: View of the excavated area.

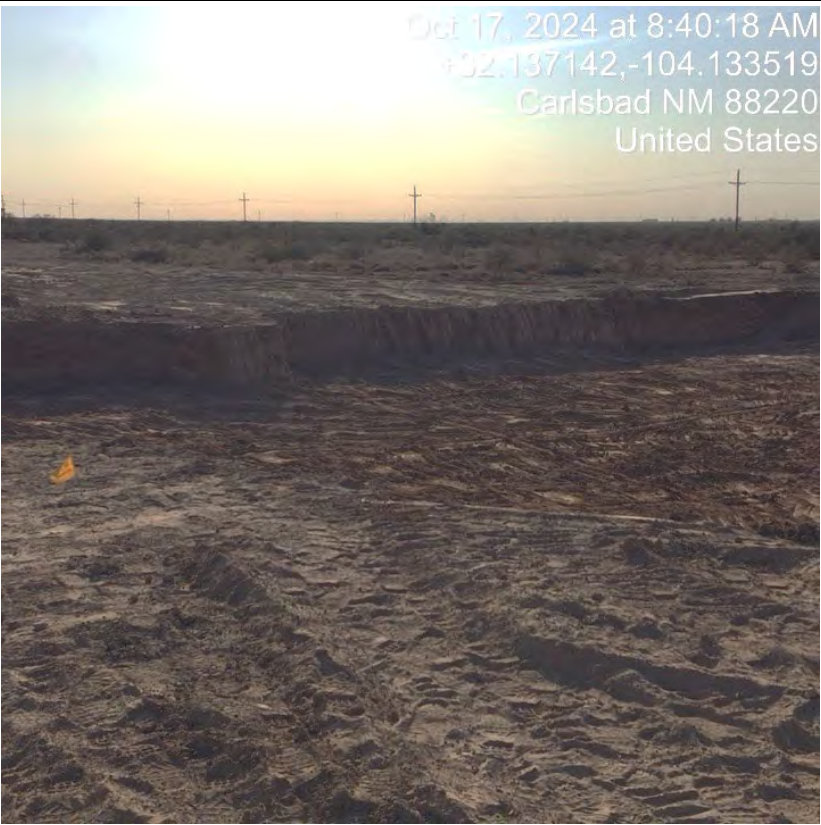
Photo Number: 11

A wide-angle photograph of a large, flat, excavated area under a bright, hazy sky at sunset. The ground is dark and uneven. In the background, several utility poles are visible against the horizon. The photo is timestamped 'Oct 17, 2024 at 8:40:18 AM' with coordinates '+32.137142,-104.133519' and location 'Carlsbad NM 88220 United States'.
Photo Direction: Southeast	
Photo Description: View of the excavated area.

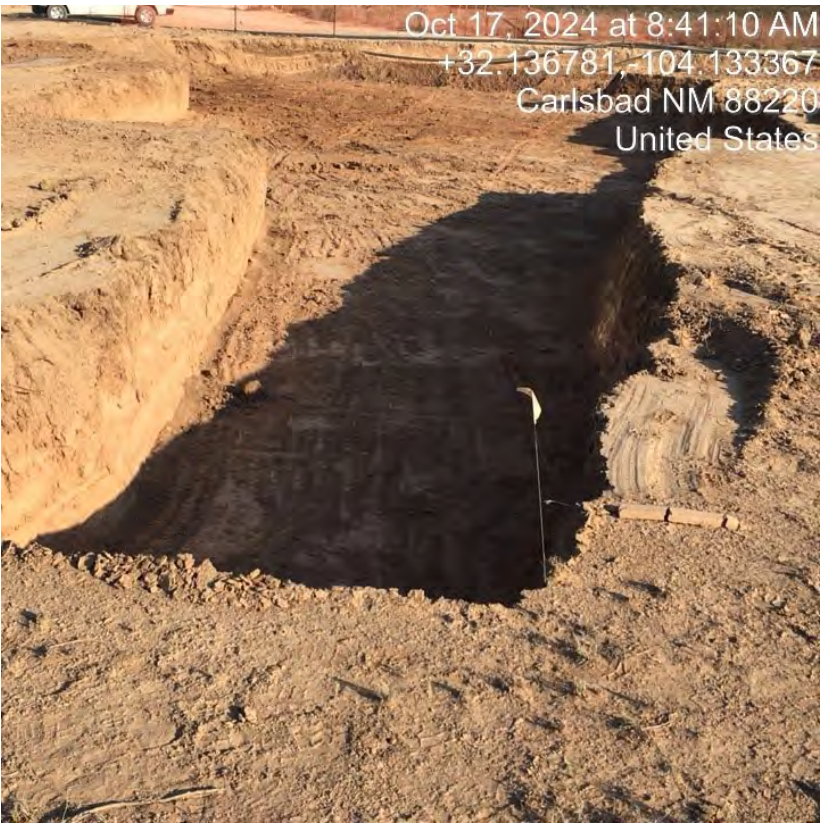
Photo Number: 12

A close-up photograph of an excavated area showing a deep shadow cast by an object off-camera. The ground is light-colored and uneven. A small, dark object is visible in the shadow. The photo is timestamped 'Oct 17, 2024 at 8:41:10 AM' with coordinates '+32.136781,-104.133367' and location 'Carlsbad NM 88220 United States'.
Photo Direction: North	
Photo Description: View of the excavated area.

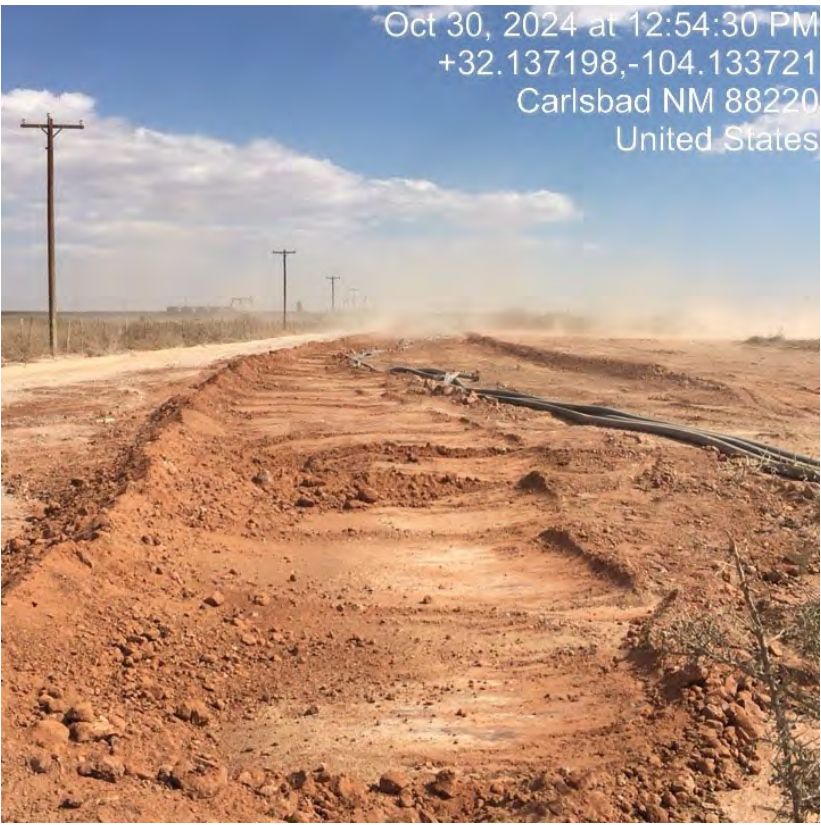
Photo Number: 14

<p>Oct 30, 2024 at 12:54:30 PM +32.137198,-104.133721 Carlsbad NM 88220 United States</p>
Photo Direction: East	
Photo Description: View of the remediated area following backfill and regrading.

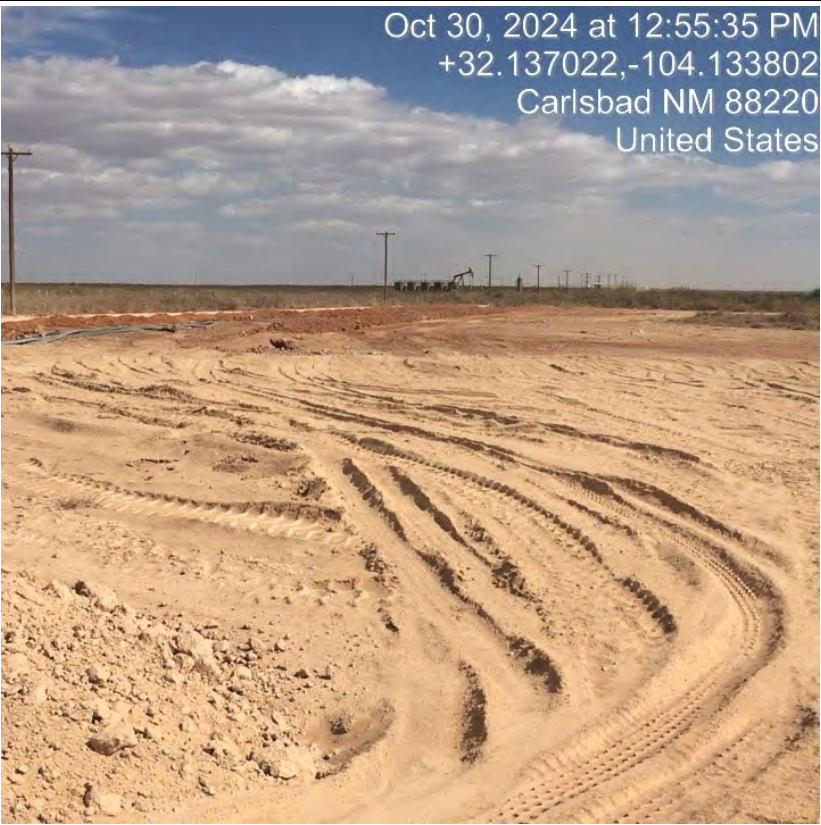
Photo Number: 15

Photo Direction: Northeast	
Photo Description: View of the remediated area following backfill and regrading.

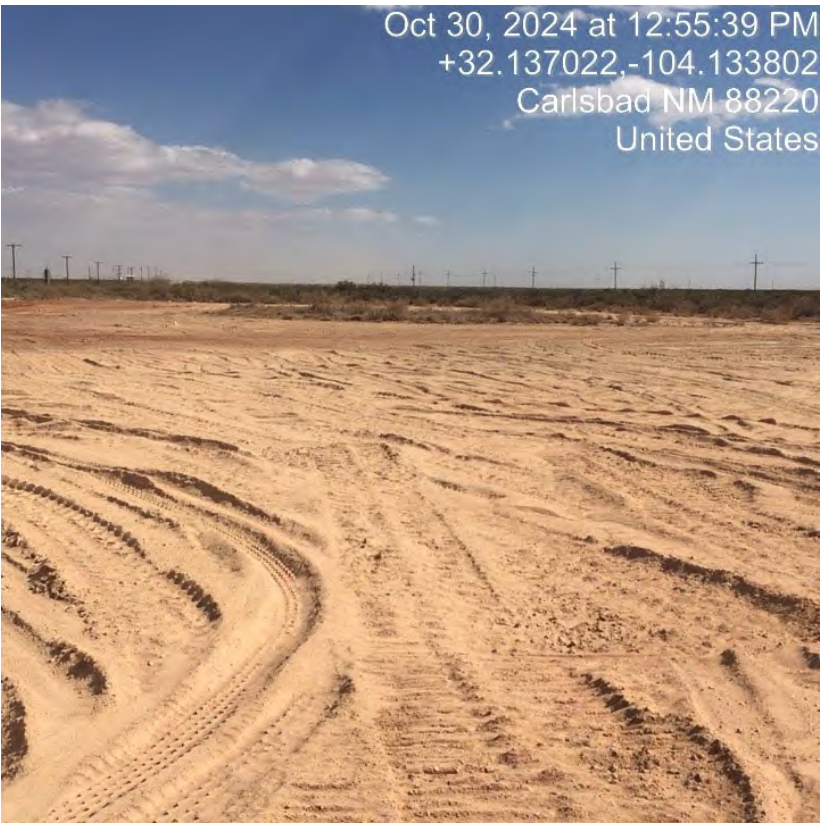
Photo Number: 16

Photo Direction: East	
Photo Description: View of the remediated area following backfill and regrading.
