December 2, 2024

**Re: Closure Report
BTA Oil Producers, LLC
Maxus B #1 Production Facility Release
Unit Letter P, Section 34, Township 22 South, Range 34 East
Lea County, New Mexico
Incident ID# nRM2026938804**

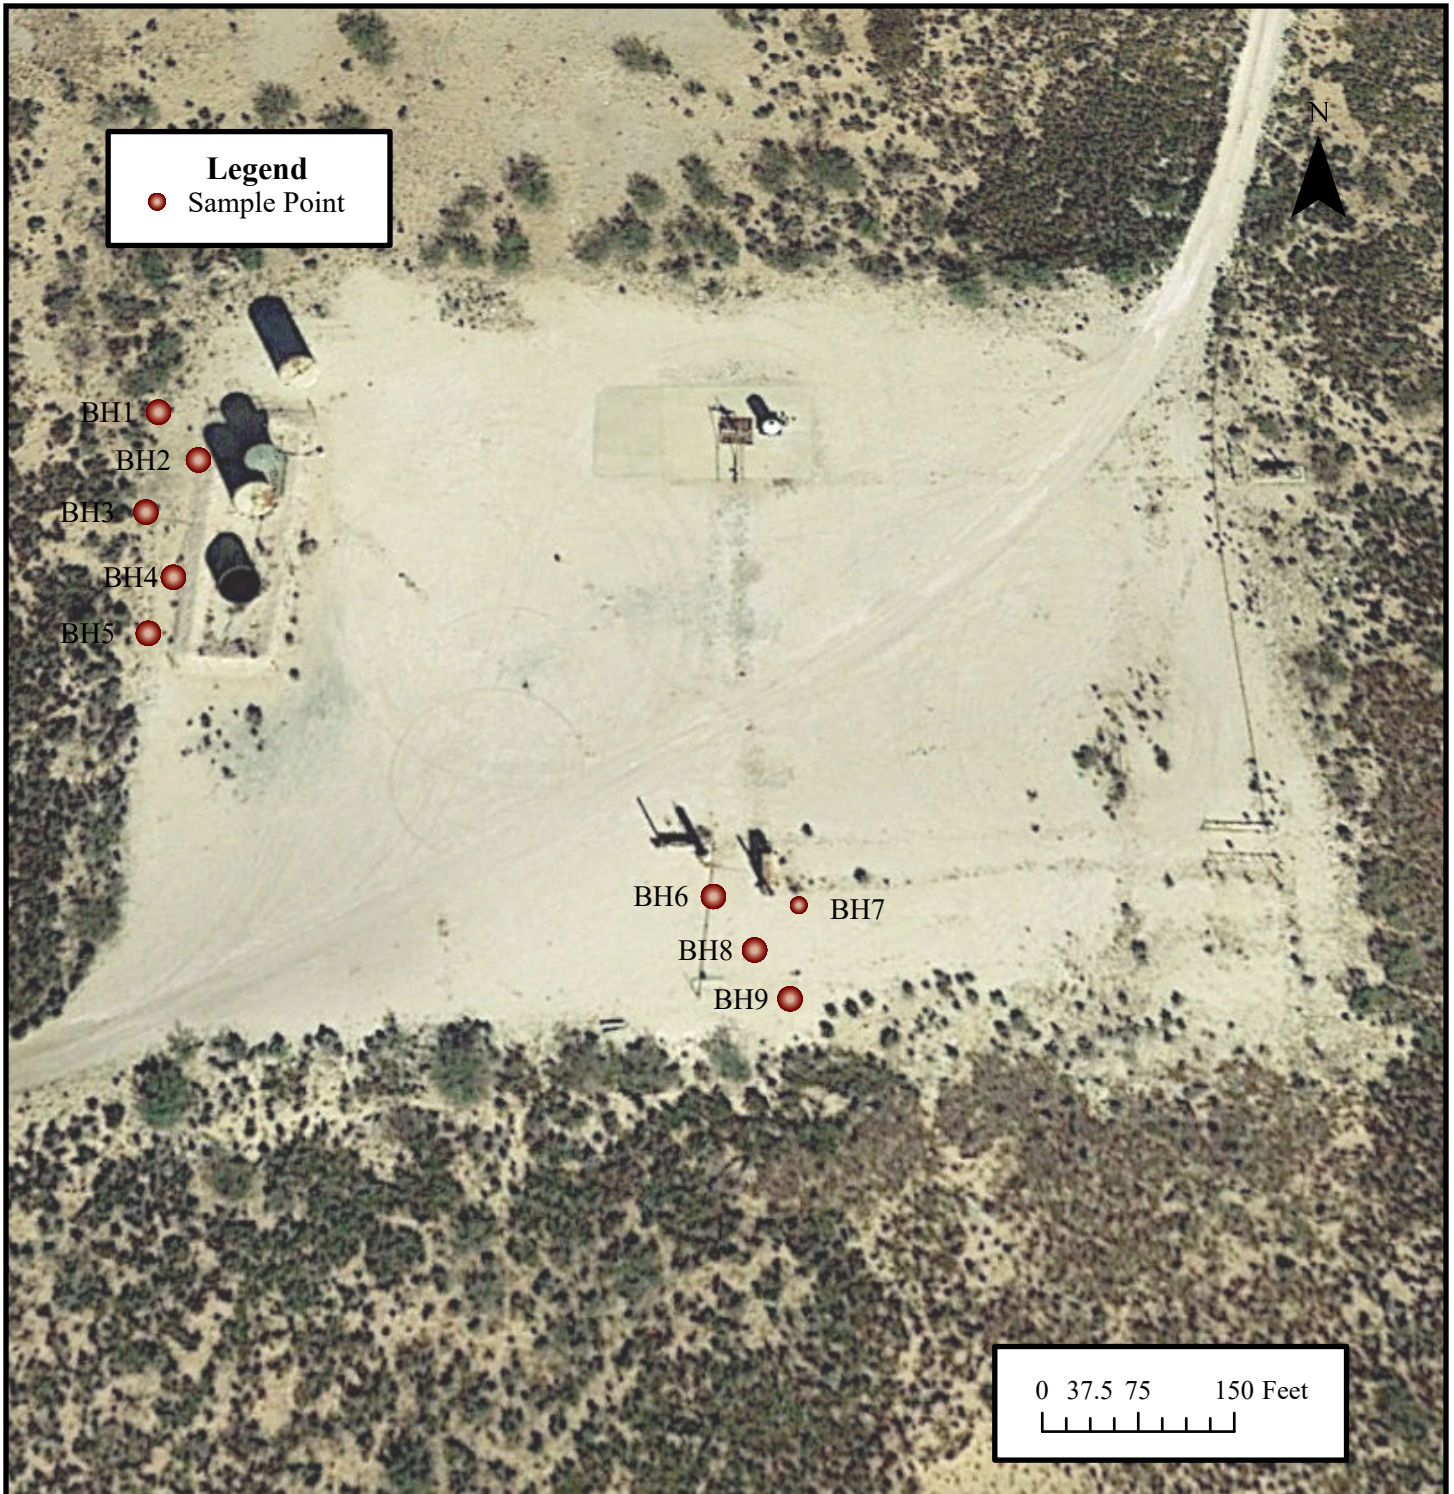
Figure 3

Sample Map

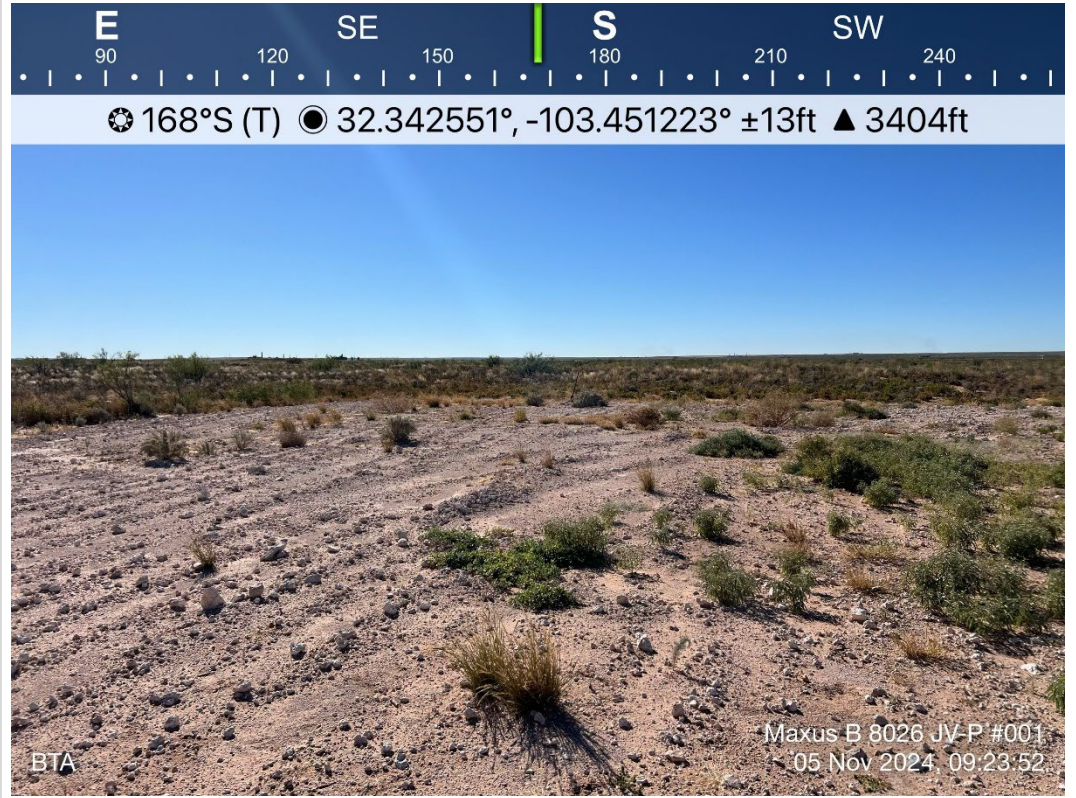
TETRA TECH, INC. PROJECT NO. 212C-MD-03675	DESCRIPTION	View south-southeast of reclaimed well pad. Dense vegetation established.	1
	SITE NAME	Maxus B 8026 JV-P #1	11/5/2024

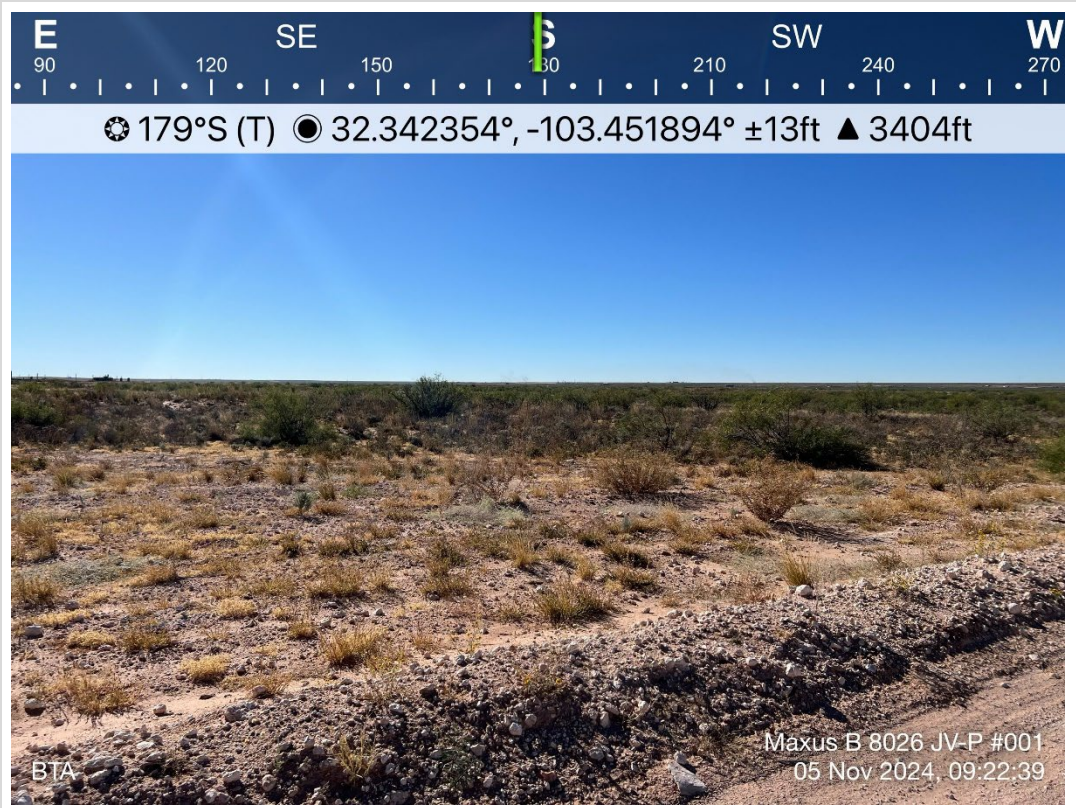
TETRA TECH, INC. PROJECT NO. 212C-MD-03675	DESCRIPTION	View south of reclaimed well pad and berm. Dense vegetation established.	1
	SITE NAME	Maxus B 8026 JV-P #1	11/5/2024
