Remediation Work Plan

Enterprise Products W24-012 Hobbs 5202 Tank Line
Enterprise Crude Pipeline Hobbs Station
Lea County, New Mexico
Incident # nAPP2401963204

Subject: **Remediation Work Plan**
Enterprise Products W24-012 Hobbs 5202 Tank Line
Lea County, New Mexico
Incident# nAPP2401963204

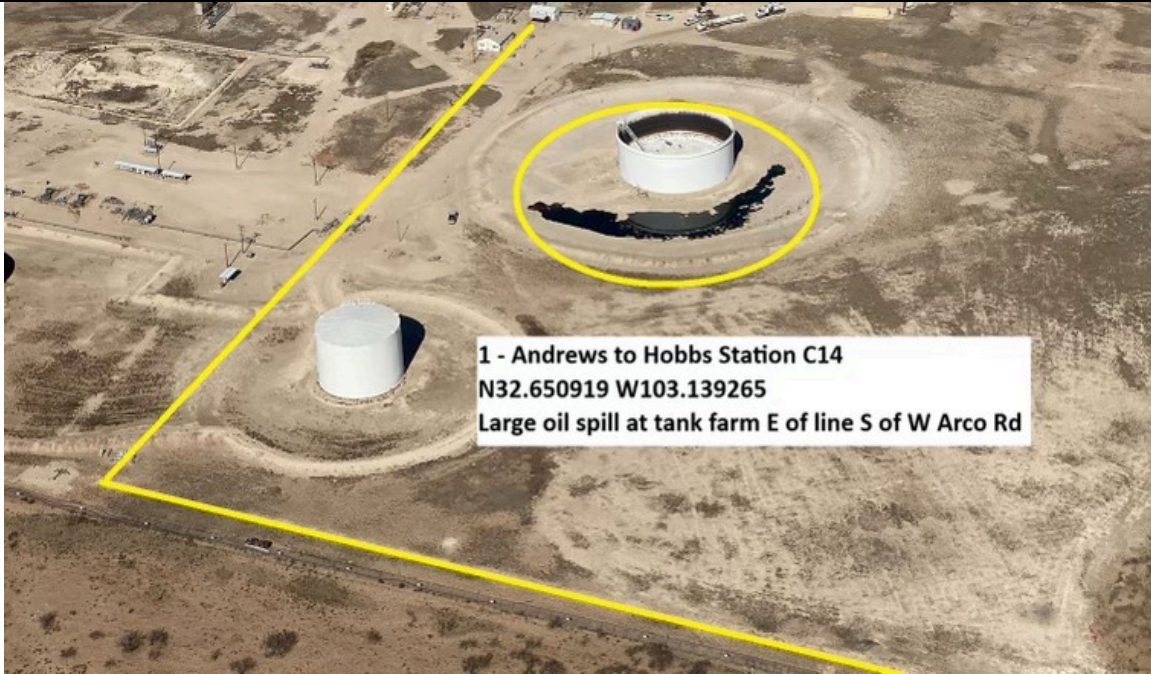
Photograph No. 1
Description:

1 - Andrews to Hobbs Station C14
N32.650919 W103.139265
Large oil spill at tank farm E of line S of W Arco Rd

Aerial view of release

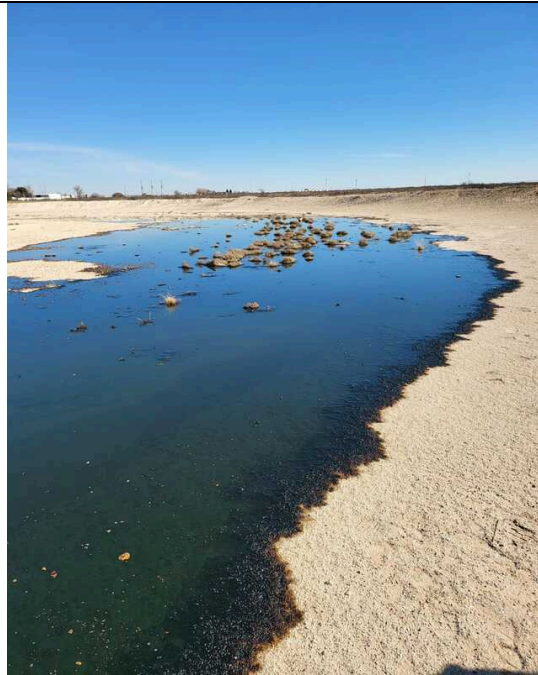
Photograph No. 2
Description:

Initial release

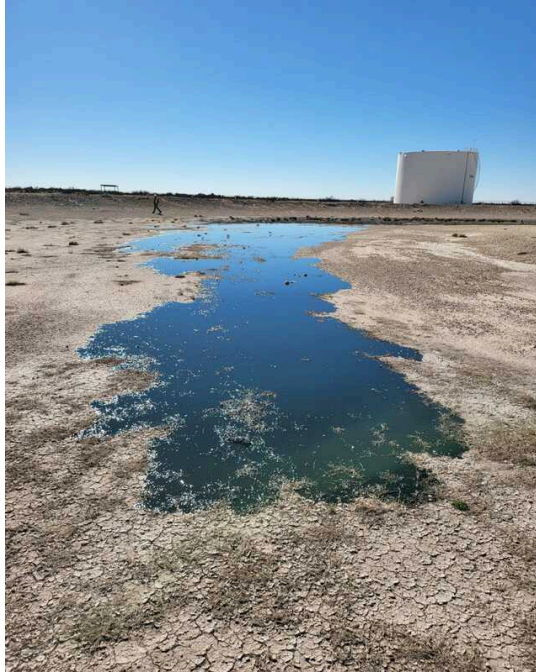
Photograph No. 3
Description:

Initial release

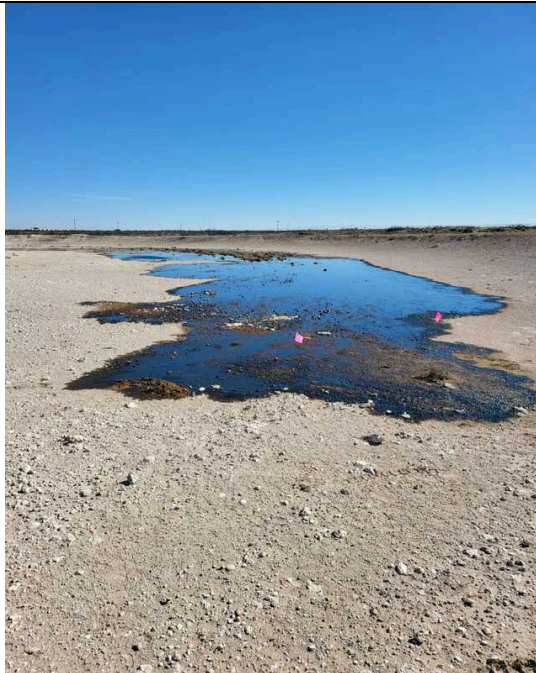
Photograph No. 4
Description:

Initial release

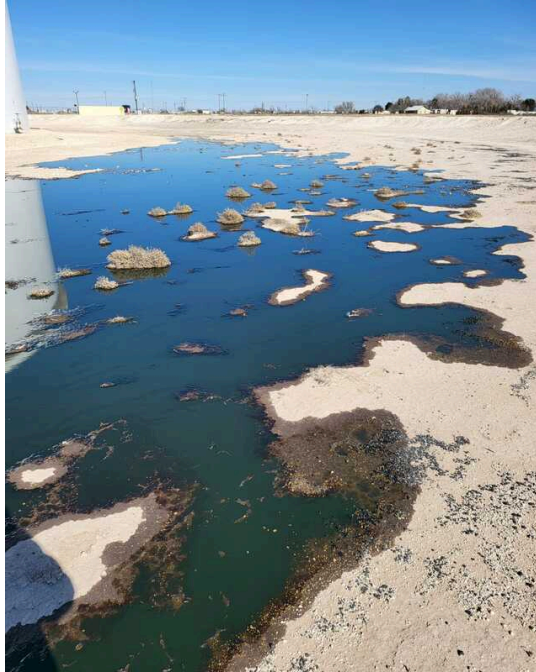
Photograph No. 5
Description:

Initial release

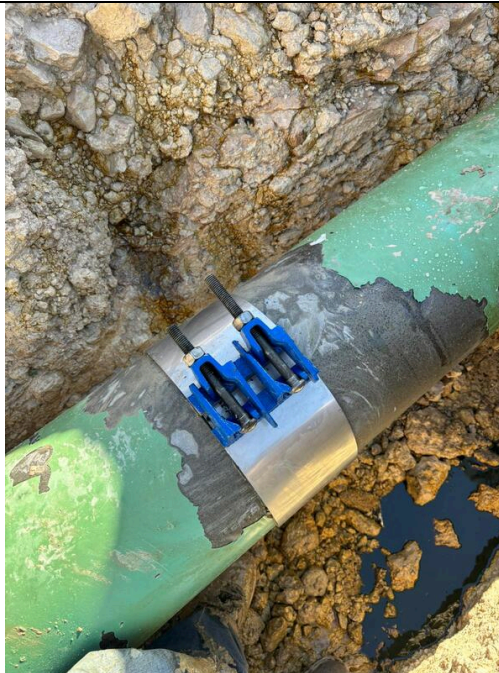
Photograph No. 6
Description:

Repaired line at source of release

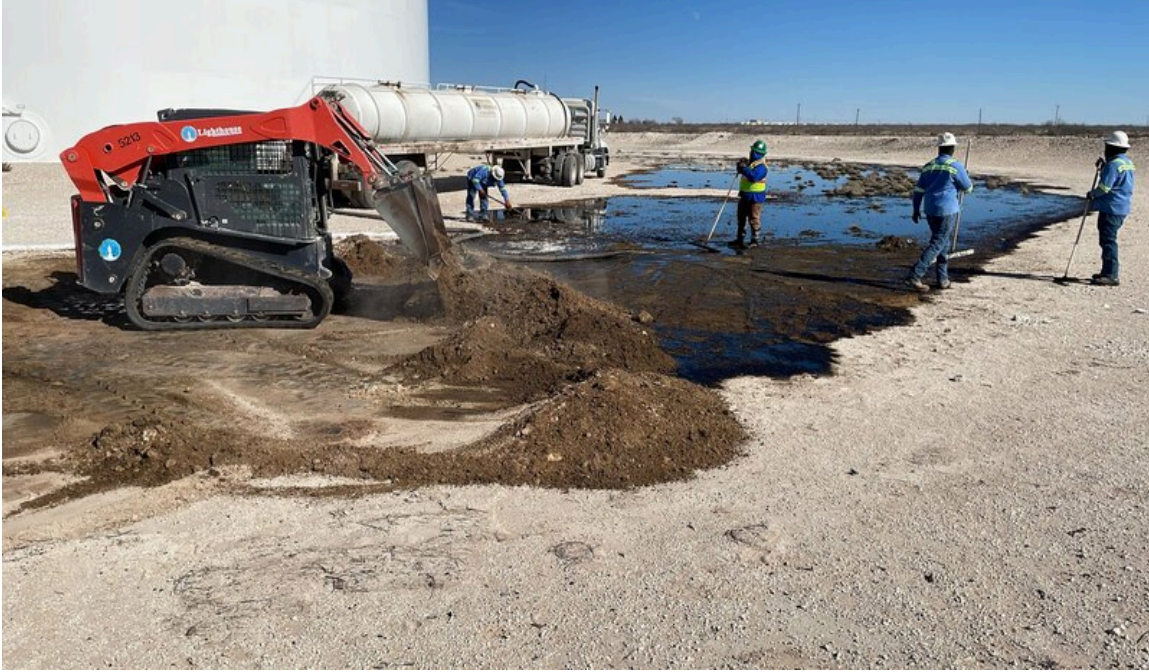
Photograph No. 7
Description:

Initial remediation activities

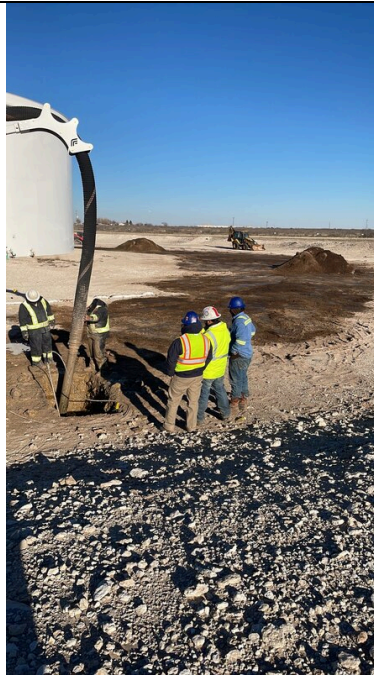
Photograph No. 8
Description:

Initial remediation activities
