# PLU 25 Brushy Draw West Intermittent Stream 331ft

The nAPP2403657069 release occurred on January 22, 2024, due to corrosion in a production flow line. The incident was reported on January 23, 2024, and involved the release of approximately 40 barrels (bbl) of produced water around and under equipment on the facility pad. Approximately 35 bbl of free fluid was removed during initial clean-up. Additional details relevant to the release are presented in the C-141 Report (Appendix A).

The nAPP2408553359 release occurred on March 11, 2024, due to corrosion on a 6” flowline. This incident was reported on March 25, 2024 and involved the release of approximately 15 bbl of produced water to the west and under equipment on the facility pad. Approximately 13 bbl of free fluid was removed during initial clean-up. Additional details relevant to the release are presented in the C-141 Report (Appendix A).

Vertex recommends no additional remedial action at this time to address the releases at PLU 25 Brushy Draw West until the equipment on-site is decommissioned and removed. Laboratory analyses of the final confirmatory samples collected outside the deferral area showed constituent of concern

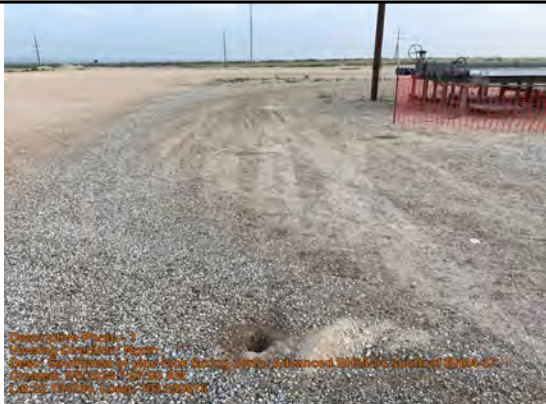
Southwest of pipe rack facing north. Advanced BH24-38 south of BH24-37.

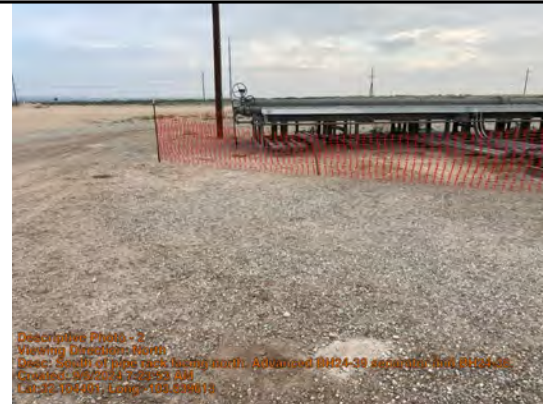
South of pipe rack facing north. Advanced BH24-39 between separator and BH24-38.

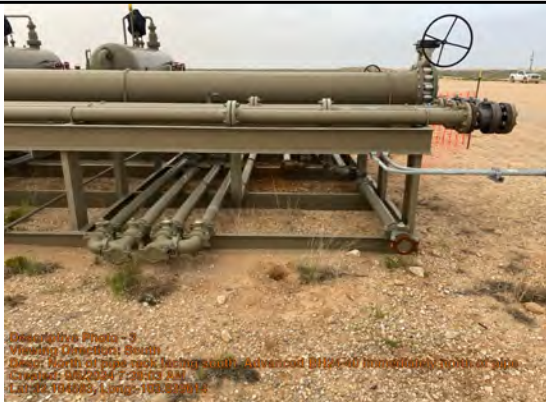
North of pipe rack facing south. Advanced BH24-40 immediately north of pipe rack.

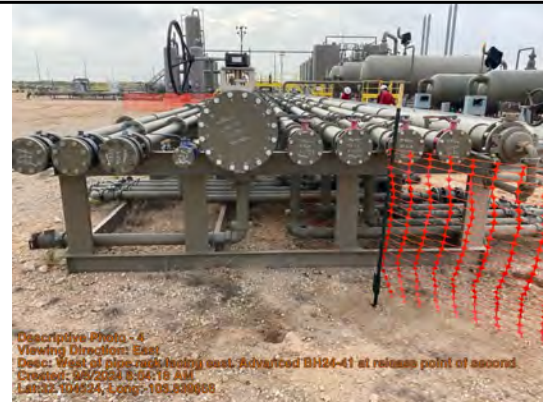
West of pipe rack facing east. Advanced BH24-41 at release point of second incident at end of pipe rack.

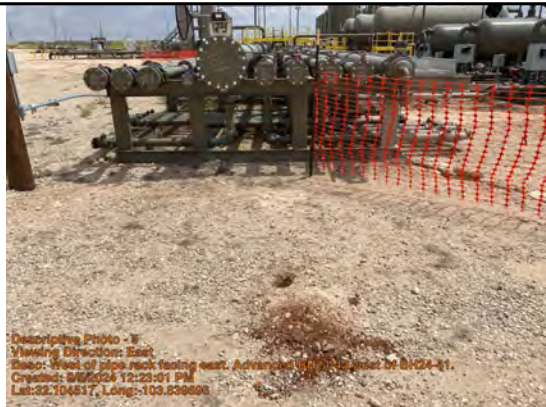
West of pipe rack facing east. Advanced BH24-42 west of BH24-41.

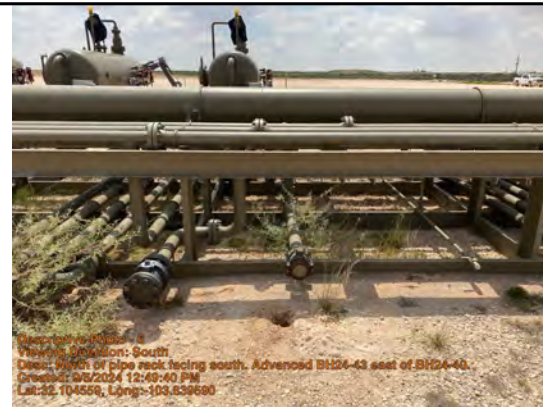
North of pipe rack facing south. Advanced BH24-43 east of BH24-40.

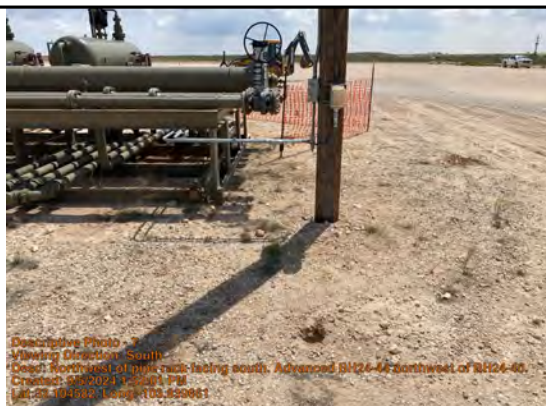
Northwest of pipe rack facing south. Advanced BH24-44 northwest of BH24-40.

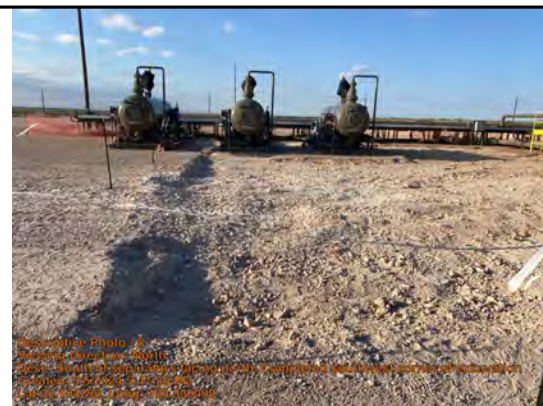
South of separators facing north. Completed southwest corner of excavation to 0.5 feet bgs.

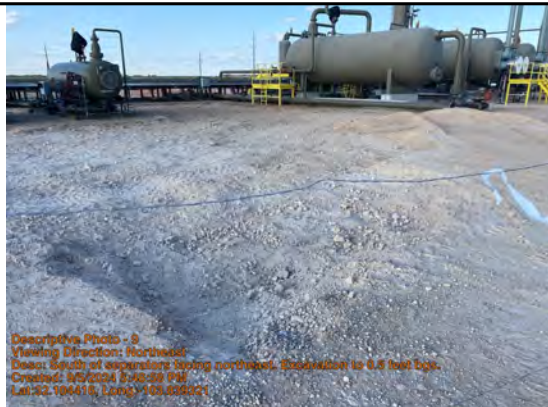
South of separators facing northeast.  
Excavation to 0.5 feet bgs.

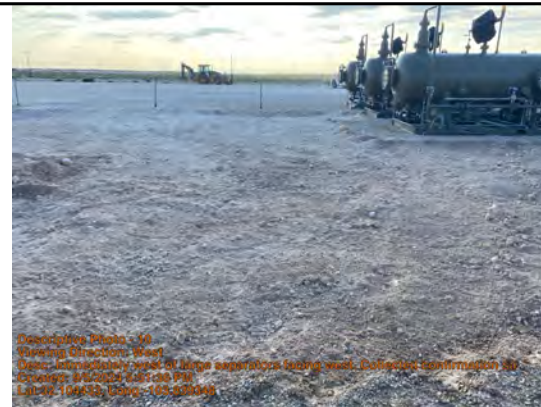
Immediately west of large separators facing west. Collected confirmation samples BS24-08 through BS24-16 from excavation to 0.5 feet bgs.

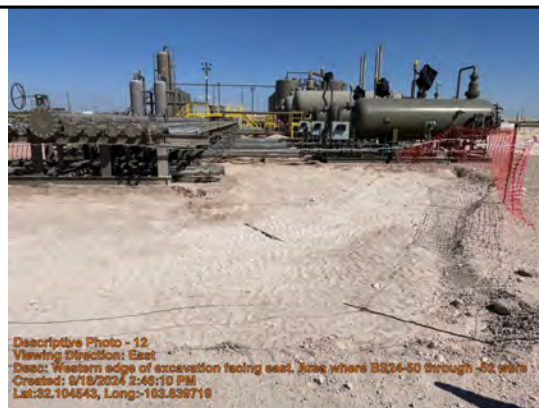
Western edge of excavation facing east. Area where BS24-50 through -52 were collected at 0.5 ft bgs.

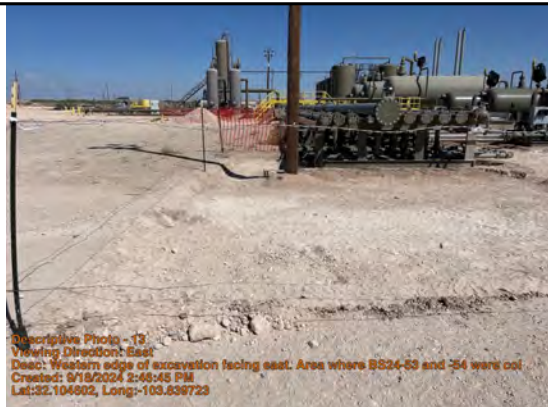
Western edge of excavation facing east. Area where BS24-53 and -54 were collected at 0.5 ft bgs.

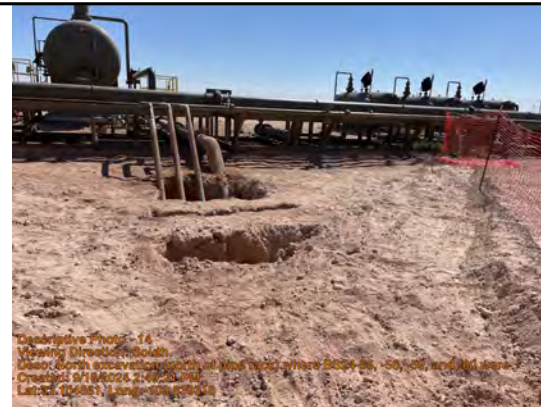
North excavation (north of pipe rack) where BS24-55, -56, -59, and -60 were collected at 0.5 ft bgs.

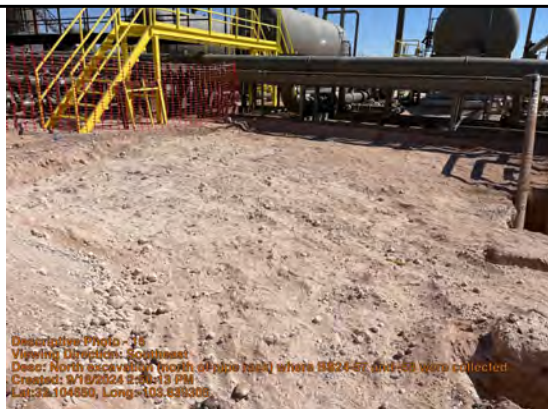
North excavation (north of pipe rack) where BS24-57 and -58 were collected at 0.5 ft bgs.

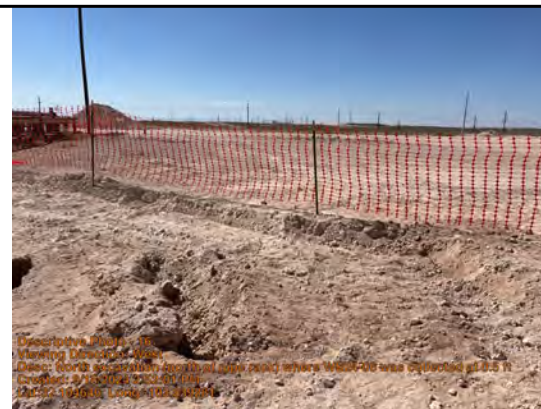
North excavation (north of pipe rack) where WS24-06 was collected at 0.5 ft bgs.

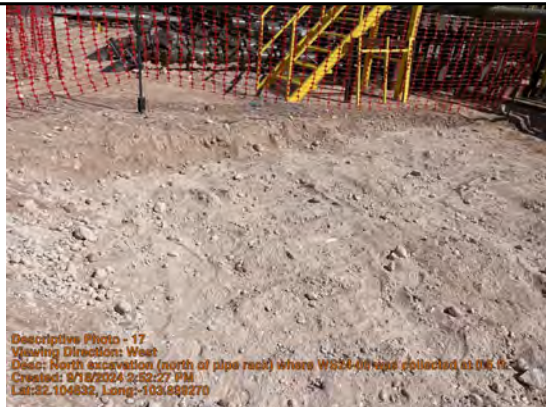
North excavation (north of pipe rack) where WS24-06 was collected at 0.5 ft bgs

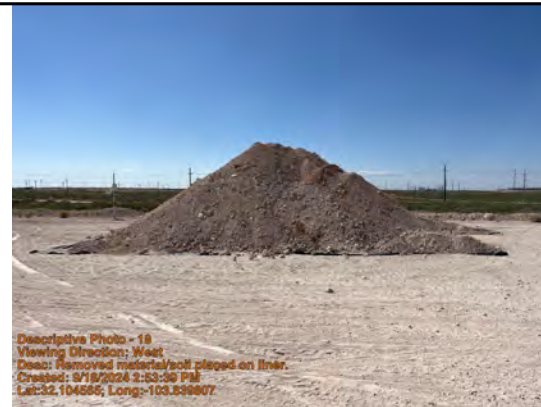
Removed material/soil placed on liner.

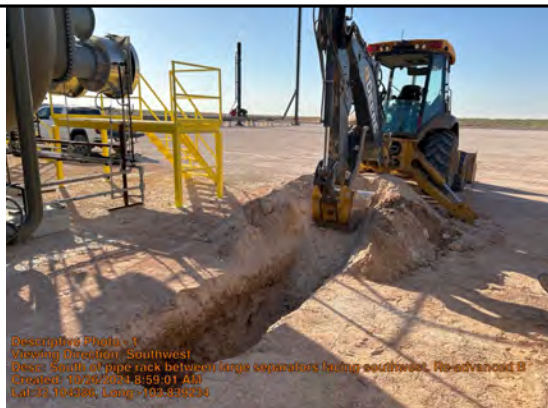
South of pipe rack between large separators facing southwest. Re-advanced BH24-04 to 5 feet bgs.

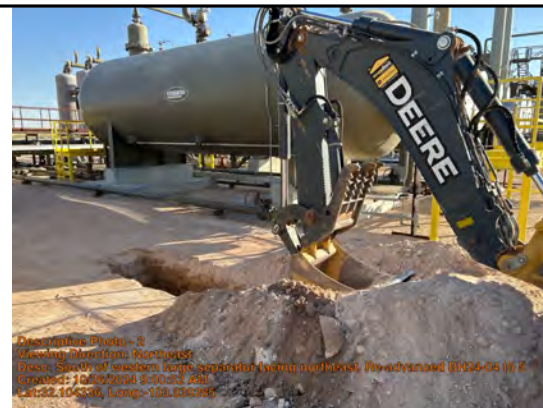
South of western large separator facing northeast. Re-advanced BH24-04 to 5 feet bgs.

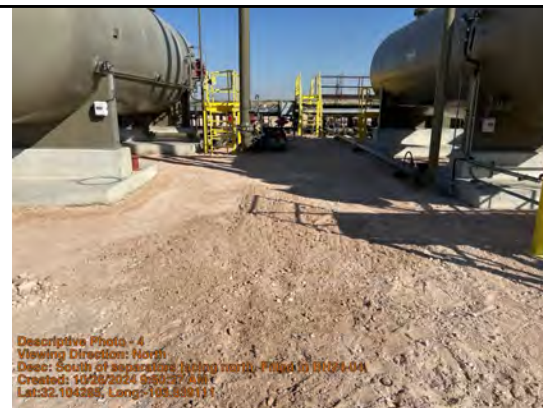
South of separators facing north. Filled in BH24-04.

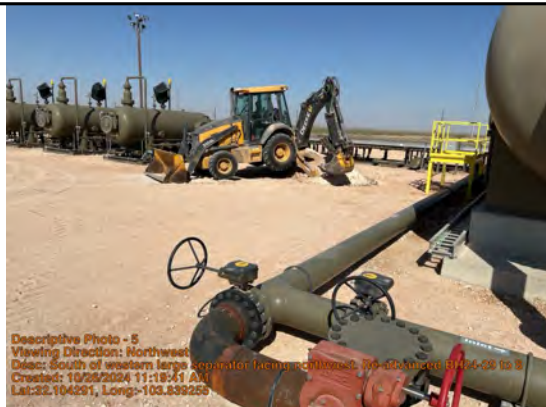
South of western large separator facing northwest. Re-advanced BH24-29 to 8 feet bgs.

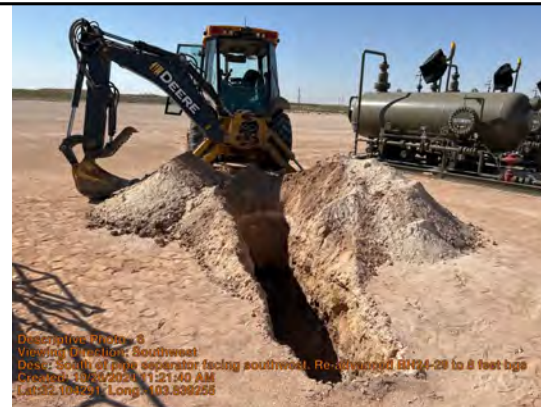
South of pipe rack facing southwest. Re-advanced BH24-29 to 8 feet bgs.

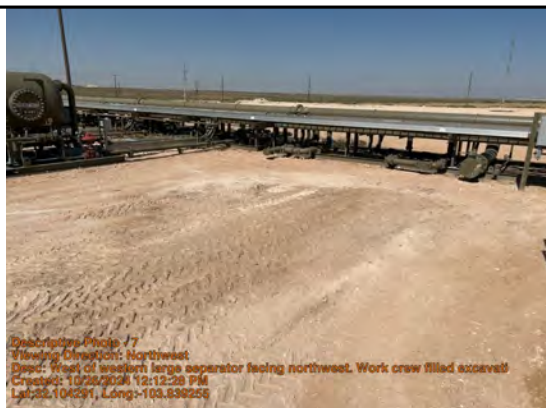
West of western large separator facing northwest. Work crew filled excavation in.
