Cooter 16 State Com #5H – Raybaw Operating, LLC

Remediation Plan Report

RE: Remediation Plan Report
Cooter 16 State Com #5H
API No. 30-015-37875 Raybaw Operating, LLC [330220]
Surface Location: O - 16 - 25S - 29E 330 FSL 2310 FEL
Lat/Long: 32.1236382, -103.9883423 NAD83
NMOCD Incident ID - nAB1517443063

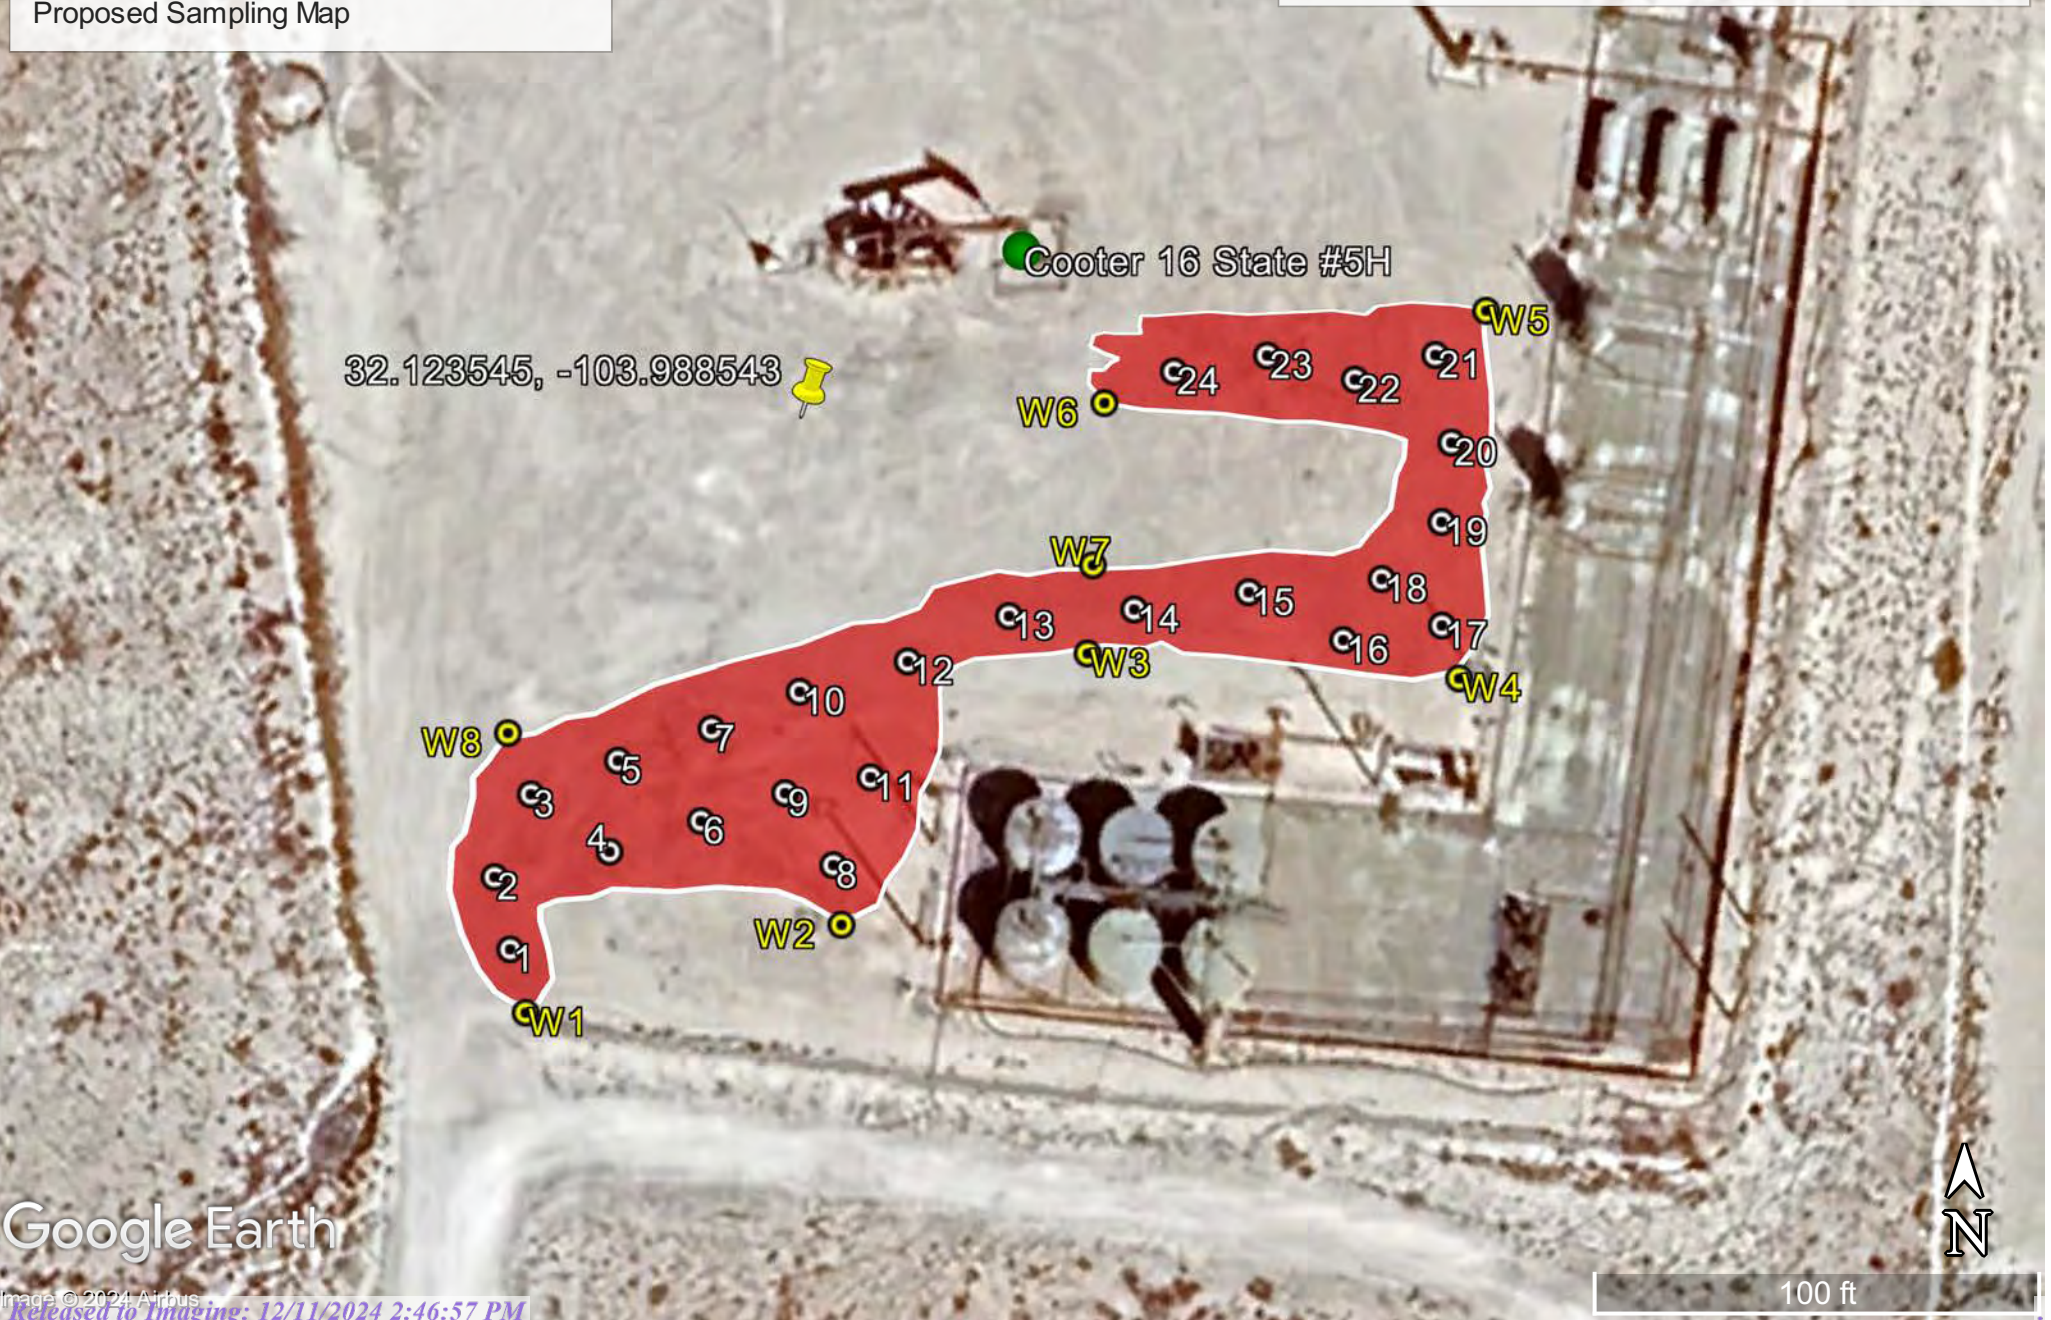
Raybaw Operating
API #30-015-37875
Eddy County, NM
nAB1517443063
Proposed Sampling Map

- Submit a 48-Hour notification to the NMOCD for a sampling event of the affected area.
- Collect discrete samples from the affected area on the pad that measures approximately 9,522 square feet and affected approximately 705 cubic yards after the 2' excavation was performed in 2020. With the approval of the Variance Request below, samples should be collected from 24 different sample points within the release area and from 8 different sample points around the edges of the release area. Each sample point will yield 4 samples from depth intervals of surface, 1', 3', and 4' bgs. A Proposed Sampling Map can be referenced in Figure 1.

- Horizontal delineation samples
- nAB1517443063 Release area - 9,522 square feet
- Vertical delineation samples

7. The impacted difference in collecting samples from every 400 square feet versus every 200 square feet can be seen in the following illustration.
8. Further illustration can be seen in the Proposed Sampling Map included in Figure 1.

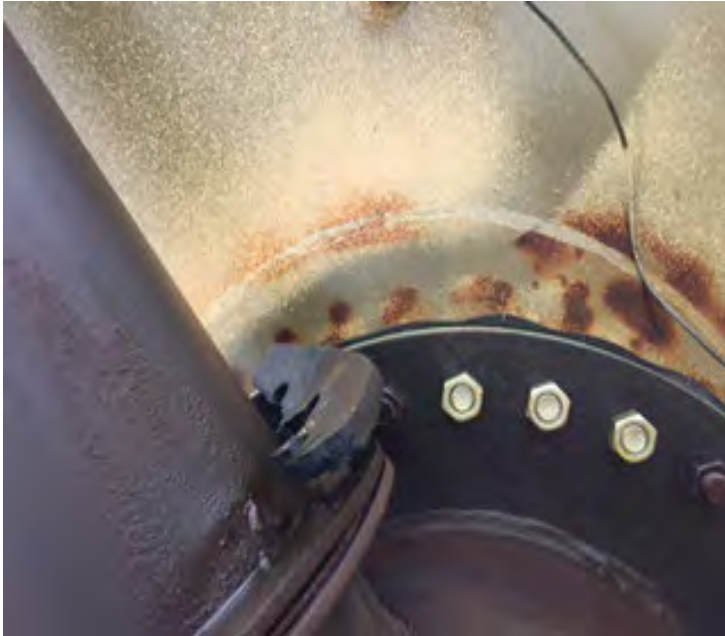
Point of Release

Lease operator inspected the heater treater and found that the gasket around the fire tube (upper left corner) of the gasket approximately 10" long had blown out causing the release of oil and water. The spill was limited to about 8bbl total 4 BBL of oil and 4 BBL of produced water. 2 BBL was in lined containment and 2 BBL recovered, no holes in lined containment. 6 BBL was spilled on pad a 10 X 20 area and 5 BBL was recovered. An environmental company will be called out to evaluate area.

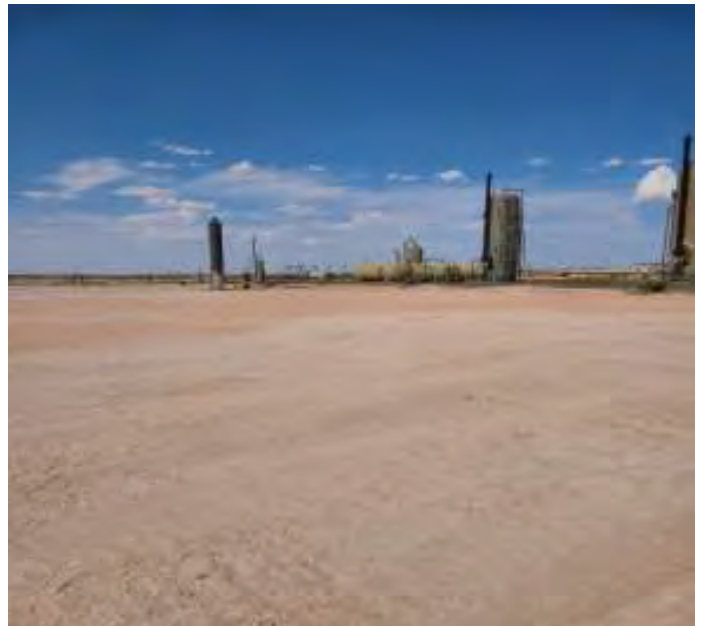
Talon Backfill 2020

Previously, a remediation took place at this site and a remediation closure report was submitted on December 21, 2020. This same report was submitted for each incident ID listed here. For nAB1517443063, the closure report can be found in OCD Online: Permitting - Application ID 12820. For nAB1614734572, the closure report can be found in OCD Online: Permitting - Application ID 12823. For nAB1701352947, the closure report can be found in OCD Online: Permitting - Application ID 12826. Included in this report for reference in Appendix E are a Talon Sampling Summary from 2020 and SESI Sampling Summary from 2015. Photographic Documentation can be found in Appendix D.

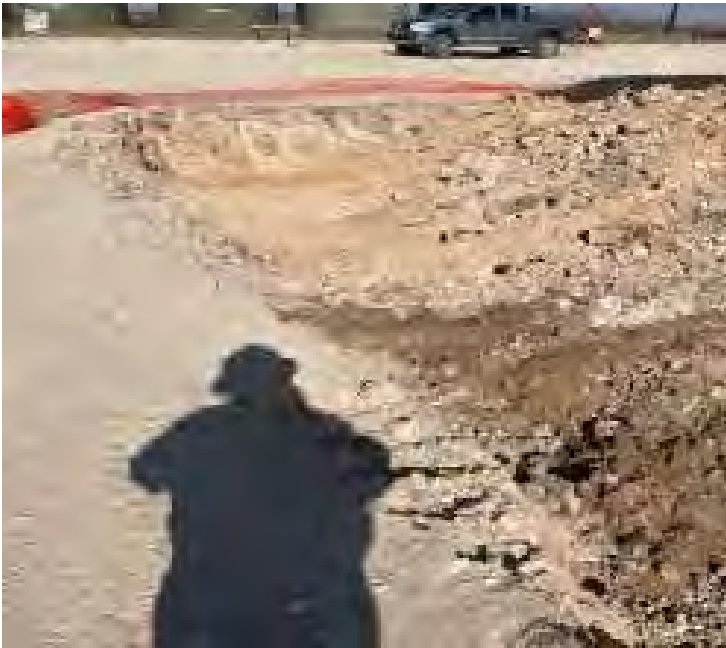
Talon Excavation 2020

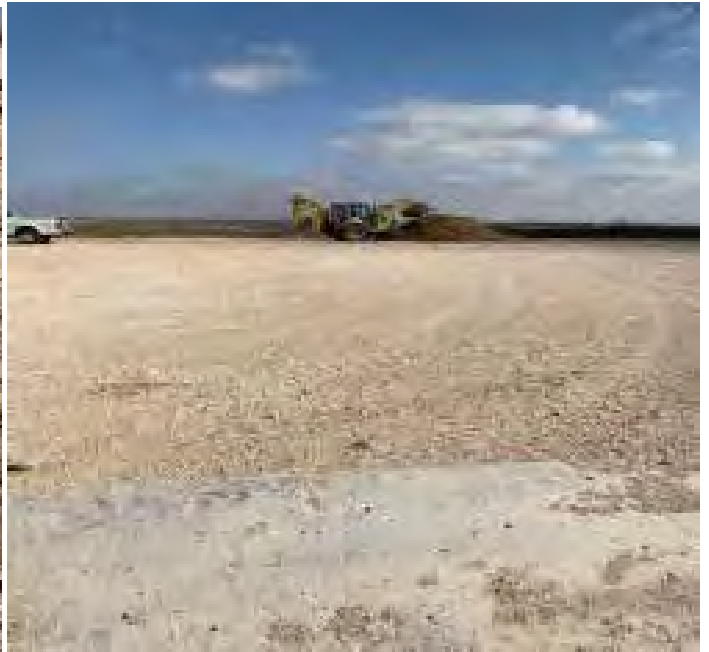
Talon Excavation 2020

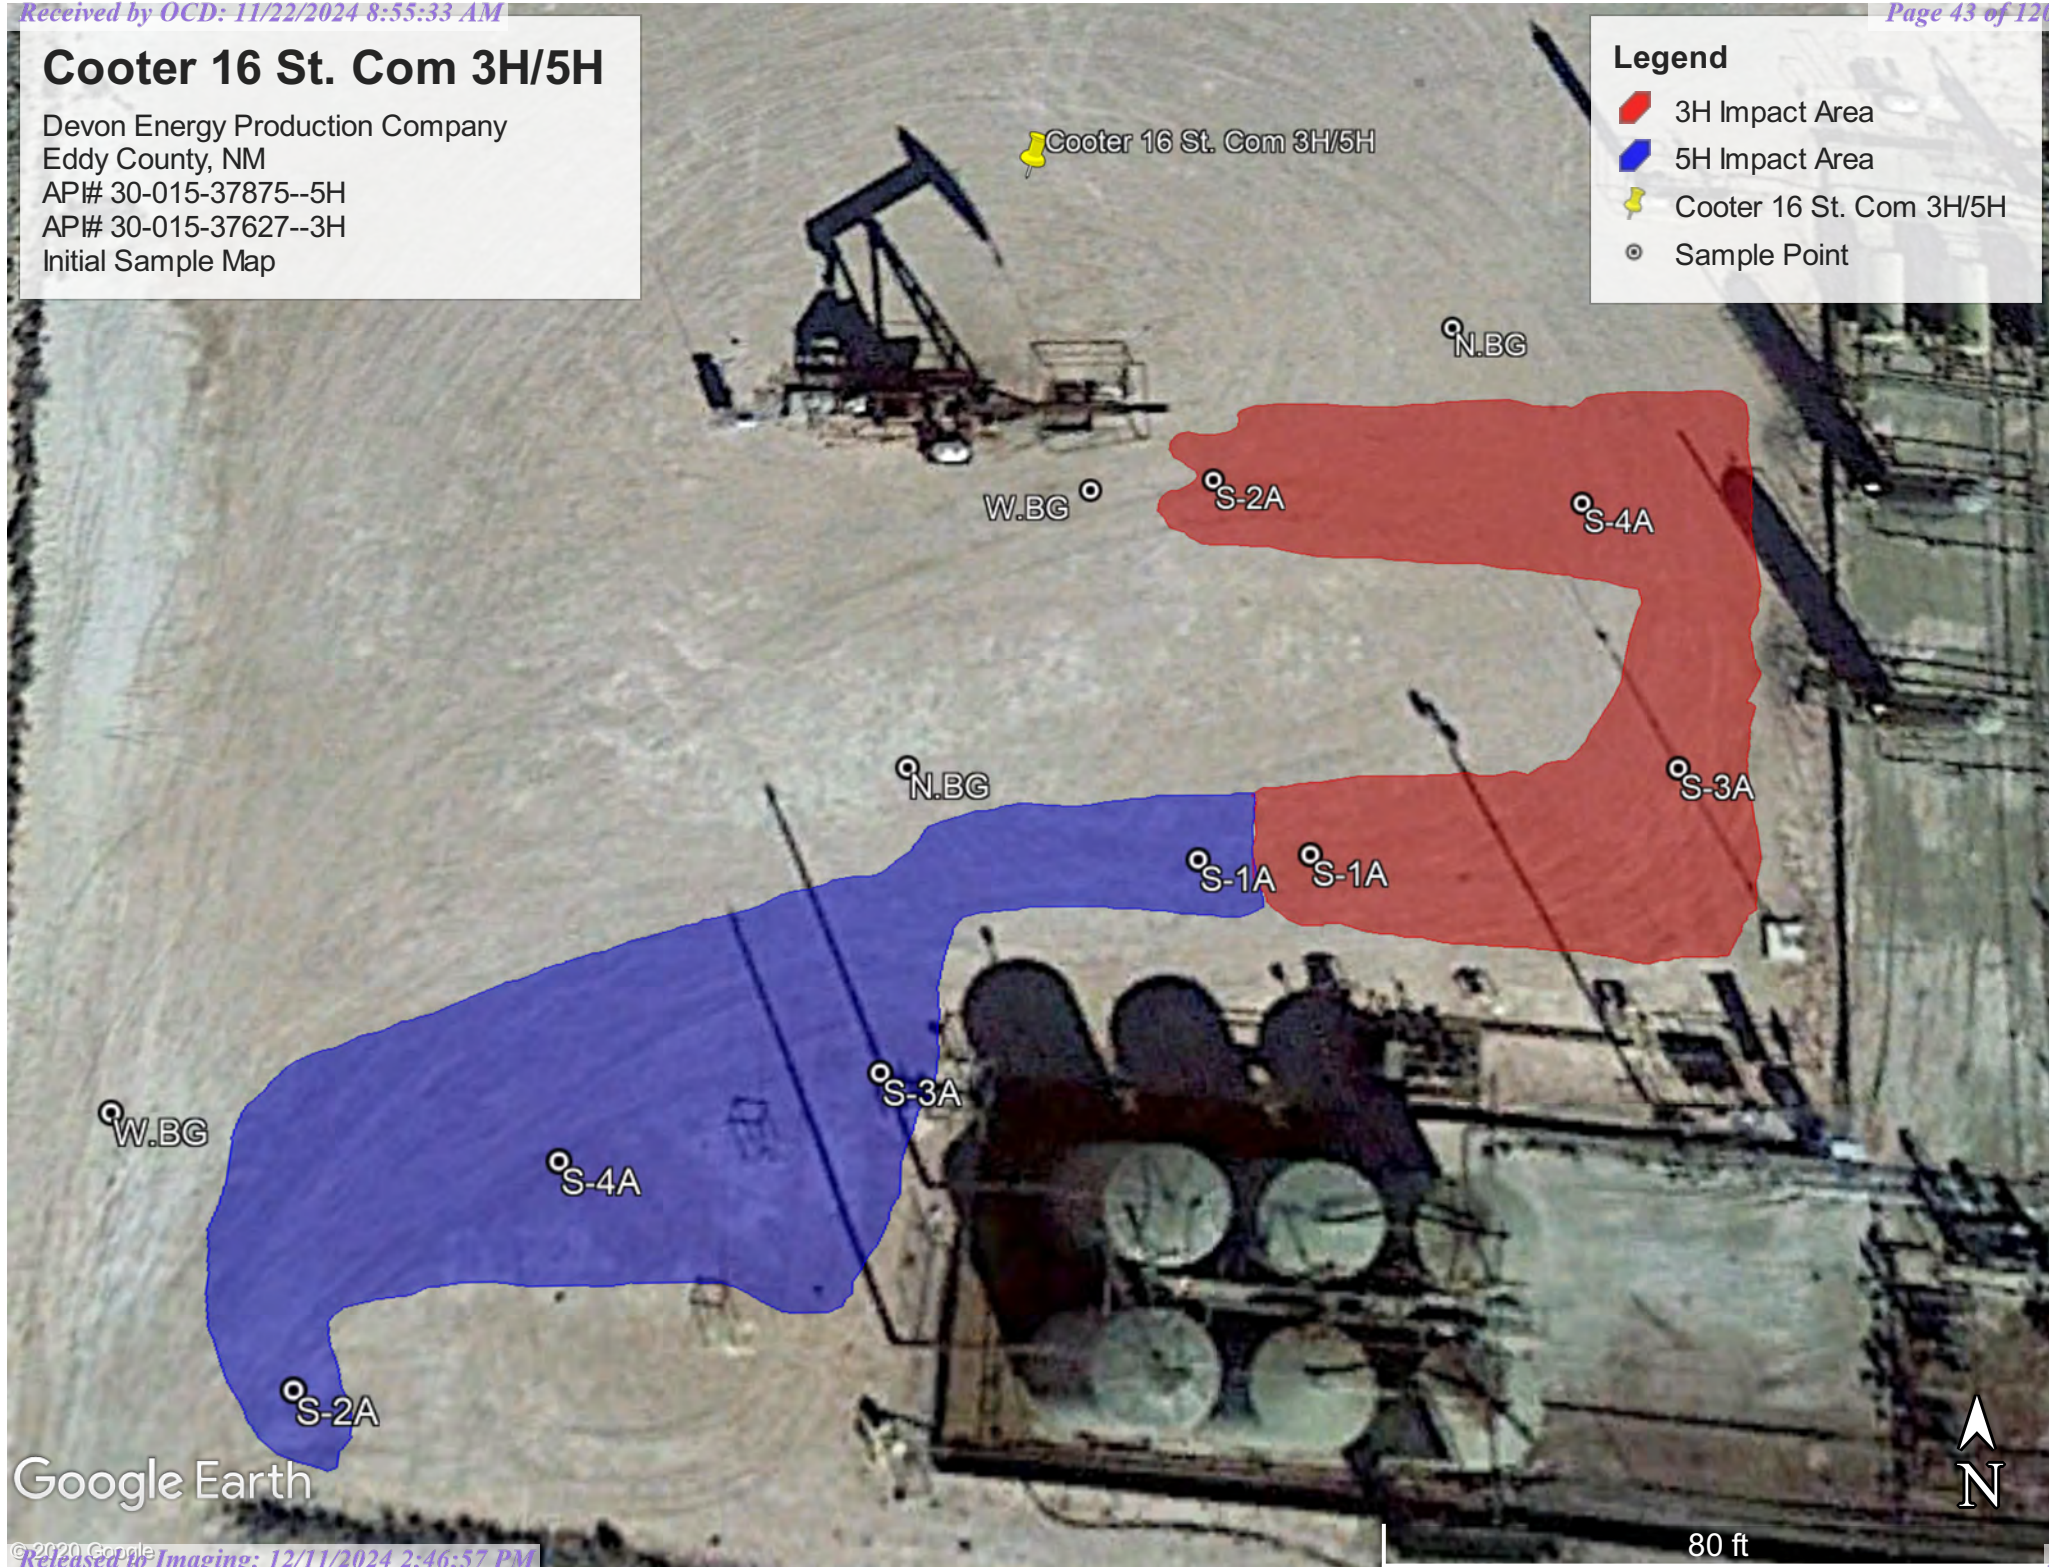
- 3H Impact Area
- 5H Impact Area
- Cooter 16 St. Com 3H/5H
- Sample Point

Sample Date 07/02/2015	Total BTEX	Chloride (mg/kg)	GRO C6-C10	DRO >C10-C28
Depth				
AH-1 @Surface	<0.600	2360	109	11600
AH-1 @ 6"	<0.300	2320	<10.0	1250
AH-1 @ 1'	<0.300	208	<10.0	1360
AH-2 @Surface	1.60	1260	214	30000
AH-2 @ 6"	.658	960	41.1	2720
AH-2 @ 1'	<0.300	160	31.1	1210
AH-3 @Surface	<0.600	1790	123	21400
AH-3 @ 1'	<0.300	64.0	<10.0	373
AH-4 @Surface	.785	2040	214	19700
AH-4 @ 1'	<0.300	112	<10.0	785
AH-5 @Surface	<0.600	336	144	11000
AH-5 @ 1'	<0.300	240	14.9	1640
