Re: Site Characterization and Remediation Work Plan
Devon Energy Production Corporation
Red Bull 29 CTB 2
Unit N, Section 29, Township 23S, Range 35E
Site Coordinates: 32.26943, -103.39078
Lea County, New Mexico
Incident ID: nAPP2425341702 & nAPP2426476658

On behalf of Devon Energy Production Corporation (Devon), New Tech Global Environmental, LLC (NTGE) has prepared this Site Characterization and Remediation Work Plan for submittal to the New Mexico Oil Conservation Division (NMCOD) District 2 Office in Artesia, New Mexico to document site assessment, remedial action activities, and sample analysis results for release numbers: nAPP2425341702 & nAPP2426476658– Red Bull 29 CTB 2 (Site). The Site is in Unit Letter N, Section 29, of Township 23 South and Range 35 East in Lea County, New Mexico. The GPS coordinates for the release site are 32.26943° N latitude and 103.39078° W longitude. The site location with respect to the nearest town is shown on Figure 1 and the topography of the area is shown on Figure 2.

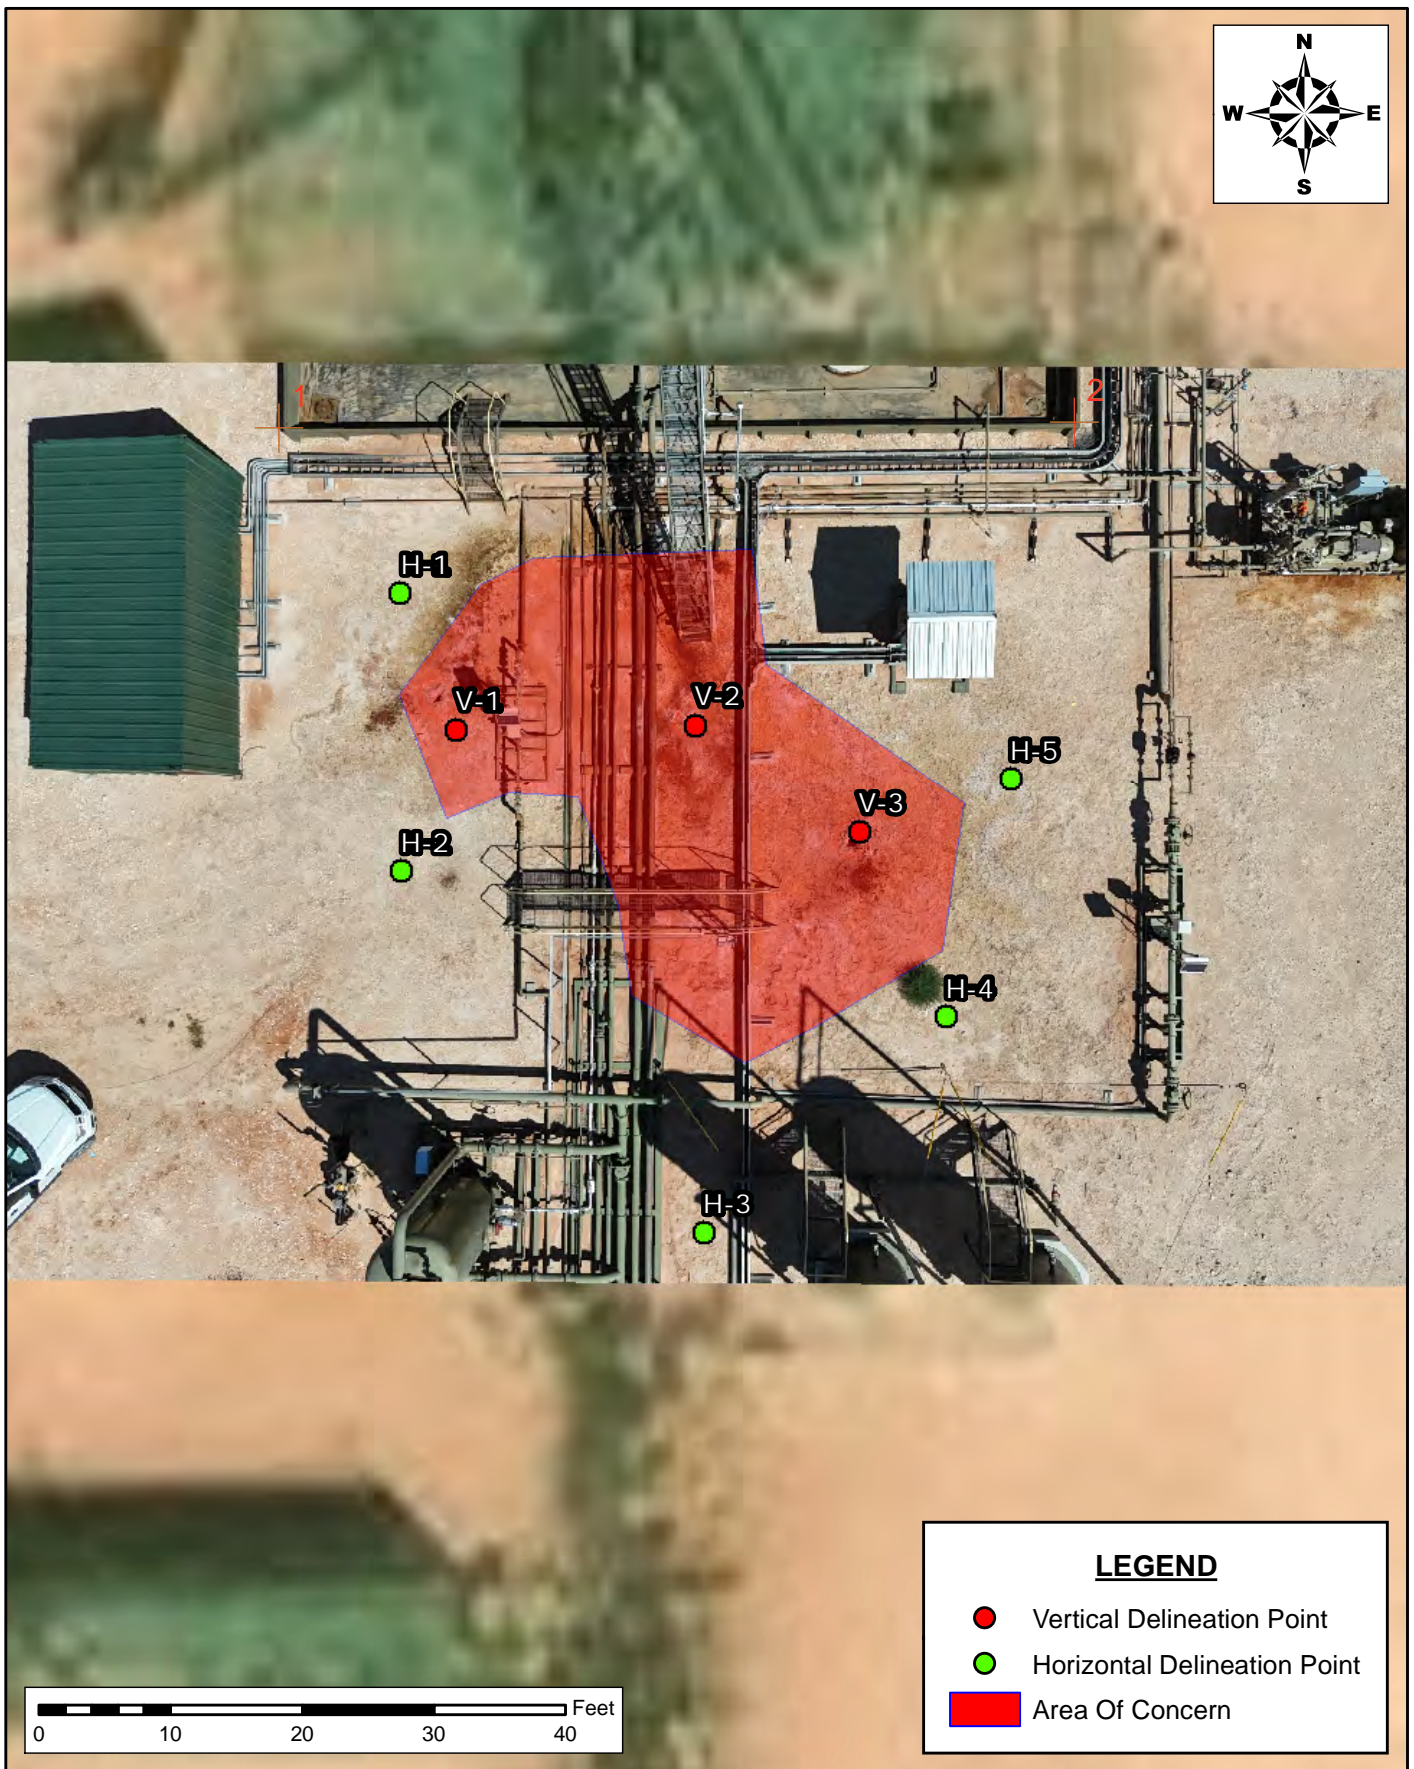
Based on the Release Notification C-141 Form, the release was discovered on September 20, 2024, and was due to an equipment failure. Upon discovery, the Site was shut-in and repairs were made. The spill resulted in a release of approximately five (5) barrels (bbls) of produced water of which two (2) barrels (bbls) were recovered, resulting in an approximate net loss of three (3) barrels (bbls) of produced water. The release areas are shown on Figure 3 & Figure 3A.

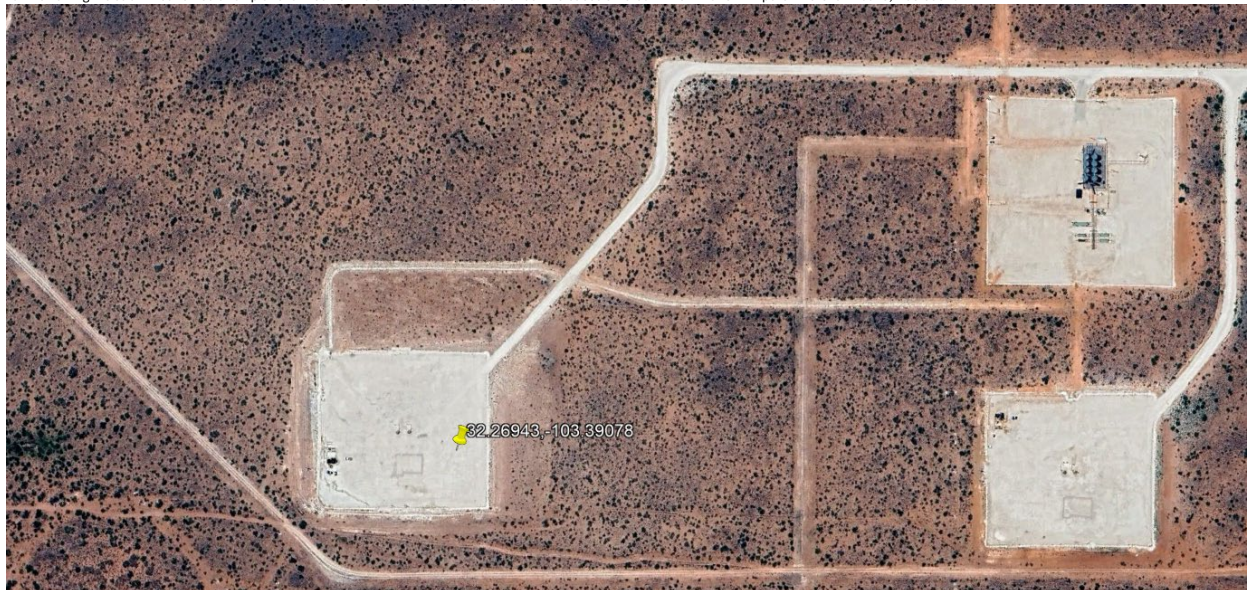
I am reviewing the submitted remediation plans for Red Bull 29 CTB 2 and the location of both releases entered in the initial C-141 puts it here: 32.26943,-103.39078

However the figures provided look like they are located .35 miles to the northeast of there-on the pad located at top right of screenshot. Also the photographs provided were taken at that location to the northeast. Can you please explain?
