October 1, 2024

**Re: Remediation and Reclamation Closure Report  
ConocoPhillips Company (Heritage COG Operating, LLC)  
Way South State Com #001H Tin Horn Release  
Unit Letter A, Section 30, Township 26 South, Range 28 East  
Eddy County, New Mexico  
Incident ID# nAB1821441824  
Landowner: NMSLO**

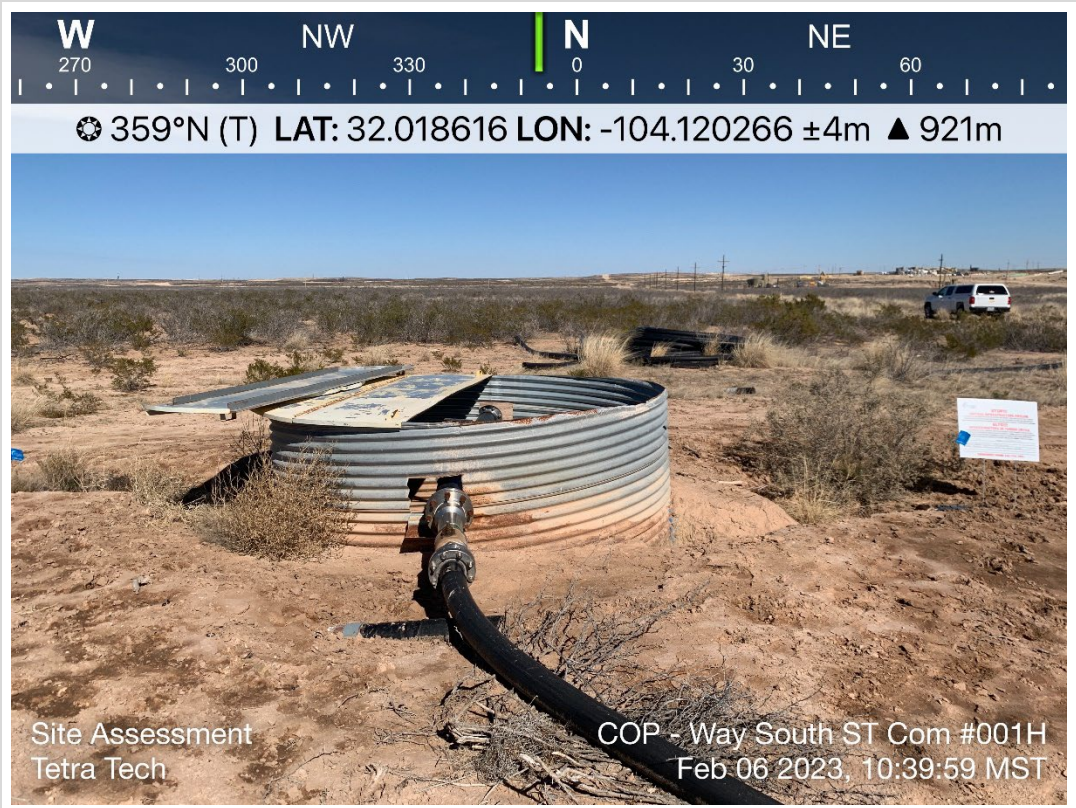
TETRA TECH, INC. PROJECT NO. 212C-MD-02994	DESCRIPTION	View north. View of tin horn and surface polyline during assessment phase.	1
	SITE NAME	Way South State Com Tinhorn Release	2/6/2023

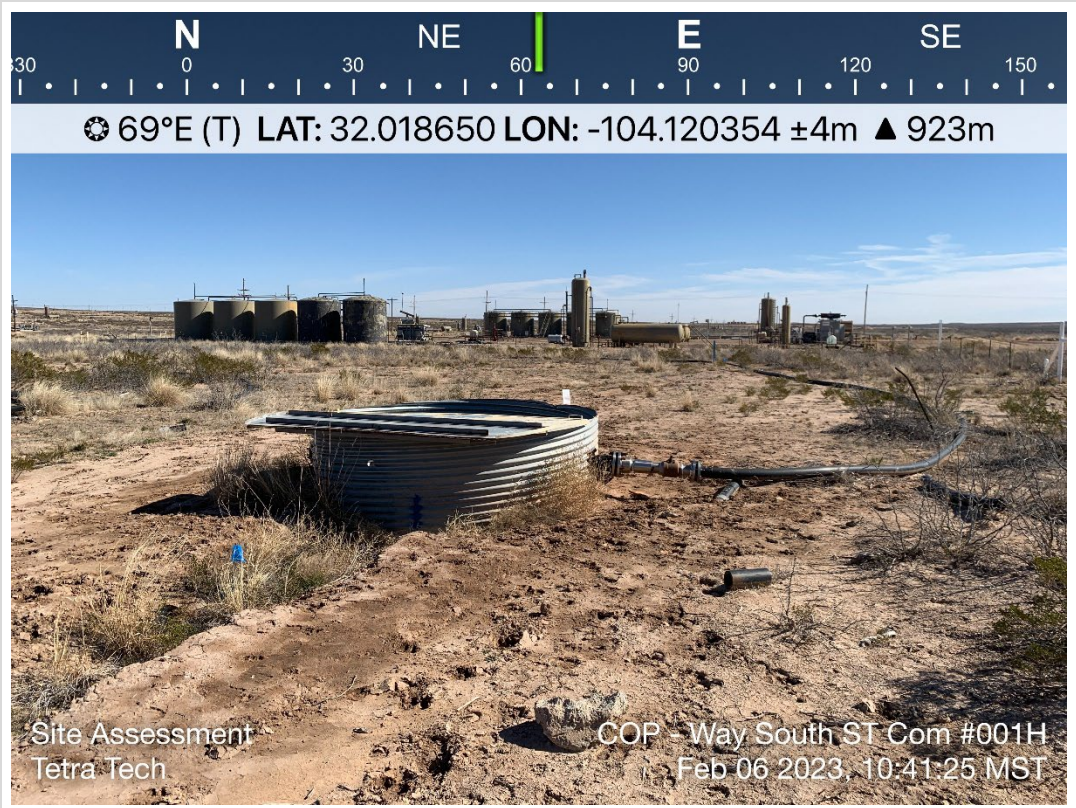
TETRA TECH, INC. PROJECT NO. 212C-MD-02994	DESCRIPTION	View northeast. View of tin horn and Way South State Com Tank battery prior to remediation.	3
	SITE NAME	Way South State Com Tinhorn Release	2/6/2023

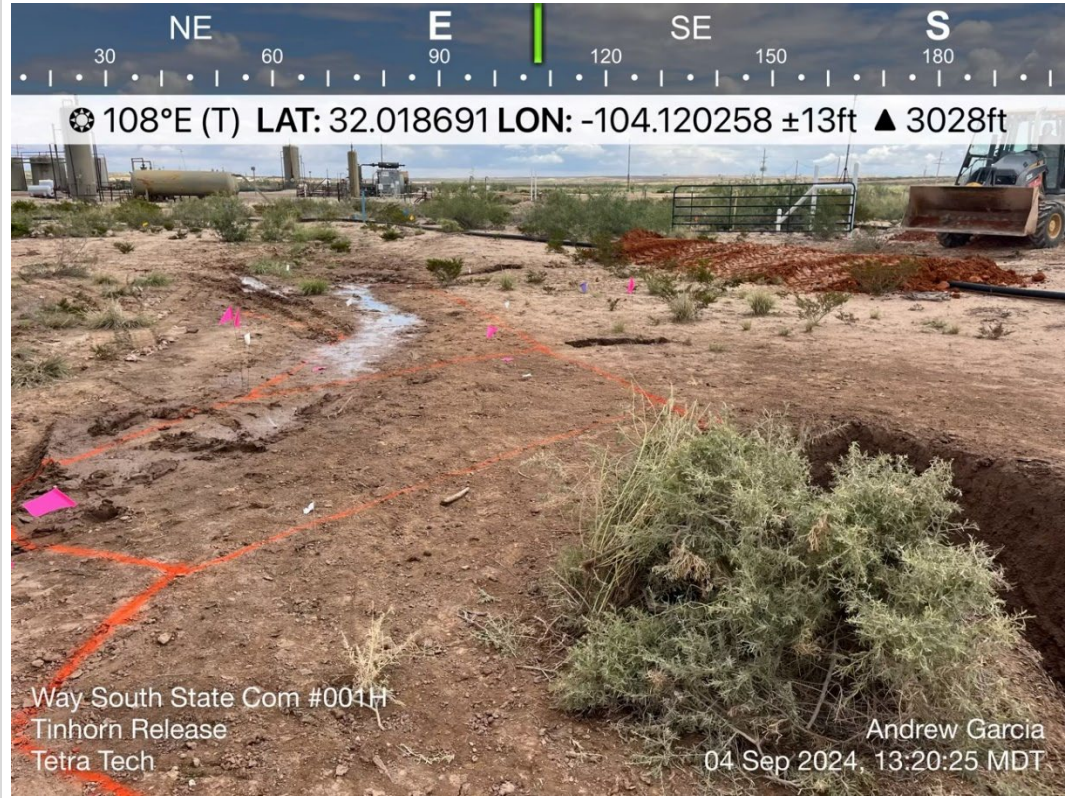
TETRA TECH, INC. PROJECT NO. 212C-MD-02994	DESCRIPTION	View east-southeast. Excavation areas outlined with paint.	4
	SITE NAME	Way South State Com Tinhorn Release	9/4/2024

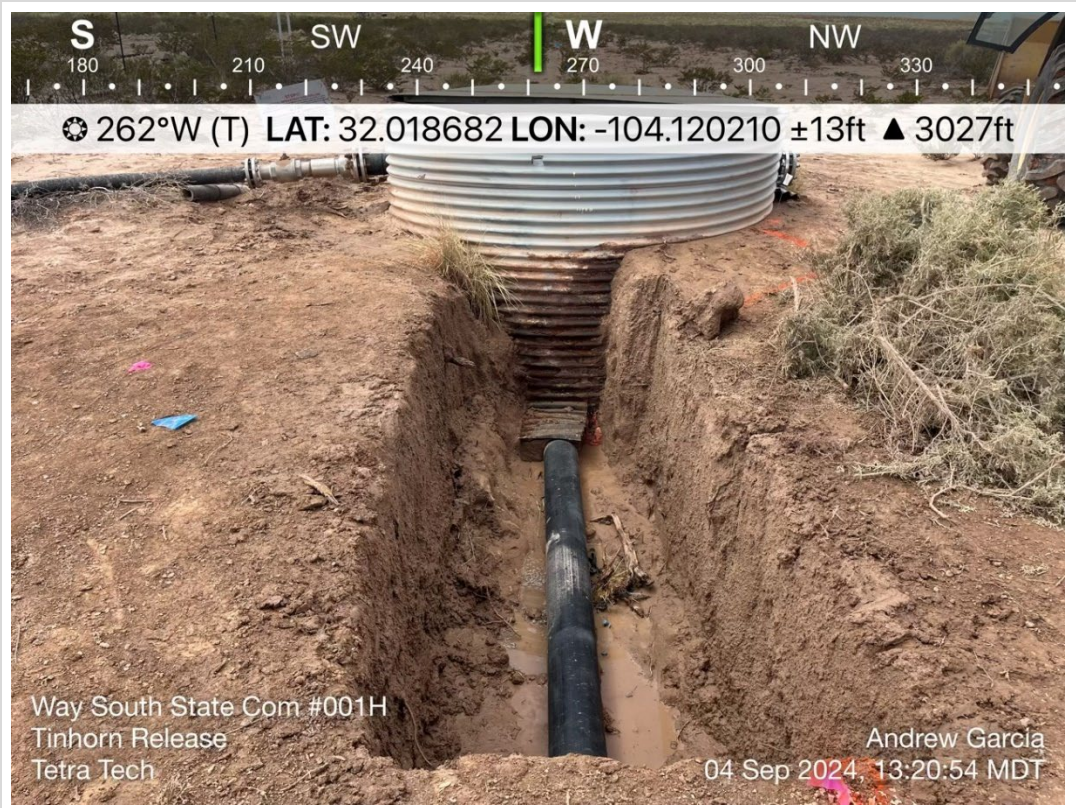
TETRA TECH, INC. PROJECT NO. 212C-MD-02994	DESCRIPTION	View west. Exposing subsurface line with hydrovac and removing impacted soils in area of remediation.	5
	SITE NAME	Way South State Com Tinhorn Release	9/4/2024

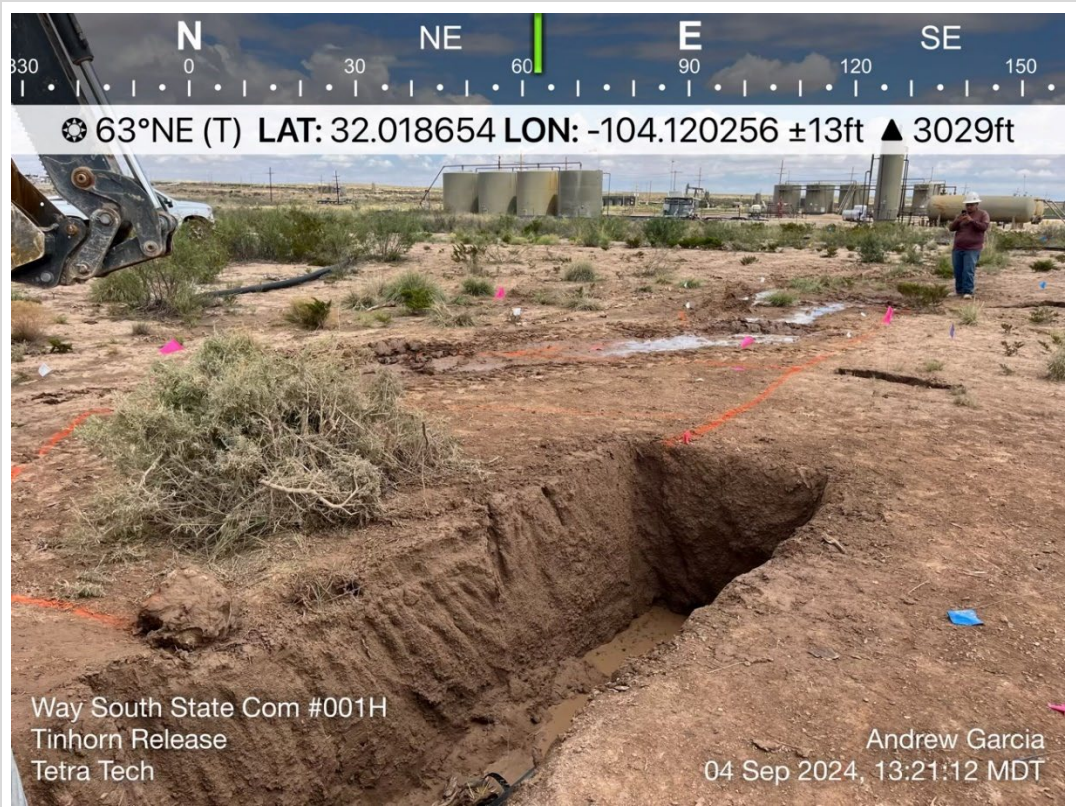
TETRA TECH, INC. PROJECT NO. 212C-MD-02994	DESCRIPTION	View east-northeast. Hydrovac area adjacent to remaining areas of excavation.	6
	SITE NAME	Way South State Com Tinhorn Release	9/4/2024

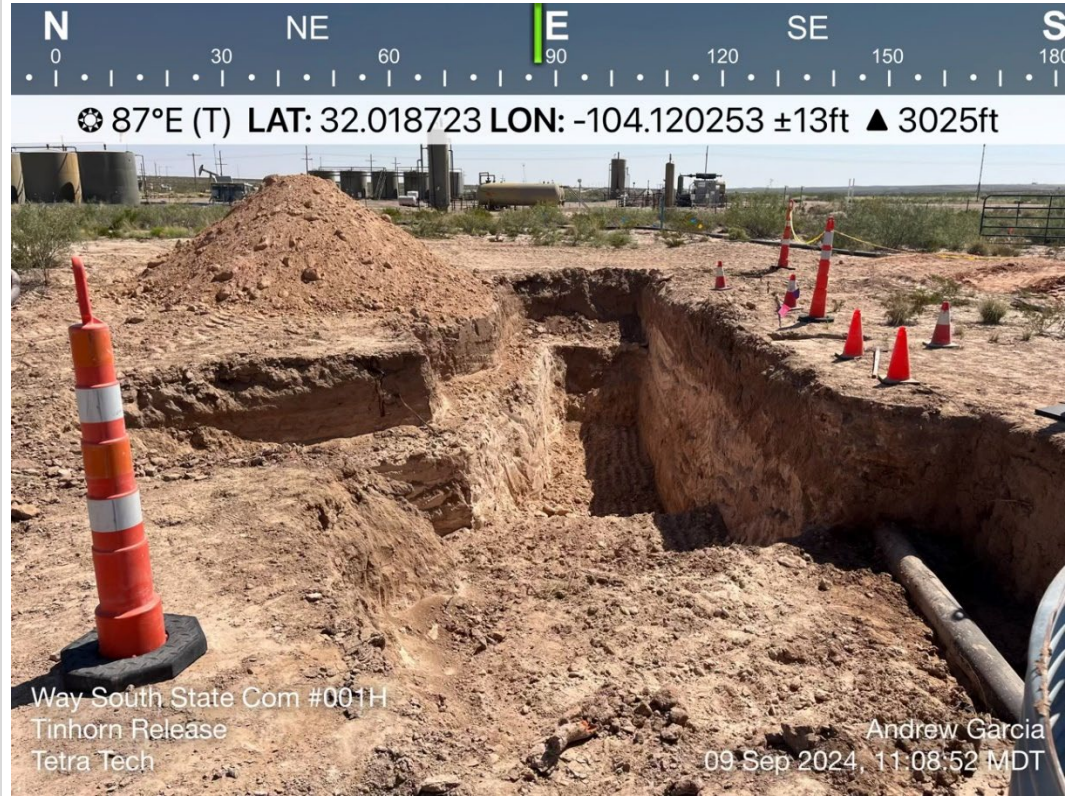
TETRA TECH, INC. PROJECT NO. 212C-MD-02994	DESCRIPTION	View east. Finalized excavation extent.	10
	SITE NAME	Way South State Com Tinhorn Release	9/9/2024

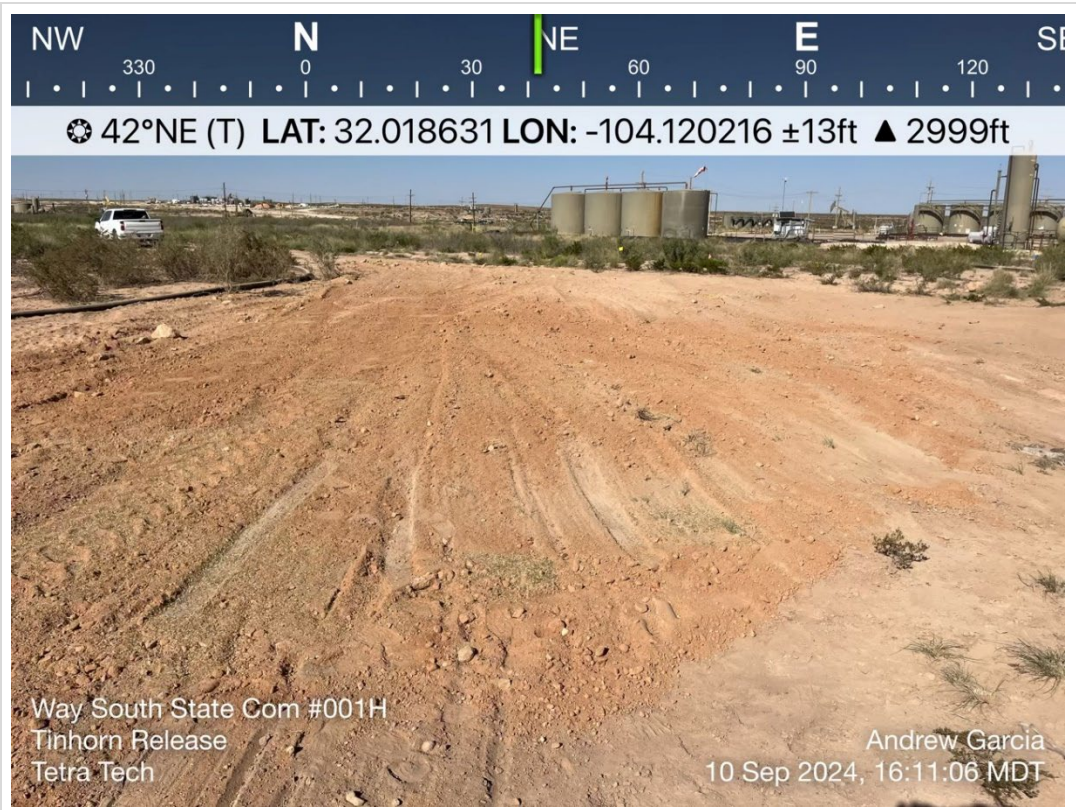
TETRA TECH, INC. PROJECT NO. 212C-MD-02994	DESCRIPTION	View northeast. Excavation backfilled with clean materials.	11
	SITE NAME	Way South State Com Tinhorn Release	9/10/2024

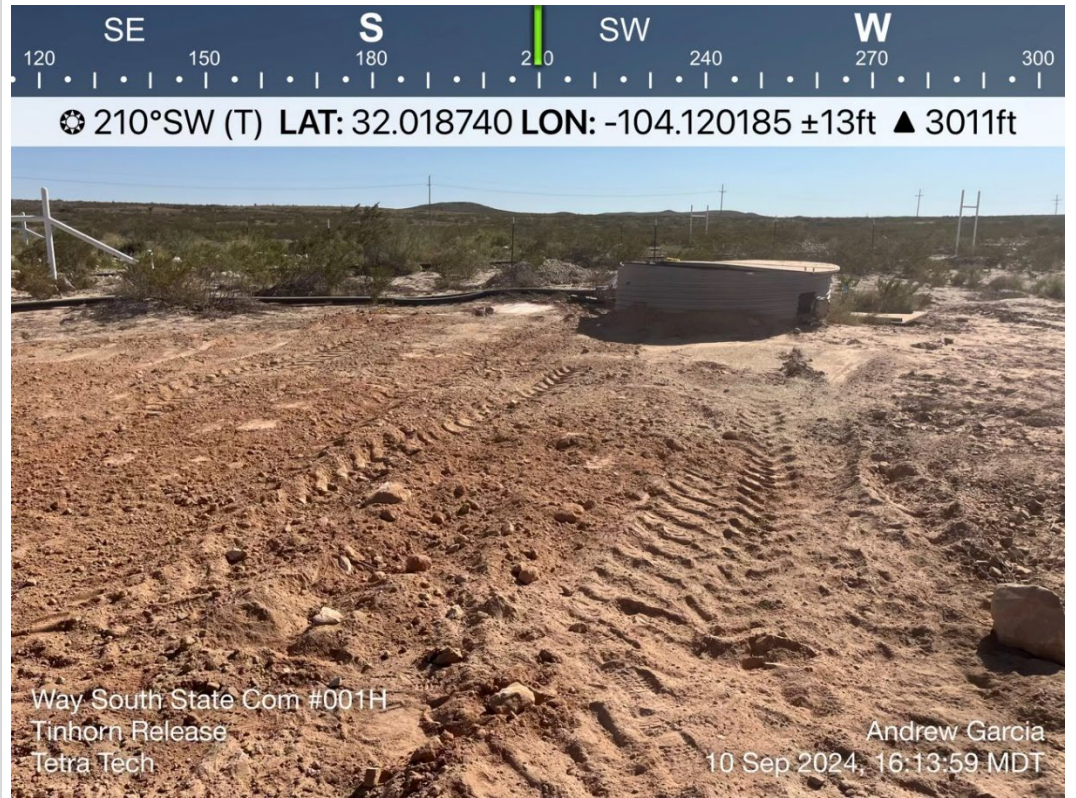
TETRA TECH, INC. PROJECT NO. 212C-MD-02994	DESCRIPTION	View south-southwest. Excavation area backfilled with clean material.	12
	SITE NAME	Way South State Com Tinhorn Release	9/10/2024
