Remediation Summary and Closure Request

**BTA Oil Producers, LLC
Pardue D 8808 Tank Battery
Eddy County, New Mexico
Unit Letter "D", Section 11, Township 23 South, Range 28 East
Latitude 32.324587 North, Longitude 104.064218 West
NMOCD Incident # NAB1911230564**

October 2024

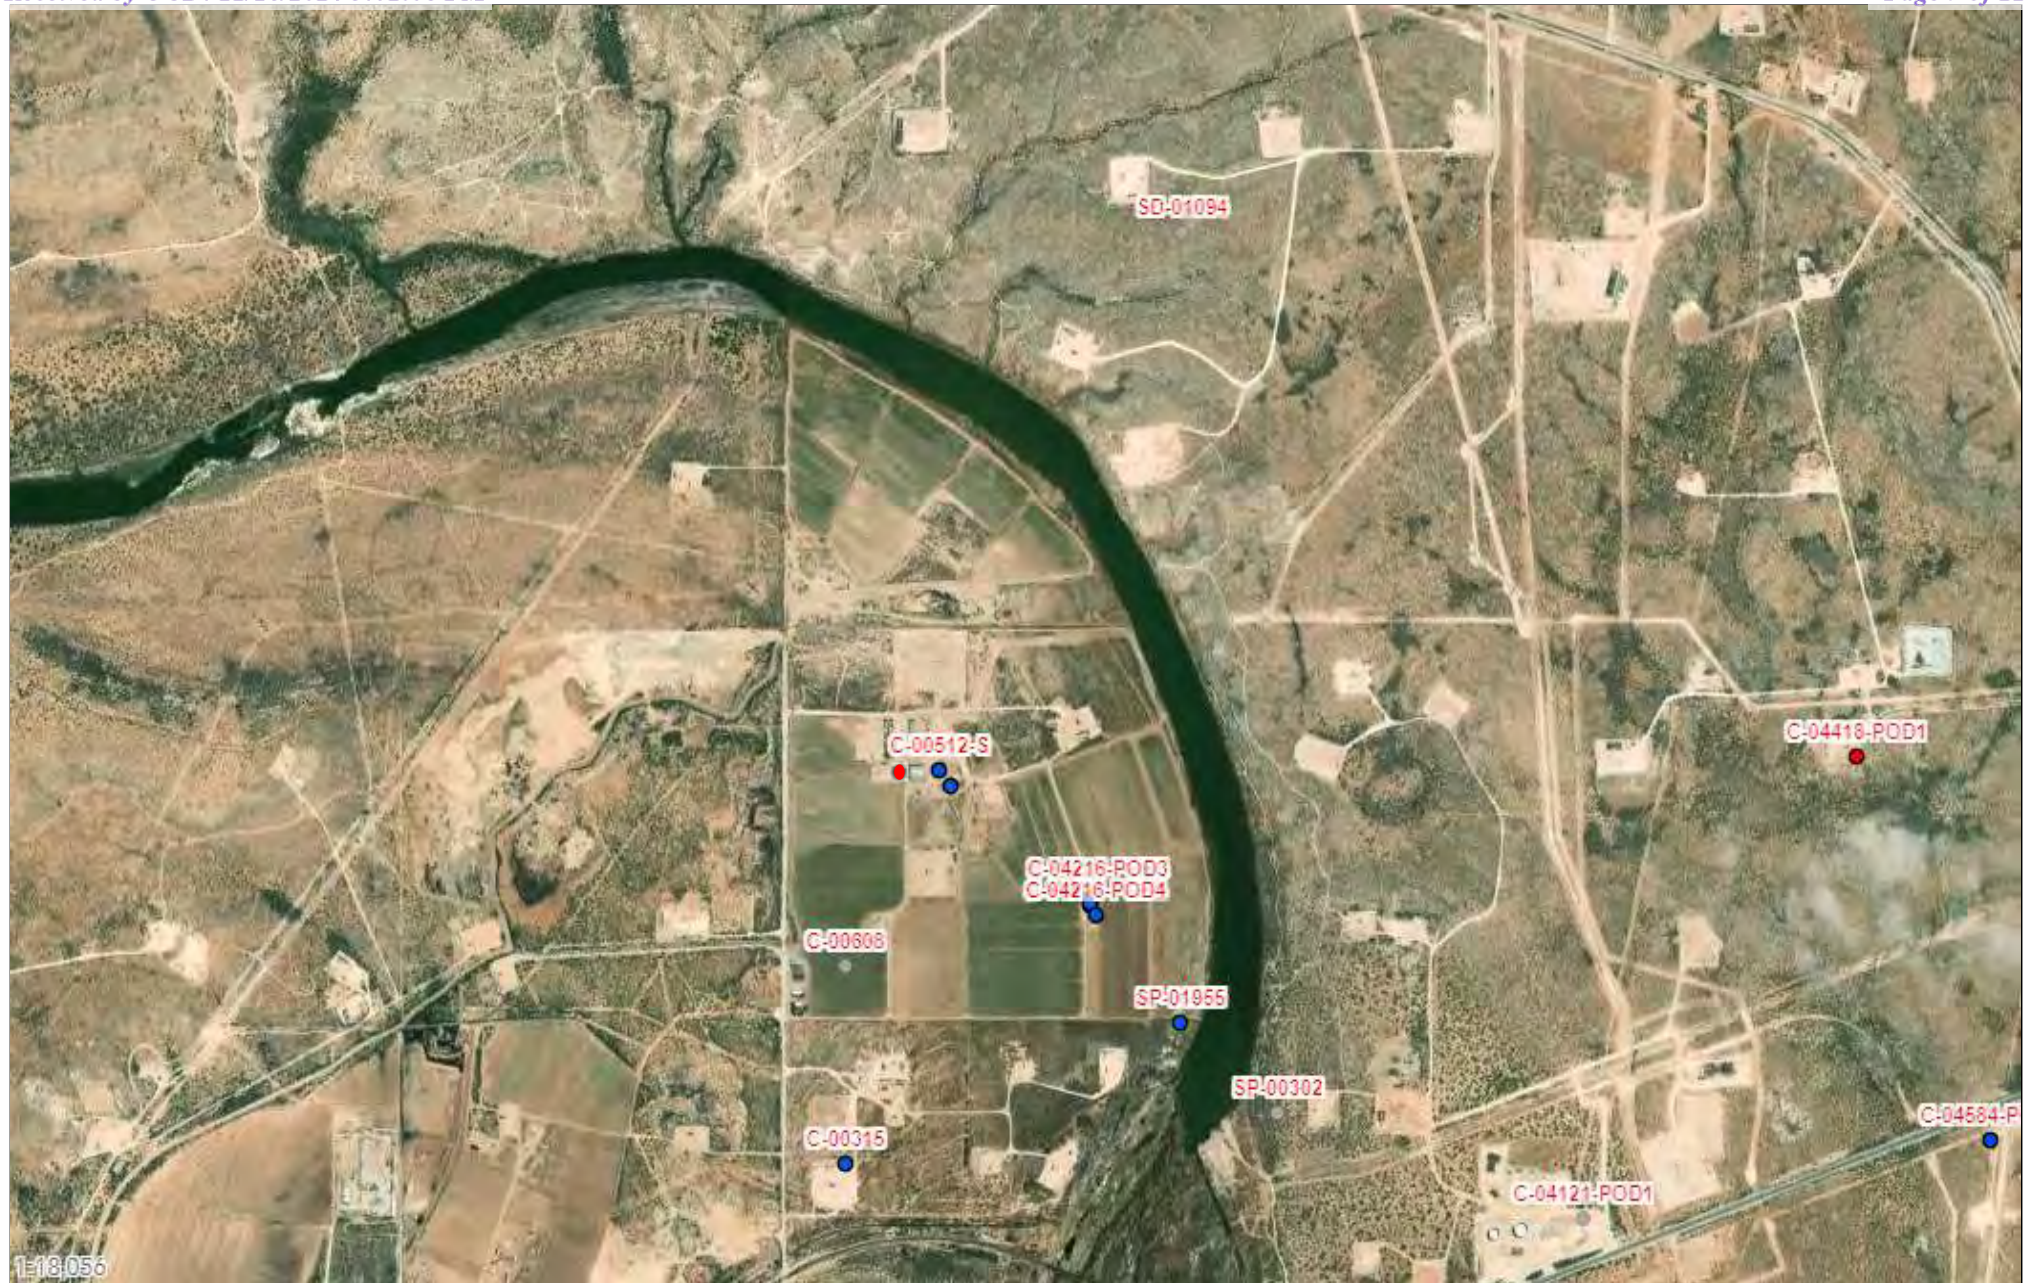
**Figure 2**

OSE POD Locations Map
 BTA Oil Producers, LLC
 Pardue D 8808 JV-P #2 Tank Battery
 GPS: 32.324587, -104.064218
 Eddy County

A search of the New Mexico Office of the State Engineer (NMOSE) and United States Geological Survey (USGS) groundwater databases was completed in an effort to determine the horizontal distance to known water sources within a half mile radius of the Release Site. Approximate depth to groundwater was determined using maintained and published water well data. Karst mapping indicates the site is located in a Gypsum Karst designated area. Depth to groundwater information is provided as Attachment III and results are depicted on Figures 2 & 3.

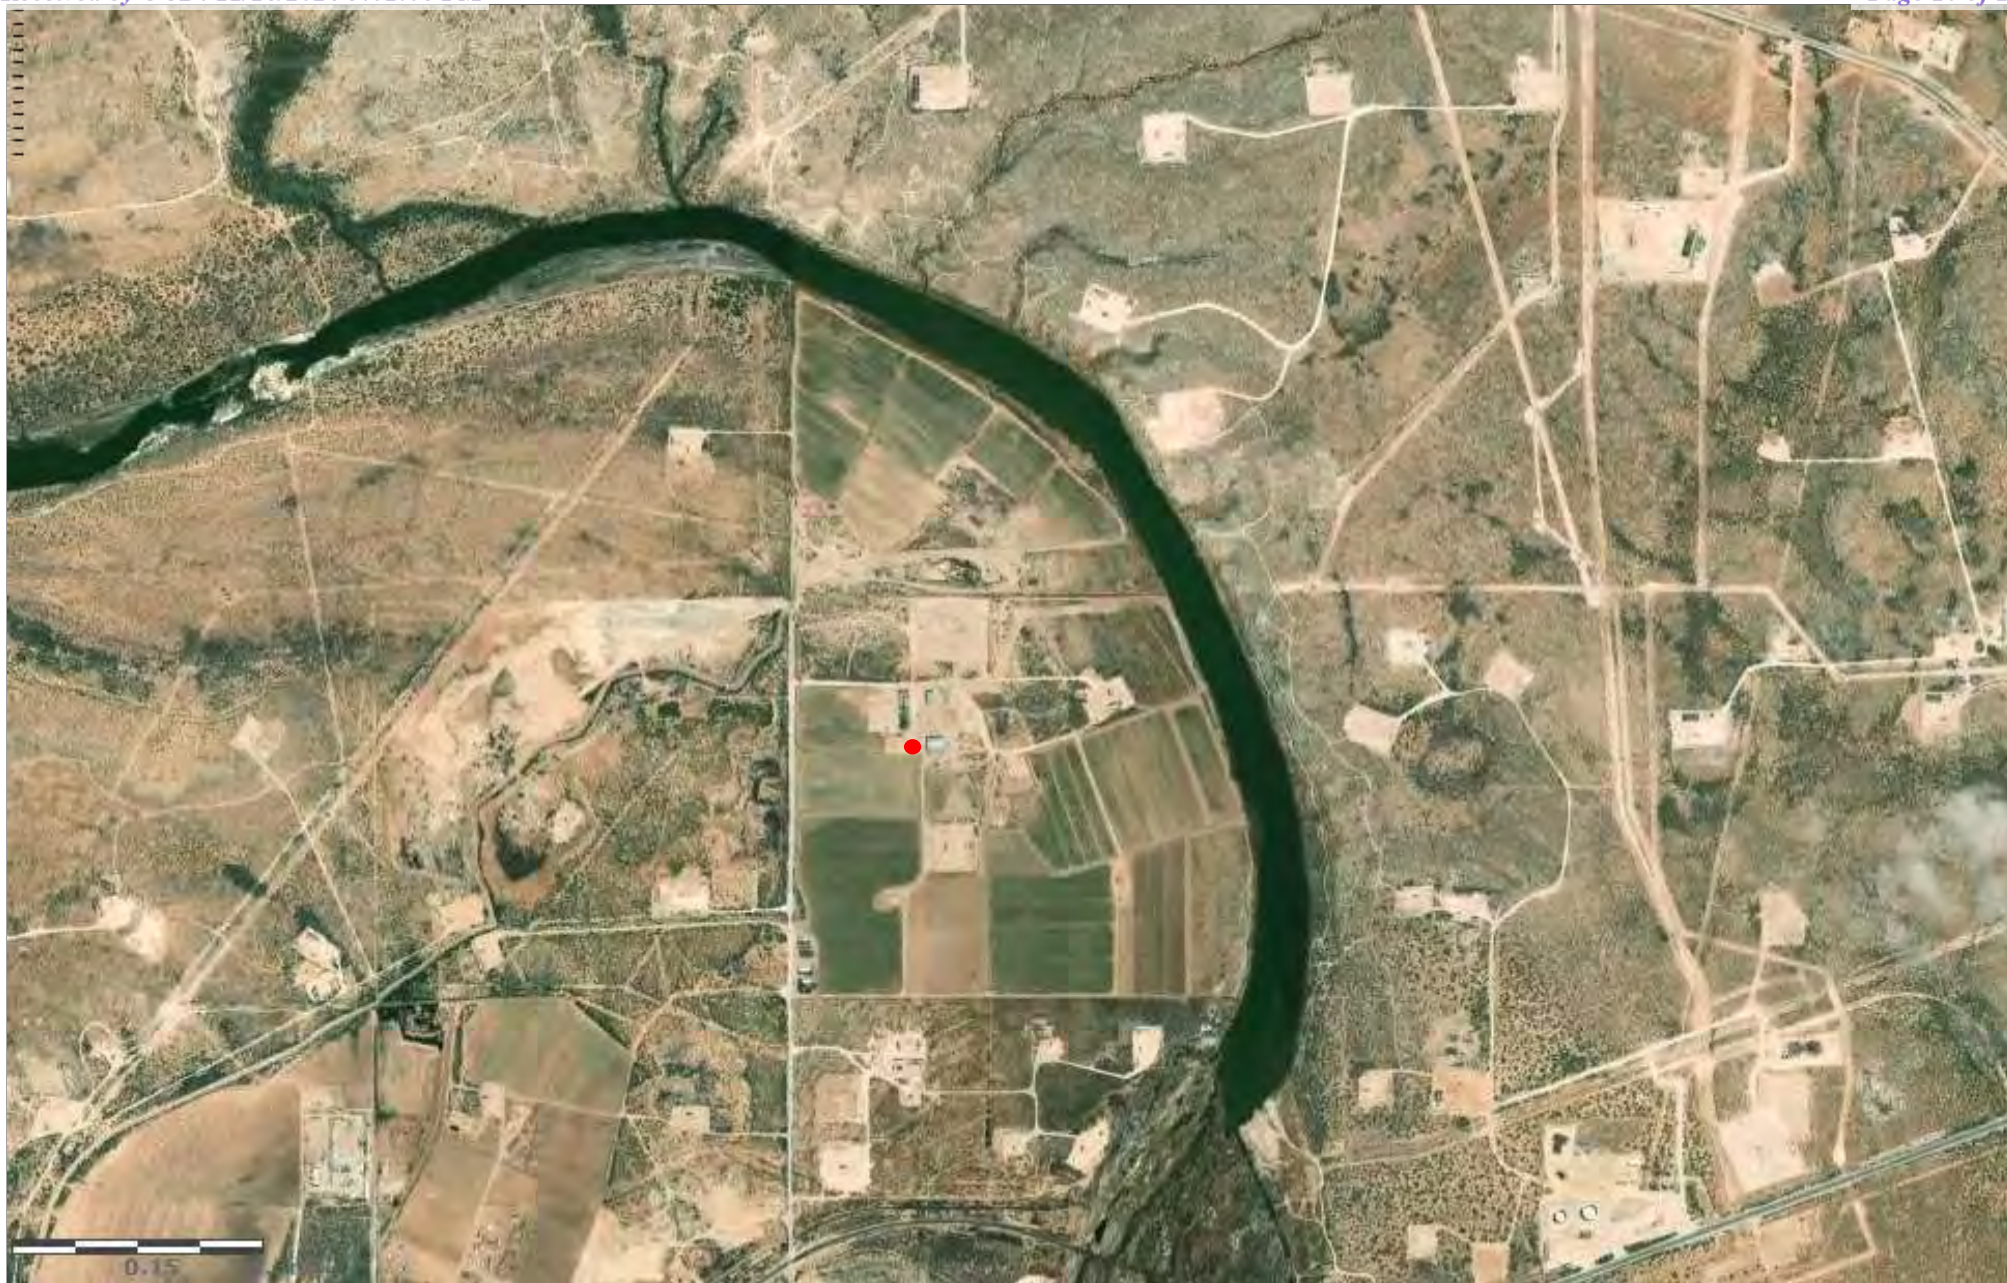
**Figure 3**

USGS Well Locations Map
BTA Oil Producers, LLC
Pardue D 8808 JV-P #2 Tank Battery
GPS: 32.324587, -104.064218
Eddy County

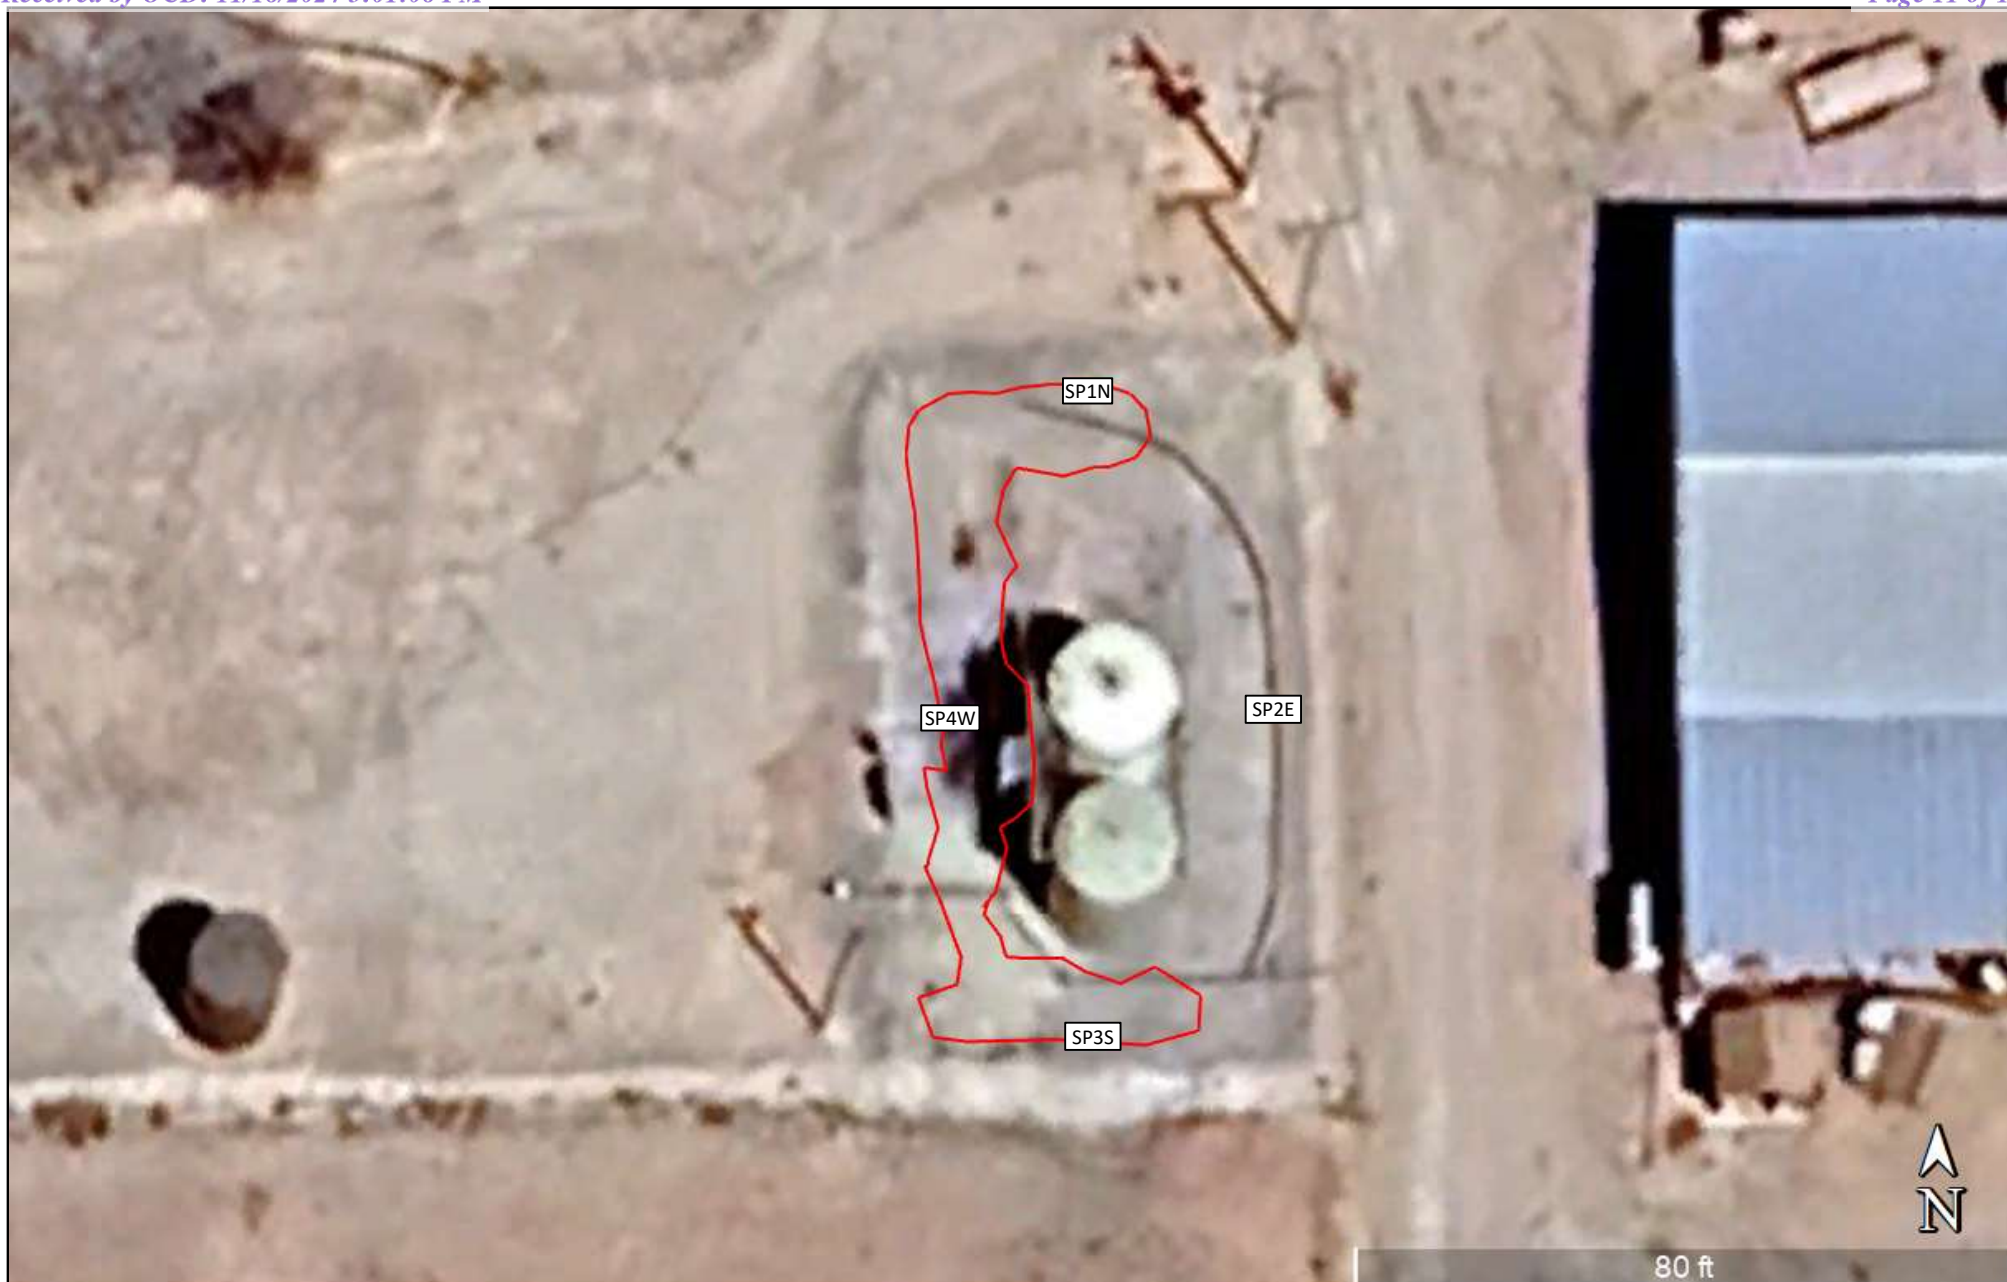
**Figure 4**

Delineation Sample Map
BTA Oil Producers, LLC
Pardue D 8808 JV-P #2 Tank Battery
GPS: 32.324587, -104.064218
Eddy County

Based on field observations and field test data noted above and provided in Attachment V, five representative soil samples were selected for laboratory analysis. Delineation soil samples SP1N, SP2E, SP3S, SP4W, and BG2 were submitted to the laboratory for analysis of BTEX, TPH, and chloride. Laboratory analytical results indicated contaminant concentrations were below the NMOCD Closure Criteria in each of the submitted samples.

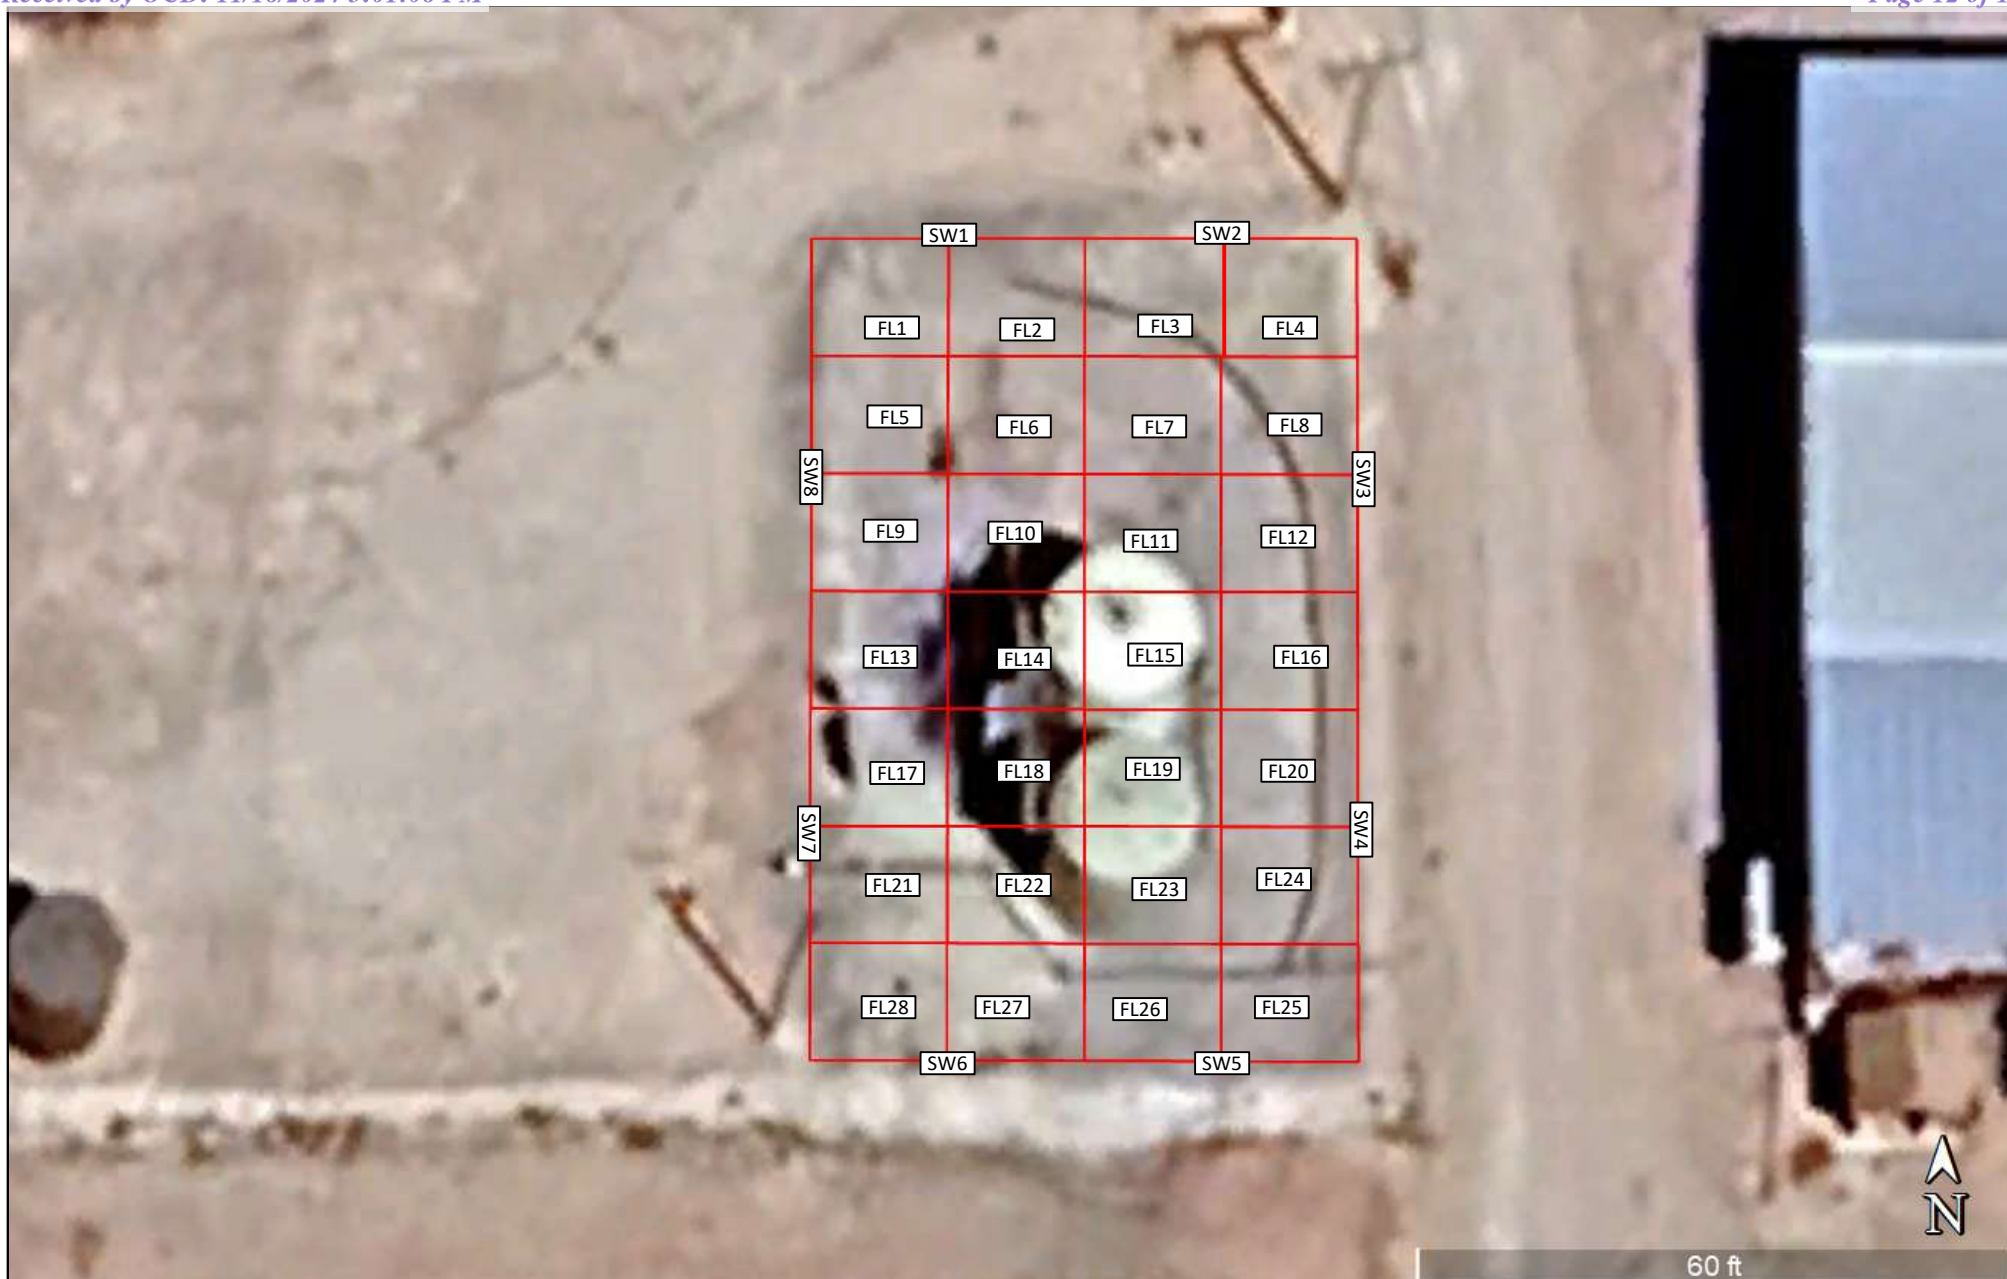
**Figure 5**

Excavation Sample Map
 BTA Oil Producers, LLC
 Pardue D 8808 JV-P #2 Tank Battery
 GPS: 32.324587, -104.064218
 Eddy County
