DTW LINE LEAK

Remediation Summary & Closure Report

NMOCD Incident No. nAPP2408932632
UL "A", Sec. 01, T23S, R31E
32.339851, -103.723865
Eddy County, New Mexico

December 16, 2024

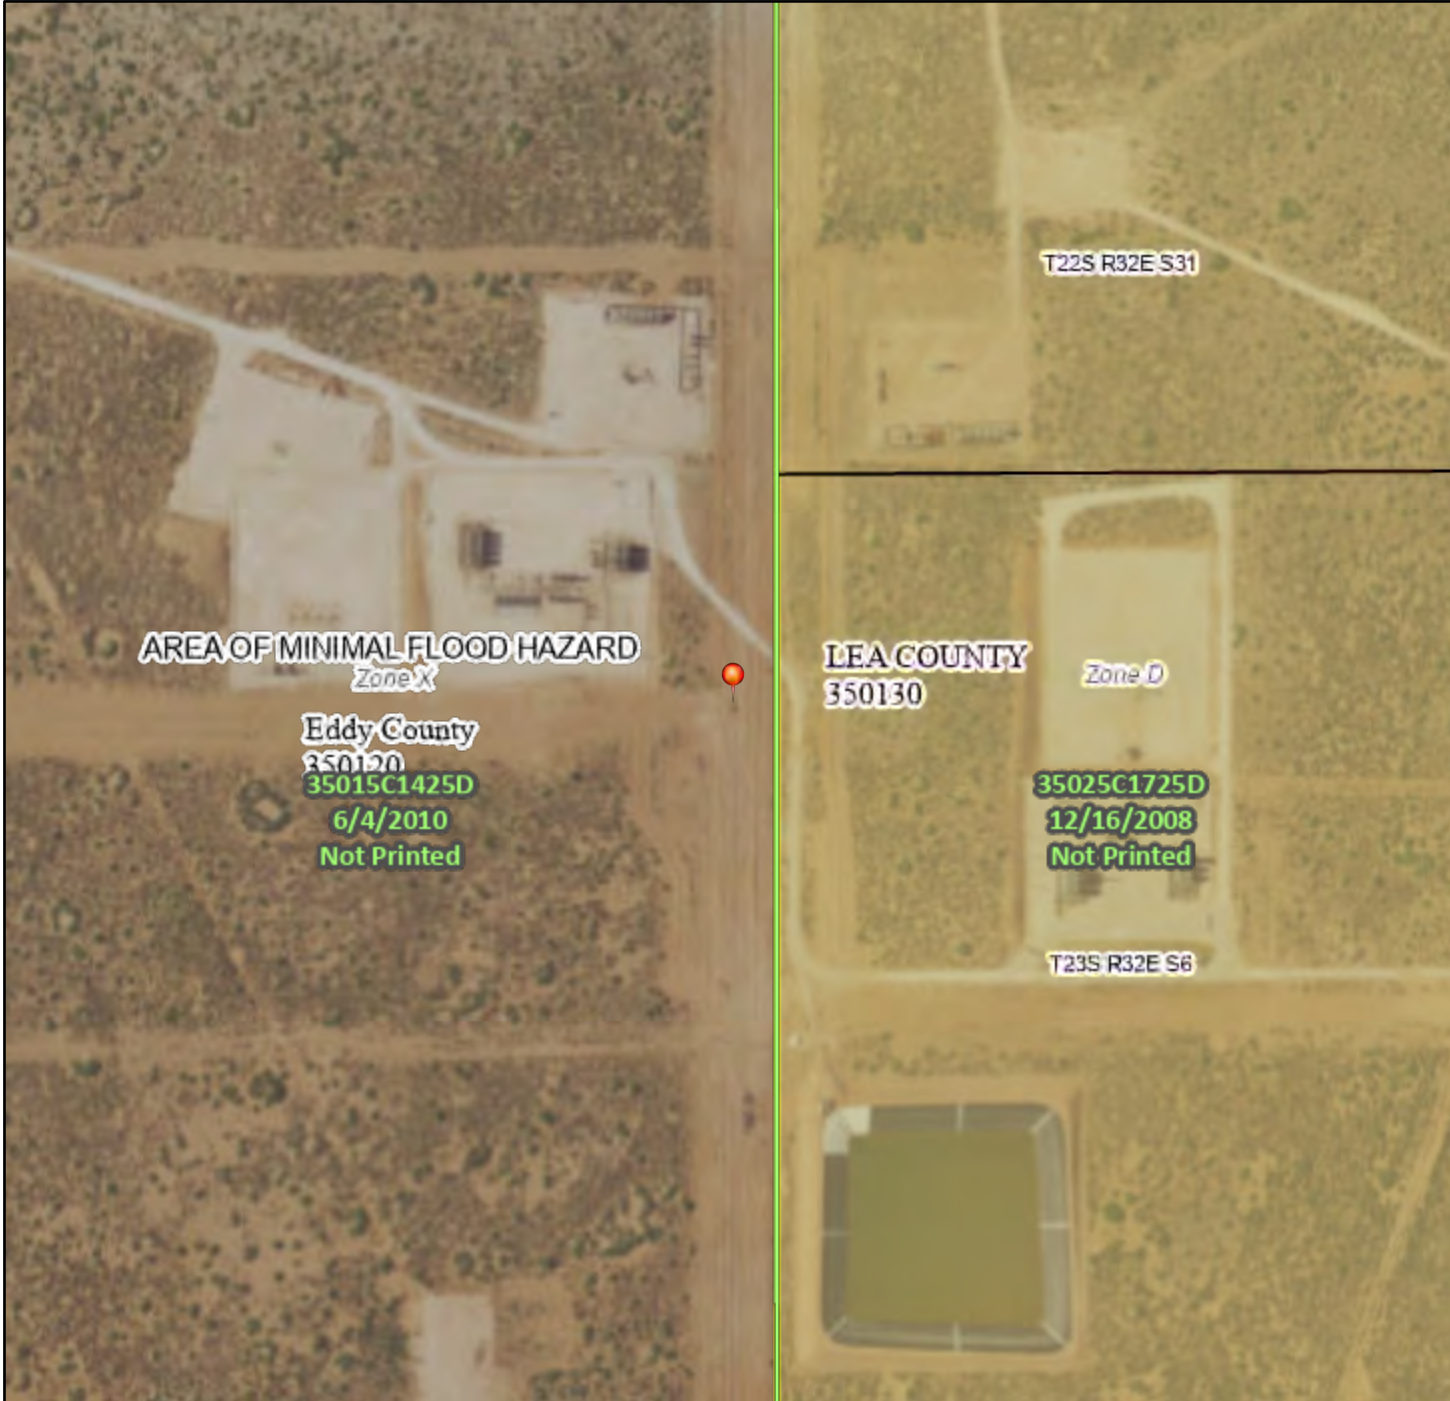
National Flood Hazard Layer FIRMette

Review of flood map data published by the Federal Emergency Management Agency (FEMA) indicates the site is not located within a 100-year floodplain. A copy of the FEMA FIRMete Map can be found attached as Figure 4.

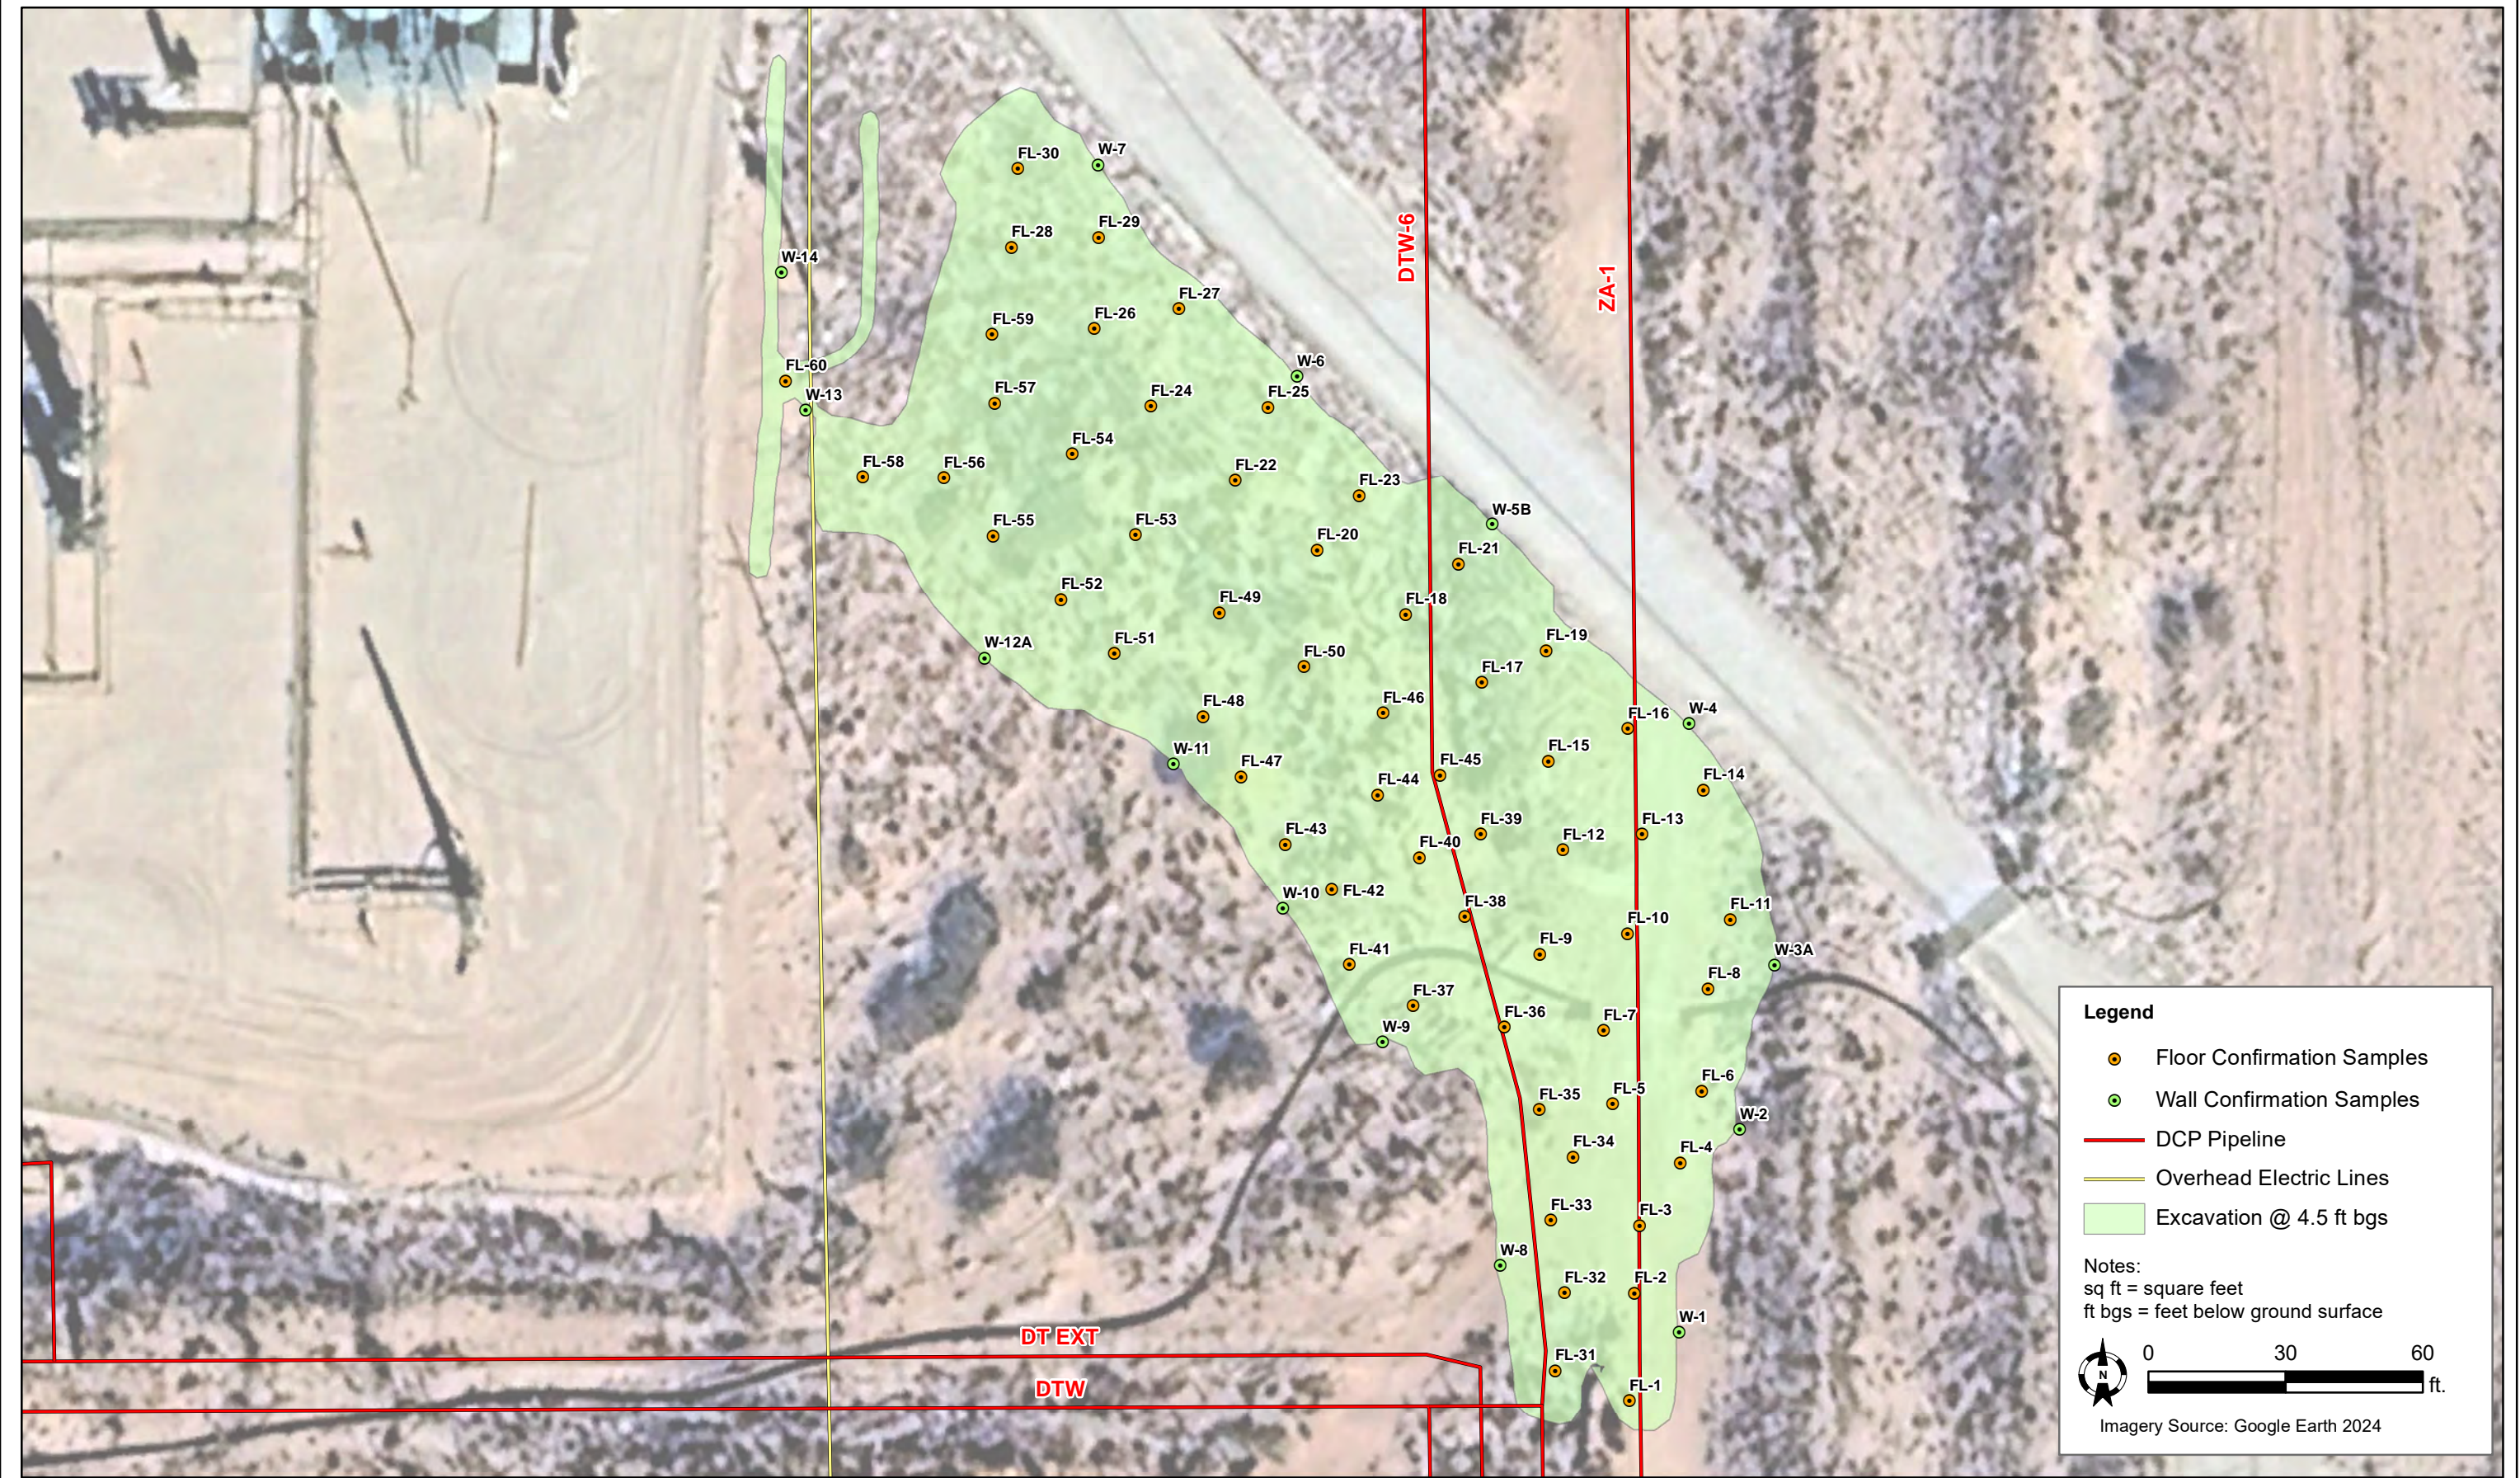
Tasman conducted initial assessment activities, identifying an approximately 23,500 square foot area that had been impacted by the release. Heavy equipment was used to remove approximately 6,612 cubic yards of impacted material from the release area. Based on laboratory analytical results from soil samples collected during confirmation sampling activities, impacted soil within the release area has been remediated below the applicable NMOCD Action Levels and in accordance with NMOCD standards. Additional project details are provided in the attached summary report.
