**Re: Remediation Work Plan  
Row 5 West Booster Station  
Incident Number NAPP2428259758  
Eddy County, New Mexico**

XTO Energy, Inc.  
Remediation Work Plan  
Row 5 West Booster Station

XTO Energy, Inc  
Row 5 West Booster Station  
Incident Number: nAPP2428259758  
Unit K, Section 20, T25S, R30E  
Eddy County, New Mexico

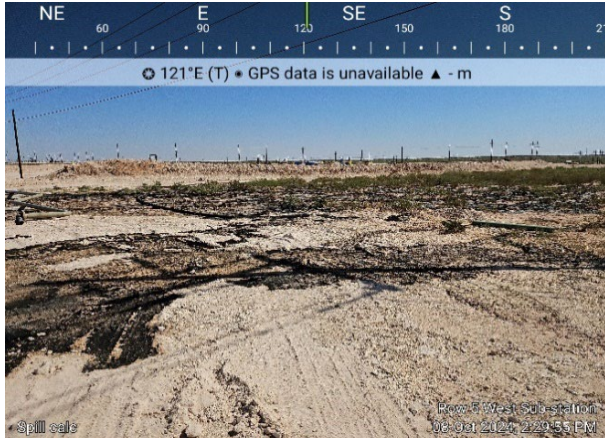
Photograph: 1 Date: 10/08/2024  
Description: Staining within release extent  
View: Southeast

Ensolum, LLC (Ensolum), on behalf of XTO Energy, Inc. (XTO), has prepared the following *Remediation Work Plan (Work Plan)* to document the site assessment activities completed to date and propose a work plan to address impacted soil identified at the Row 5 West Booster Station (Site). The purpose of the site assessment activities was to delineate the lateral and vertical extent of impacted soil resulting from a release of produced water at the Site. The following *Work Plan* proposes to excavate impacted soil within the top 4 feet of the release extent.

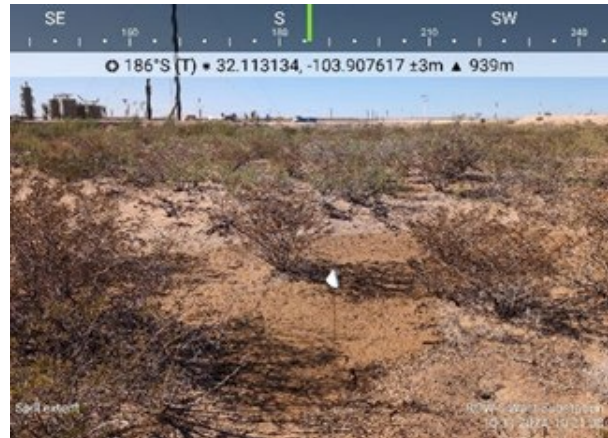
Photograph: 2 Date: 10/31/2024  
Description: Staining within release extent  
View: South

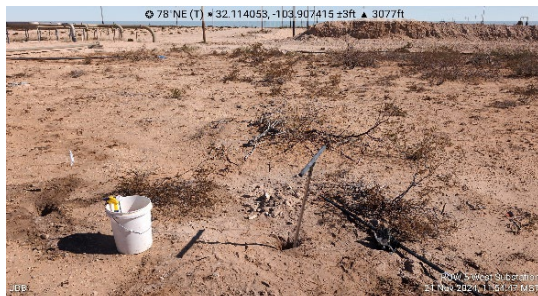
Photograph: 3 Date: 11/21/2024  
Description: Delineation activities  
View: Northeast

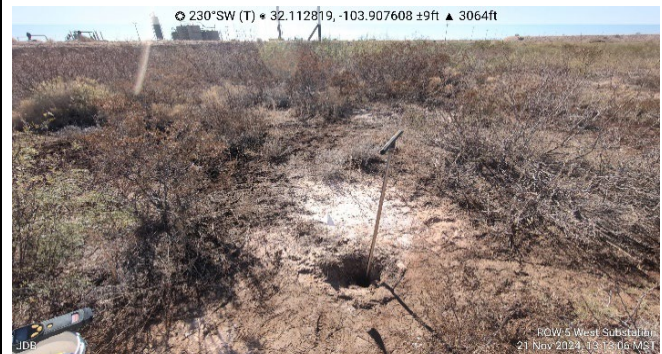
Photograph: 4 Date: 11/21/2024  
Description: Delineation activities  
View: Southwest
