**Re: Closure Request
Big Eddy Unit 251H
Incident Number NAPP2419336478
Eddy County, New Mexico**

Ensolum, LLC (Ensolum) on behalf of XTO Energy, Inc. (XTO), has prepared this *Closure Request* to document excavation and soil sampling activities performed at the Big Eddy Unit 251H (Site). The purpose of excavation and soil sampling activities, conducted in accordance with an approved *Remediation Work Plan (Work Plan)*, was to address impacts to soil resulting from a release of produced water and crude oil at the Site. XTO is submitting this *Closure Request*, describing excavation activities that have occurred and requesting no further remediation for Incident Number NAPP2419336478.

XTO Energy, Inc
Big Eddy Unit 251H
Closure Request

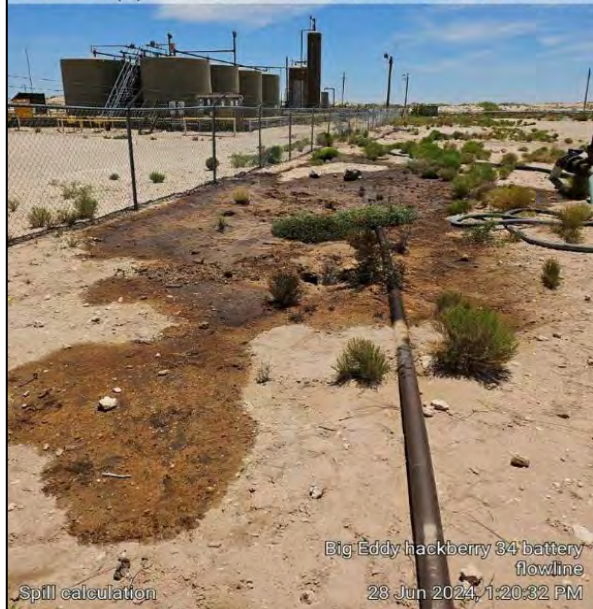
Photograph: 1 Date: 6/28/2024

Description: Staining after discovery of release.

View: South

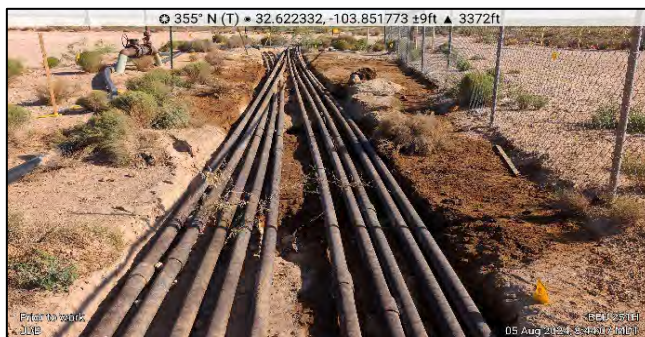
Photograph: 2 Date: 8/5/2024

Description: Site assessment activities.

View: North

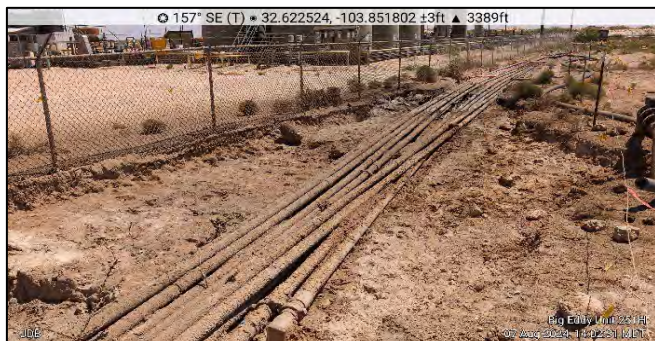
Photograph: 3 Date: 8/7/2024

Description: Excavation extent area.

View: Southeast

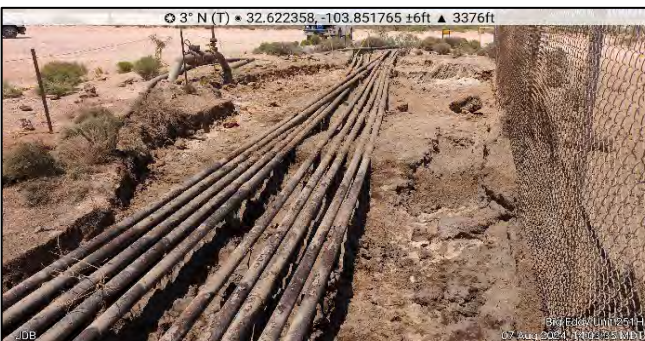
Photograph: 4 Date: 8/7/2024

Description: Excavation extent area.

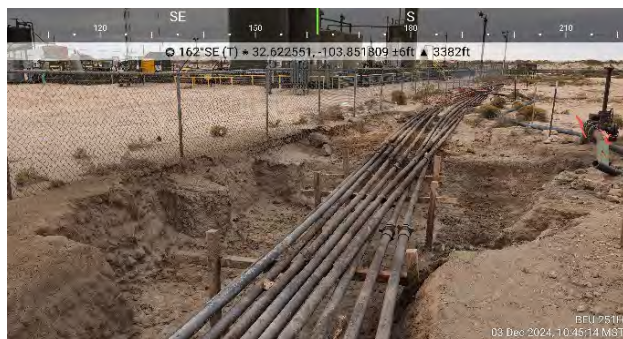
Photograph: 5 Date: 12/3/2024
Description: Excavation activities.
View: Southeast

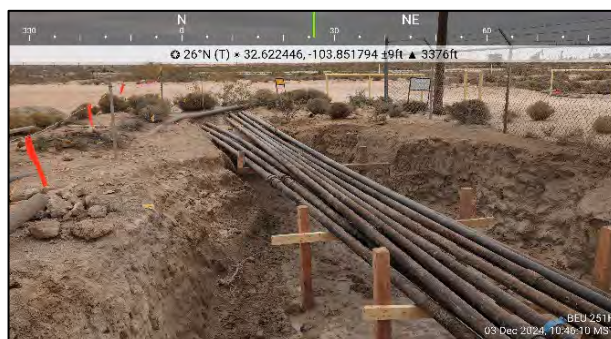
Photograph: 6 Date: 12/3/2024
Description: Excavation activities.
View: Northeast

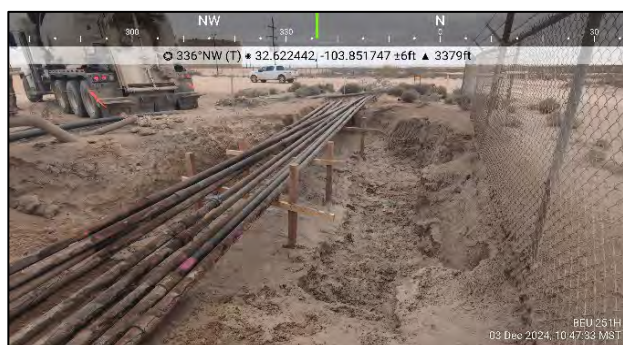
Photograph: 7 Date: 12/3/2024
Description: Excavation activities.
View: Northwest

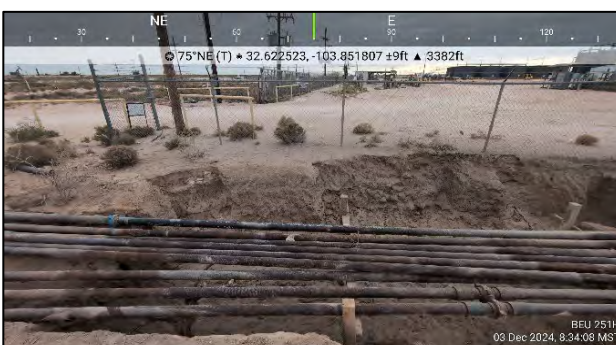
Photograph: 8 Date: 12/3/2024
Description: Excavation activities.
View: Northeast

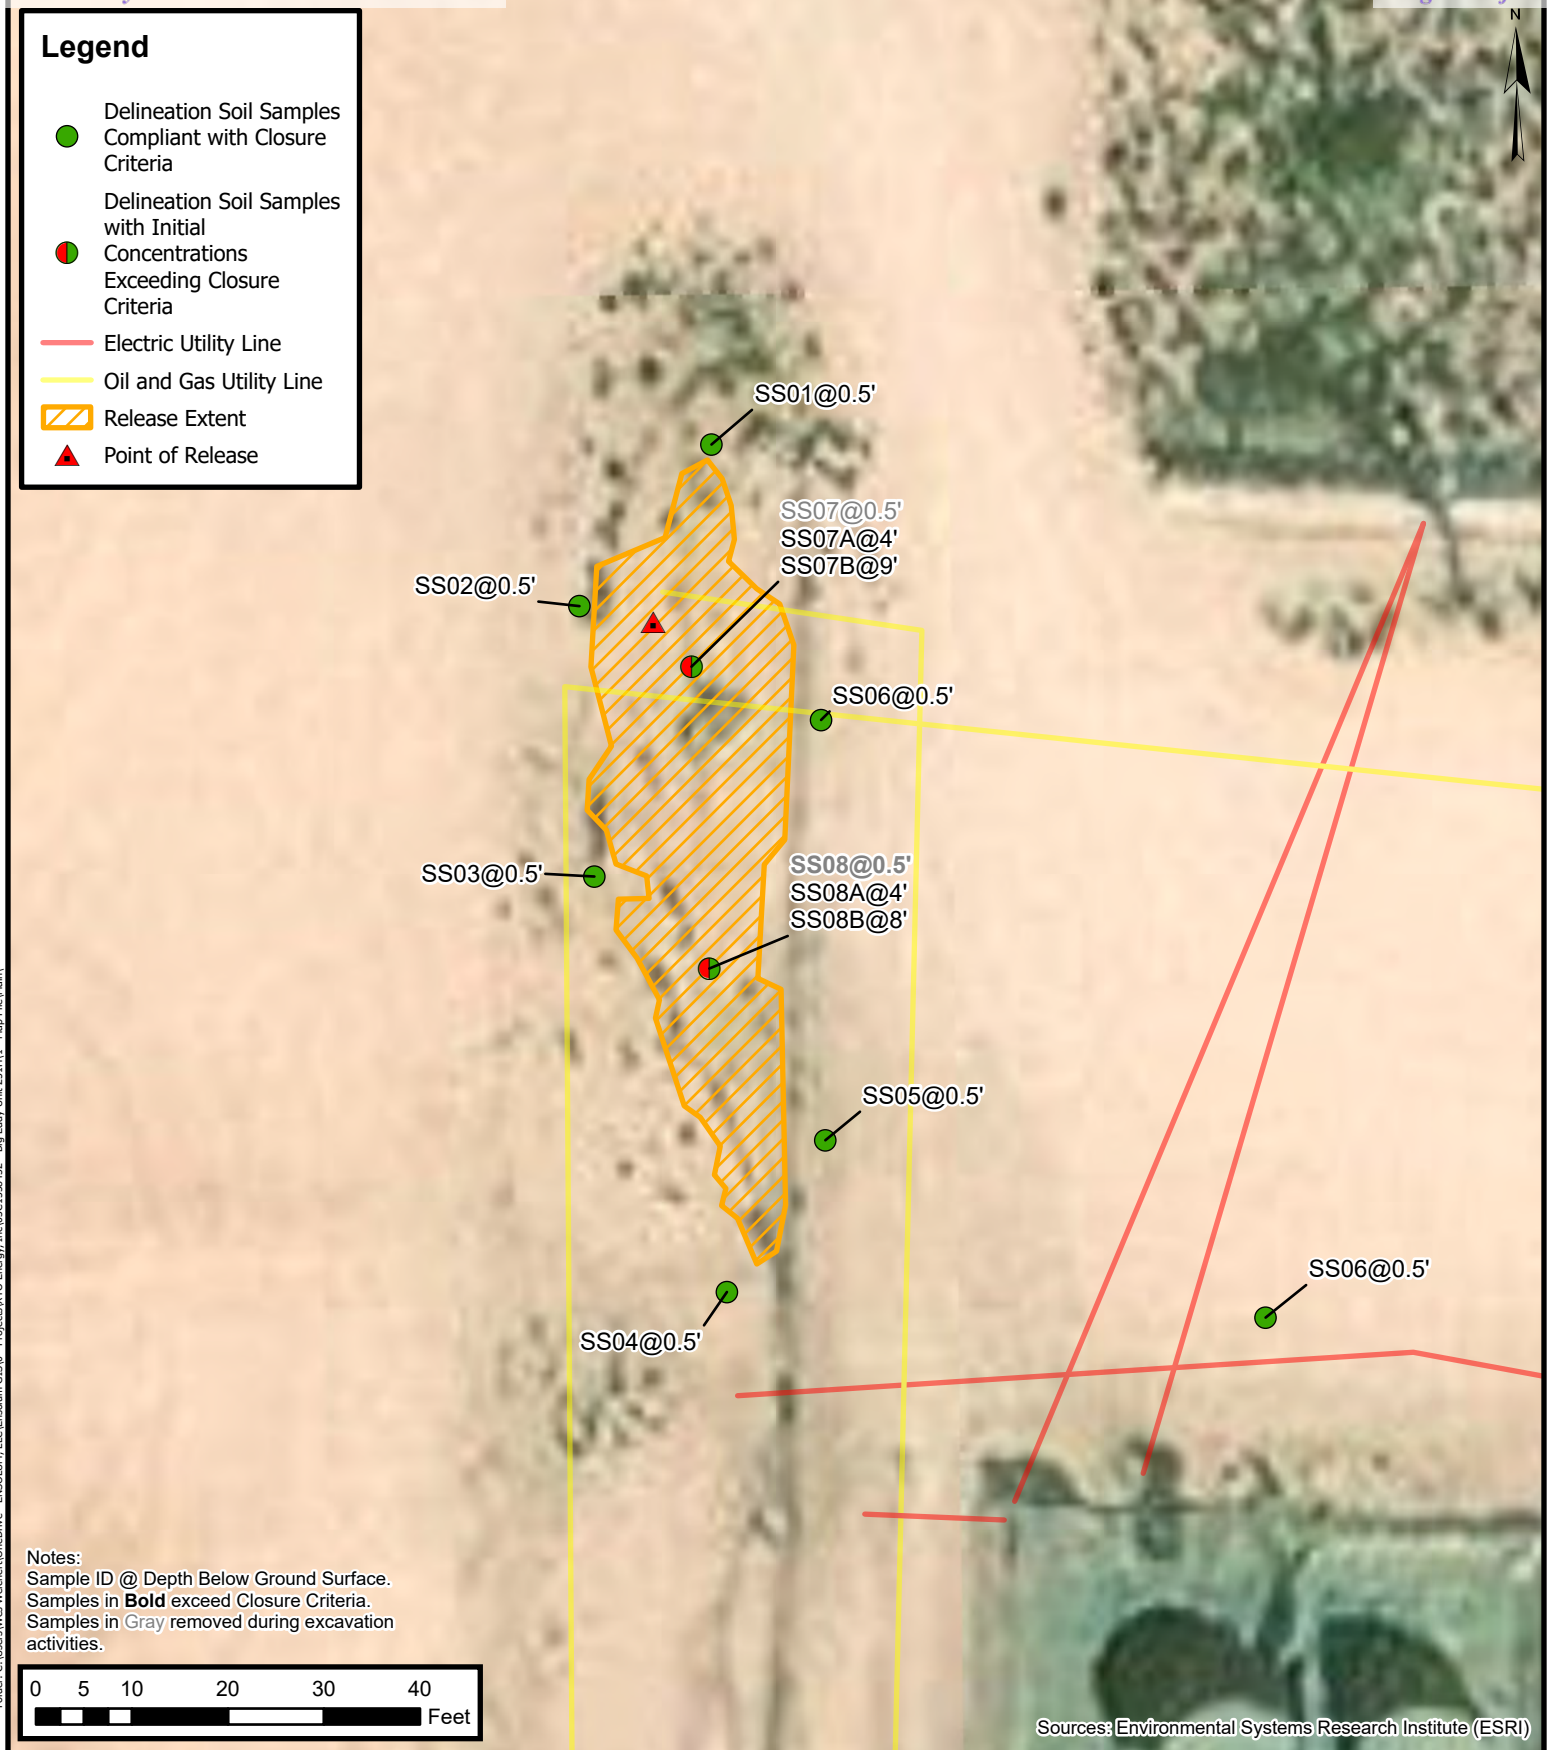
Delineation Soil Sample Locations

Notes:
 Sample ID @ Depth Below Ground Surface.
 Samples in **Bold** exceed Closure Criteria.

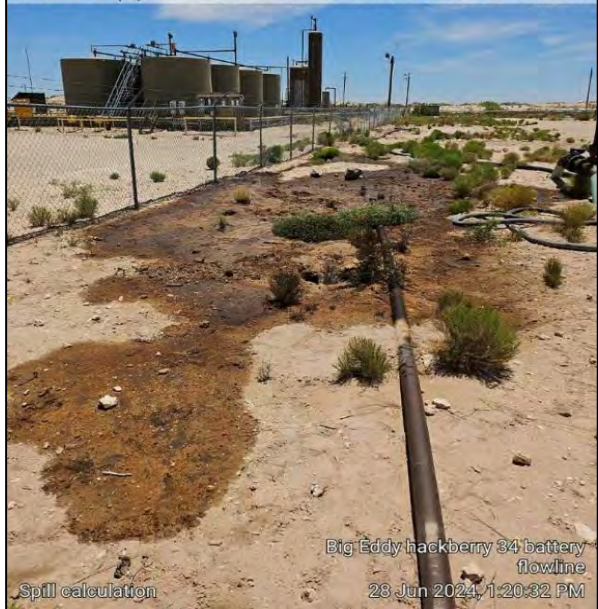
Photograph: 1 Date: 6/28/2024
Description: Staining after discovery of release.
View: South

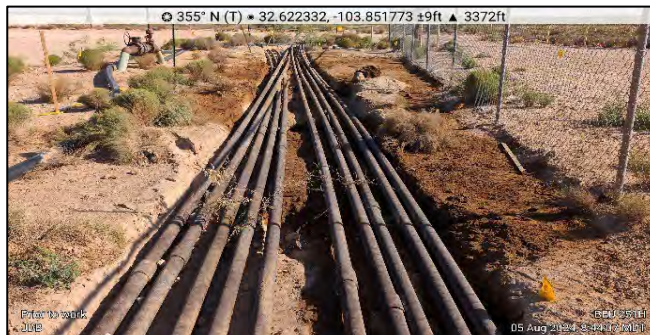
Photograph: 2 Date: 8/5/2024
Description: Site assessment activities.
View: North

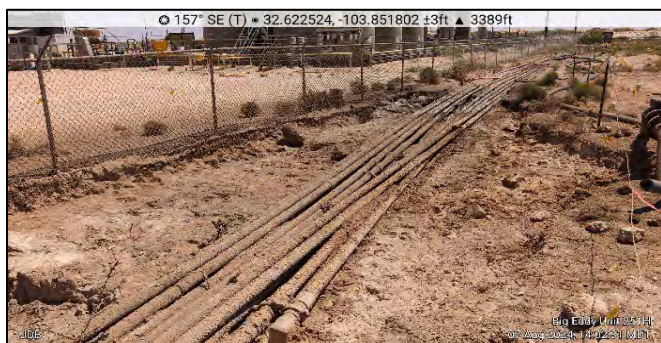
Photograph: 3 Date: 8/7/2024
Description: Excavation extent area.
View: Southeast

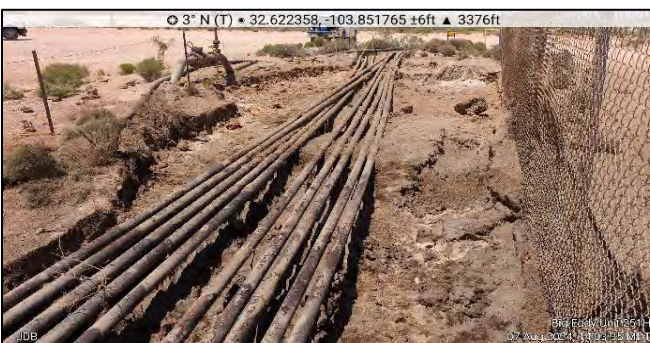
Photograph: 4 Date: 8/7/2024
Description: Excavation extent area.
View: North
