Revised Site Characterization Report and Remediation Workplan

Dagger
Produced Water Release
Incident No. nAPP2402032332
Lea County, New Mexico

Dagger Produced Water Release
Revised Site Characterization Report and Remediation Workplan

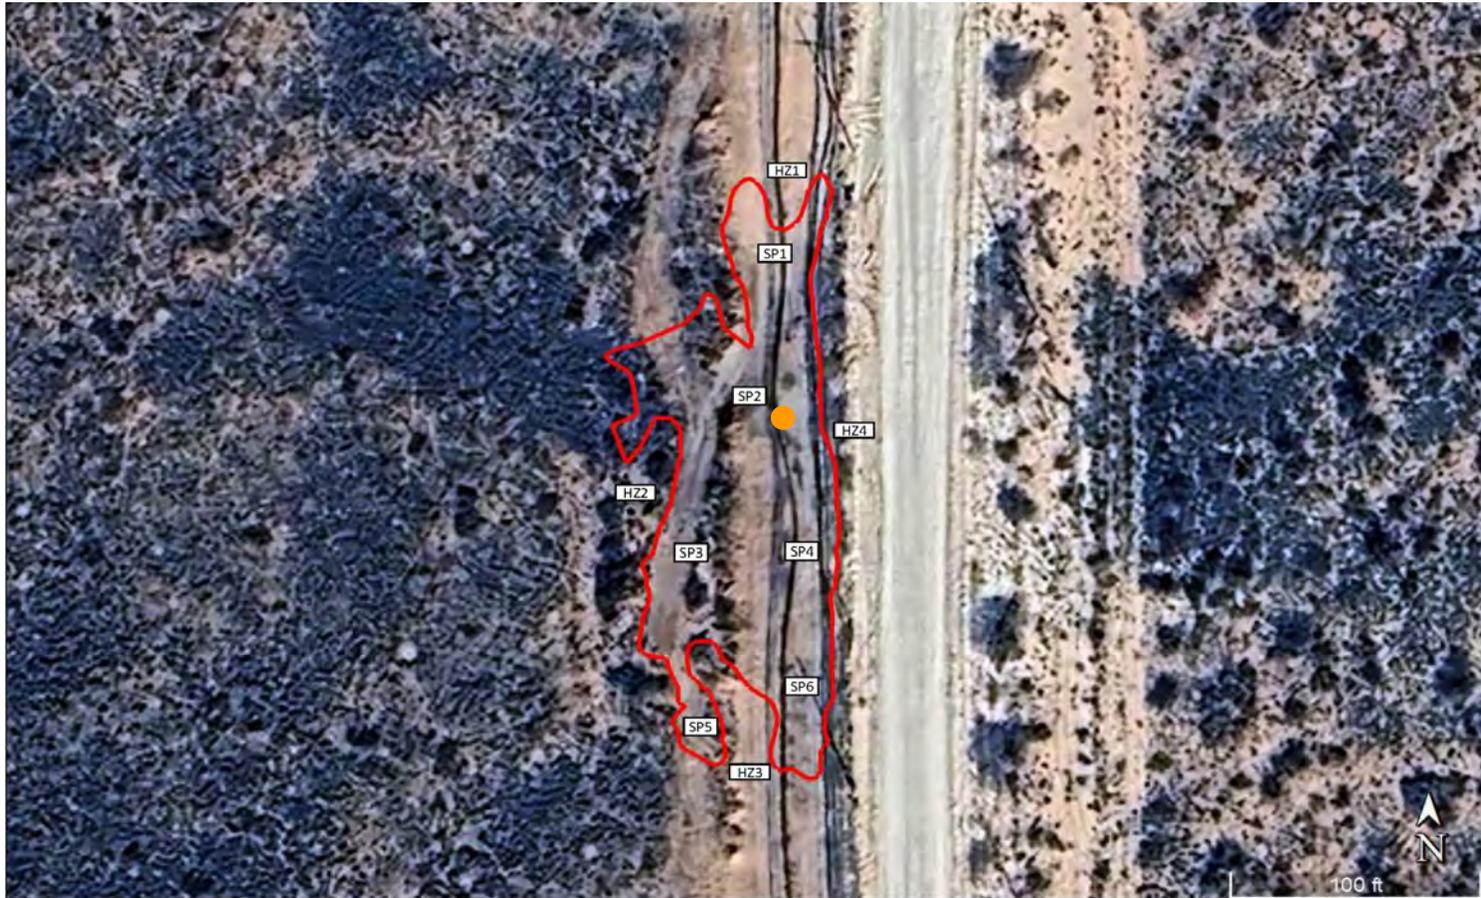
Figure 2
 Delineation Map by
 Hungry Horse
 Select Water Solutions, LLC
 Dagger
 Lea County, New Mexico

On January 19, 2024, Select discovered a weak spot in a layflat line during transfer of fluids. Approximately 438 barrels (bbls) of produced water were released into a right of way (ROW). Immediately following the release, the area was secured, a vacuum truck was mobilized to the Site, and the line was repaired. The released fluid covered a surface area of approximately 12,900 square feet (sq ft). Approximately 380 bbl of fluid were recovered. The release point and the surface extent of the release are depicted on Figures 2 and 3.
