## Incident Closure

James Ranch Unit DI 11

**XTO Energy, Inc.**  
**James Ranch Unit DI 11**

**Incident Closure**  
**January 2025**

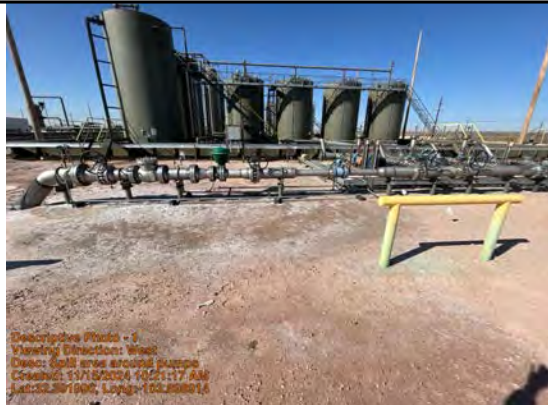
Viewing Direction: West

Spill area around pumps

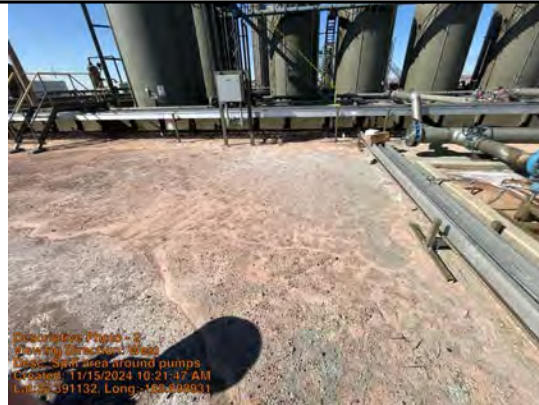
Viewing Direction: West

Spill area around pumps

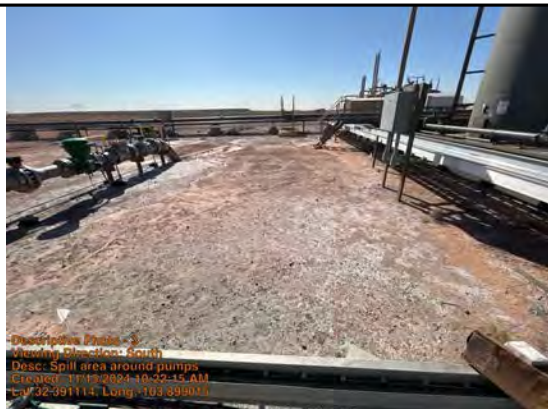
Viewing Direction: South

Spill area around pumps

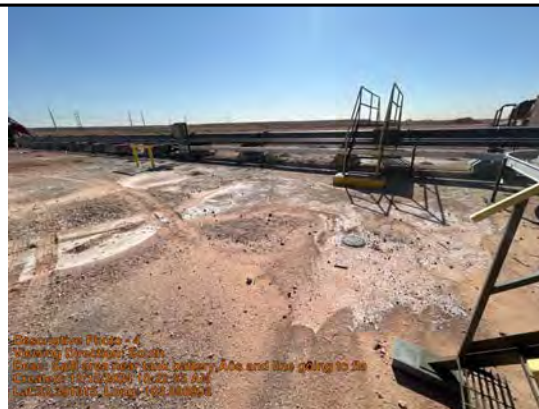
Viewing Direction: South

Spill area near tank battery's and line going to flare

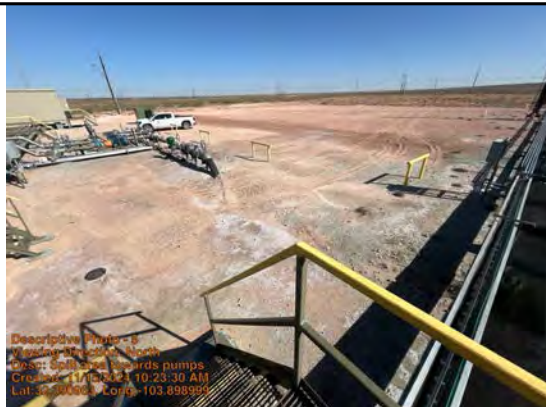
Viewing Direction: North

Spill area towards pumps

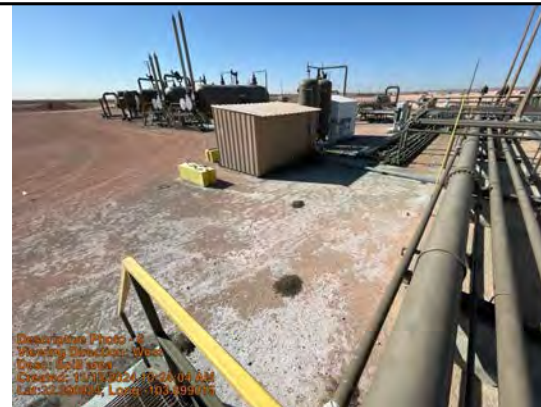
Viewing Direction: West

Spill area

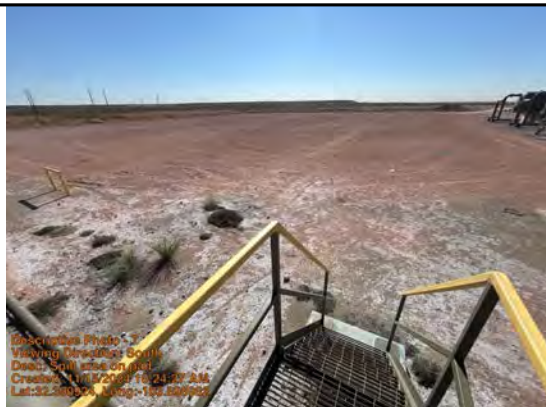
Viewing Direction: South

Spill area on pad

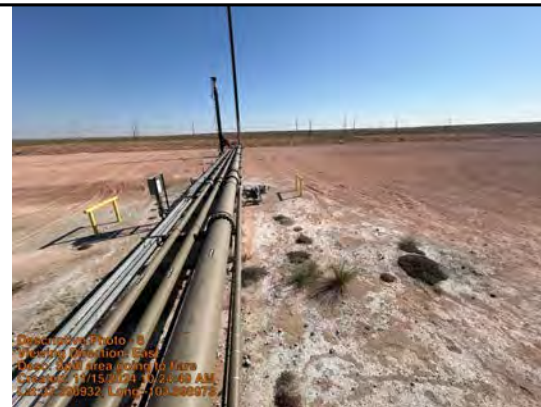
Viewing Direction: East

Spill area going to flare

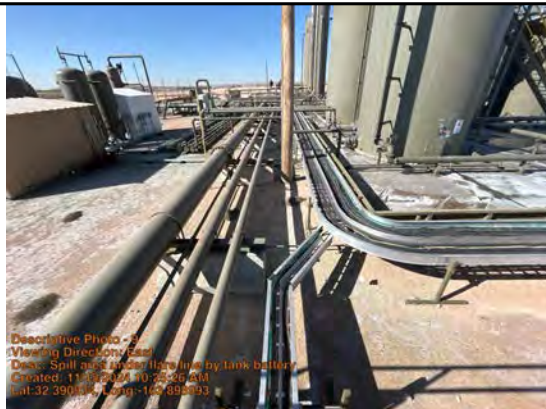
Viewing Direction: East

Spill area under flare line by tank battery

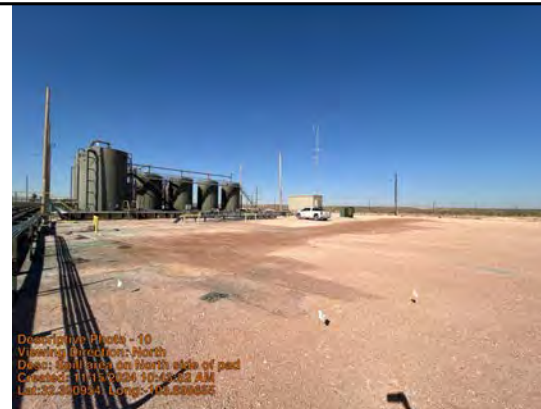
Viewing Direction: North

Spill area on North side of pad

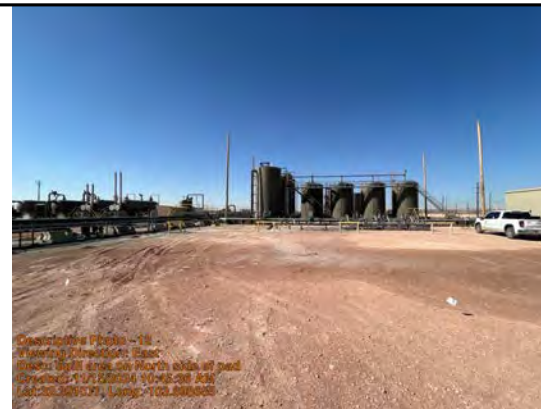
Viewing Direction: East

Spill area on North side of pad

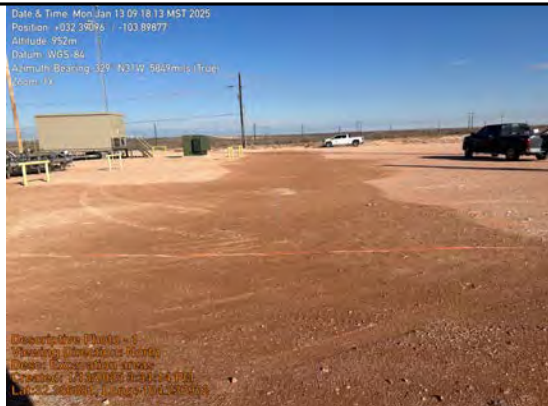
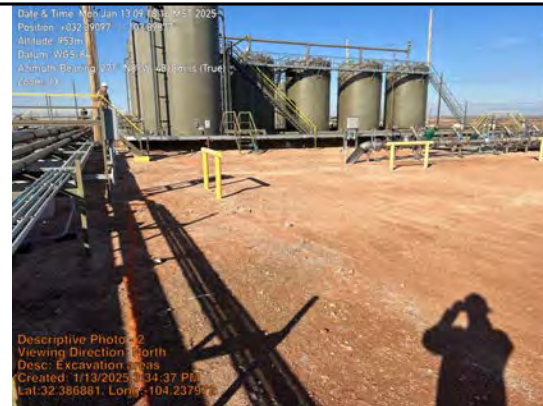
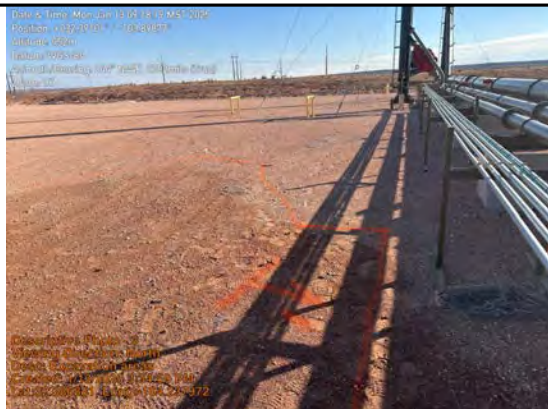
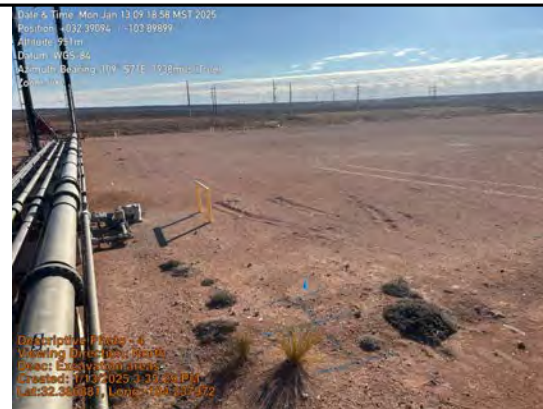
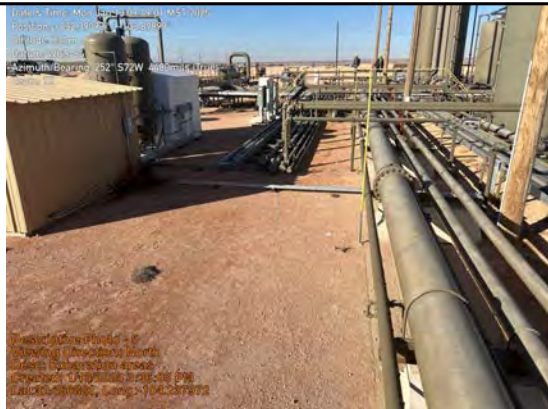
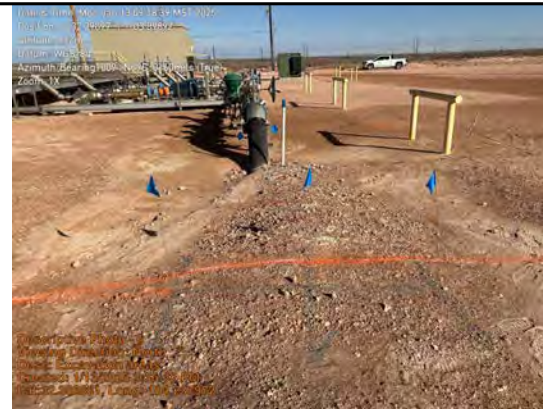
Excavation areas

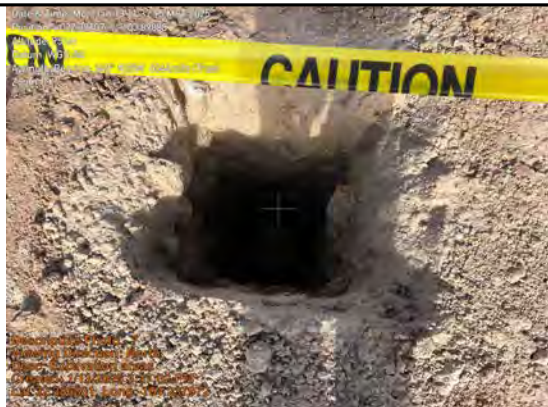
Viewing Direction: North

areas hydro vac to window out electrical lines

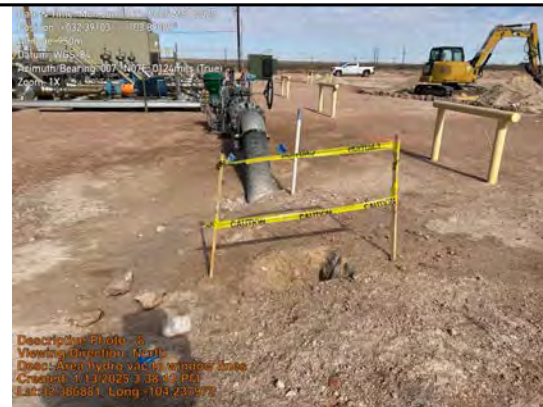
Viewing Direction: North

Area hydro vac to window lines

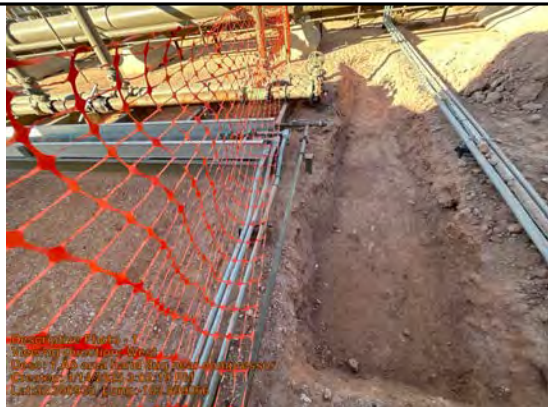
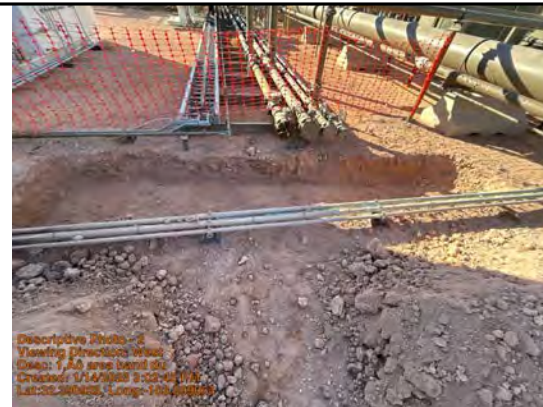
1' area hand dug near compressors

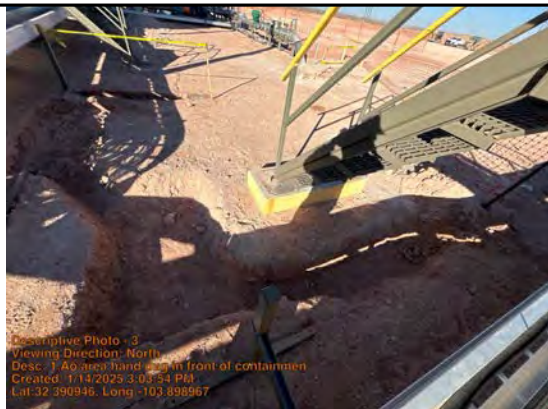
Viewing Direction: North

1' area hand dug in front of containment

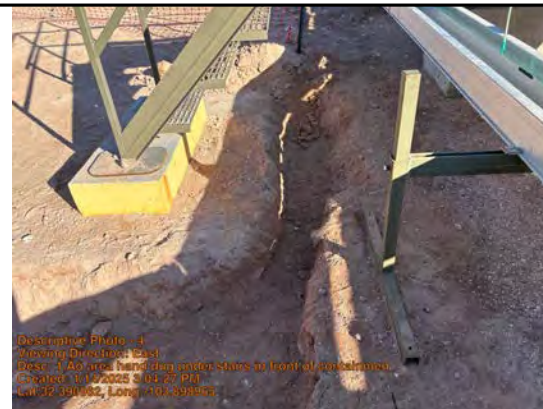
Viewing Direction: East

1' area hand dug under stairs in front of containment

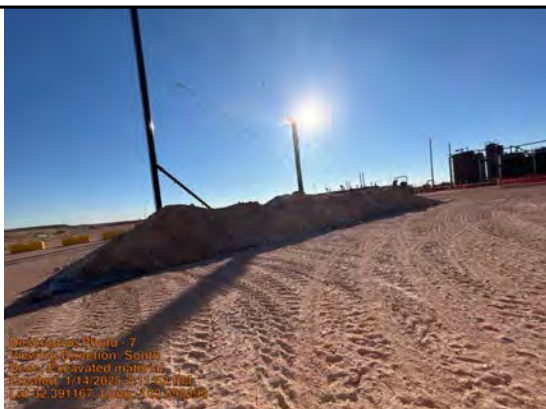
Viewing Direction: South

Excavated material

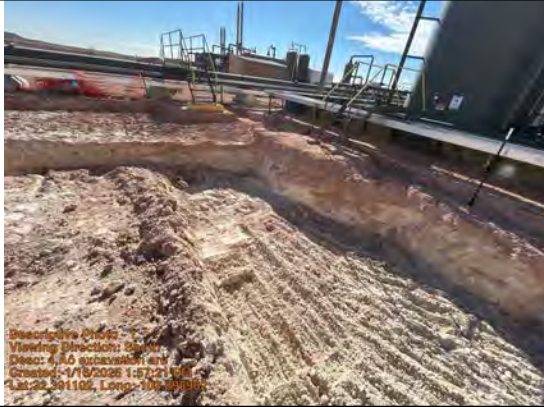
Viewing Direction: South

4' excavation area

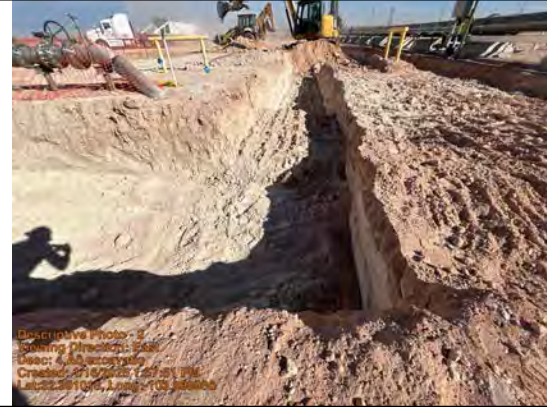
Viewing Direction: East

4' excavation

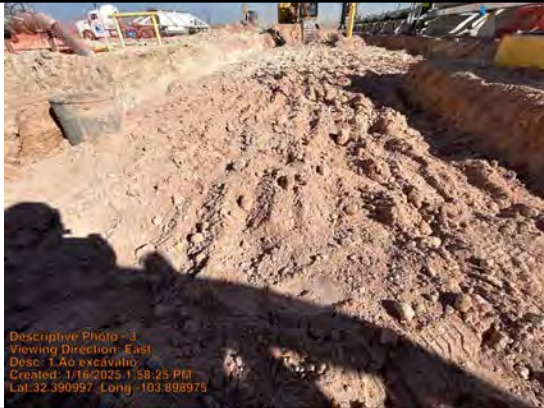
Viewing Direction: East

1' excavation

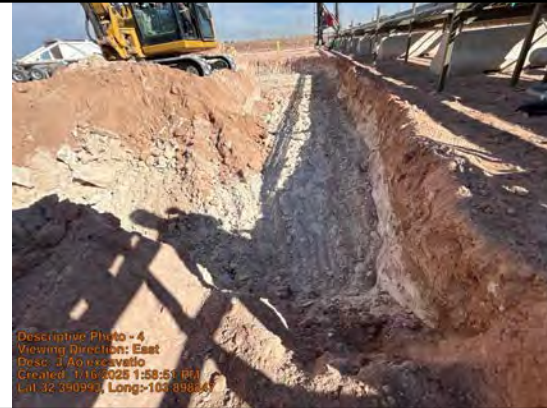
Viewing Direction: East

3' excavation

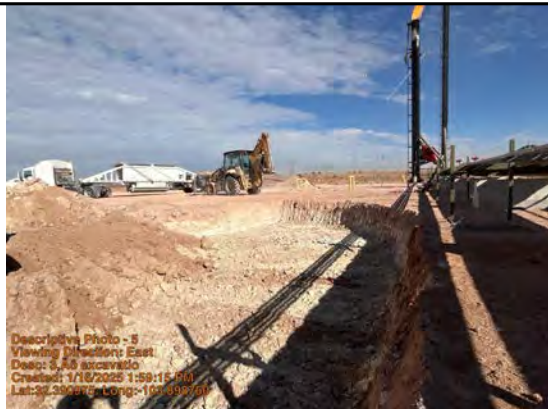
Descriptive Photo - 5  
Viewing Direction: East  
Date: 1/16/2025  
Created: 1/16/2025 1:59:15 PM  
Lat: 32.390975 Long: -104.99975

3' excavation

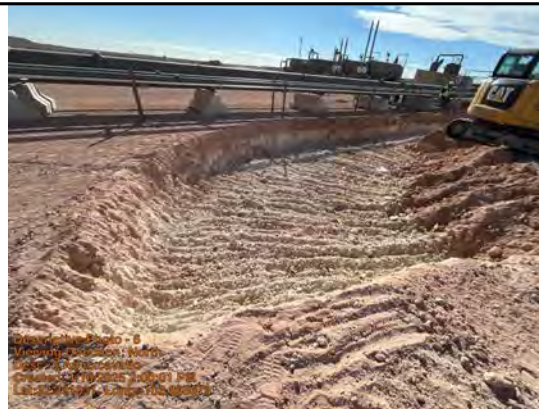
Descriptive Photo - 6  
Viewing Direction: North  
Date: 1/16/2025  
Created: 1/16/2025 2:00:01 PM  
Lat: 32.390975 Long: -104.99975

3' excavation
