REMEDIATION WORK PLAN

North Brushy PW Line

Eddy County, New Mexico

Incident Numbers

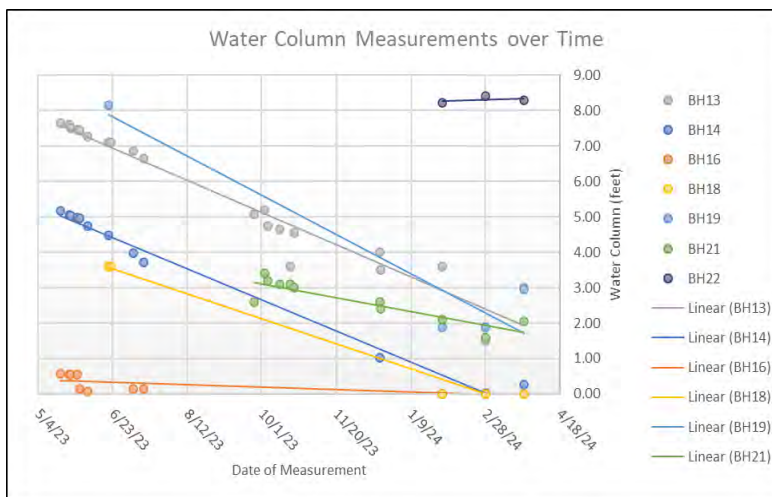
A graph depicting the decreasing water column trend over time is shown below:

While water was detected in the perched water-bearing zone, it appears to have limited volume and/or recharge potential as the depth of water was stabilized or decreased between well measurement dates. The area where the releases occurred was likely fed by surface water infiltration (rainfall and/or snowfall events) that is temporarily stored within low spots in the more porous poorly graded sand layer on top of the clayey sand. To supplement this determination, between May 15, 2023, and March 25, 2024, Etech purged wells BH13, BH14, and BH21 and recovered approximately 1,500 gallons of fluid via hand bailing and staged onsite inside 275 and/or 550-gallon totes. One new bailer was used and dedicated to each well throughout fluid recovery efforts to avoid cross-contamination. It should be noted that, on May 18, 2023, an effort to recover fluids from subsurface was attempted via hydrovacuum was used to recover fluids from the wells with a 2-inch fitting from the vacuum hose to the 2-inch PVC well top. Fluid recovery via these methods was unsuccessful, likely due to insufficient vacuum and/or low fluid volume in wells.

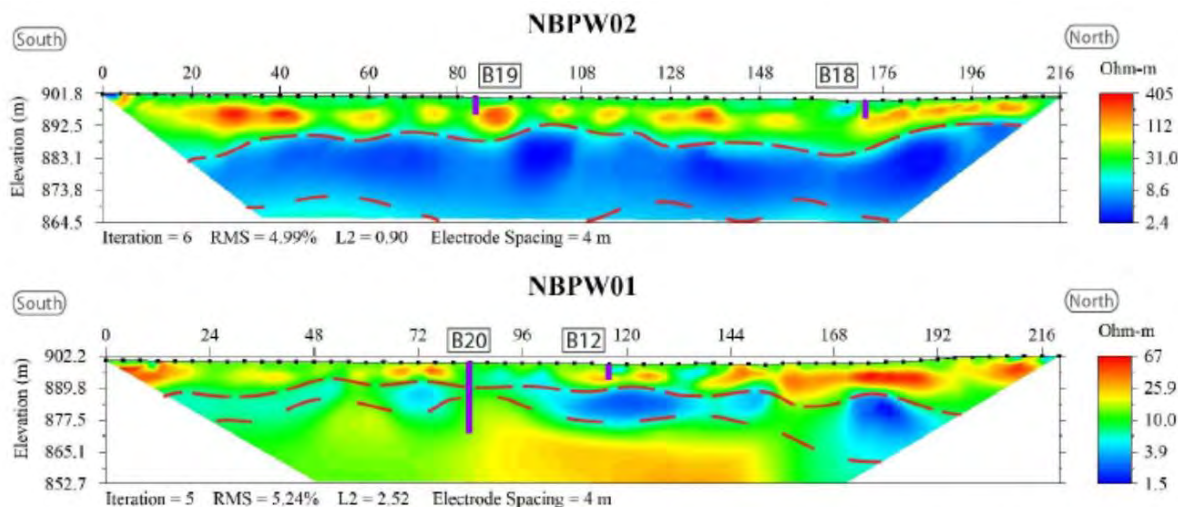
Based on the results from the survey, a low resistivity anomaly (discontinuous perched aquifer) was found beneath the surface from 43 feet to 104 feet bgs (interpretation model from the ERI report illustrated below) and further supports drilling findings. The low resistivity value range identified within the survey boundaries may be associated with either an aquifer, layers of moist to saturated halite or clay. When correlating the ERI survey results with nearby soil borings and general Site geology, the low resistivity anomaly coincides with an observed dry clay layer and appears to be the most likely case for the anomaly.

The perched water zone encountered during drilling activities is not clearly displayed in the ERI imaging due to the desired depth of the survey (121 to 164 feet bgs), which required 4-meter electrode spacing and in turn decreased the imagery resolution. However, the ER survey depth and resolution was chosen to provide an overall picture of the subsurface geology and an understanding of location(s) for potential perched zones and/or groundwater. All the delineation soil sampling locations advanced to or beyond 20 feet bgs have been vertically delineated to the Site Closure Criteria, except BH13 which was advanced up to 30 feet bgs, before reaching the depth(s) of the low resistivity anomaly interpreted as clay based on process knowledge of observed soil horizons encountered throughout drilling at the Site. As such, it is inferred that while concentrations of TDS, chloride and/or iron and manganese in the perched water-bearing units appear to be elevated, it does not appear to have impacted the true groundwater table which is beyond 103 feet bgs based on BH20 and subsequent ERI survey investigation. The complete ERI report is provided in **Appendix G**.

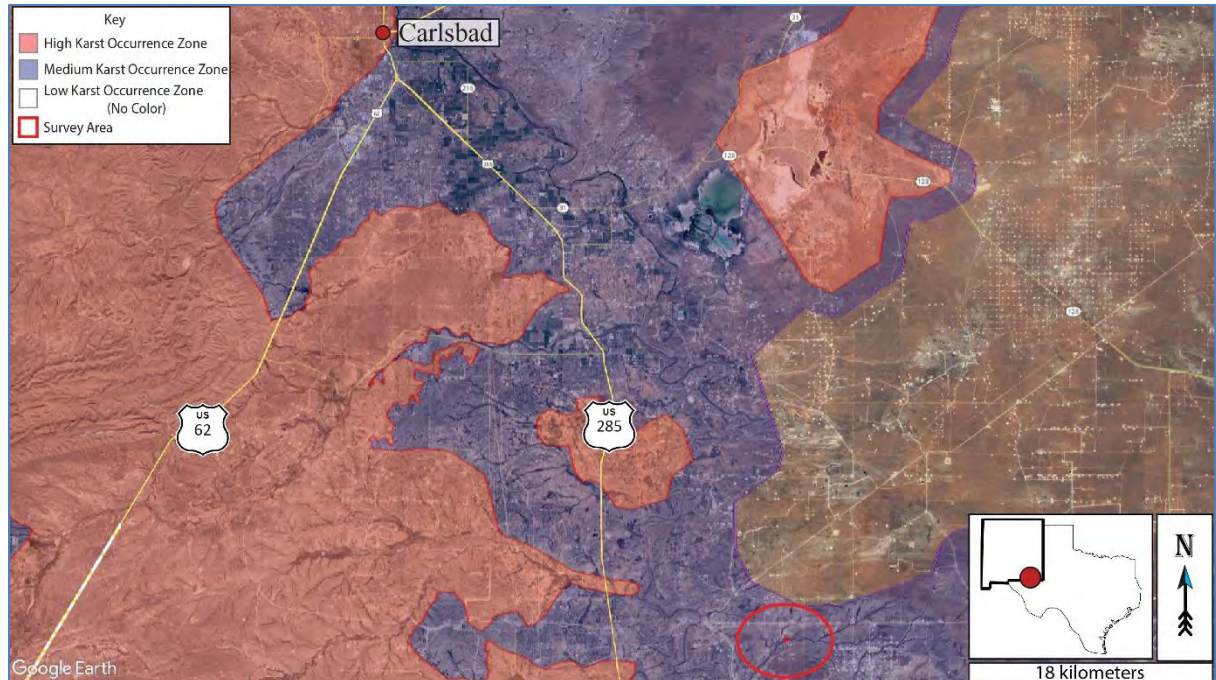
Figure 1: Karst occurrence zone overview. Background image credit: Google Earth. Image date: December 21, 2019. Image datum: WGS-84.

The Bureau of Land Management (BLM) categorizes all areas within the Carlsbad Field Office (CFO) zone of responsibility as having either low, medium, or high cave potential based on geology, occurrence of known caves, density of karst features, and potential impacts to freshwater aquifers^[1]. The New Mexico State Land office also recognizes these categories. This project occurs within a **MEDIUM** karst occurrence zone^[2] (MKOZ, **Figure 1**).

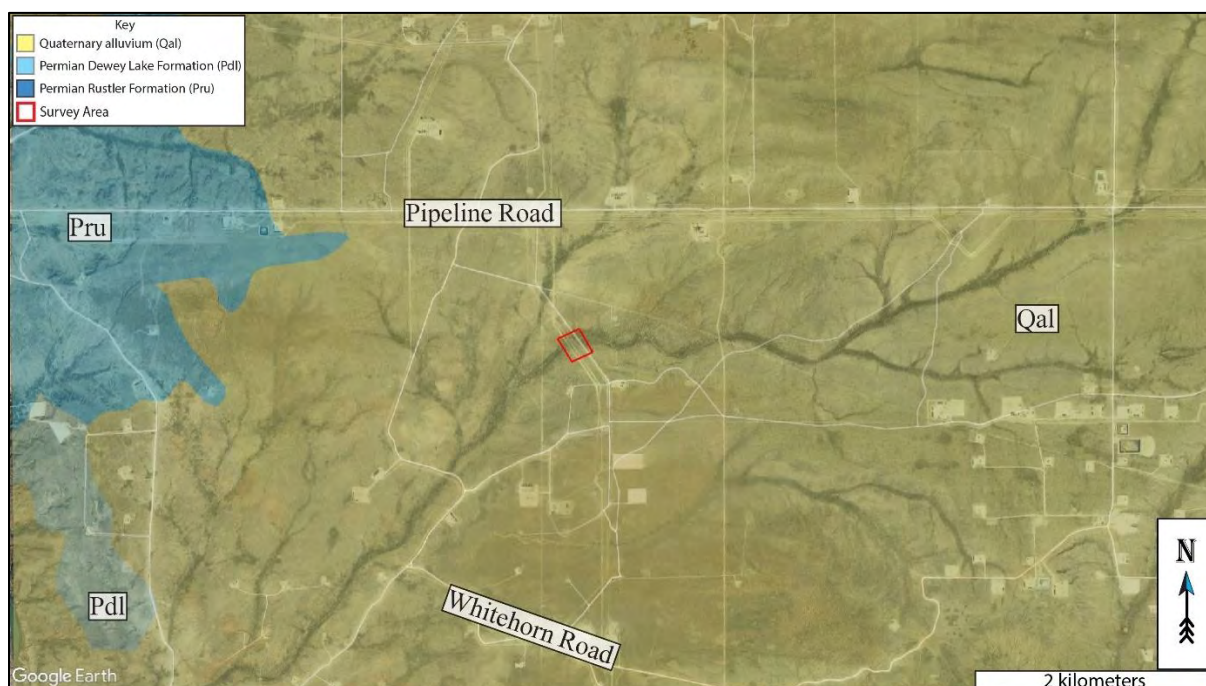
The Dewey Lake Formation is composed of calcite-cemented, hematite-stained quartz sand grains^[8] and occasional gypsum lenses and can, in favorable conditions, form cavernous porosity within 30 meters of the top of the Rustler^[9]. The Dewey Lake Formation is also known to be highly fractured near areas of heavy halite dissolution such as Nash Draw (approximately 30 kilometers north), and these fractures can act as hydrologic conduits.

Figure 3: Geology overview. Geology map credit: The Digital Geologic Map of New Mexico in ARC/INFO Format^[10]. Background image credit: Google Earth. Image date: December 21, 2019. Image datum: WGS-84.

The Rustler Formation is an evaporite facies and is composed mainly of thin siltstones and sandstones interbedded with claystones, dolomite and gypsum^[8], and contains both karst-forming strata (the Forty-niner and Tamarisk Members) and two shallow aquifers (the Magenta and Culebra Dolomite Members). The Forty-niner and Tamarisk Members are known to have highly developed karst features, including large voids and solution-enlarged fractures^[8].

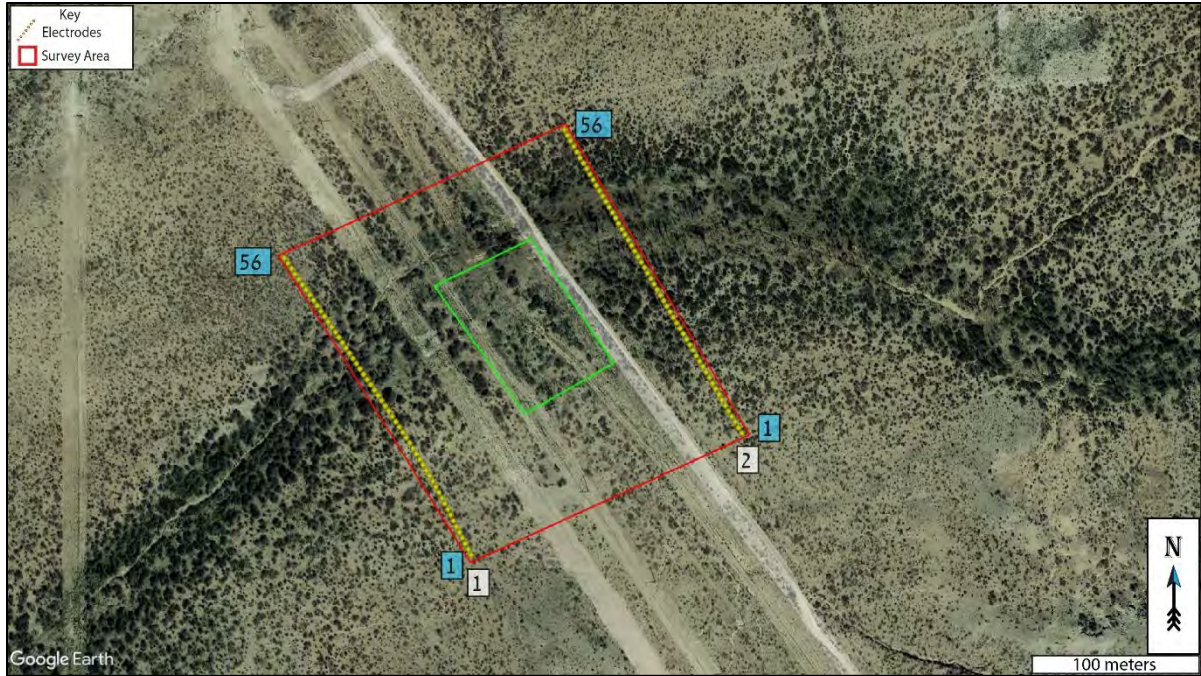
Figure 4: Survey overview. Two survey lines (denoted with white numbers) were conducted with 56 electrodes each at 4-meter spacing (yellow dots denoted with blue numbers). Background image credit: Google Earth. Image date: December 21, 2019. Image datum: WGS-84.

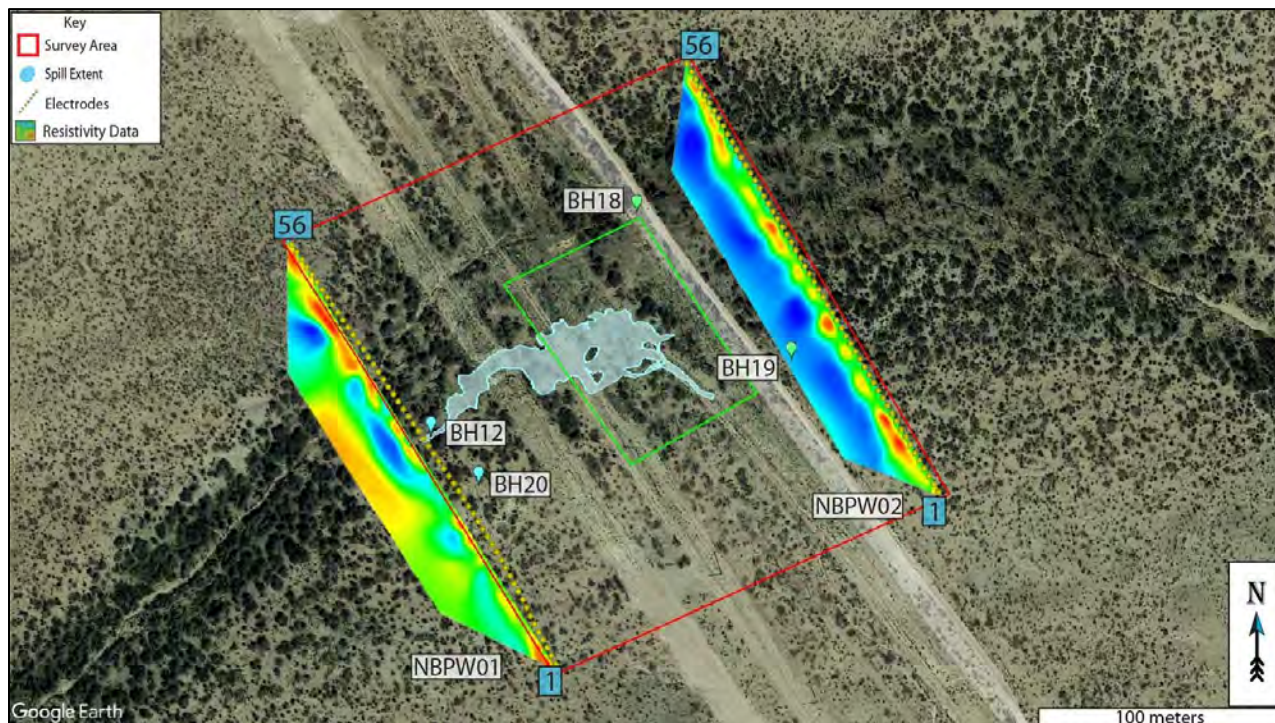
The NBPW survey area has a horizontal, low-resistivity anomaly that is interpreted as a discontinuous perched aquifer between 13 – 30 meters (43 to 104 feet) beneath the surface (**Figure 6**). Resistivities within these boundaries drop to 1.5 – 15 Ohm-m, which is consistent with either a saturated medium (aquifer) or layers of either clays or moist to saturated halite. Higher resistivity values (between 35 and 600 Ohm-m) are interpreted as dry to slightly moist gypsum and clay-rich sandstone bedrock.

Figure 6: Interpretation. Colored trapezoids are 2D inverted resistivity lines. Green polygon is the area of interest. Blue and green placemarks are borehole locations. Background image credit: Google Earth. Image date: December 21, 2019. Image datum: WGS-84.

The lowest resistivity zone (1.5 Ohm-m) within the survey is directly beneath the downstream portion of the release footprint. This indicates the possibility that the fluids from the release made their way into the subsurface at this location. Borehole BH12 is the closest geotechnical investigation to this location; however, it does not reach deep enough to confirm or refute this interpretation (**Figure 5**). BH12 was drilled to a depth of 8 meters (26) feet, 5 meters (16 feet) shy of the top of this anomaly.
