REMEDiation CLOSURE REPORT

PREPARED FOR:
DEVON ENERGY PRODUCTION, LP.

PREPARED BY:
PIMA ENVIRONMENTAL SERVICES, LLC.

RE: Remediation Closure Report
LOCATION: Todd 36 CTB 3
FACILITY ID: fAPP2123651847
GPS (NAD 83): 32.256706, -103.728556
INCIDENT LOCATION: O-36-T23S-R31E
COUNTY: Eddy
NMOCD REF. NO. nAPP2315623222

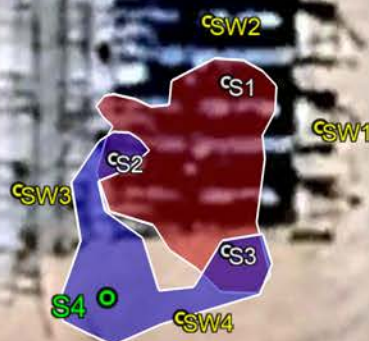
On May 31, 2024, after Devon submitted a 48-Hour Notification of Sampling event (Appendix C), Pima personnel returned to the site to reassess the release area. Due to research of initial pictures and description, it was concluded that the previously reported spill area was incorrect. A Corrected Site Map with assessment sample points and existing production equipment can be found in Figure 6. Discrete samples were collected from three (3) of the previous sample points along with an additional sample point (S4) added to the corrected area. These samples were collected from depths of surface and 1' bgs. All samples were put on ice, prepared for delivery, and delivered to Cardinal Laboratories for official analysis of all constituents listed in Table 1 19.15.29.12 NMAC. The lab results of this sampling event can be found in the Data Tables included in Figure 5. Complete Laboratory Reports can be referenced in Appendix E. Photographic Documentation can be found in Appendix D.

- Background sample
- Corrected release area - 518 sqft
- Horizontal delineation samples
- Incorrect release area - 904 sqft
- S4
- Vertical delineation samples

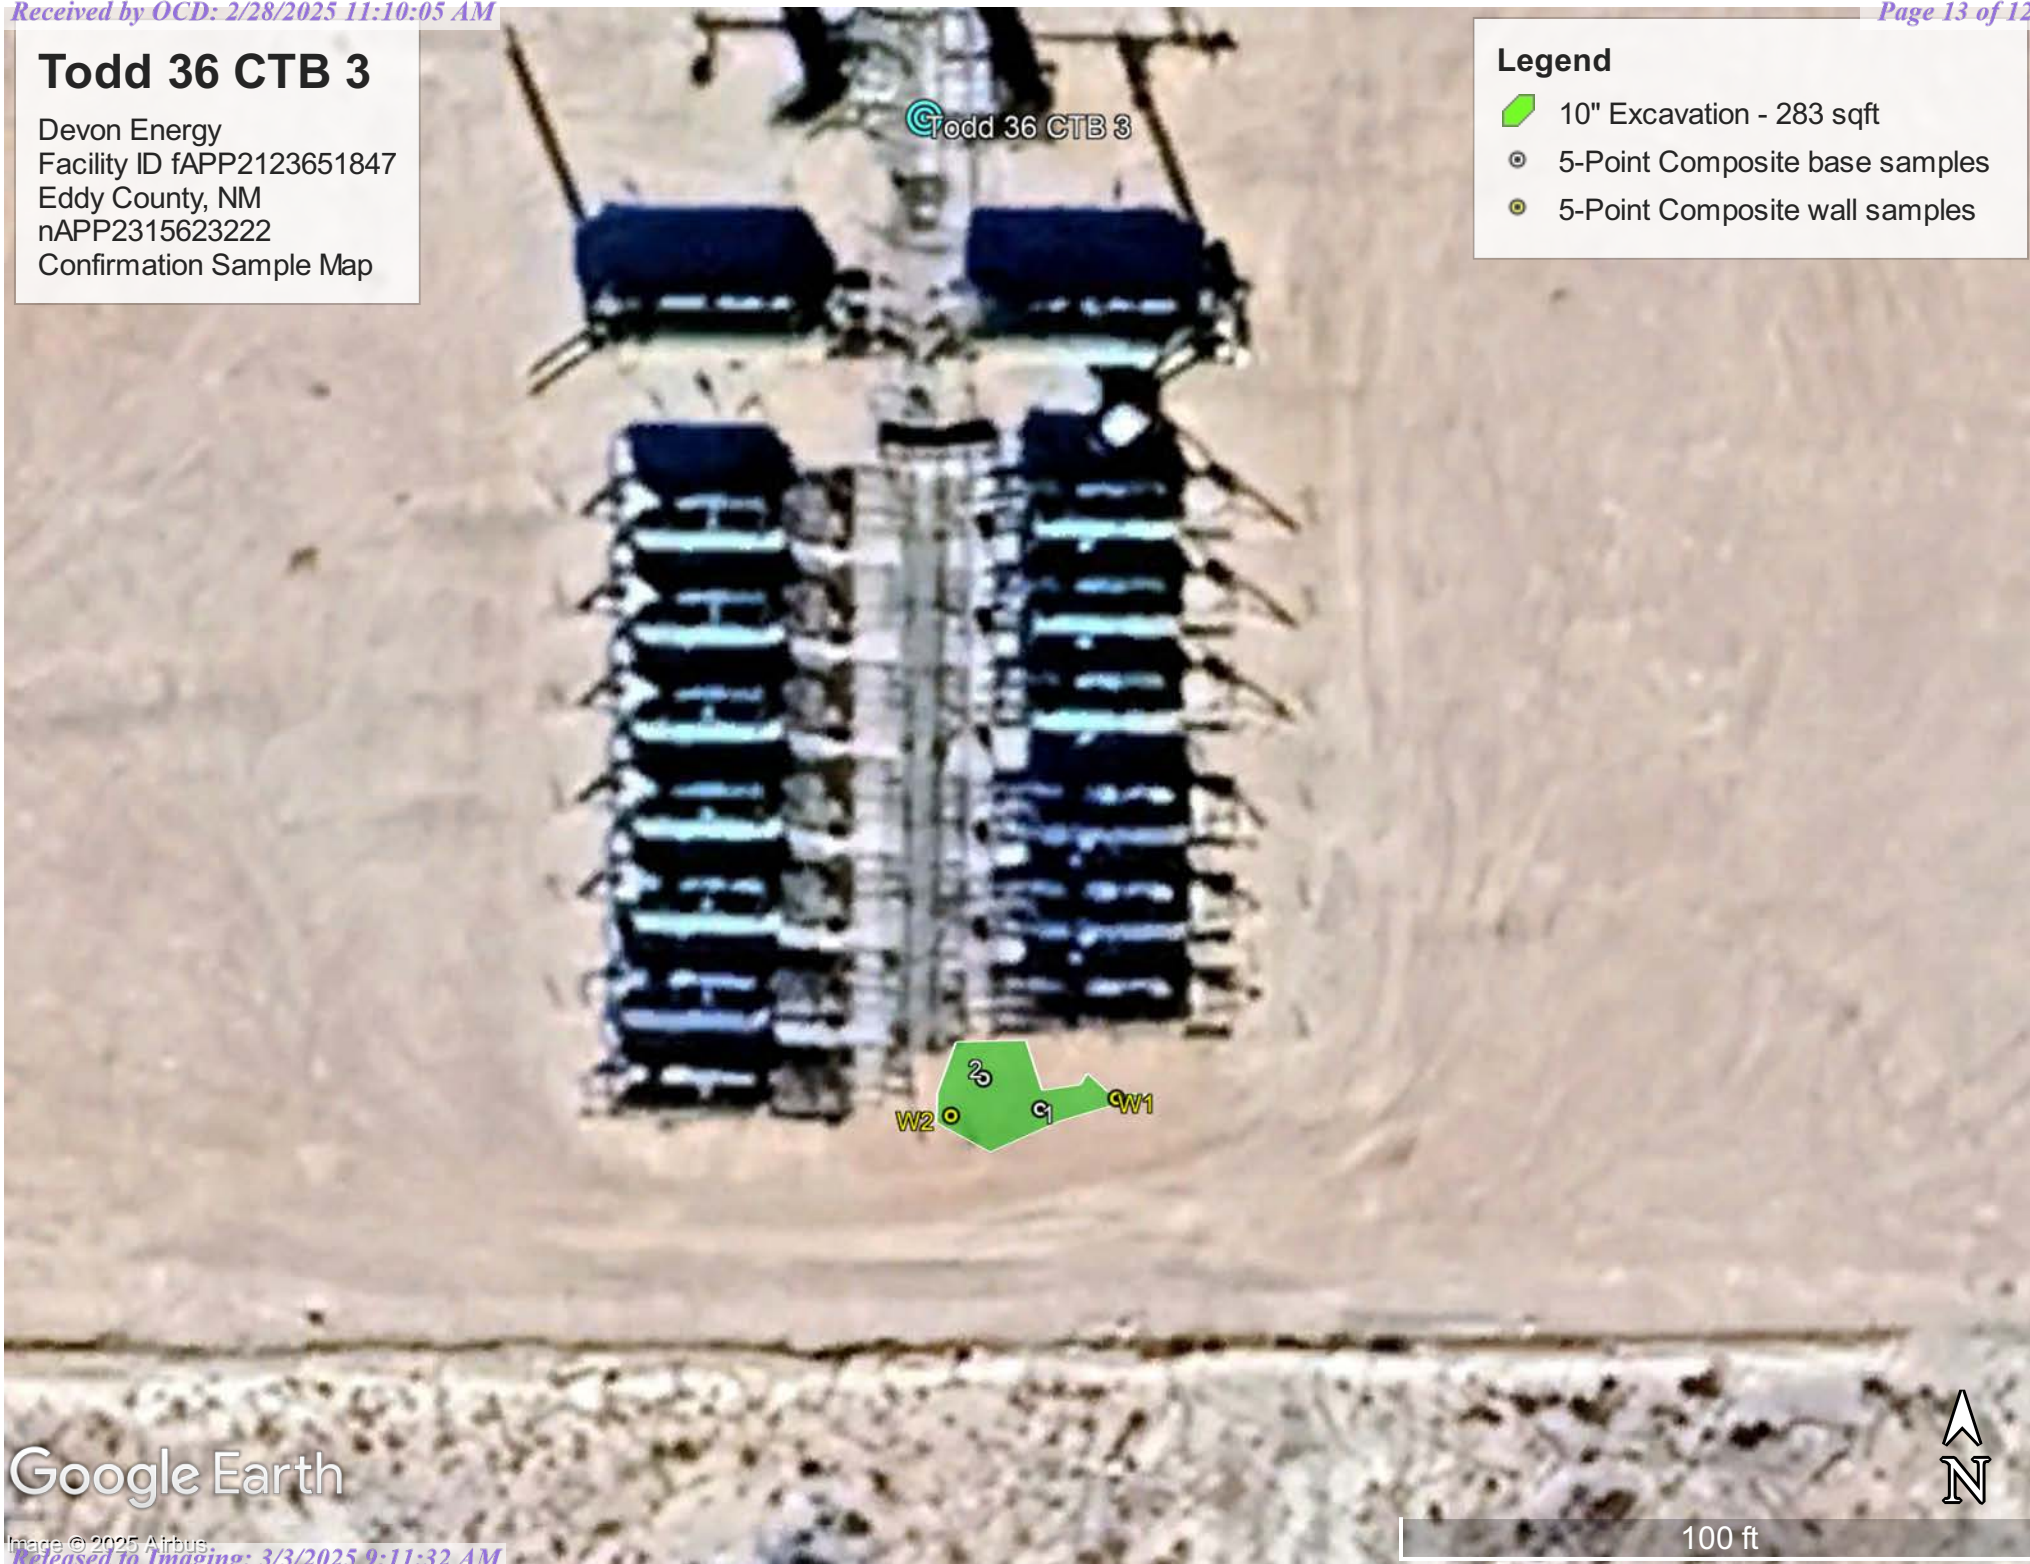
On February 12, 2025, after Devon submitted a 48-hour notification for sampling (Appendix C), Pima returned to the site to collect 5-point composite confirmation samples of the excavated area. Ten (10) subsamples were collected to create two (2) composite samples of the base of the excavation. Ten (10) subsamples were collected to create two (2) composite samples of the walls of the excavation. A total of four (4) samples were put on ice, prepared for delivery, then delivered to Envirotech Analytical Laboratory for official analysis of all constituents listed in Table 1 19.15.29.12 NMAC.

On February 14, 2025, an analytical report was received and verified that all sample results are under the regulatory limits of the greater than 100-foot depth to groundwater section of Table 1. Sample results can be referenced in the Data Tables included in Figure 5. A corresponding Confirmation Sample Map can be referenced in Figure 7. Complete Laboratory Reports are included in Appendix E.

5-Point Composite wall samples

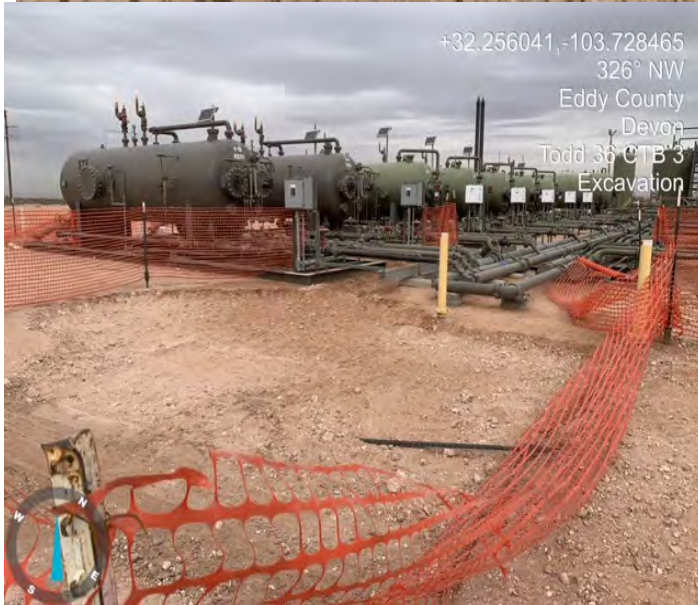
On February 7, 2025, the Devon construction department and Pima mobilized personnel and equipment to the site to begin excavating the area of concern. The entire 283 square foot area was excavated using hand tools and mechanical equipment to a depth of 10" bgs to remove all surface staining. Approximately 9 cubic yards of soil were removed and hauled to Northern Delaware Basin Landfill for disposal. Clean, like material was brought back to the site and stockpiled to be used for backfilling. This excavation was combined with the excavation for nAPP2501625164, which will be addressed in a separate report. Photographic Documentation can be found in Appendix D.

+32.255994,-103.728403
260° W
Devon
Todd 36 CTB 3
Excavation

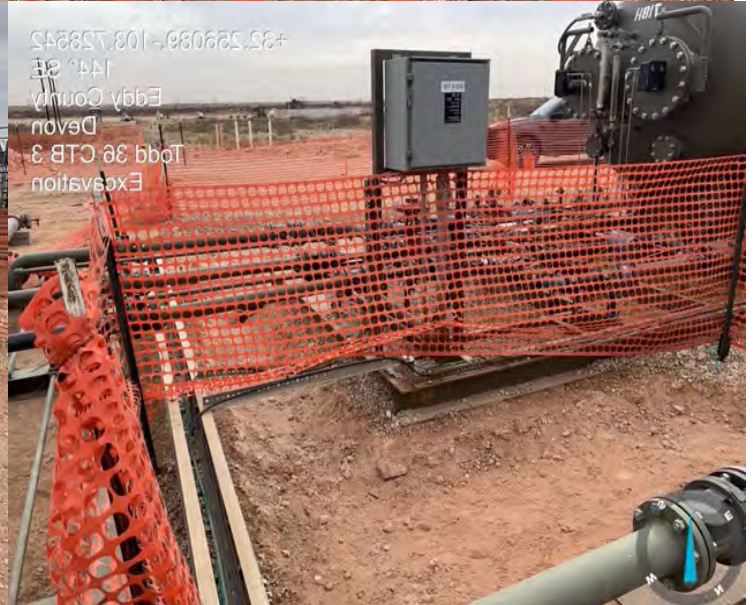
+32.256041,-103.728465
326° NW
Eddy County
Devon
Todd 36 CTB 3
Excavation

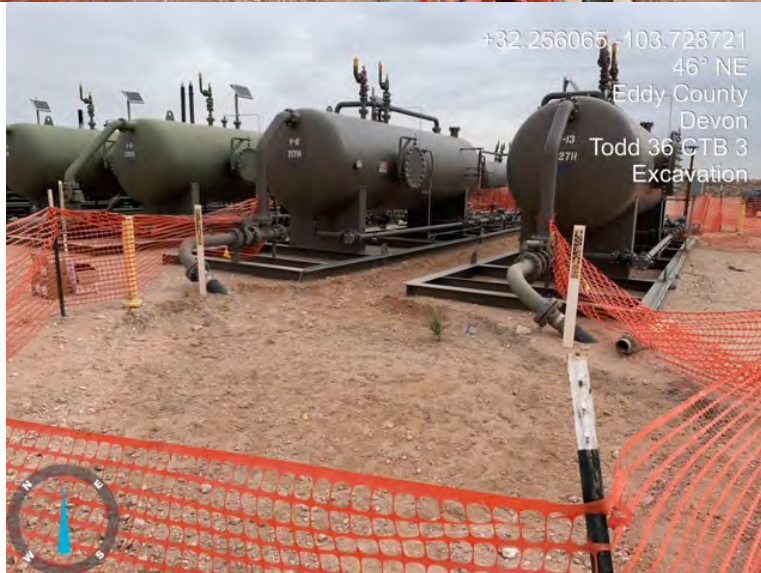
+32.256041,-103.728465
326° NW
Eddy County
Devon
Todd 36 CTB 3
Excavation
