Remediation Summary and Closure Report

November 18, 2024

**West Eumont Unit #407 Battery
Produced Water Release
Incident No. nAPP2316652967
Lea County, New Mexico**

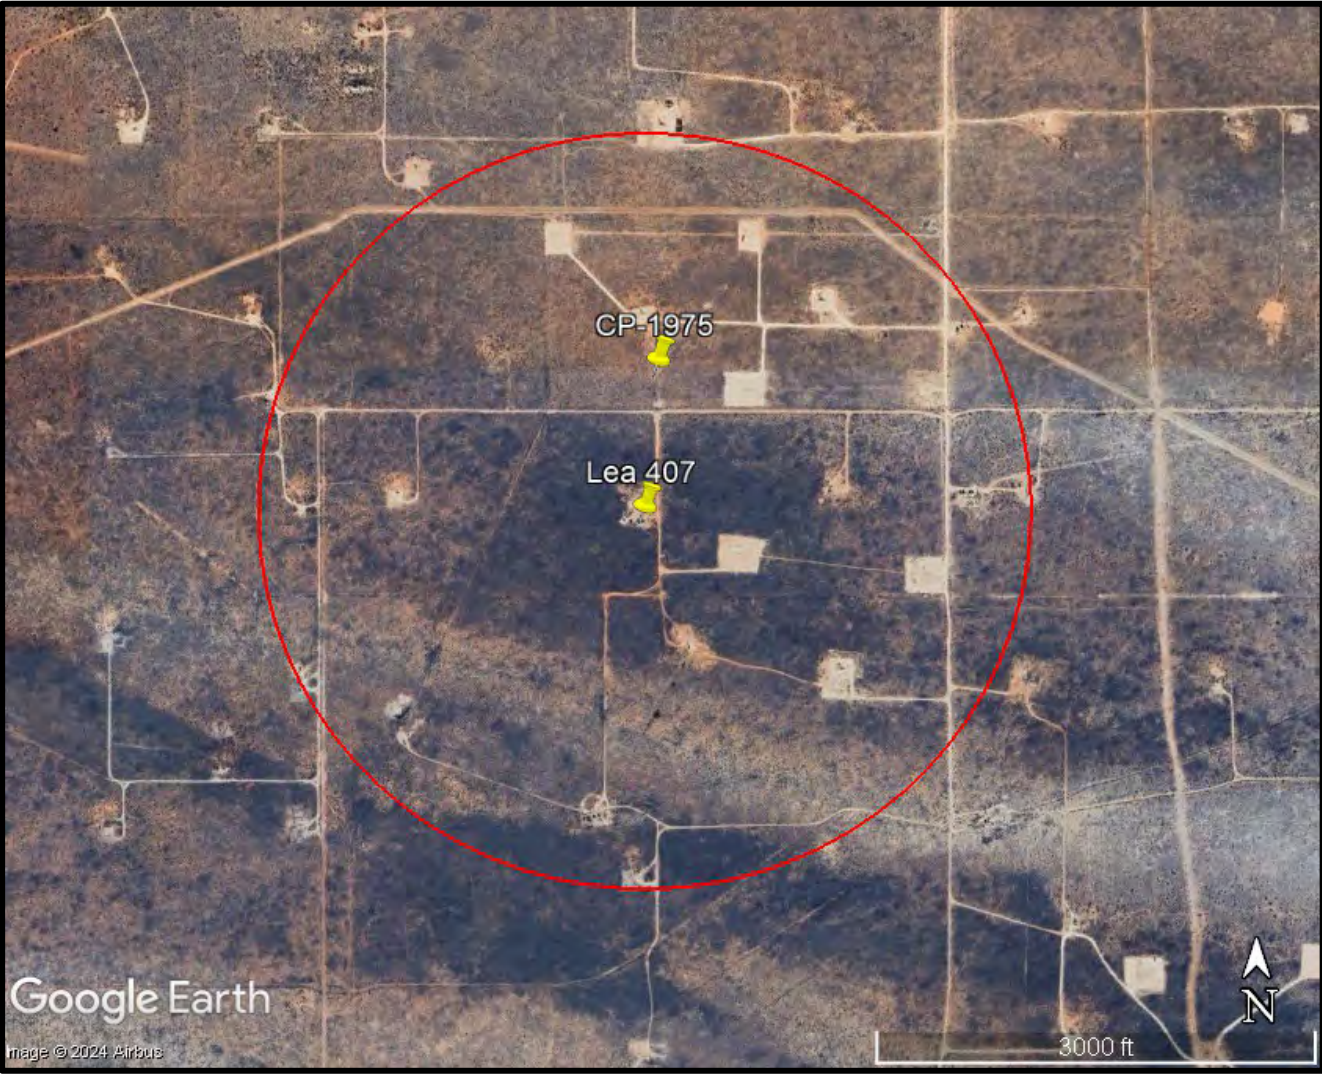
Site and Well Location</div> <div>Base Map from Google Earth Pro</div>	<div>Figure 3</div> <div>Wellhead Protection Area Map</div> <div>Forty Acres Energy, LLC</div> <div>West Eumont Unit 407 Battery</div> <div>Lea County, New Mexico</div>

The 0.5-mile wellhead protection area is shown on Figure 3. One water well was drilled within 0.5 mile of the Site in 2023, but the well was dry. There were no other water sources, springs, or other sources of freshwater extraction identified within 0.5-mile of the Site.

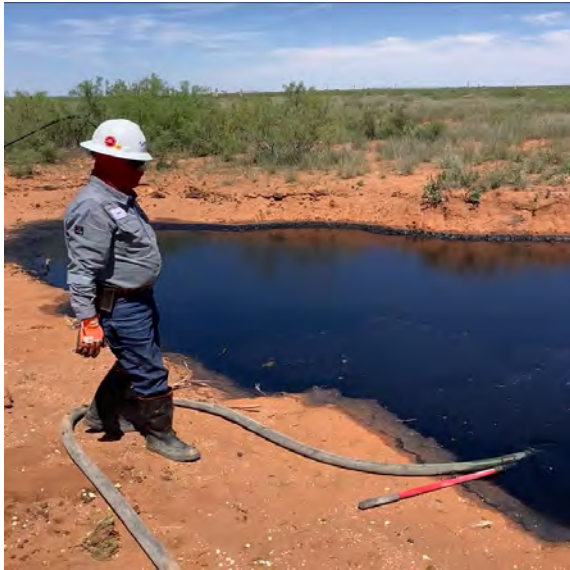
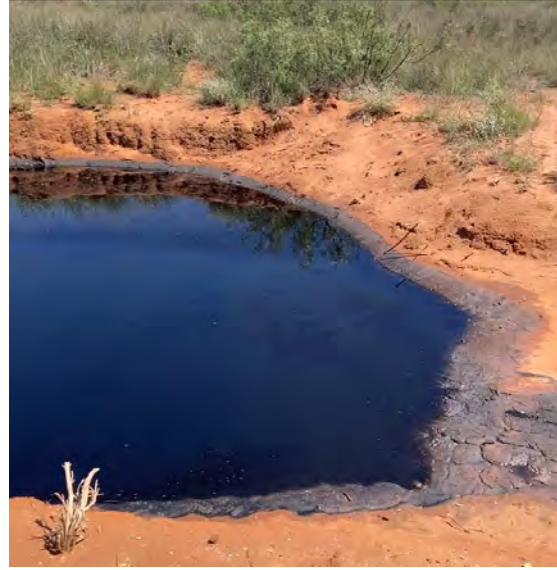
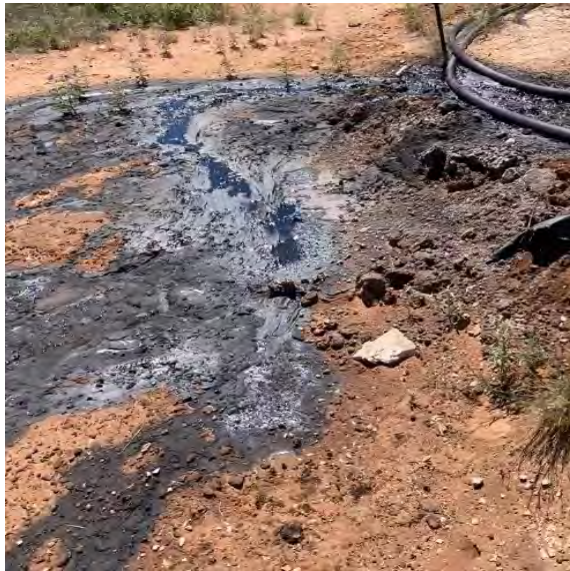
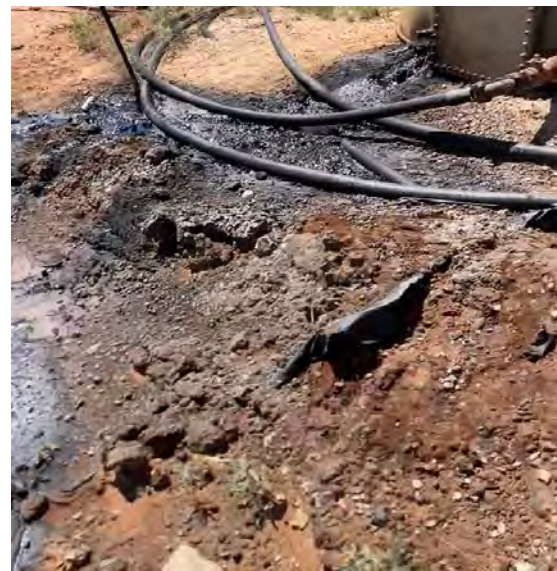
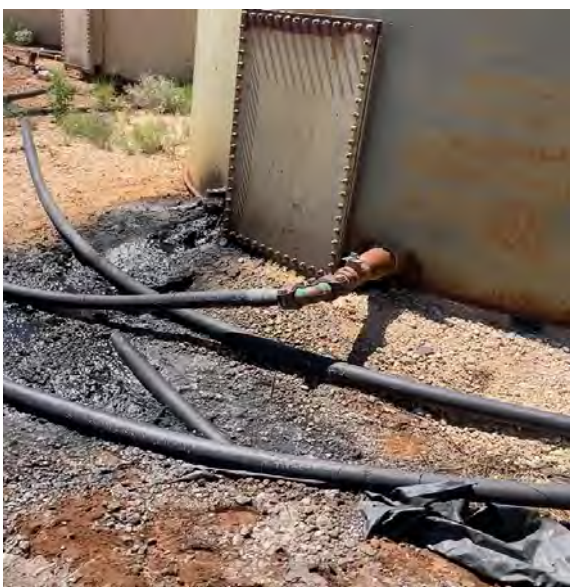
View of release area (6/14/23).

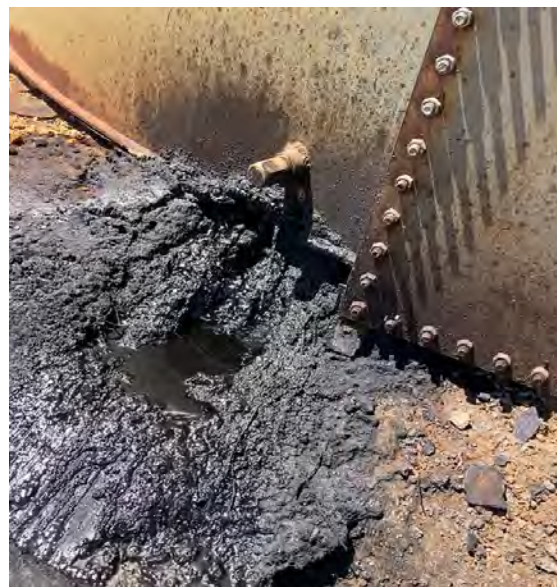
View of release point (6/14/23).

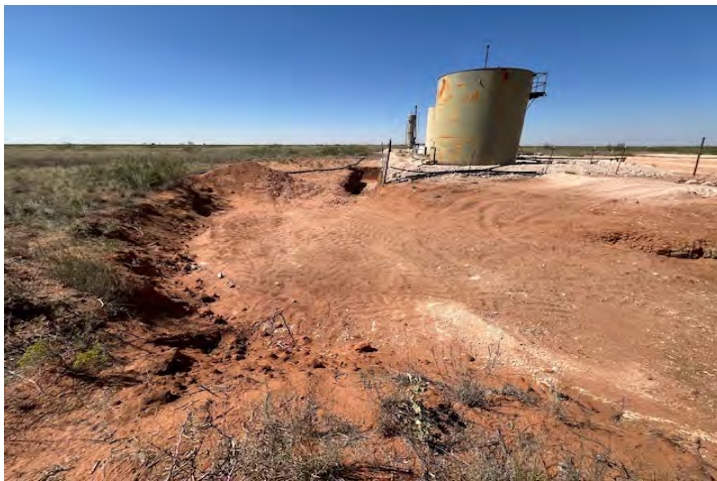
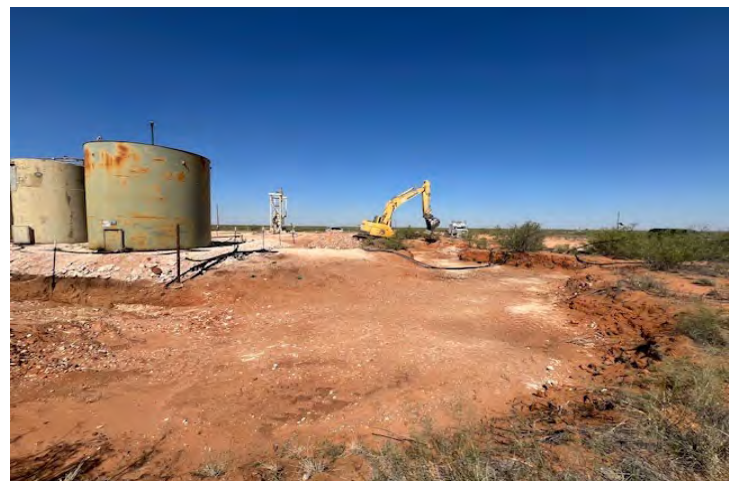
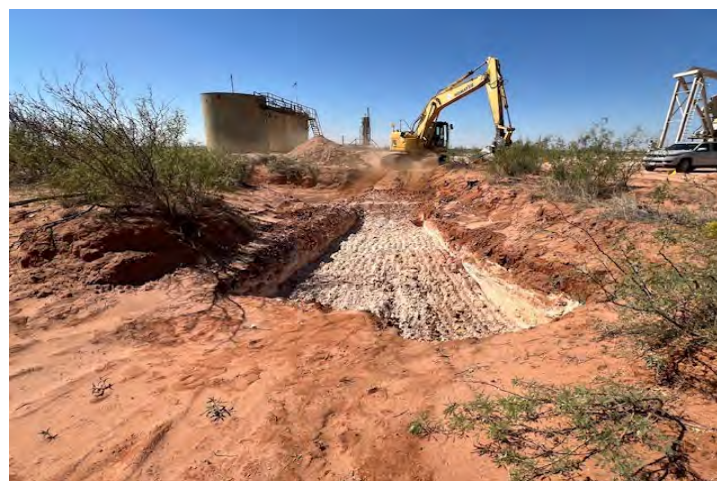
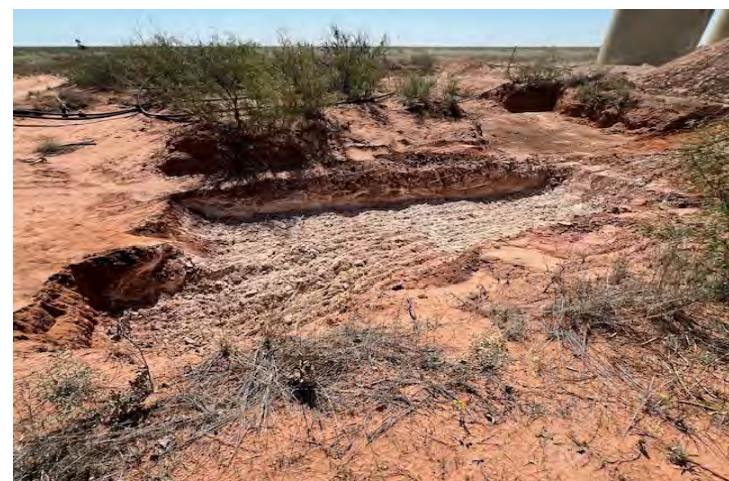
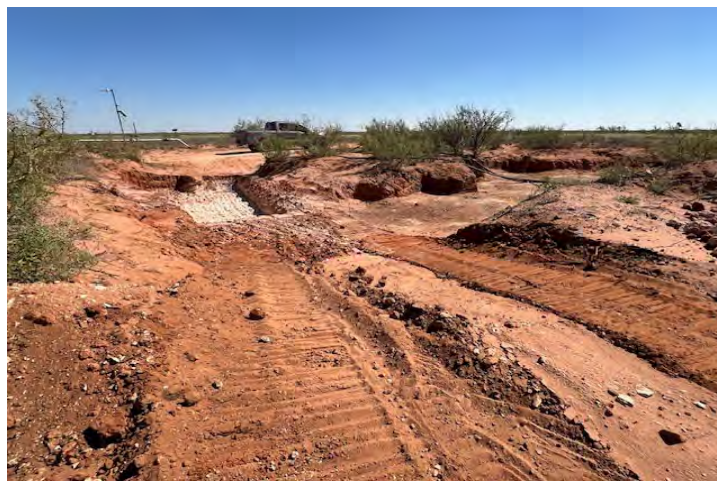
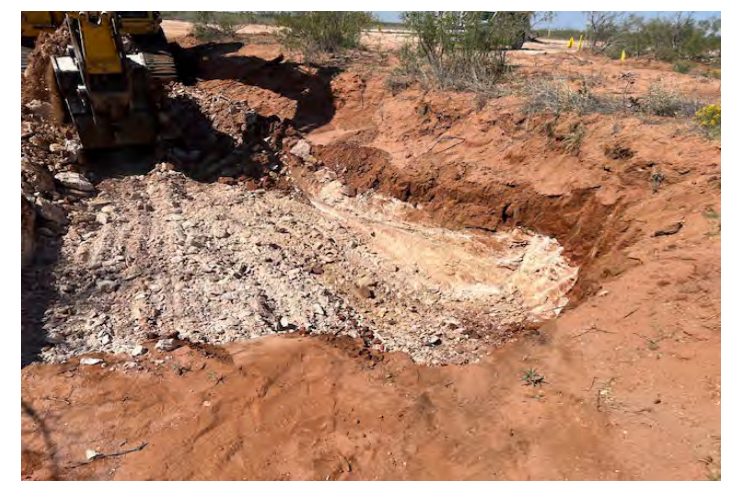
View to W of excavation (10/15/24).

View to N of excavation (10/15/24).

View to S of excavation (10/15/24).

View to E of excavation (10/15/24).

View of excavation at NE corner (10/15/24).

All affected soil has been excavated, and 356 cubic yards (cy) of soil were hauled to J&L Landfarm for disposal between July 24 and October 21, 2024. Waste Manifests are provided in Appendix F.
