# Remediation Summary & Soil Closure Request

## Permian Resources Laguna 23 Fed Com 1H

Lea County, New Mexico  
Unit Letter N, Section 23, Township 20 South, Range 34 East  
Latitude 32.552474 North, Longitude 103.53345 West  
NMOCD Reference No. NAPP2426430978

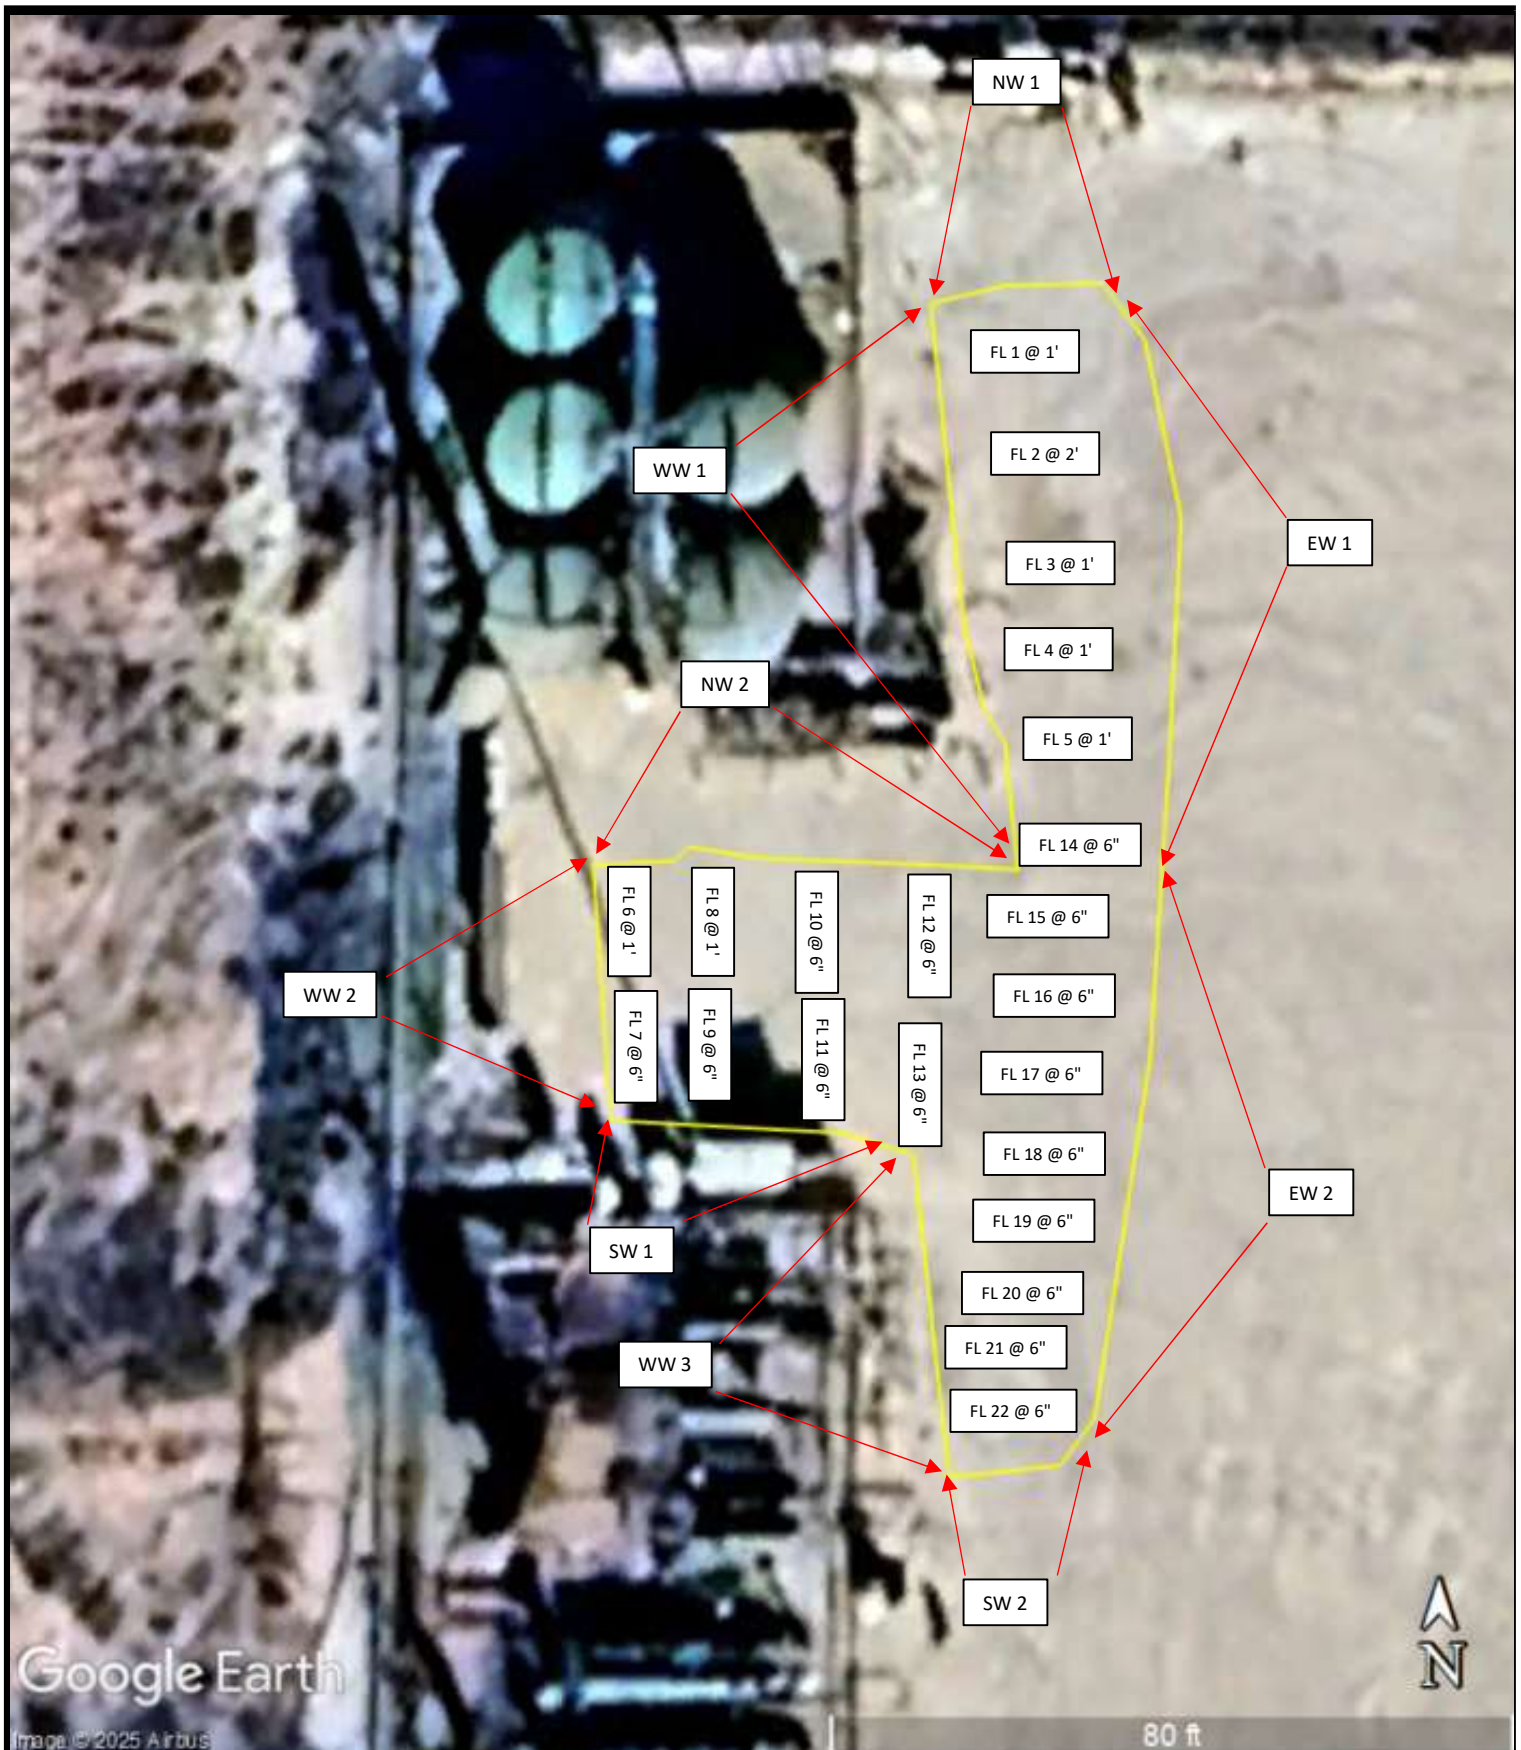
## **Figure 3**

### **Site and Sample Location Map**

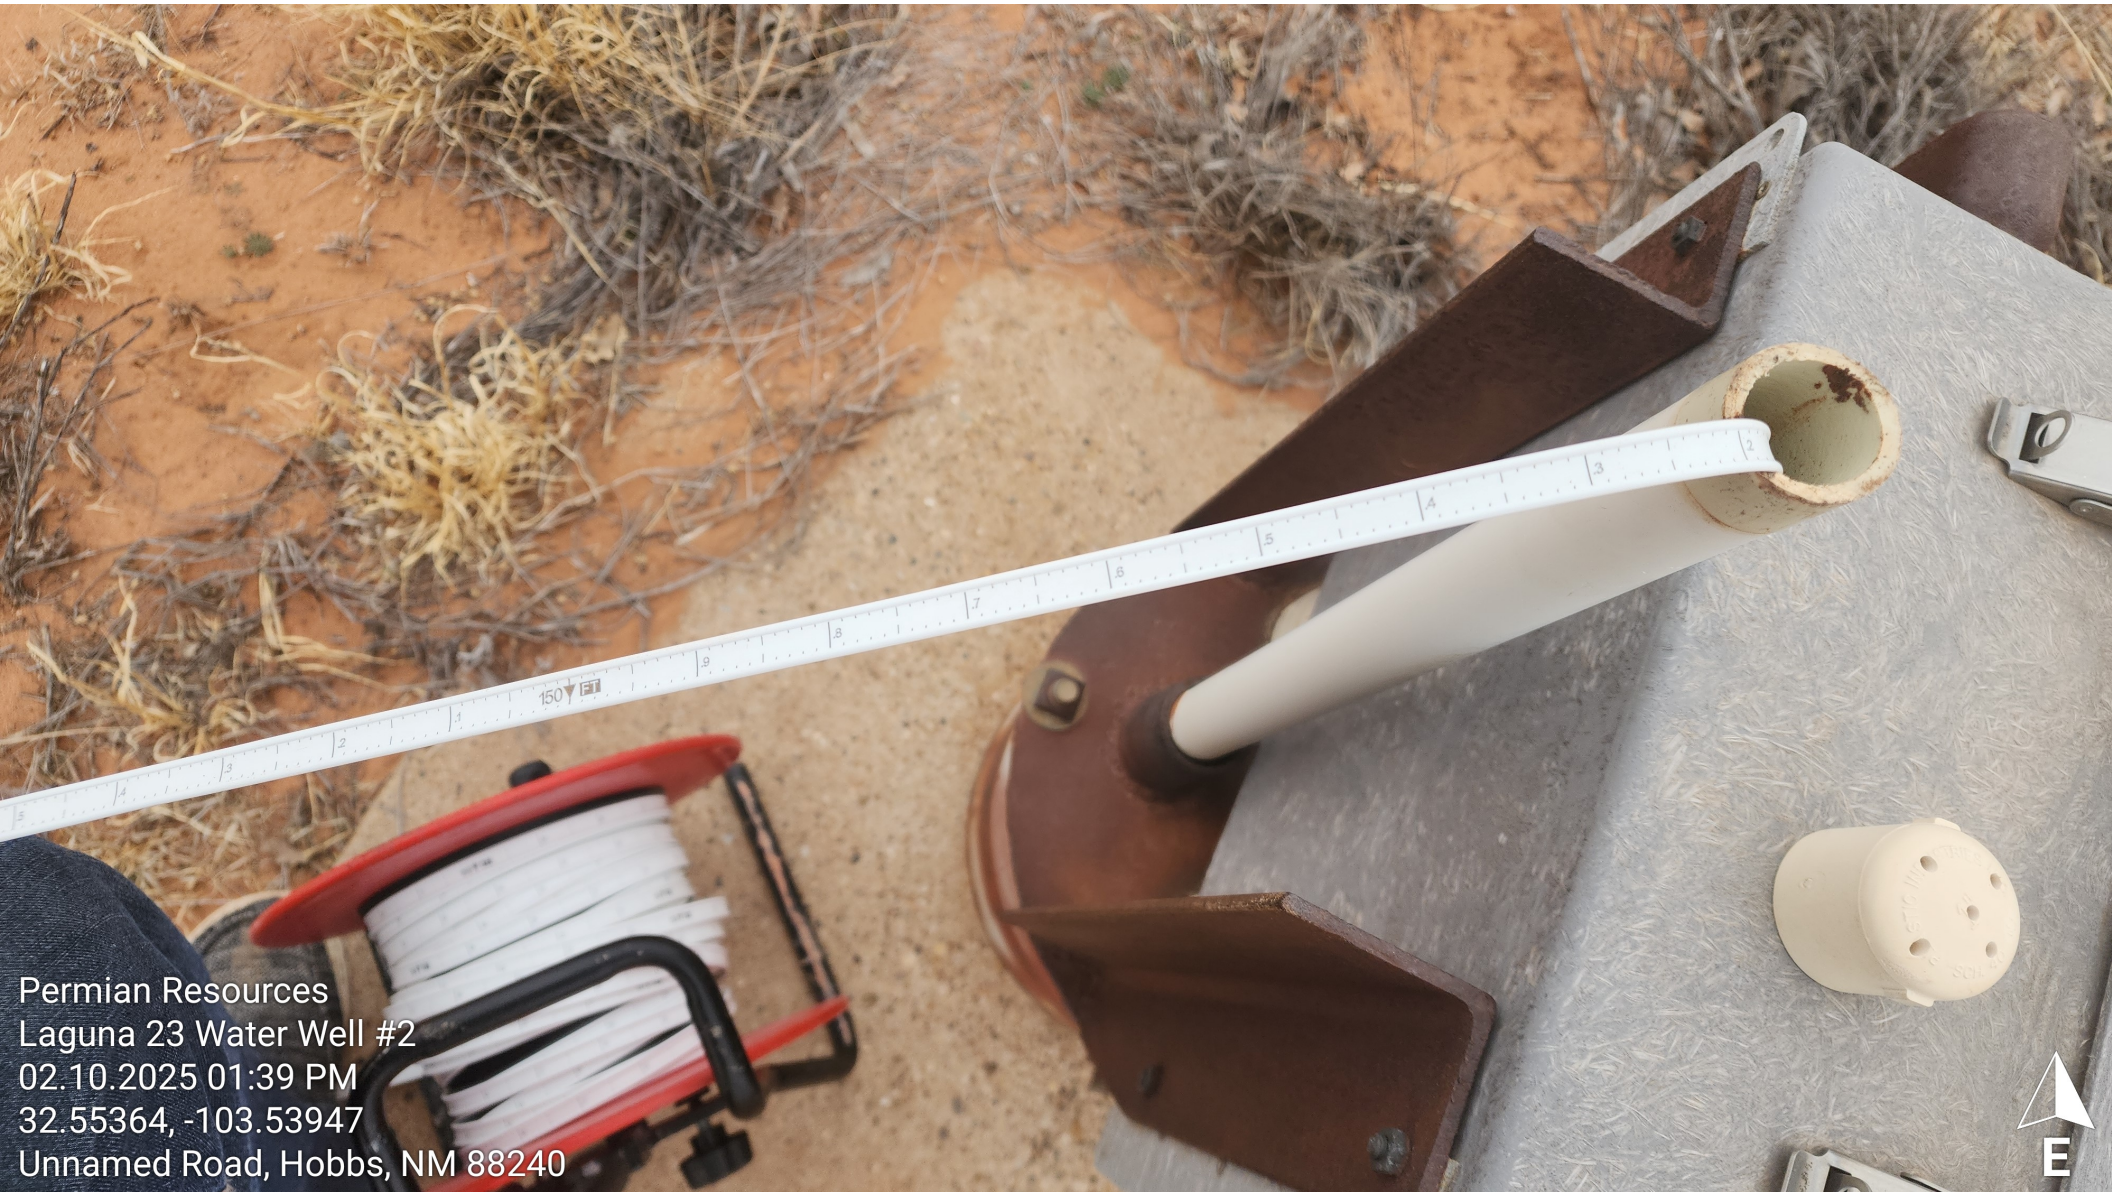
Permian Resources  
Laguna 23 Water Well #2  
02.10.2025 01:39 PM  
32.55364, -103.53947  
Unnamed Road, Hobbs, NM 88240

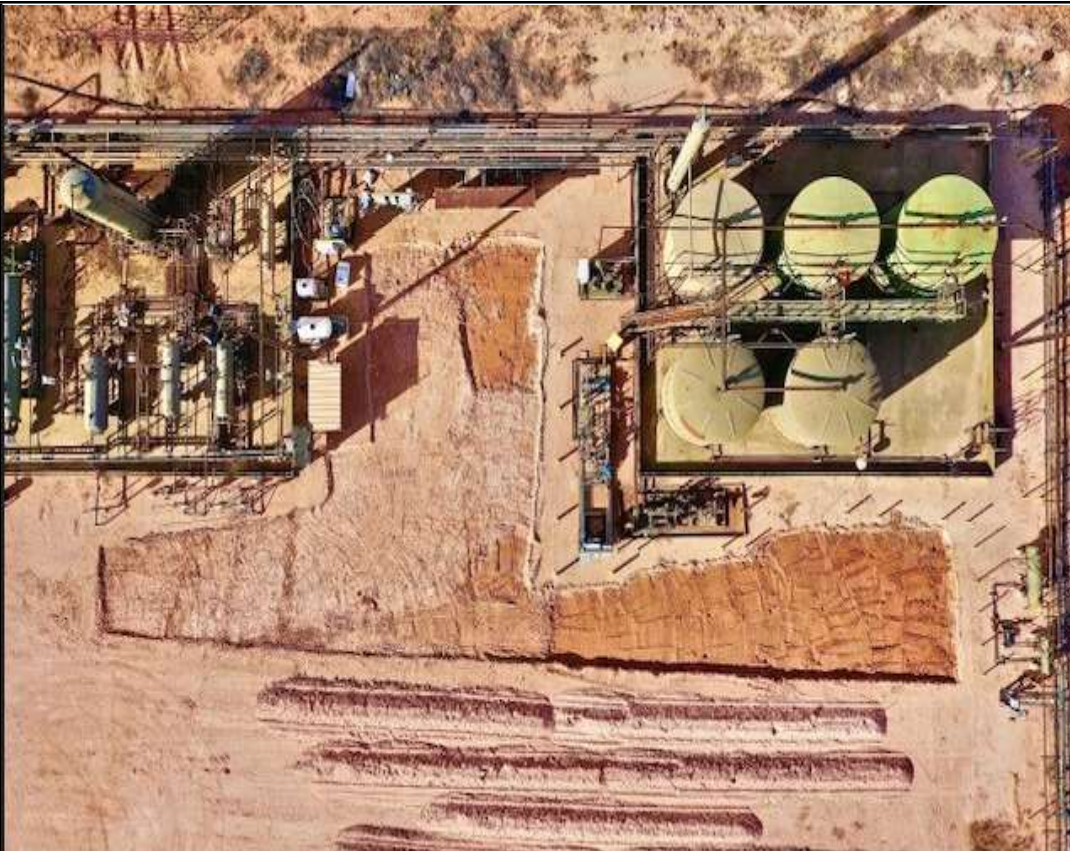
<b>Photo Number:</b> 6

An aerial photograph of an industrial facility. On the right side, there are four large, cylindrical storage tanks, two of which are painted yellow. To the left of the tanks is a complex network of pipes, walkways, and smaller industrial structures. The surrounding ground is a mix of reddish-brown soil and some vegetation. The overall scene shows a large-scale industrial or remediation project.
<b>Photo Direction:</b> Top Down	
<b>Photo Description:</b>  <i>Aerial view of affected area after remediation activities.</i>
